Carruthers Creek Watershed Plan Fluvial Geomorphic Assessment

FLUVIAL GEOMORPHIC ASSESSMENT OF REGIONAL WATERSHED MONITORING PROGRAM DATA 2003-2016

Prepared by:
MATRIX SOLUTIONS INC.

REVISED
October 2019
Mississauga, Ontario

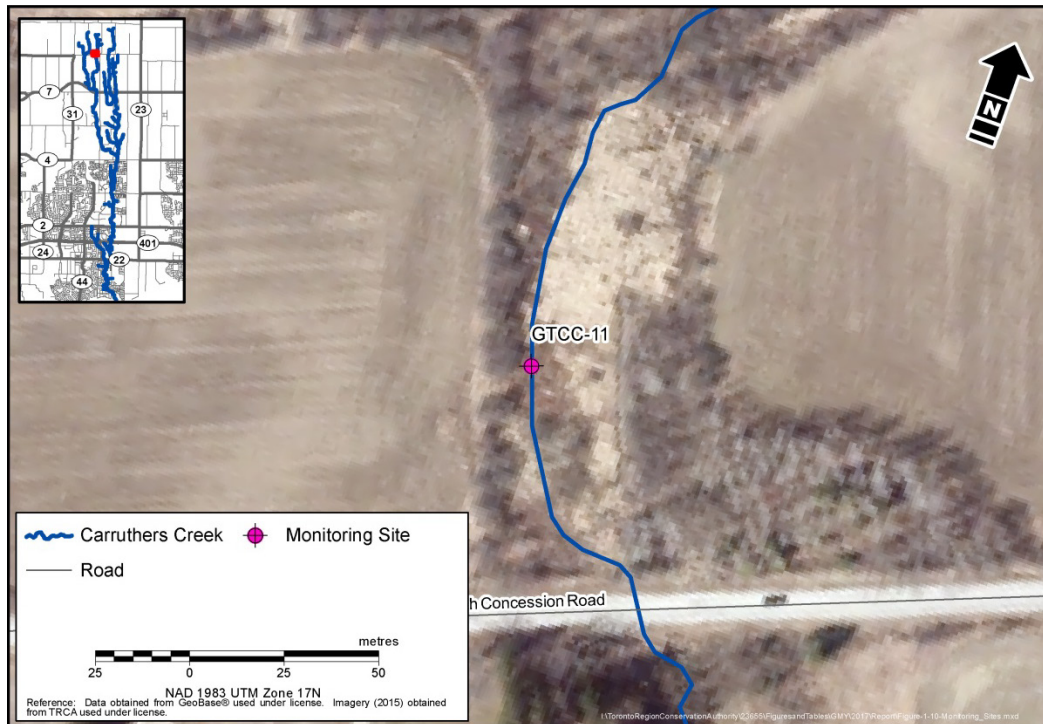
FIGURE 7 Location of GTCC-11 Monitoring Station

The GTCC-11 station is located approximately 200 m upstream of Highway 7. The channel is located in an area vegetated with shrubs, tall grasses, and deciduous trees. This vegetated area is approximately 60 m wide beyond which are agricultural fields. The eastern bank is vegetated with poplar trees and red osier dogwoods, while the western bank is vegetated with tall dense grasses.

In 2003, the cross-sectional area for the monitoring cross-section was 0.41 m². The cross-section had a narrow “V” shape, typical of a small tributary. At the time of survey (October) the wetted width was 0.30 m. The bankfull width was approximately 0.71 m and the max depth was 0.36 m. Over the monitoring period, the cross-section exhibited a steadily increasing cross-sectional area. Between 2003 and 2016, the cross-sectional area increased by 0.10 m² or approximately 48%. The cross-section overlay indicates that this change corresponds to a deepening and widening of the thalweg, transitioning the cross-section from a “V” to a “U” shape. The 2006 and 2009 cross-sections show the cross-section deepening to a maximum depth of 0.43 m in 2009. The 2012 and 2016 cross-sections then show widening of the bed through ongoing toe erosion, while the maximum depth returns to a consistent 0.40 m. Comparing the 2016 cross-section to the other years also suggests deepening of the floodplain area. This could be a result of higher flows more frequently spilling onto the floodplain and establishing a larger bankfull cross-section. Shifts in floodplain topography can also be tied to growth and die-off of dense, tall grass vegetation. These changes in cross-sectional shape are a manifestation of typical channel processes in a small headwater channel.

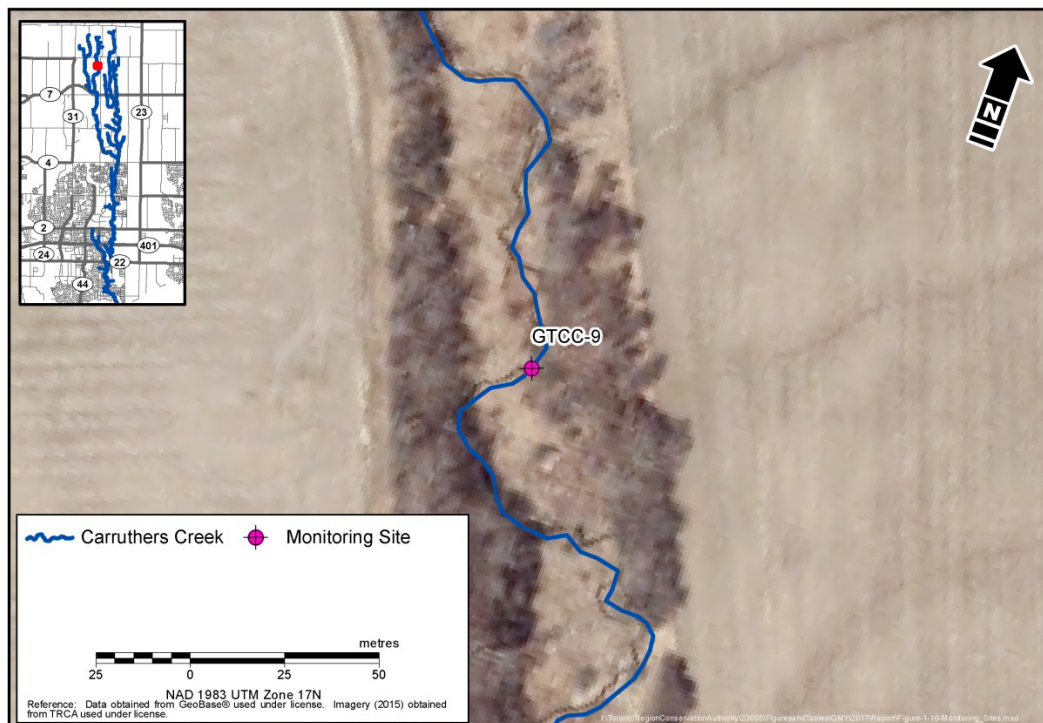
FIGURE 8 Location of GTCC-9 Monitoring Station

The GTCC-9 station is located approximately 700 m downstream of GTCC-11. It is approximately 2 km from the confluence with the main channel. At GTCC-9 the channel is located on the floor of a valley, which is approximately 20 to 40 m wide. The channel meanders across the valley floor, periodically contacting the valley walls. The valley floor is vegetated with meadow grasses and woody shrubs such as buckthorn and red osier dogwoods. The slopes are populated by deciduous trees. Beyond the top of the valley are agricultural fields. At the monitoring cross-section, the right bank (western) is vegetated with tall grasses and the left bank (eastern) is covered by a large red osier dogwood. The monitoring photographs indicate that the cross-section was originally installed immediately downstream of the dogwood. Over time the dogwood has grown sufficiently large that it encompasses the area where the left bank pin is located. This made it difficult to properly level the measuring tape along the left bank due to the dense woody vegetation that must be pushed down to allow the tape to lie flat.

In 2003, the cross-sectional area for the monitoring cross-section was 0.83 m². The cross-section had a notched low-flow channel in the center with a bottom width of approximately 0.50 m. The 2006 cross-section was distinctly different from all other monitoring years and appears to have captured a transitional period. The cross-section bottom width increased to approximately 0.77 m and no longer exhibited a defined low-flow area. Between 2003 and 2006, cross-sectional area increased by 0.16 m², the largest change during the 13-year period. Due to the transitional shape, it was difficult to define bankfull for the 2006 cross-section. The cross-sections for 2009, 2012, and 2016 all indicate that the channel is migrating toward the right bank. This is evidenced by the increasing elevation of the left bank profile and the consistent retreat of the right bank. The cross-section is also deepening along the right side. Over the 13-year monitoring period, the bed has deepened by approximately 0.10 m, based on comparison of the maximum depth values from 2016 and 2003. The overall cross-sectional area has increased by 0.30 m² or 35%. This overall increase in cross-sectional area is likely a result of the ongoing channel migration, as noted above. It is anticipated that this channel adjustment will ultimately stabilize, provided sediment and flow regimes remain generally consistent.

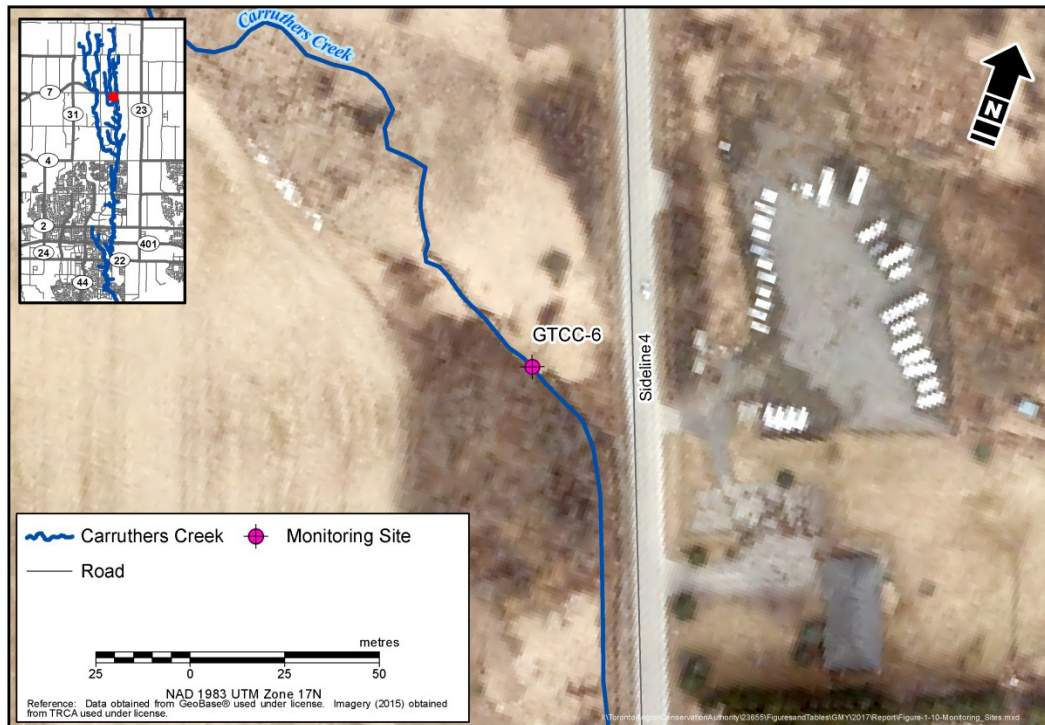
FIGURE 9 Location of GTCC-6 Monitoring Station

The GTCC-6 station is the most upstream station, located approximately 325 m downstream of Highway 7, near the crossing of Concession 4. On the south side of the channel is a small deciduous woodlot with meadow grasses. The north side is vegetated with tall, dense meadow grasses and shrubs. The monitoring cross-section is located in a highly active area of the channel where ongoing erosion of the right bank is occurring. As a result of this, there were challenges maintaining the cross-section bank pins. The 2003 cross-section was not considered as part of the results because the cross-section was reinstalled in 2006 after the right bank pin was completely lost. The 2006 cross-section is 2.3 m wider than the original 2003 cross-section. There also appeared to be an issue with the 2006 cross-section when compared to subsequent cross-sections. This is likely related to the movement of the right pin from 6.0 m (2006) to 6.85 m (2009). Therefore only the 2009, 2012, and 2016 cross-sections were evaluated. Flow in GTCC-6 is intermittent, as evidenced through the lack of flow observed during the field visits, completed at different times. However, the monitoring results demonstrate that this channel experiences sufficient flow during wetter periods, to result in toe erosion and undercutting.

The three cross-sections indicate that the cross-section has deepened and also migrated further into the right bank. This is expected given the erosion and severe undercutting of the right bank seen in the monitoring photographs. Minimal change to the left bank profile has occurred. Between 2009 and 2012, the cross-section deepened with the maximum depth increasing from 1.00 m to 1.13 m. The 2016 cross-section exhibits aggradation along the left bank toe and erosion of the right bank toe. There were increases in cross-sectional area both in 2012 and 2016, indicating that the channel is not just migrating toward the right bank, but also enlarging. The cross-sectional area in 2009 was 3.35 m² and increased to 4.05 m² in 2012, and then 4.23 m² in 2016. Over the 7-year period, this was an increase of 0.88 m² or 26.2%.

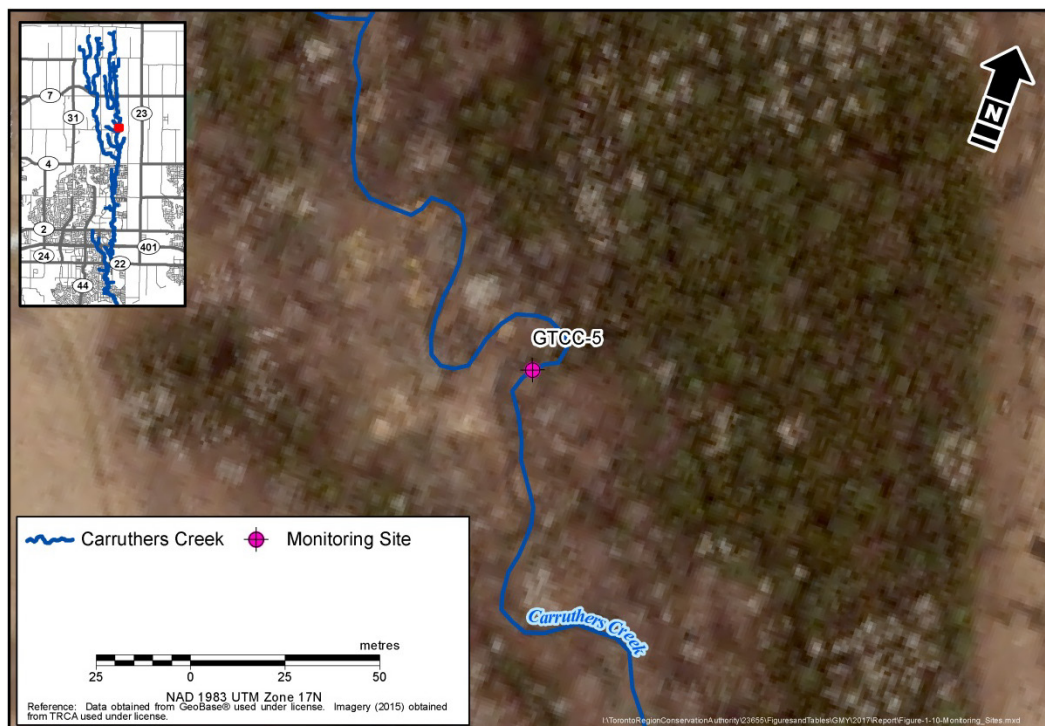
FIGURE 10 Location of GTCC-5 Monitoring Station

The GTCC-5 station is located in a large woodlot upstream of the Deer Creek Golf Course. Through this area the channel is quite sinuous with tight bends and steep eroding banks. Woody debris, such as branches and downed trees, was common, resulting in debris jams. The banks in this reach were higher than those upstream, ranging from 0.50 to 1.25 m. This is indicative of incision. The monitoring cross-section is located on the downstream straight section of an “S” bend. There is substantial erosion along the outer bank upstream of the cross-section; the bend has overwidened and formed a large pool. A large willow tree fell across the channel at the monitoring cross-section between 2009 and 2012; due to this, the measuring tape would not lie flat in 2012 and 2016. The impact on the cross-section graph could not be quantified; it is assumed that the cross-section shape is representative of field conditions. Specific depth measurements for 2012 and 2016 are likely to be slightly higher than in the field due to the tree pushing the tape higher in the center of the cross-section. The two cross-sections correlate well with each other signifying that the tree had a consistent impact on measuring tape and cross-section measurement.

The monitoring cross-section at GTCC-5 experienced the most significant change out of all the monitoring stations. The channel has substantially incised at this location as the result of a debris jam failure. Debris jams establish a sharp change in elevation on the channel profile. When a debris jam fails, the channel will incise to remove the difference in elevation and re-establish a consistently sloped profile. This process was well documented at the GTCC-5 cross-section. Based on the cross-section overlay and corroboration

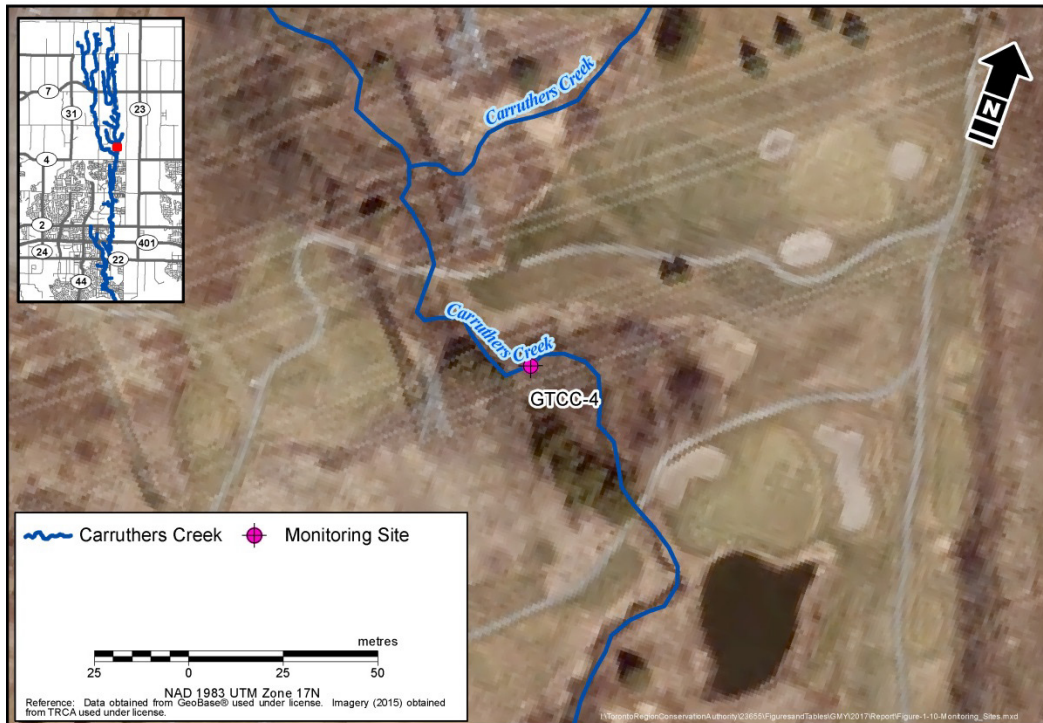
FIGURE 11 Location of GTCC-4 Monitoring Station

bend. In the upstream bend, there was severe woody debris obstruction. Upstream of the bend, the channel flows adjacent to a valley wall along the right bank. The bend downstream of the cross-section has severe erosion of the outer bank. The bank is steep and elevated, with minimal vegetative buffer from the golf course, approximately less than 5 m.

In 2003, the cross-sectional area for the monitoring cross-section was 1.64 m². The maximum depth was 0.81 m. The cross-section had a narrow low-flow area, with a bottom width of approximately 0.60 m. Between 2003 and 2009 the cross-sectional area steadily increased, primarily through erosion of the vertical left bank, widening the bottom width of the channel. The 2009 cross-section appears to be capturing a transition between the 2003/2006 cross-sections and the 2012/2016 cross-sections. In 2009, the cross-section incised to a maximum depth 0.87 m. This is the deepest measured cross-section during the monitoring period. The 2012 cross-section then exhibits a large loss of material from the lower portion of the right bank, where very little change was noted in the previous cross-sections. It is unclear from the monitoring photographs what may have caused this. The left bank also exhibited a noticeable retreat between 2009 and 2012. The change in cross-sectional area between these 2009 and 2012 was 0.15 m² or approximately 8%. The 2012 and 2016 cross-sections have a wider bottom width of approximately 1.4 m as compared to approximately 0.60 m in 2003. Visually comparing the cross-sections, the 2003/2006 cross-sections have a narrow defined low-flow area, while the 2012/2016 cross-sections have a larger general “U” shape. This change in cross-sectional shape is reflected by a 25% increase in cross-sectional area over the 13-year monitoring period.

One erosion pin is located at the monitoring cross-section in the left bank, EP2. The pin exhibited increases in exposure ranging from 6 to 15.5 cm. Based on this data, the average erosion rate for the left bank was approximately 2.86 cm/year. Erosion pin 4 exhibited variable results ranging from large increases in exposure (36.5) to large decreases in exposure (-19.5). This is indicative of an area which is eroding, destabilizing, and collapsing. Erosion pin 1 was located in the outer bank of the eroding bend downstream of the cross-section. It was found eroded out of the bank in 2016 and exhibited large increases in exposure in 2012 and 2009. Based on EP1, the average erosion rate in this bend is approximately 8.6 cm/year. Overall, based on all the erosion pin data for GTCC-4, the average erosion rate was 5.03 cm/year.

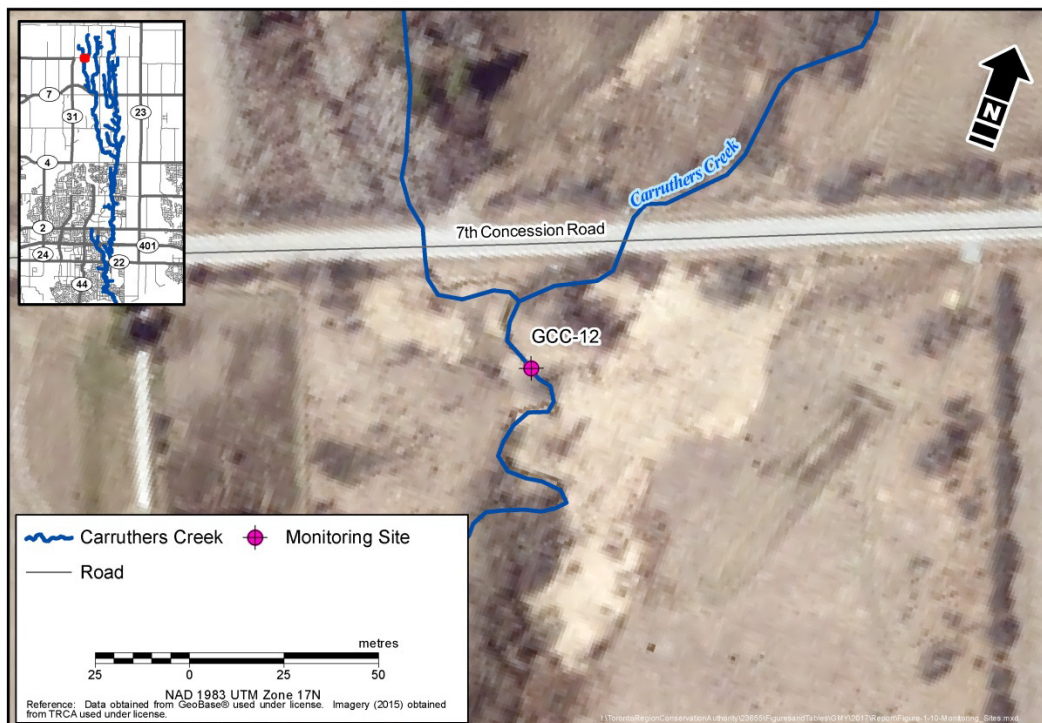
FIGURE 12 Location of GCC-12 Monitoring Station

The GCC-12 station is the most upstream station on the Main Branch of Carruthers Creek. It is located approximately 100 m downstream of Concession 7. The channel flows adjacent to a rural residential property with agricultural fields surrounding the riparian corridor. The riparian corridor is relatively wide at the monitoring station approximately 80 to 100 m. The surrounding vegetation is predominantly tall meadow grasses and small willow woodlots. At the monitoring cross-section, both banks are vegetated with meadow grasses.

There were challenges maintaining the monitoring cross-section at GCC-12 due to ongoing erosion of the right bank. Neither of the cross-section bank pins could be located in 2016. The cross-section was reinstalled based on an erosion pin that corresponded to the cross-section. Therefore, the 2016

cross-section should not be compared with other monitoring years. It was also noted during the 2016 measurement that the right bank was noticeably higher than the left bank, making it difficult to level the tape. Assuming the cross-section was reinstalled at the correct location, this difference in bank height could have impacted previous cross-section measurements. Notes from the 2009 cross-section measurement also indicated that the tape was not level. This may have been a result of moving the right pin back which occurred in 2009. The pin was moved from 4.3 m to 5.1 m, presumably to prevent loss due to erosion. The movement of the right bank pin in 2009 made comparisons to the earlier years, 2003 and 2006, difficult.

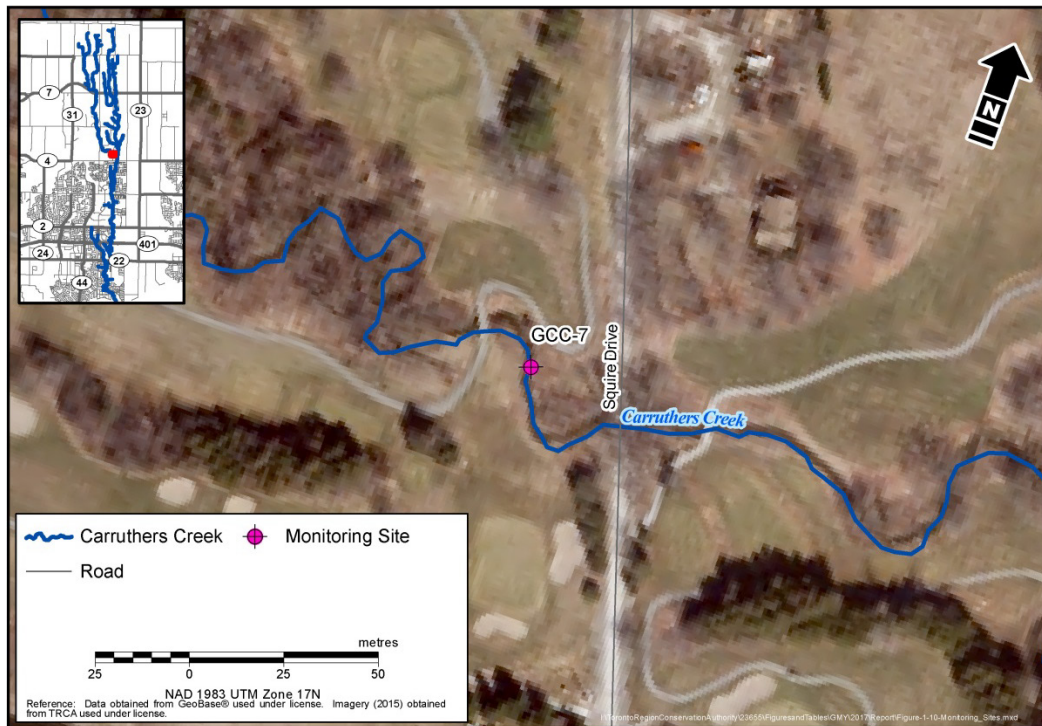
FIGURE 13 Location of GCC-7 Monitoring Station

The GCC-7 monitoring station is located at the south end of the Deer Creek Golf Course. Specifically, it is located in a 50 m reach of channel between a cart path crossing and a golf course road (Squire Drive). The channel is surrounded by golf course fairway and has a minimal riparian buffer of less than 5 m. The close proximity to golf course operations led to challenges in maintaining the cross-section. The 2009 cross-section needed to be reinstalled after the right bank pin was found lying on the bank. The pin was reinstalled 1.5 m wider than the original cross-section. The right bank pin had to be reinstalled again in 2012 due to the removal by golf course maintenance staff. A cross-section was not completed in 2016 because neither of the bank pins could be located; due to previous issues it was not reinstalled. Based on these issues, only the 2003 and 2006 cross-sections could be compared.

Between 2003 and 2006, the cross-section exhibited evidence of erosion along the right side of the cross-section and right bank face. This was paired with an accumulation of material on the left side of the cross-section. The cross-sectional area was reduced from 1.75 m² to 1.5 m², approximately -14%. Based on these two years, the channel was migrating toward the right bank. Without subsequent years of data it is unclear if this process continues and if there is a general trend of reduction in cross-sectional area.

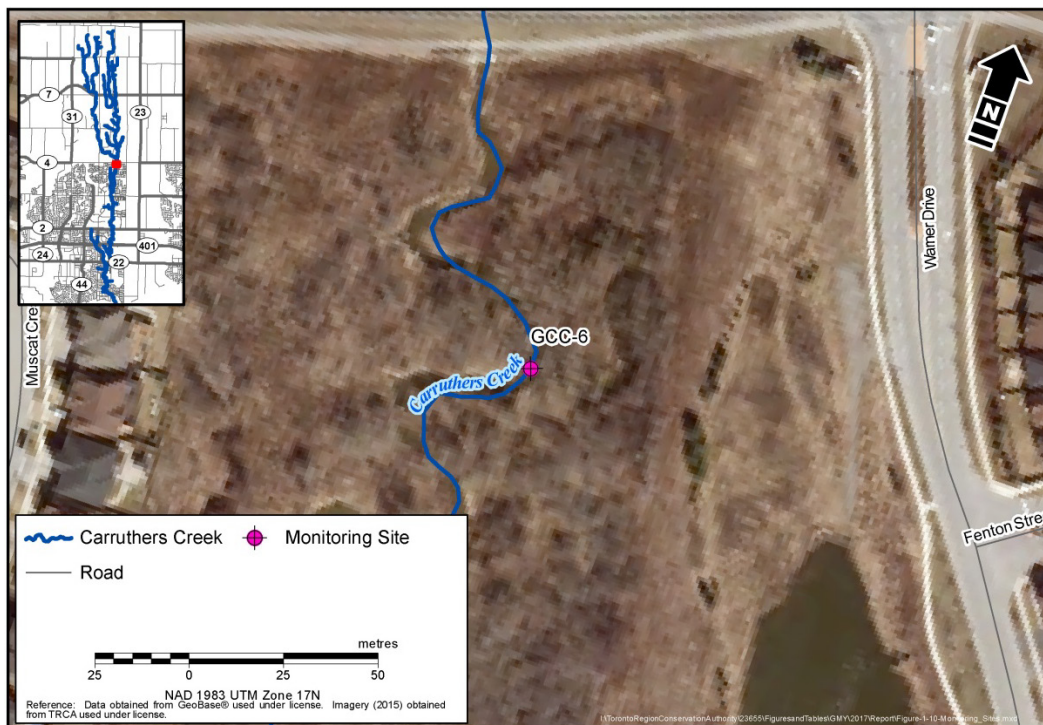
FIGURE 14 Location of GCC-6 Monitoring Station

The GCC-6 monitoring station is located immediately south of Taunton Road in a riparian corridor between two residential areas. The residential area to the east was completed between 2005 and 2008, while the area to the west was completed shortly after. Stormwater management ponds are located on either side of the channel corridor, as well as a paved trail to the east. This is the first of three stations located in the southern developed portion of the watershed. The channel is situated within a woodland area approximately 125 m wide. Vegetation consisted of deciduous trees, woody shrubs, and tall grasses. The channel is quite sinuous with tight eroding bends. Eroding and undercutting banks were common throughout the reach resulting in frequent slumped vegetated blocks. The monitoring cross-section is located in a straight section of a large bend. The left bank at the monitoring cross-section corresponds with the outer bank of the bend and is vertical, while there is a vegetated point bar located along the right side of the cross-section. The wetted width is narrowed by the point bar and flow is focused along the toe of the left bank. This encourages erosion and undercutting.

Out of all the monitoring sites, the cross-section at GCC-6 was the most consistent, exhibiting minimal change over the 13-year monitoring period. The cross-sectional area in 2003 was 5.42 m² with a maximum depth of 1.37 m. Maximum depth was extremely consistent at 1.34 m in both 2006 and 2009 and 1.33 m

in 2012. This indicates that the channel bed has not changed. The only change in the cross-section was retreat of the left bank. The most significant change during the monitoring period was noted between 2006 and 2009; cross-sectional area increased from 5.20 m² to 5.54 m², approximately 6.6%. Over the entire monitoring period, the cross-sectional area increased by only 4.8%. The cross-section can be considered stable.

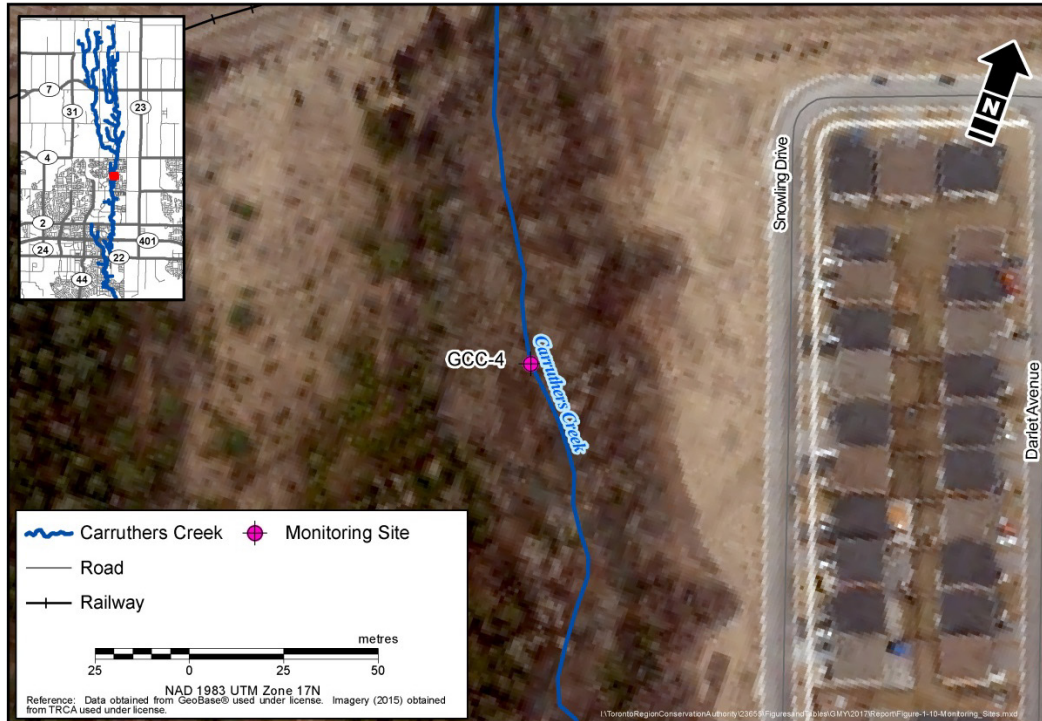
FIGURE 15 Location of GCC-4 Monitoring Station

The GCC-4 monitoring station is located south of a railway crossing in a forested valley. Channel sinuosity is reduced through the reach by the confining effects of the surrounding valley. Surrounding land use is residential development which is located on either side of the valley. The residential development on the east side began around 2005 and was completed around 2014. On the west side, development began around 2012 and was completed around 2015. The forested valley consists of a variety of both coniferous and deciduous species. Leaning and fallen trees were common, particularly along the right bank which coincided with the valley wall.

The monitoring cross-section is located in a straight section which flows along the western toe of the valley. The cross-section is wide compared with other monitoring stations located in grass-lined areas. Toe erosion was noted along both banks. The cross-sectional area in 2003 was 7.81 m² with a maximum depth of 1.38 m. Over the monitoring period, the cross-sectional area steadily reduced to 6.41 m² in 2016 and a maximum depth of 1.13 m. The cross-section overlay indicates that the reduction was primarily through accumulation of bed material. There was erosion of the right bank which is expected because the channel abuts the valley wall along this side. The reduction in cross-sectional area was approximately 18%. Generally, a reduction in cross-sectional area is related to accumulation of fine material as a result of reduced velocity. Reviewing the monitoring photographs suggests that the reduction is a result of accumulation of coarse material across the riffle. This material appears to be a result of natural geomorphic processes where coarse materials settle out in the riffles and fine materials are flushed out, ultimately further armouring the riffle.

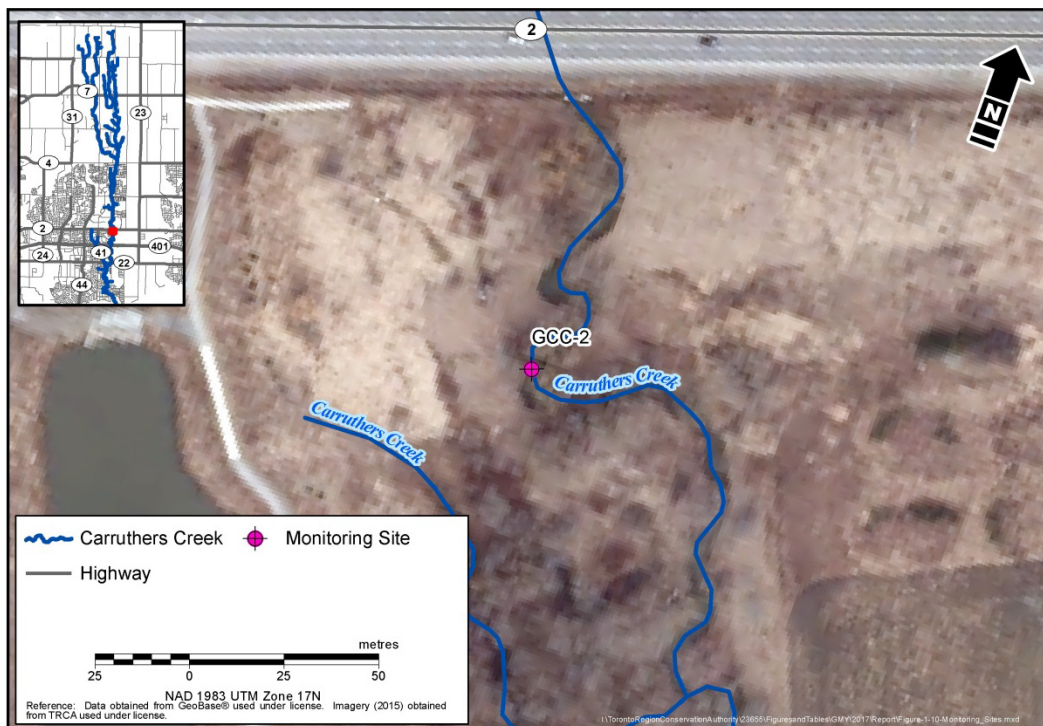
FIGURE 16 Location of GCC-2 Monitoring Station

The GCC-2 monitoring station is located immediately south of Kingston Road and it is the furthest downstream station. The channel flows through a meadow dominated area with some small deciduous woodlots. To the west is a residential development, a stormwater management pond, and a paved trail. The development was built over the course of the monitoring period, completed between 2009 and 2012. To the east is an agricultural field. The channel is quite sinuous through this reach. The reach was characterized by tall, steep, undercutting banks. Bank height was frequently 1 m with material scoured out from beneath the upper vegetative root layer. Deep scour pools and accumulation of fine material was also noted. The reach can be considered fairly active based on these indicators.

The monitoring cross-section is located in a short, straight section of channel between two bends. The cross-section was highly active during the monitoring period, both increasing and decreasing cross-sectional area. The cross-section shape has shifted and changed but when cross-sectional areas from 2003 and 2016 are compared, there is negligible difference. The 2003 cross-sectional area was
