Geomorphology Technical Memo (Palmer 2020)

Date: January 15, 2020

Project #: 1903601

Re: Fluvial Geomorphology Baseline Assessment – West Duffins Creek and Duffins Creek
Pickering and Ajax Flood Control Dykes Rehabilitation Class Environmental Assessment

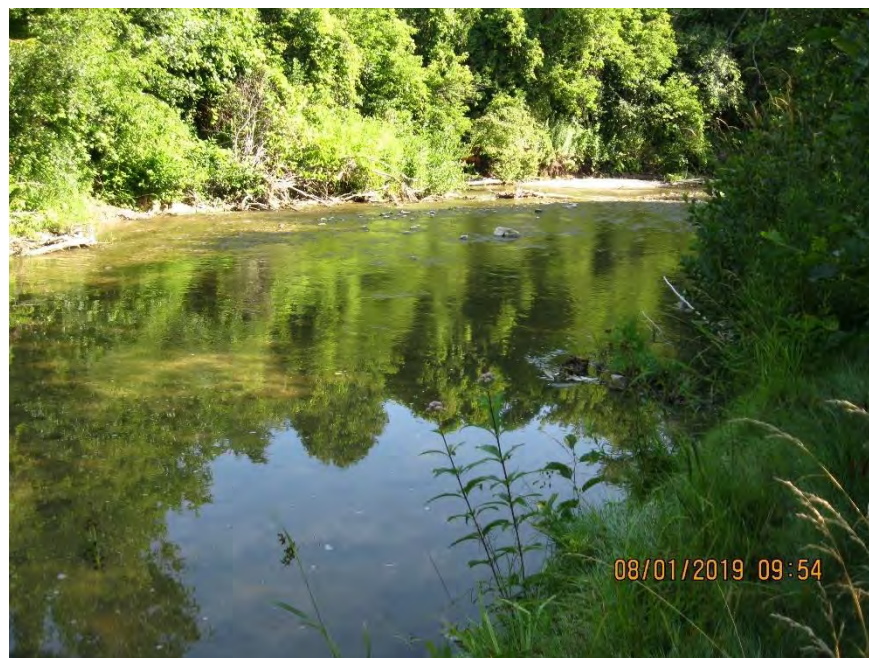
Upstream of Brock Road, the channel has a riffle-glide bed morphology. The previous straightening and associated bed and bank armouring have led to the formation of these steeper geomorphological units. Downstream of Brock Road, the channel has regained some sinuosity and re-established a pool-riffle bed morphology (**Photo 1**). Two prominent riffles (upstream of M2 and upstream of M4) act as natural grade controls and strongly influence the upstream and downstream energy gradients (**Figure 2**). The formation of medial and lateral gravel bars and overbank sand deposits throughout the reach suggest the channel is likely aggrading, which corroborates the findings of previous geomorphic assessment of the reach (Geomorphic Solutions – Sernas Group, 2009).

Photo 1. Looking downstream at the riffle crest upstream of M2

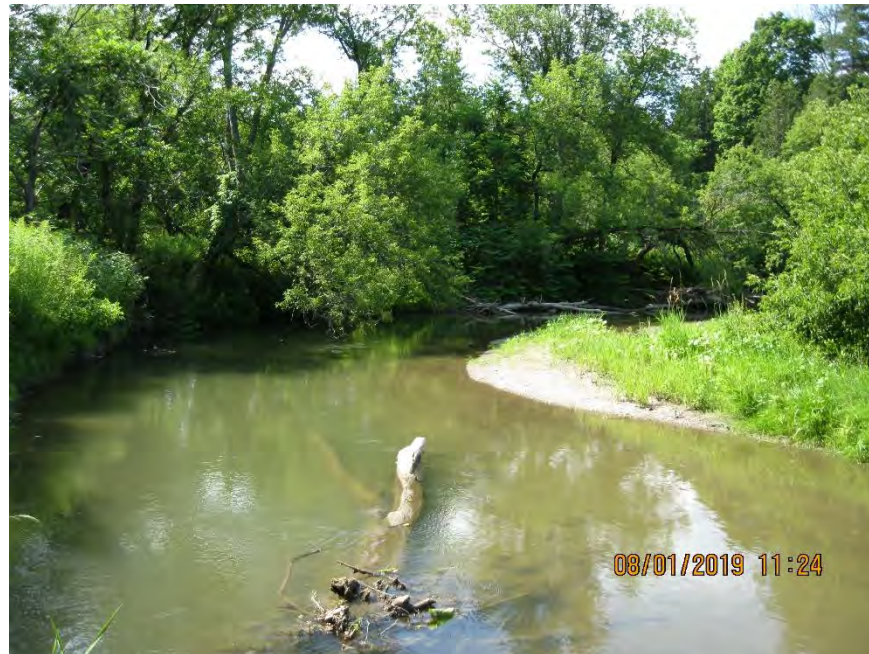
Reach 1b has a defined pool-riffle bed morphology, with pools located near the apices of meanders (**Photo 2**). Small point bars and a medial gravel bar are present in the reach. Bankfull width and bankfull depth are approximately 16 m and 1.6 m, respectively (**Table 1**). The cross-sections in the riffles are nearly symmetrical, whereas the pool units, which are situated near the apices of meanders, are asymmetrical. Localized overbank sand deposits suggest the channel has good connection to its floodplain.

Photo 2. Looking downstream in Reach 1b at a pool, vegetated point bar and large wood upstream of M7

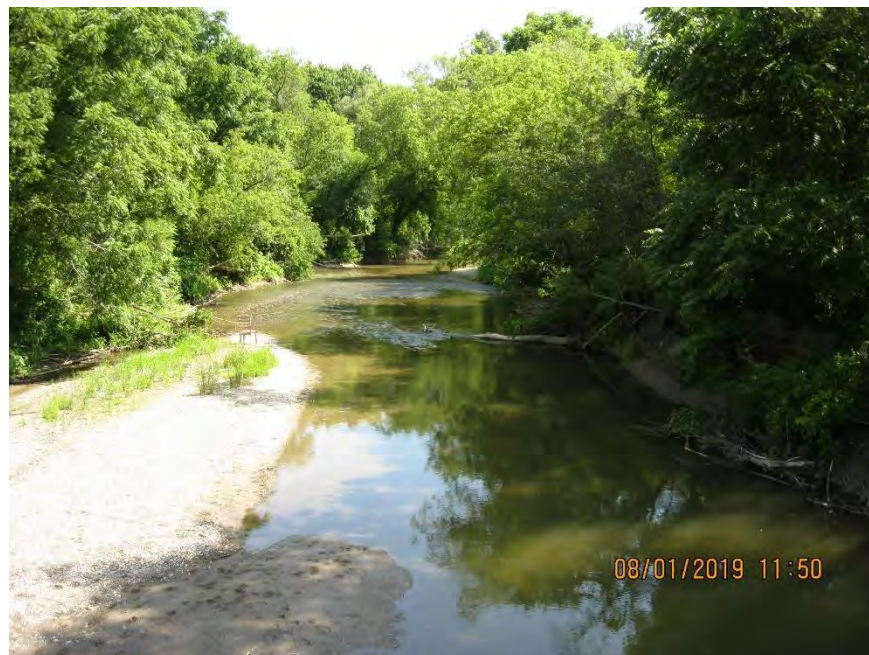
Reach 2 has a defined pool-riffle bed morphology, with pools located near meander apices (**Photo 3**). Large point, medial and lateral gravel bars are present throughout the reach. The large gravel deposits could be sourced from the channel avulsion that occurred near the West Duffins Creek-Duffins Creek confluence between 2002 and 2004. Some localized overbank sand deposits are present; however, the reach appears to be more entrenched than upstream reaches (i.e. floodplain is less accessible).

Photo 3. Looking downstream from pedestrian bridge (M11) at pool (foreground) and riffle (background)

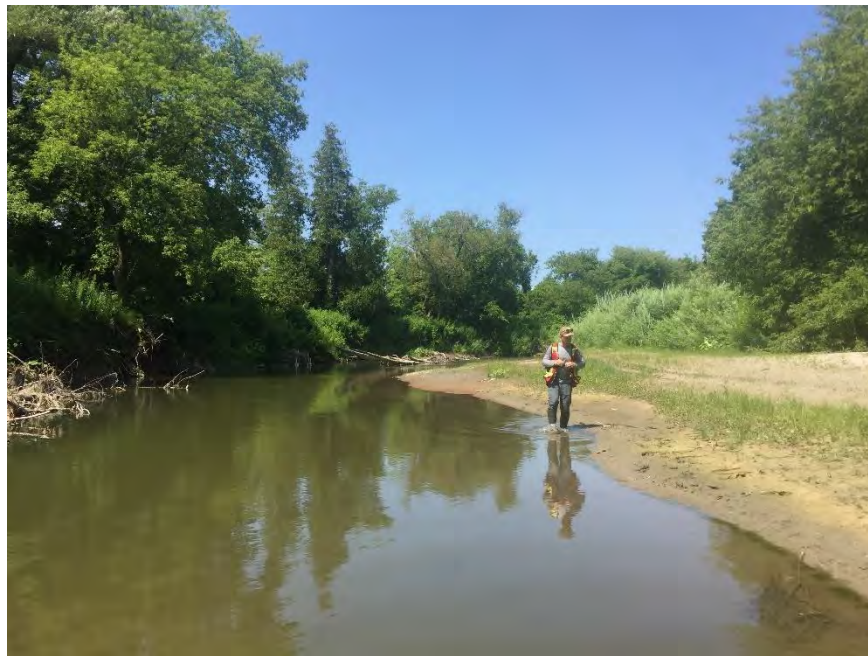
Photo 4. Large wood on outer bank and large fine gravel/coarse sand point bar (looking upstream)

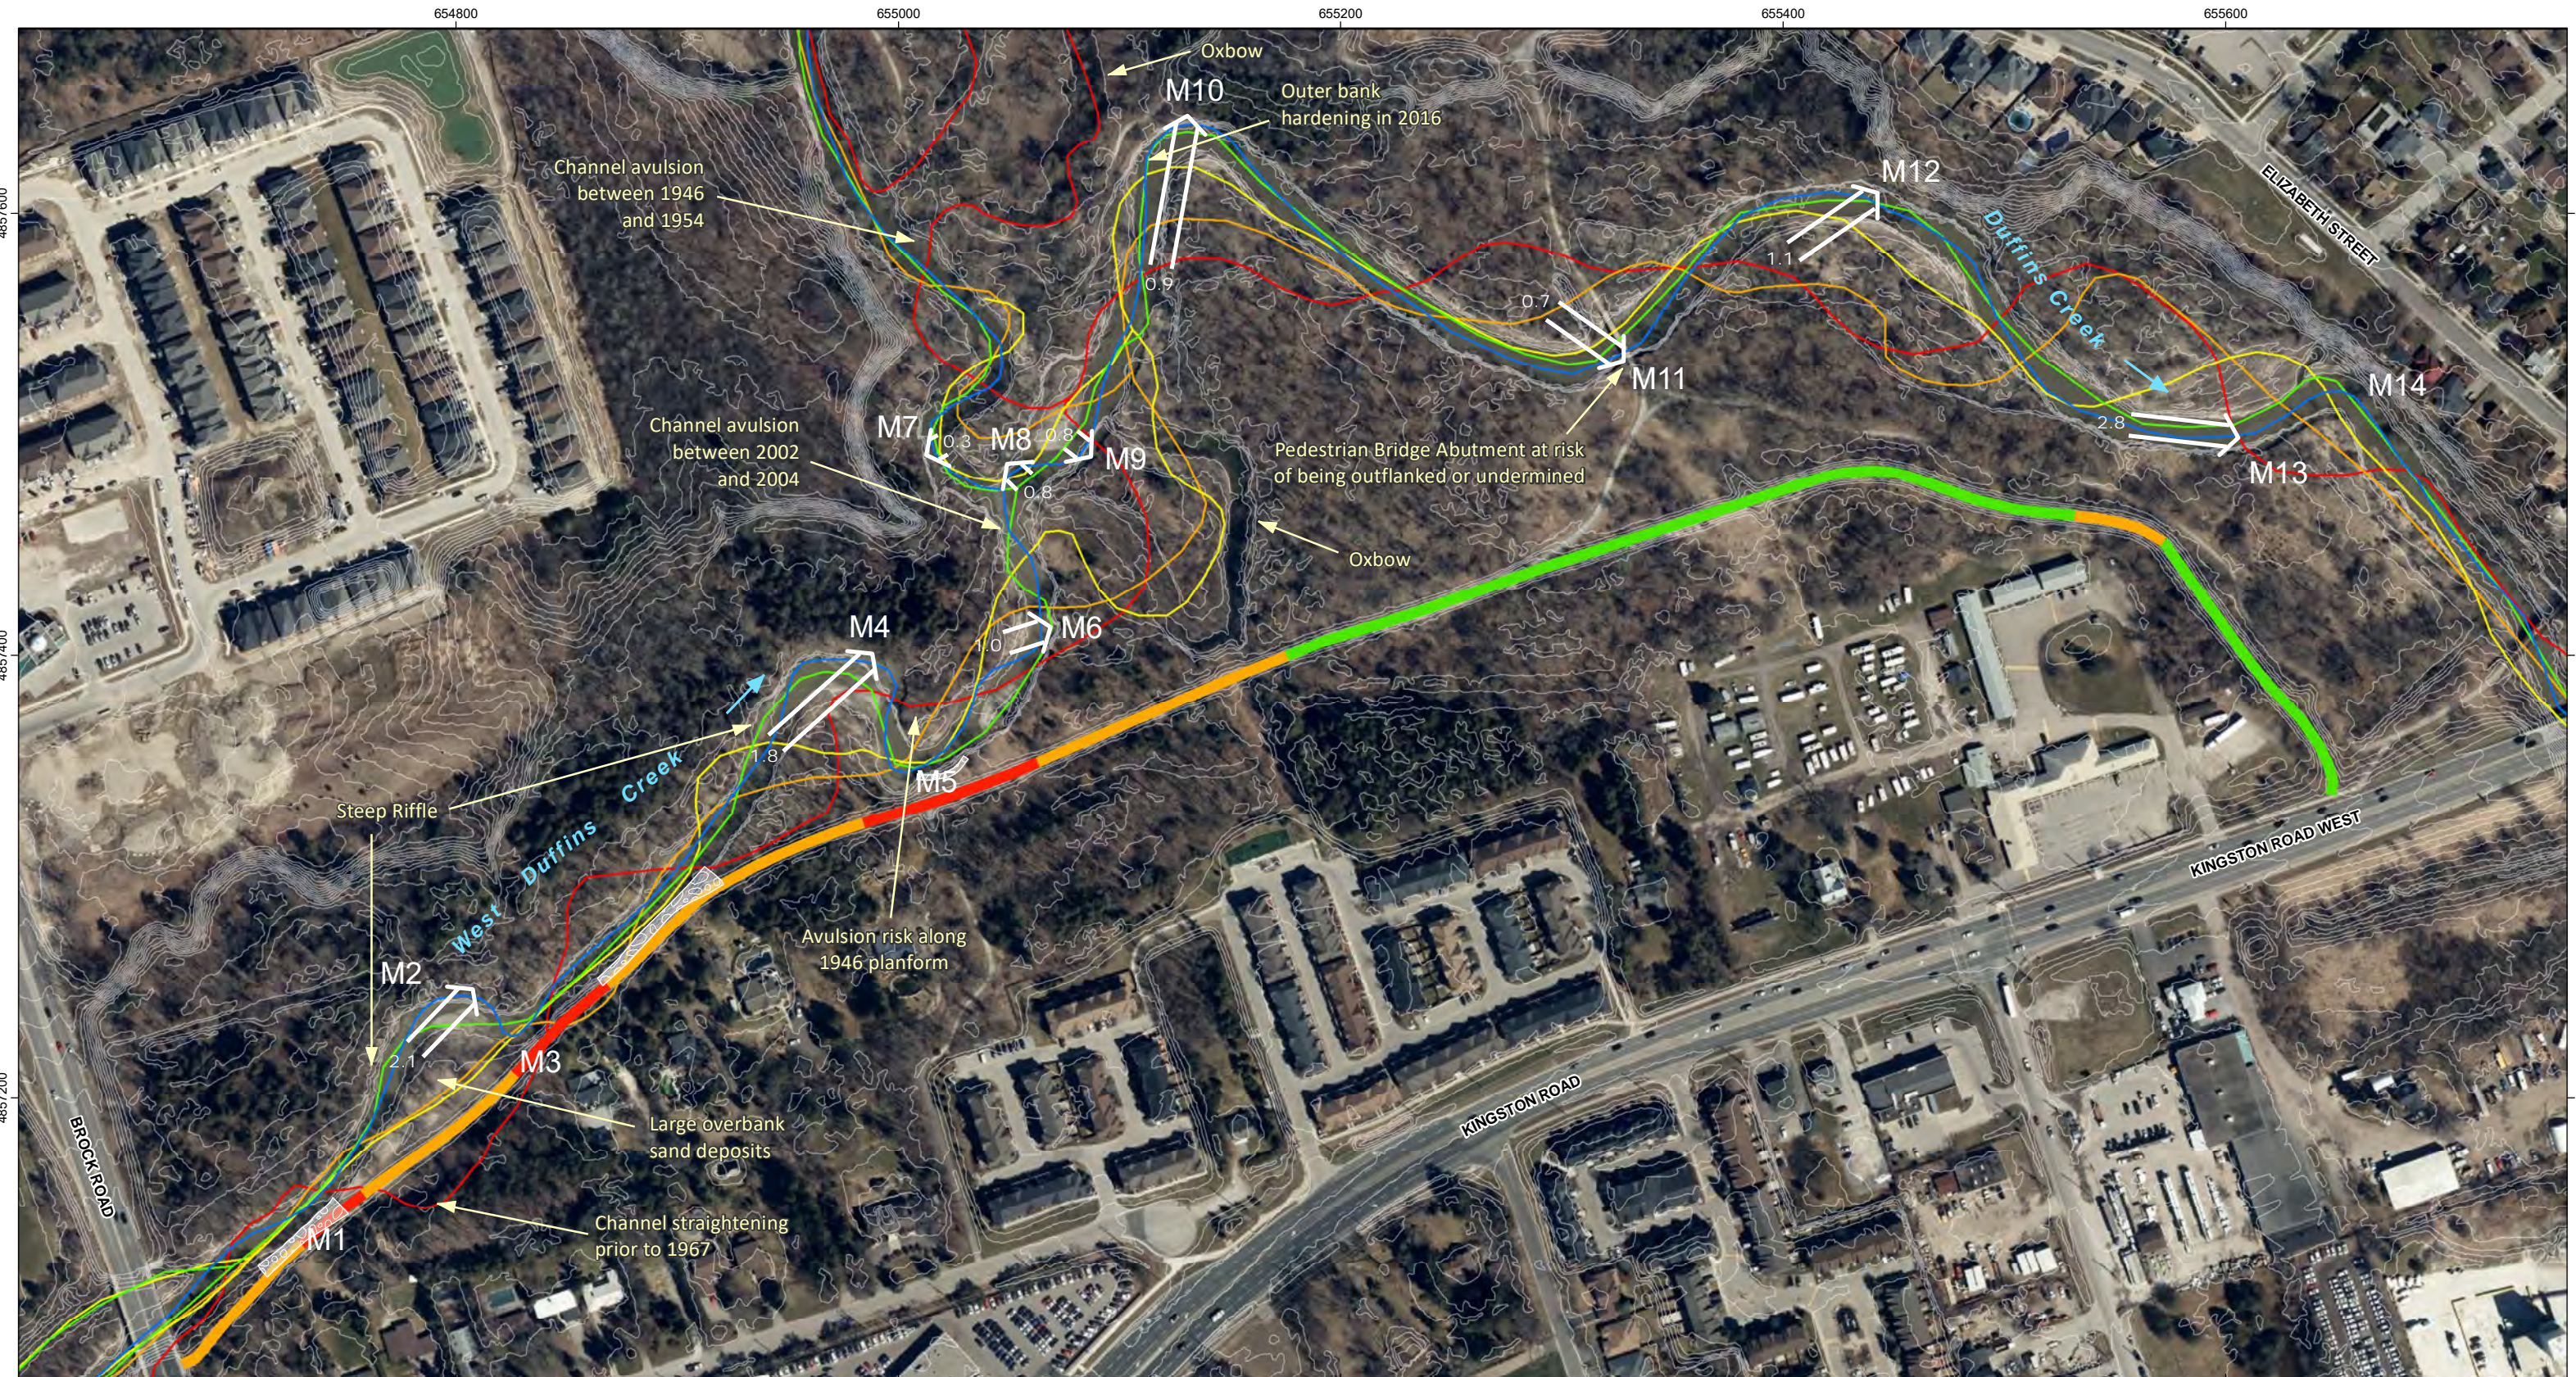
Pickering Dyke
 Figure 2

Rates of channel migration were documented at 14 meanders (**Figure 2**) near the Pickering Dyke. Time-averaged rates and the associated time period in which the meander displayed systematic channel migration are detailed in **Table 1**. Migration rates for individual time periods (e.g. 2002 to 2009) are documented in **Appendix B**. Four existing meanders do not display systematic channel migration due to confinement by the Pickering dyke itself (M1, M3, M5) or by a valley wall (M14). High migrations rates were observed at M2 and M4 in Reach 1a and M13 in Reach 2. Both M2 and M4 are downstream of two prominent riffles that steepen the channel as it enters the meanders. Review of aerial imagery and field reconnaissance indicate the riffles have migrated, which has led to the subsequent down-valley migration at M2 and M4.

Three high risk areas were delineated at M1, M3, and M5 (**Figure 2**). These are consistent with erosion areas documented in the previous geomorphic assessment (Geomorphic Solutions – Sernas Group, 2009). The previous assessment noted failing erosion control blankets, localized soil loss and scour at these three sites. Review of aerial photography and site photographs from the previous assessment reveal growth of riparian vegetation on or near the dyke at all three encroachment sites. Riparian vegetation and associated root networks could increase the shear resistance of the bank to erosion. However, the vegetation could also locally displace the stone comprising the erosion protection. Although active erosion was not observed during field reconnaissance, erosion is expected at or near these locations in the future based on reach-scale planform adjustments. As well, toe erosion of the valley wall is likely to occur at M14 at a rate that could be estimated based on detailed site assessment.

- Replace and extend the riprap protection at M1, M3 and M5. The current riprap is locally displaced/failing and needs to be further extended upstream and/or downstream. The extent of the riprap at the three sites should encompass the 'High' risk line segments, at a minimum.

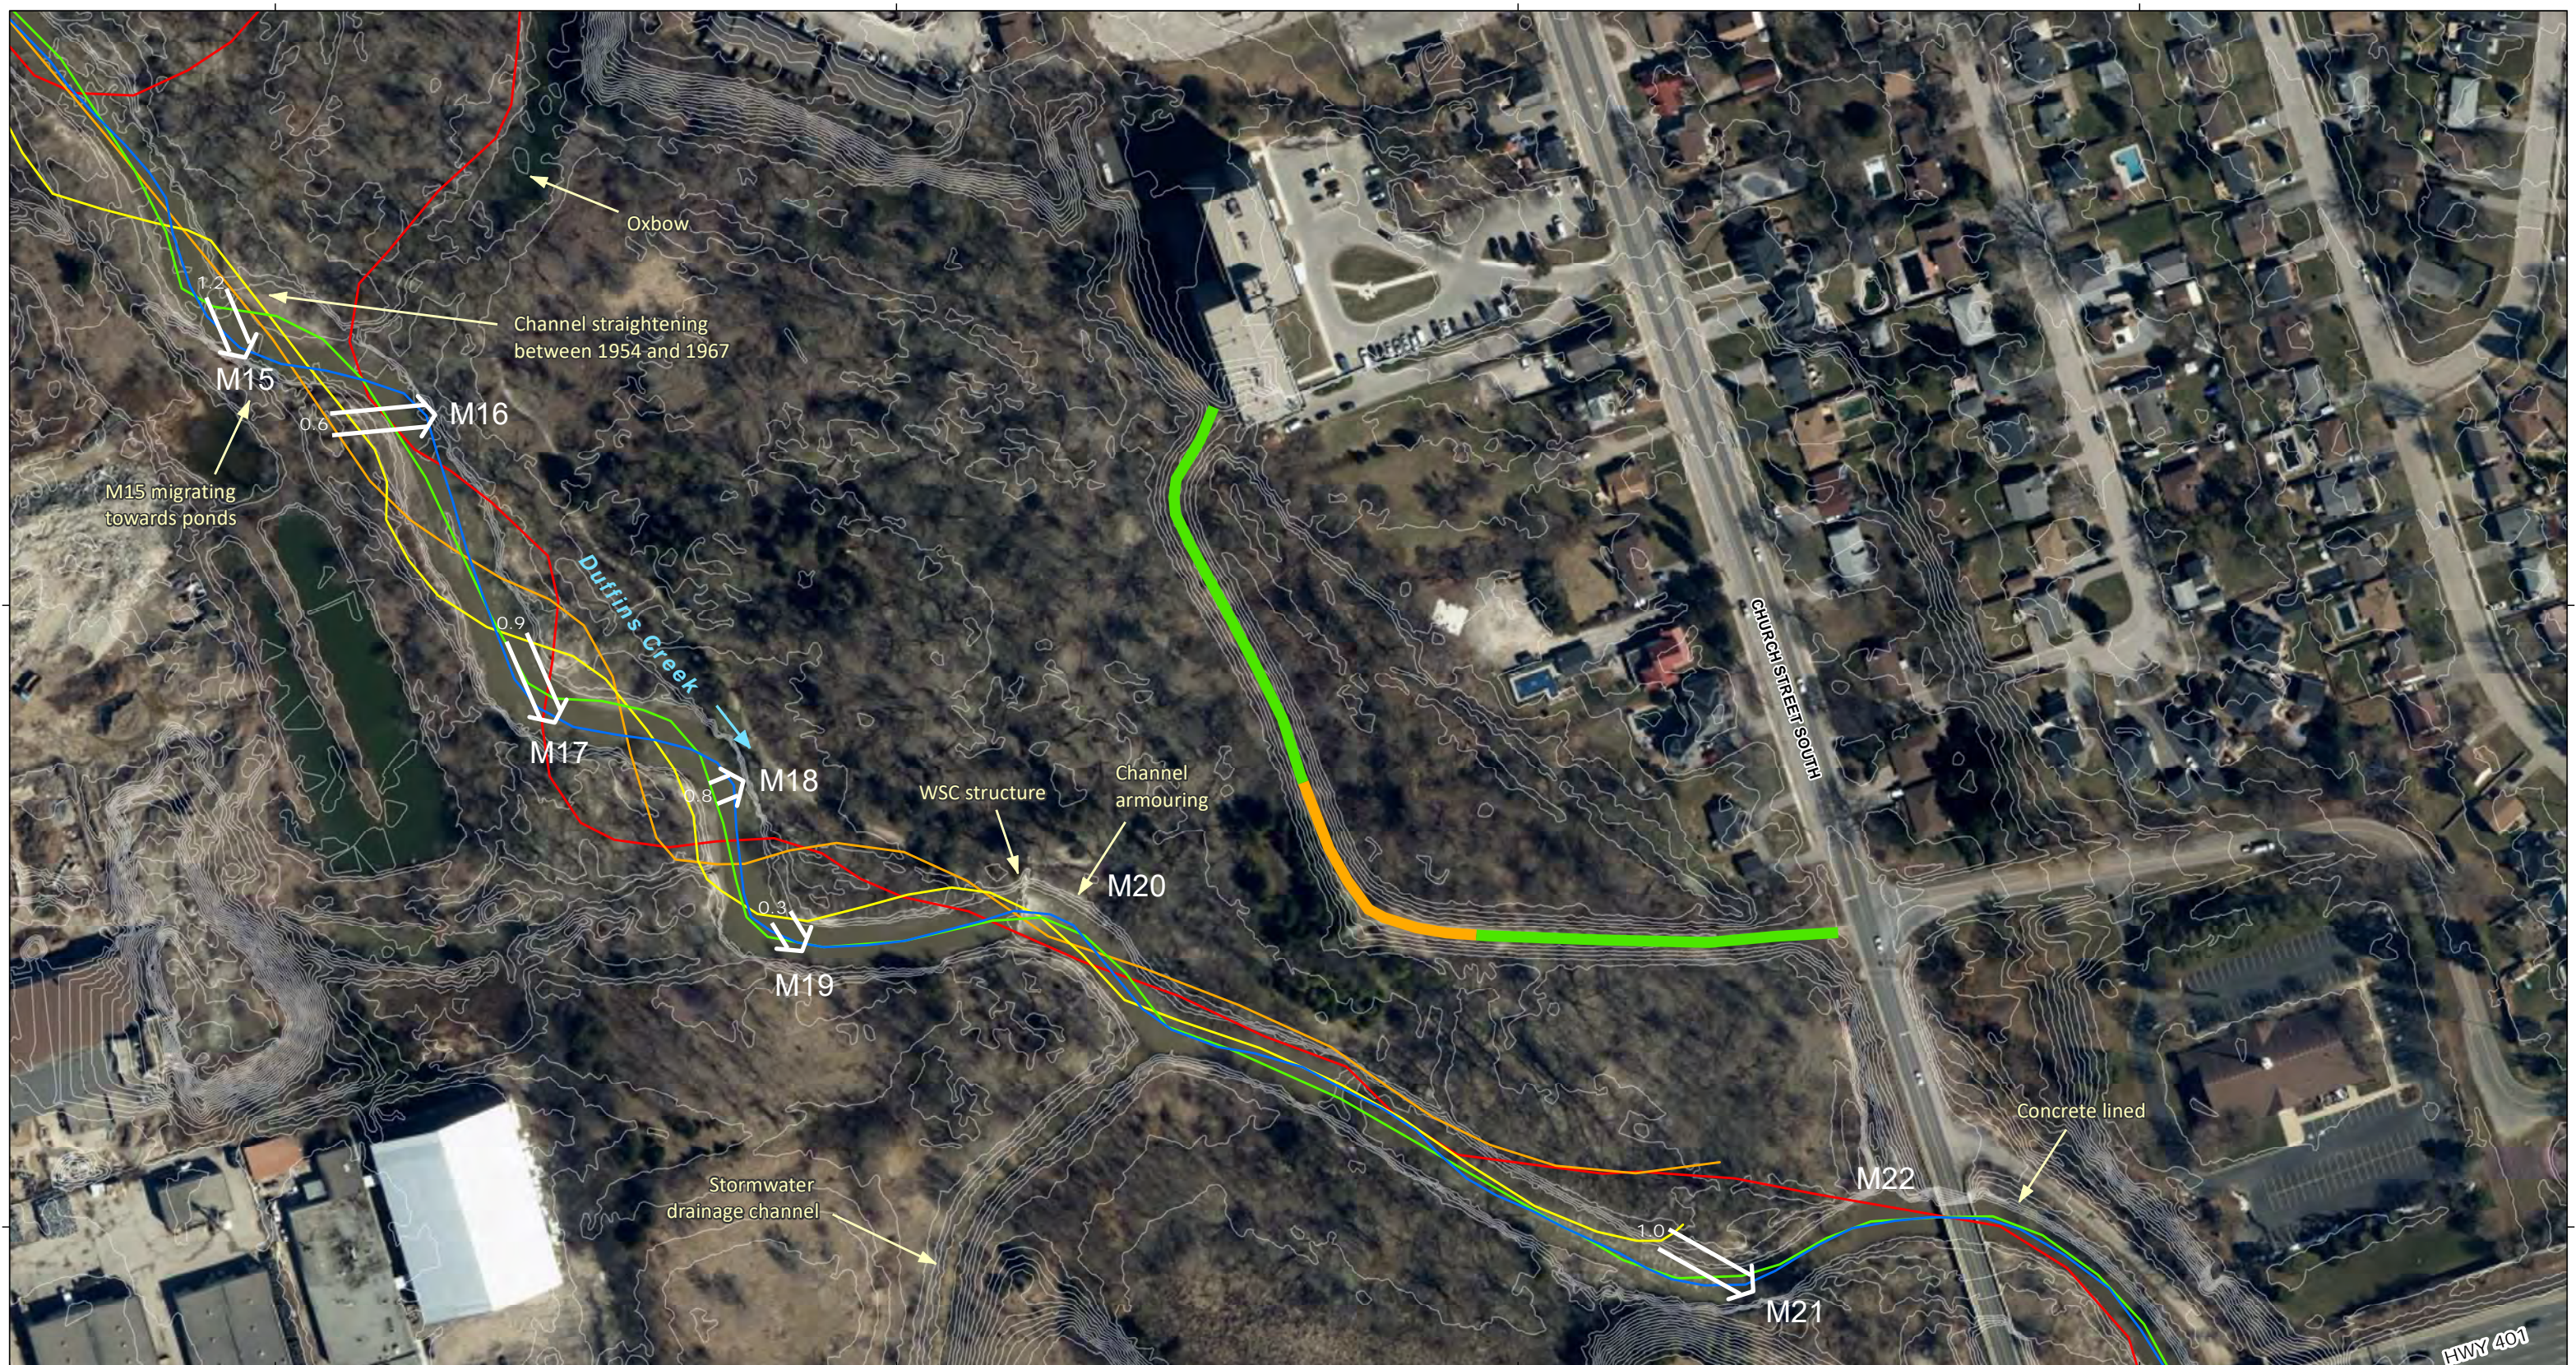
Figure 3

Rates of channel migration were documented at eight meanders (**Figure 3**) near the Ajax Dyke. Time averaged rates and the associated time period in which the meander displayed systematic channel migration are detailed in **Table 2**. Migration rates for individual time periods (e.g. 2002 to 2009) are documented in **Appendix B**. Two meanders did not display systematic channel migration since 1988 (i.e. shortly after the dykes were constructed). M20 is confined by localized channel hardening downstream of the WSC structure. Lateral migration of M22 is hindered by the downstream Church Street South bridge. The other six meanders are migrating both laterally and longitudinally as Reach 3 readopts a more sinuous planform following channel straightening in the mid 20th century.

Based on historic and existing morphological conditions, the Ajax Dyke was divided into erosion risk categories (**Figure 3**). Most of the dyke is considered low risk because the dyke is greater than 50 m from the channel and there are no signs of migration toward the dyke. The dyke is locally within 40 m of the channel, however, the bank protection at M20 will hinder channel migration towards the dyke. M15 is migrating towards the stormwater ponds in the western floodplain. Migration of the channel into the ponds and the potential avulsion that could result would drastically alter channel dynamics and sediment supply downstream in the vicinity of the dyke. Migration of M15 should be monitored. The Church Street South crossing controls the channel location near M22 and, thus, channel migration is not expected at M22 unless the crossing is modified/replaced.

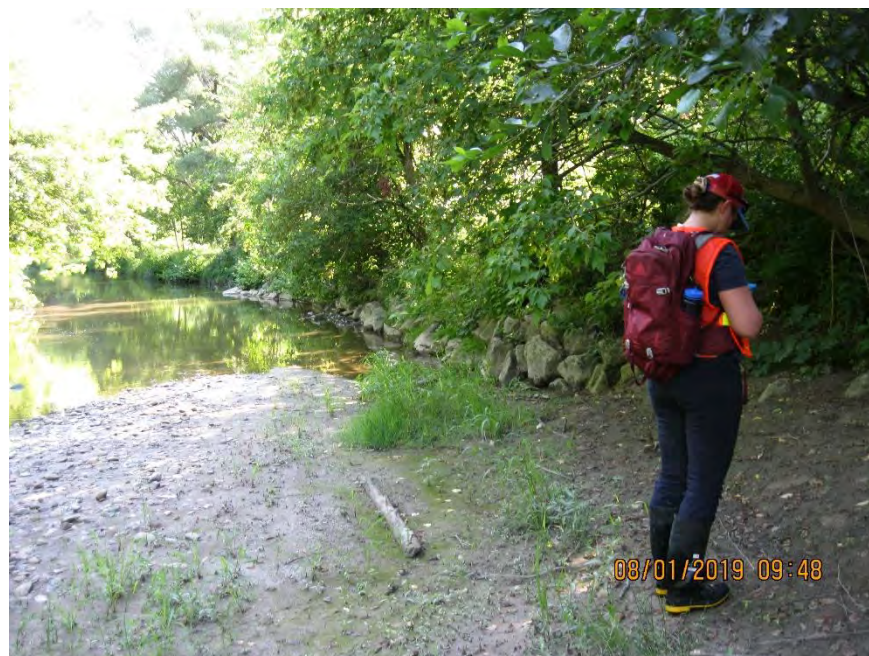
During the recent field reconnaissance, the boulder revetment at M1 was intact and young deciduous trees and shrubs were growing atop and in the voids of the boulder revetment (**Photo 5**). The channel thalweg was located closer to the north (i.e. opposite) bank, which temporarily reduces erosion potential along the dyke. The energy gradient was low due to the prominent downstream riffle crest, which acts as a natural grade control. Some bank/dyke scour was noted at the downstream extent of the existing erosion protection. Lowering of the downstream riffle crest or a shift in the position of the thalweg adjacent the dyke could increase the erosion potential along the dyke at M1.

Photo 5. Looking downstream at sand deposition (foreground), low gradient pool unit (background) and the boulder revetment at M1 (right)

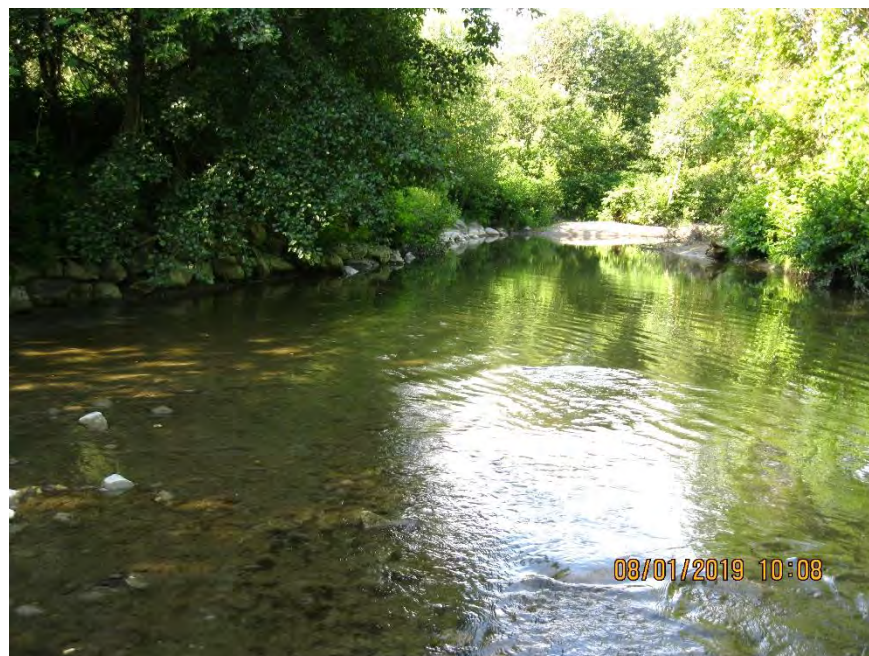
Similar to the energy gradient at M1, the energy gradient along M3 is low due to a prominent downstream riffle crest, which acts as a natural grade control. The boulder revetment along the downstream limb of M3 is intact and young deciduous trees and shrubs are growing atop and in the voids of the boulder revetment (**Photo 6**). Previous bank/dyke erosion was observed upstream of the boulder revetment near the upstream limb of M3, but recent down-valley channel migration of M2 has reduced the erosion severity at this site and has caused notable sand deposition adjacent the erosion. Lowering of the downstream riffle crest could increase erosion potential along the dyke at M3.

Photo 6. Looking upstream at boulder revetment (left) and sand deposition (background) near M3

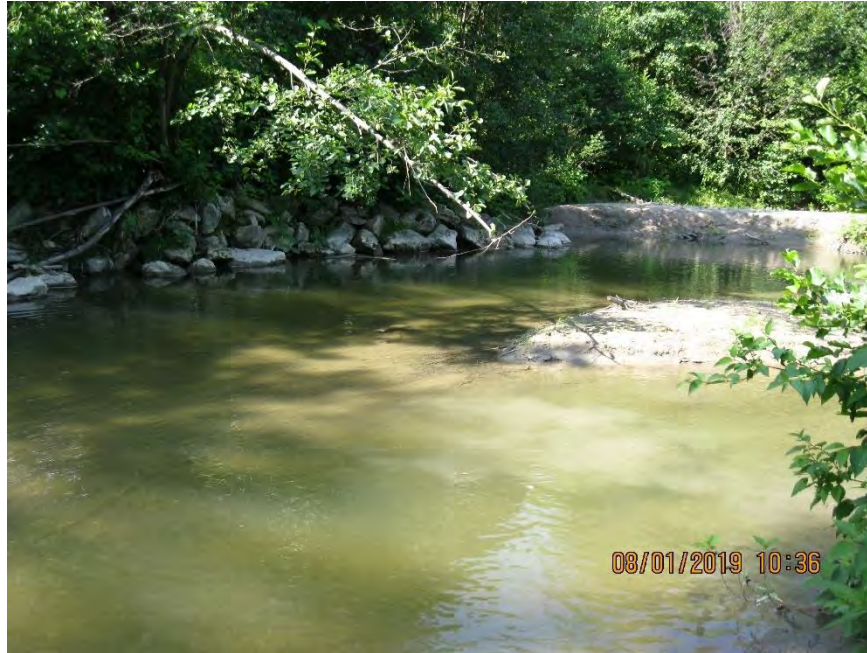
Many boulders in the localized revetment at M5 are displaced (**Photo 7**). The structure is less extensive than the erosion protection at M1 and M3. A down-valley shift in channel position could result in the thalweg abutting an unarmoured section of the dyke. Rapid channel migration at M4 has reduced the radius of curvature at both M4 and M5, which can increase erosion potential along both meanders. A large, high-relief sand deposit has formed at the upstream limb of M5 (concave-bank bench).

Photo 7. Looking upstream at the boulder revetment (left) and large sand deposit (centre and background)

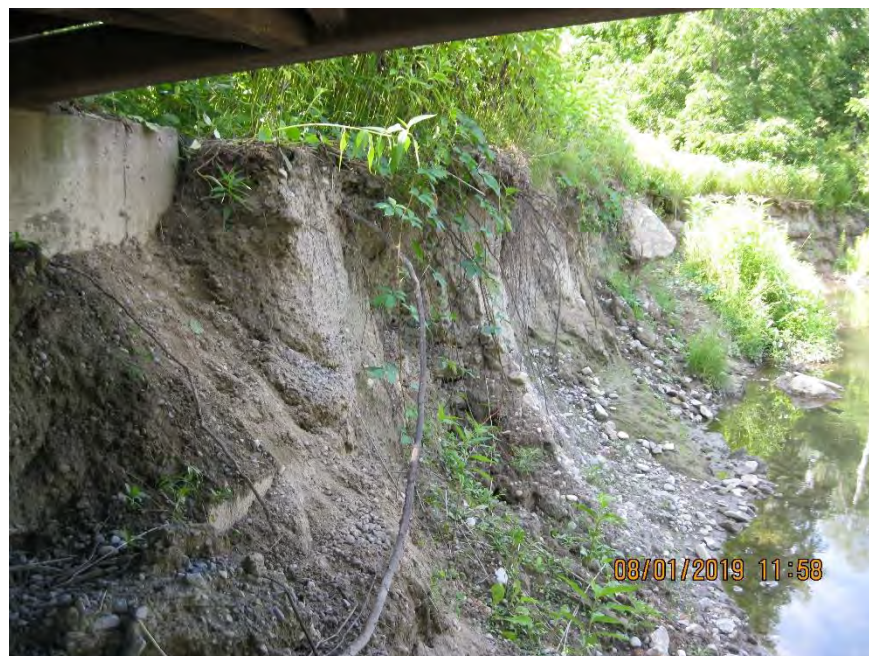
Photo 8. Actively eroding south bank of Duffins Creek (M11) in front and upstream of a pedestrian bridge abutment (looking upstream)

- Complete a detailed geomorphological and engineering assessment of the watercourse near the pedestrian bridge in Reach 2 to determine appropriate erosion mitigation to protect the southern abutment.

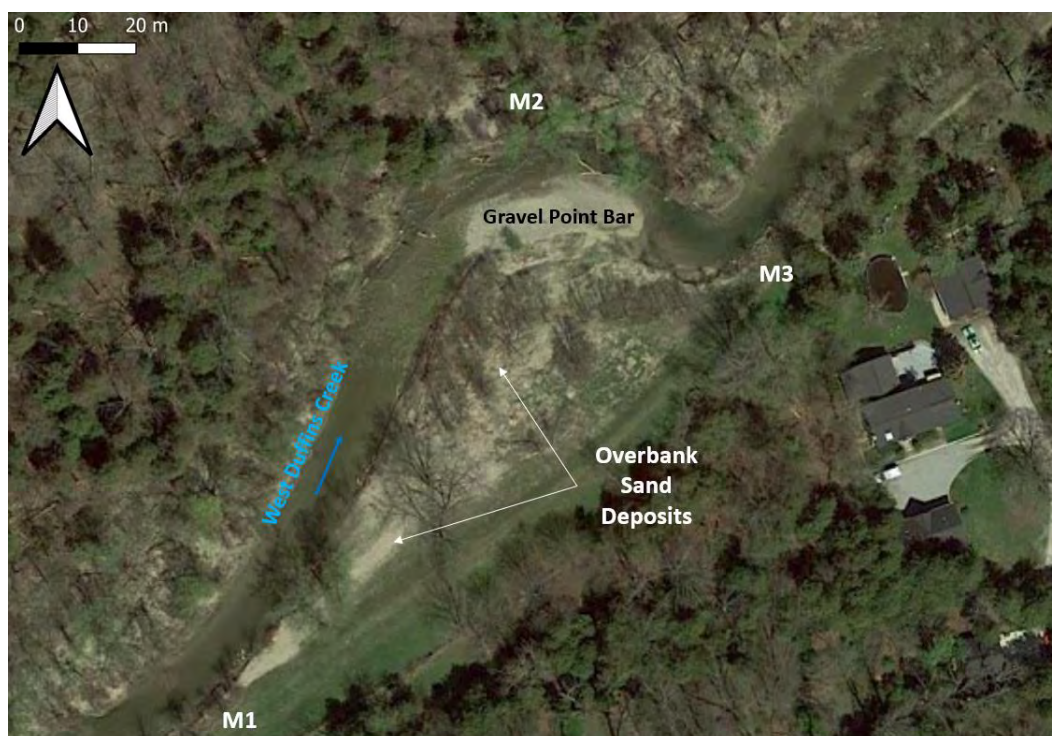
Overbank sand deposition occurs throughout Reach 1a, Reach 1b, and Reach 2, suggesting high flows have good connection to the floodplain. In particular, a large overbank sand deposit was observed during field reconnaissance and in recent aerial imagery atop the south bank between M1 and M3 (**Figure 4**). Concave bank benches are present where the channel abuts the Pickering Dyke (e.g. M3 and M5). Gravel point, lateral, and medial bars are present throughout Reach 1a, Reach 1b, and Reach 2. Notable gravel bar deposits include the large point bars at M2 and M4, where the channel is actively migrating, and the lateral and medial bars downstream of the Duffins Creek-West Duffins Creek confluence. The riffles immediately upstream of M2 and M4 are significant deposition areas for gravel and cobble.

Figure 4. Overbank sand deposition between M1 and M3
