West Don River at E.T. Seton Park – Detailed Fluvial Geomorphic Analysis and Erosion Risk Assessment

Contract # 10009019

Toronto and Region Conservation Authority

October 2, 2019

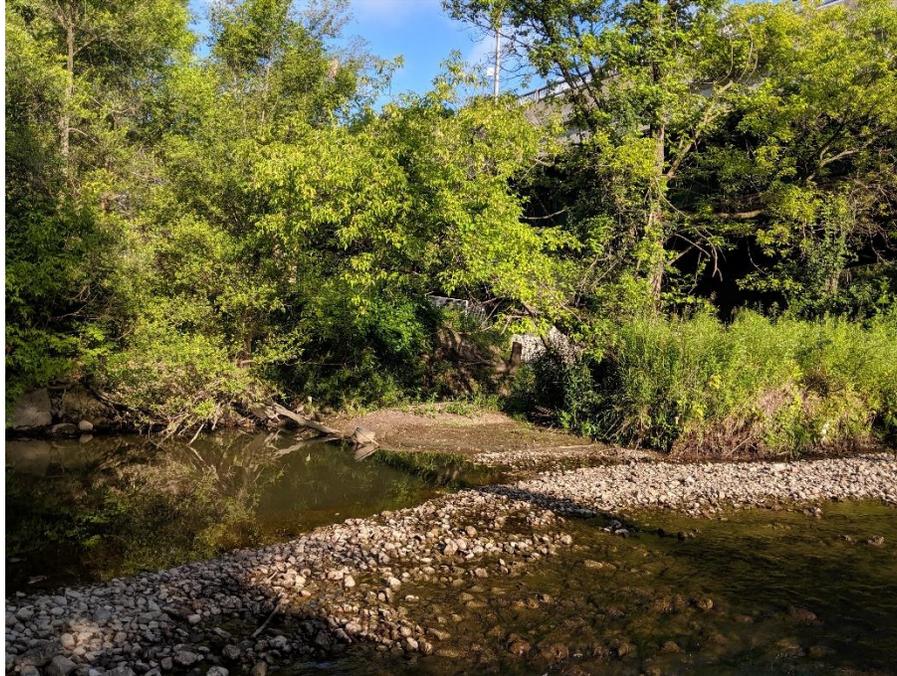
Bed materials within Reach 1 are dominated by gravels but range from silt to cobble-sized (~10 cm diameter) stone released from deteriorated gabion baskets (**Photo 1**). A thin veneer of sand embeds gravels in pools, whereas gravels and cobbles form the riffles. The representative median grain size (D_{50}) along the reach was estimated to be 33 mm.

Photo 1. Looking upstream at a riffle with its natural stone composition augmented by stone released from deteriorated gabion baskets upstream

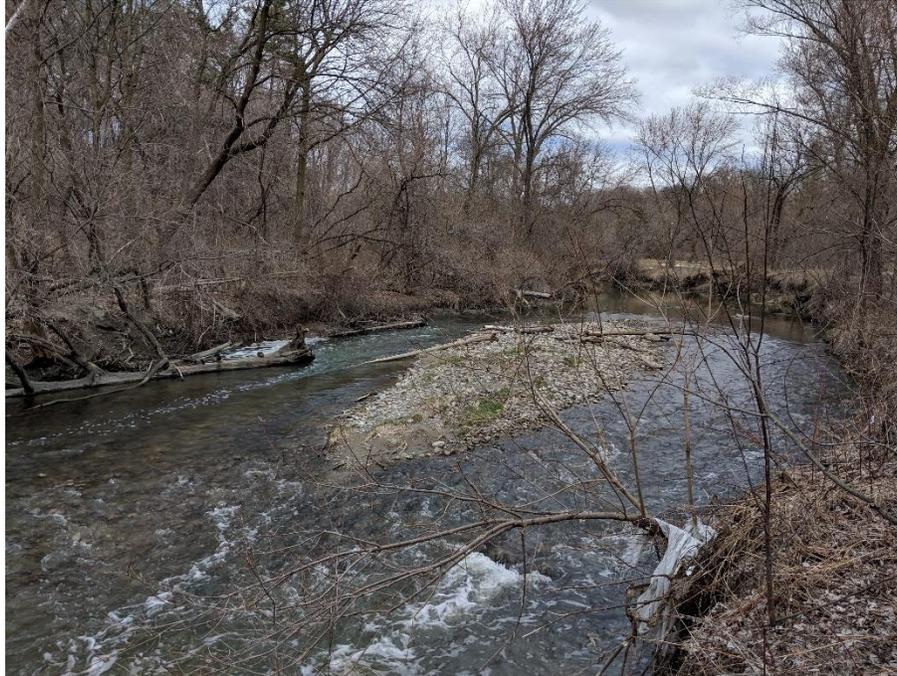
Photo 2. Looking upstream at mid-channel bar at the upstream end of Reach 1

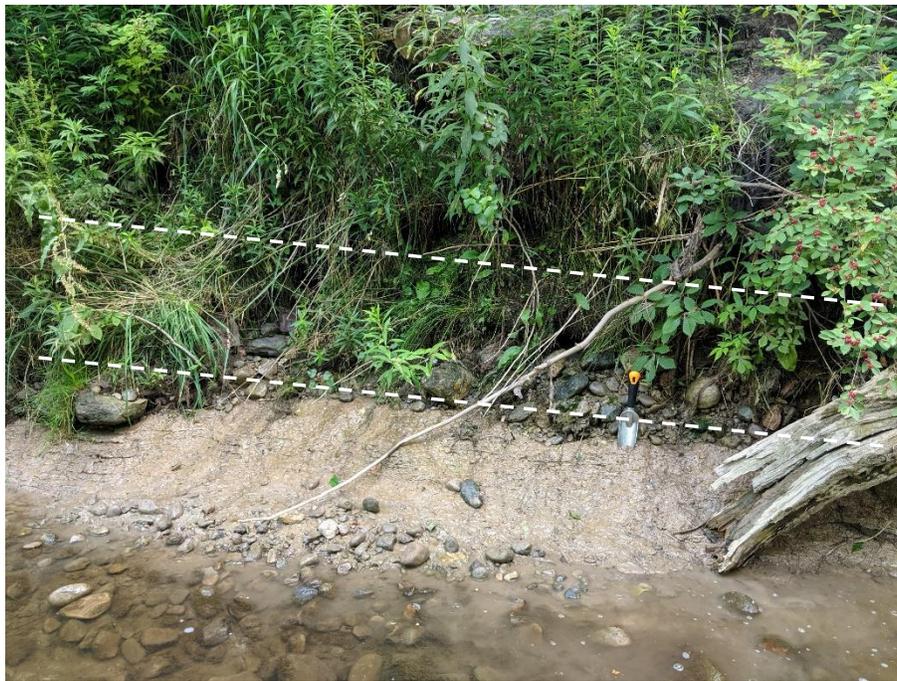
Banks are generally composed of loose alluvial silts and sands with an elevated gravel armour layer visible (**Photo 3**). The channel has incised by approximately 0.5 m into underlying laminated, fine-grained glaciolacustrine sediments along the straight section that parallels the southern valley wall. Eroded banks are nearly vertical with a slight undercut along unprotected outer banks of meanders. The outer banks of meanders are generally armoured with gabion basket retaining walls, which transfer energy and promote erosion downstream. Most gabion basket retaining walls have released a portion of the stone from their bottom tier, following deterioration of their wire cages, or have partly failed structurally and exposed loose alluvial material in behind. Cobble rip-rap revetments generally do not extend to the tops of bank; scour is common above. Erosional hollows are present where the thalweg is in contact with a bank in straightened sections (**Photo 4**). Riparian vegetation is a mix of grasses, shrubs and trees. Mature trees are present along the channel banks at the upstream extent of the reach. Mature trees are discontinuously scattered along the left bank (park side) likely due to historic clearing and realignment. Large wood was observed locally along channel banks, but no channel-spanning jams were present at the time of survey. Leaning trees with undercut roots are at risk of collapsing into the channel along the reach.

Photo 3. *Left bank with stratified glaciolacustrine sediments overlain by alluvial gravels and cobbles (active channel deposits) and silt and sand (flood deposits)*

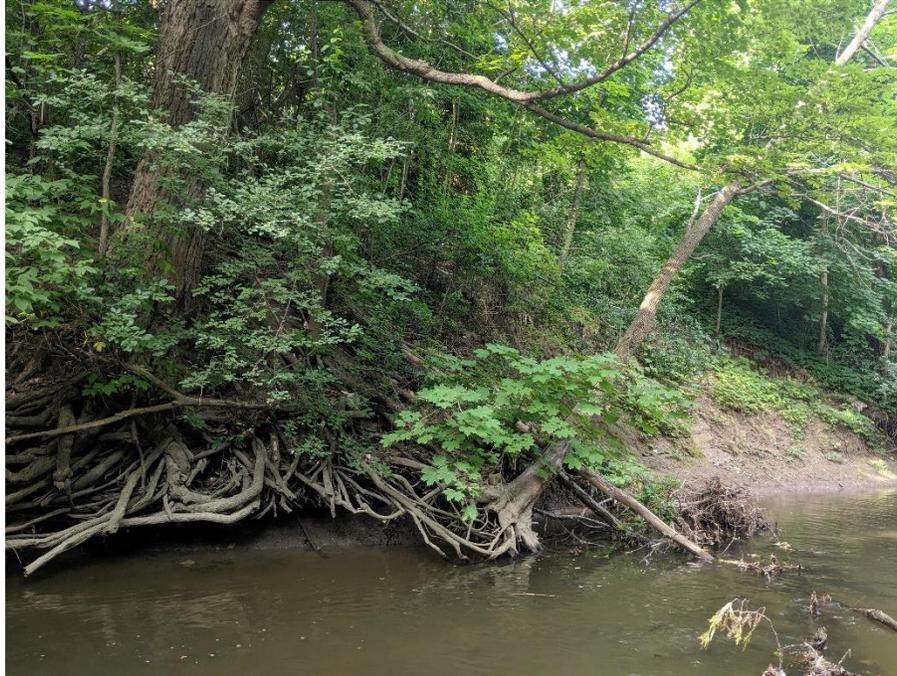
Photo 4. Erosion hollow and severely undercut tree roots along right bank immediately downstream of a gabion basket retaining wall

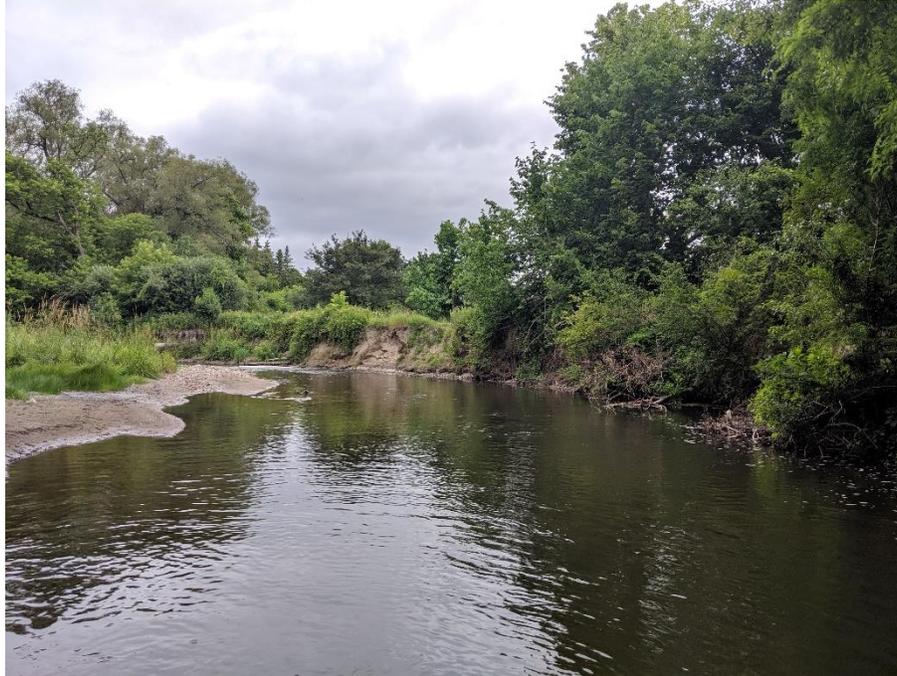
Photo 5. Upstream view toward severe bank erosion adjacent to an active seepage site protecting into the channel from the western valley wall

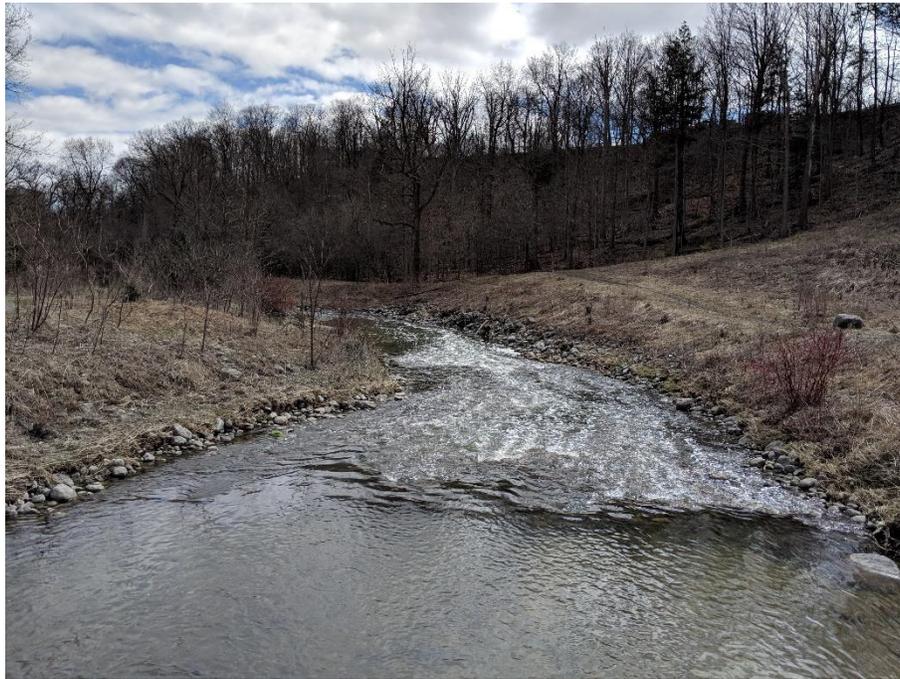
Photo 6. Looking downstream at steepened realigned meander at upstream end of Reach 2

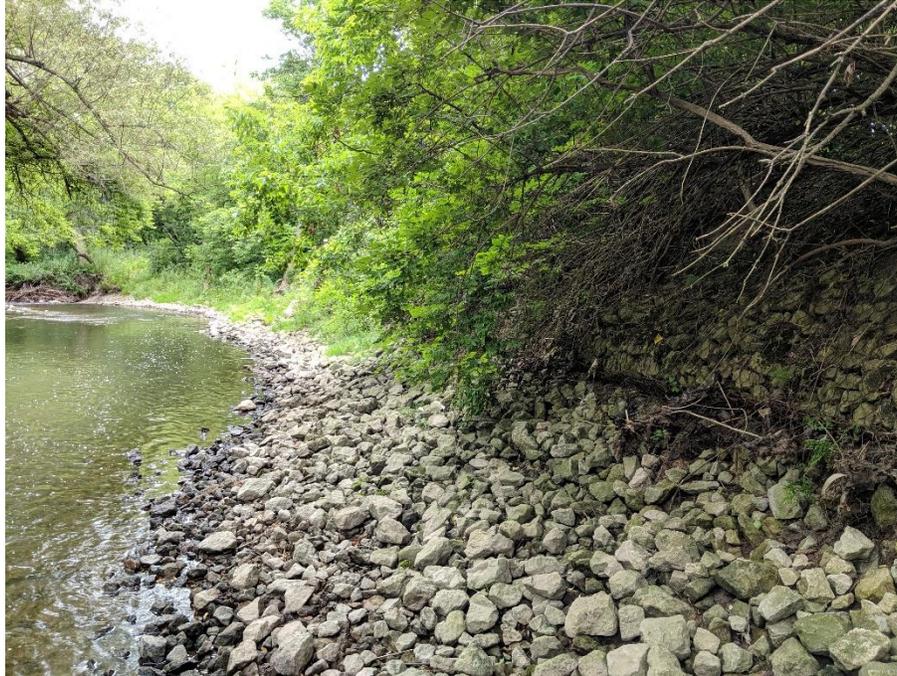
Photo 7. Downstream view of stone released from deteriorated wire basket

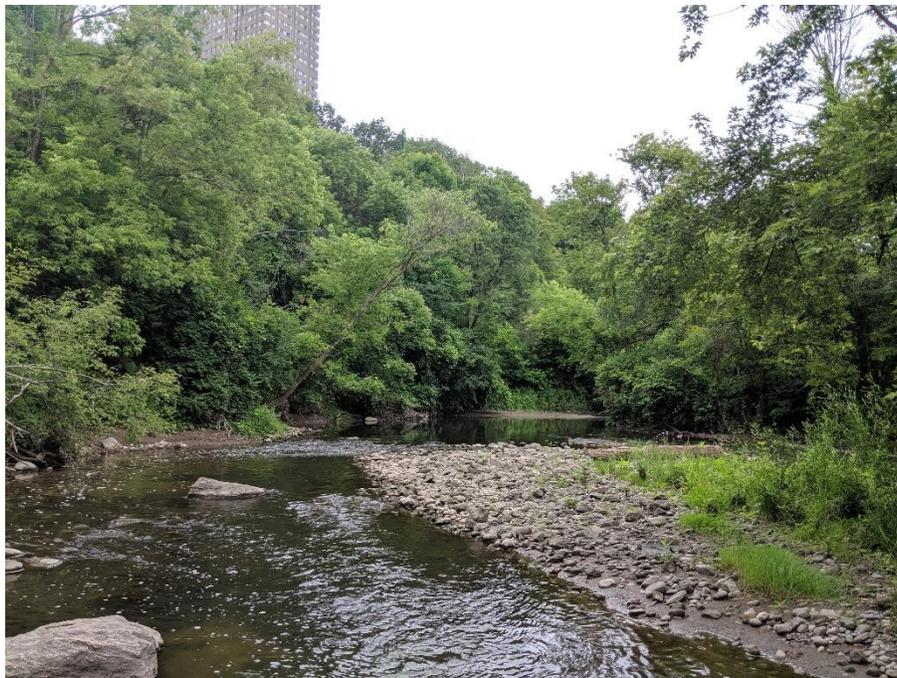
Photo 8. Upstream view of mid-channel bar at an anomalously wide section of channel

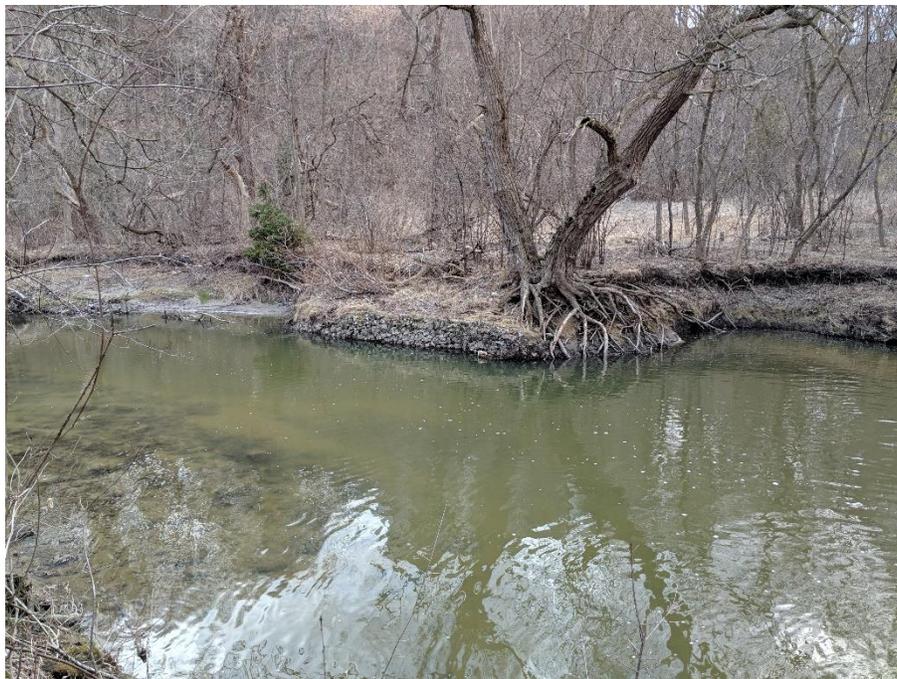
Photo 9. View of outflanked and failed gabion basket along the outer (right) bank of a meander

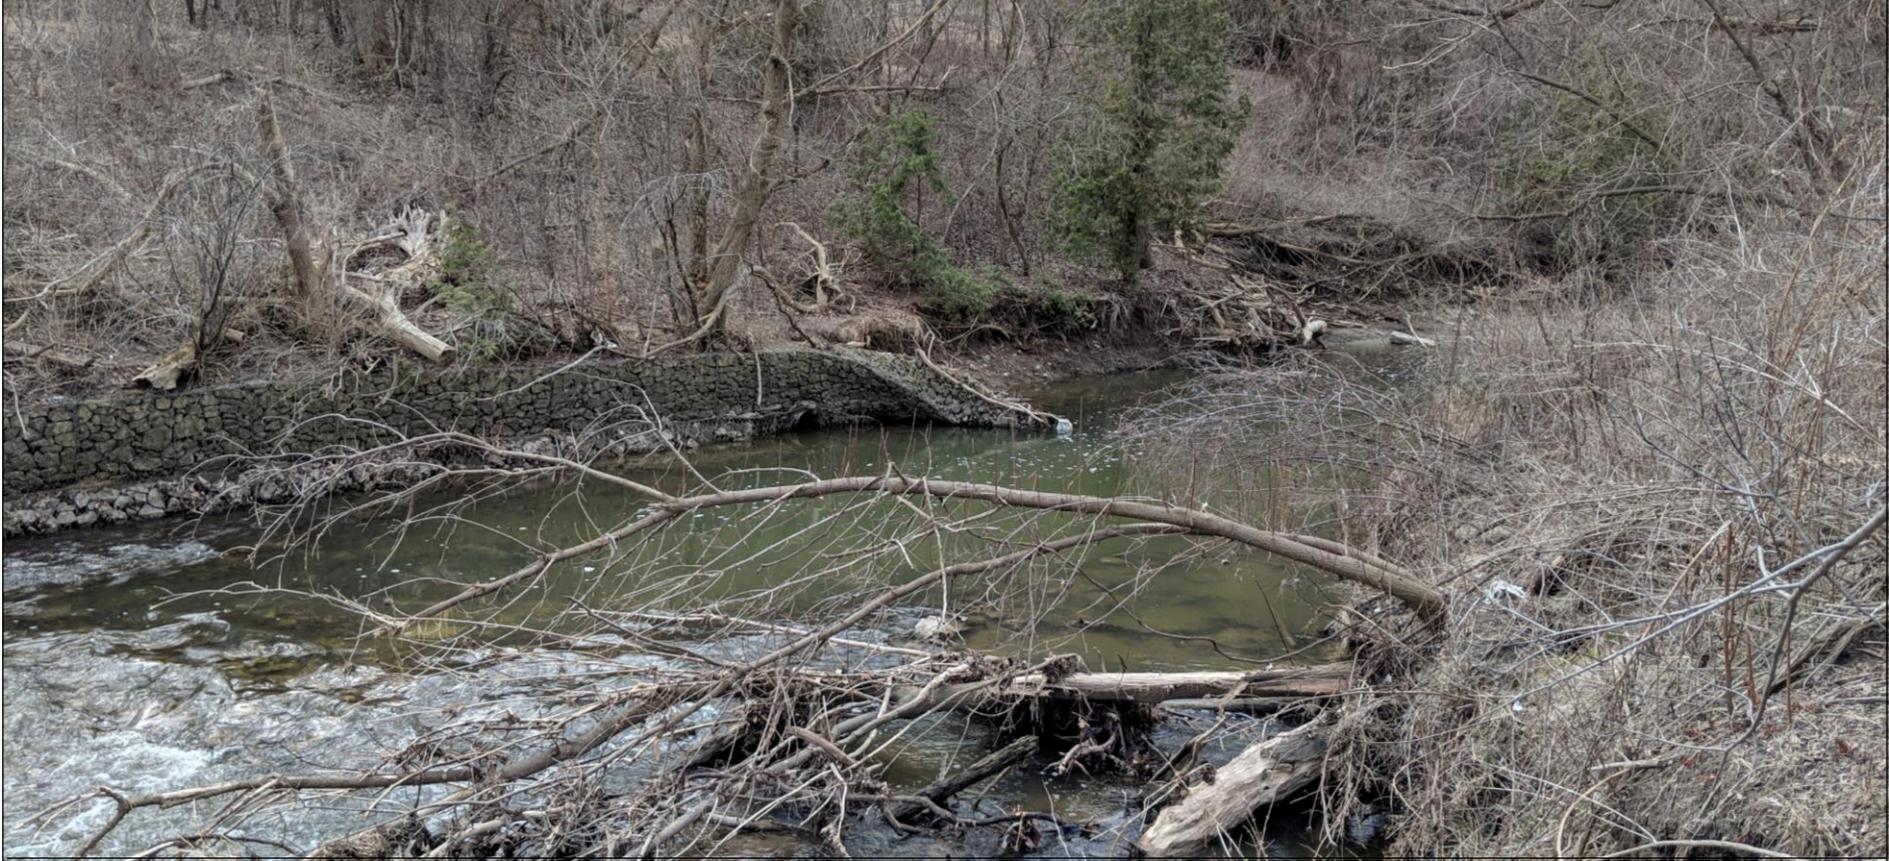
Site 5	TRCA ID: DR05.21	Likelihood: High	Consequence: High	Risk: Very High
		Recommended Action(s): Construct New Structure – Vegetated boulder revetment to replace deteriorated gabion basket. Coordinate with Sites 6, 7, 8 and 41.

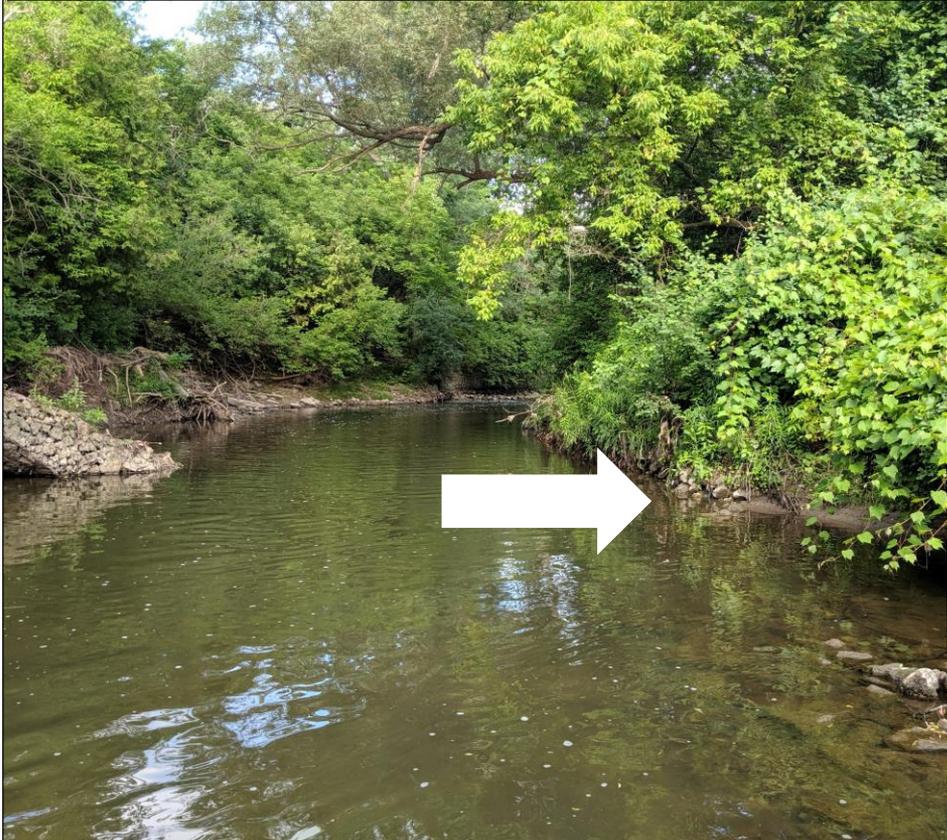
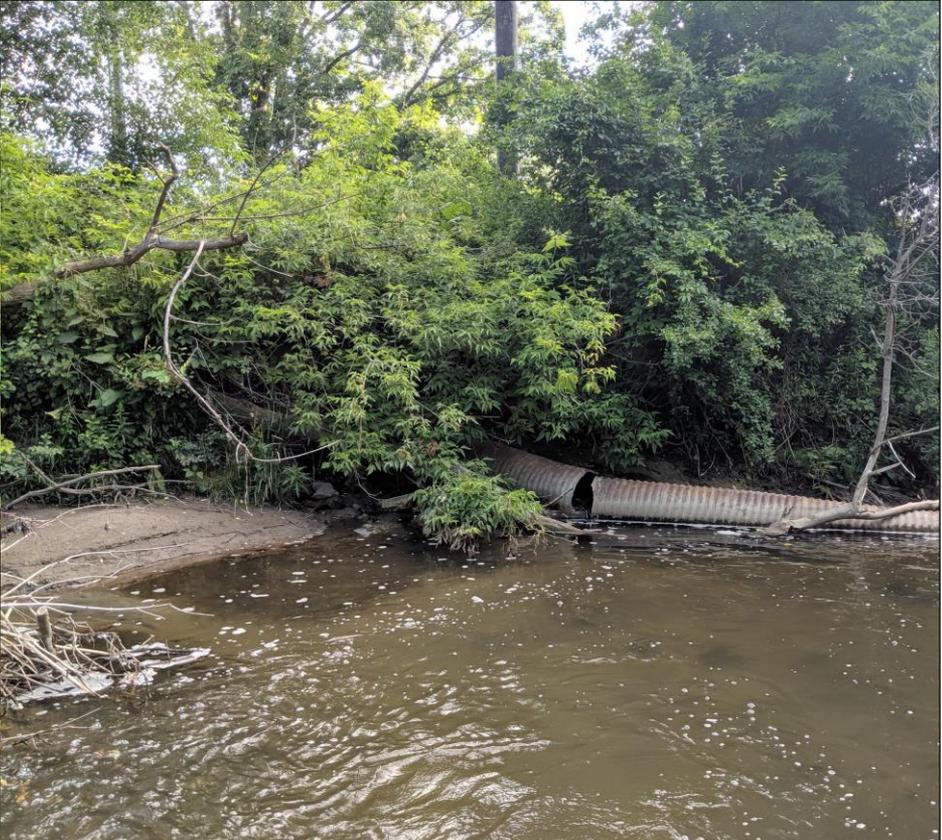
Site 6	TRCA ID: DR05.20	Likelihood: High	Consequence: Moderate	Risk: High
		Recommended Action(s): Construct New Structure – The urgency of this work can be reduced by removing the gabion on the opposite bank. Coordinate with Sites 5, 7, 8 and 41.

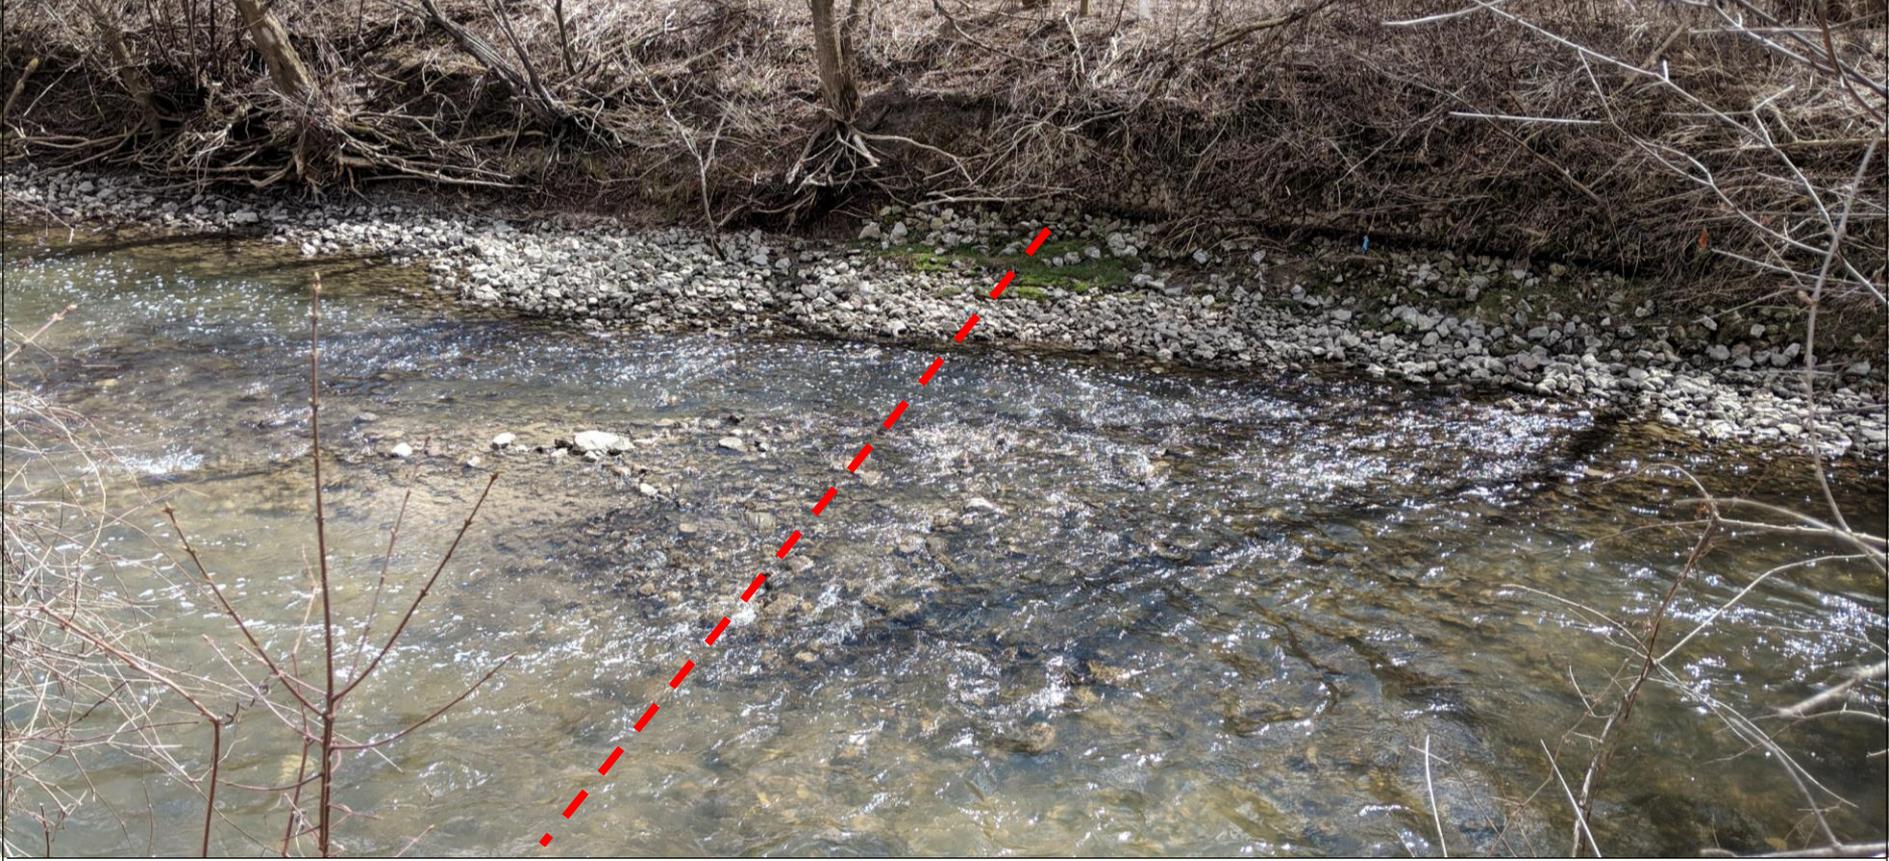
Site 23	TRCA ID: Gas Crossing	Likelihood: Low	Consequence: High	Risk: Moderate
		Recommended Action(s): Construct New Structure – An existing conditions survey should be completed to determine depth of cover, and the bed elevation should be monitored for signs of degradation. New grade control to be installed if cover insufficient.

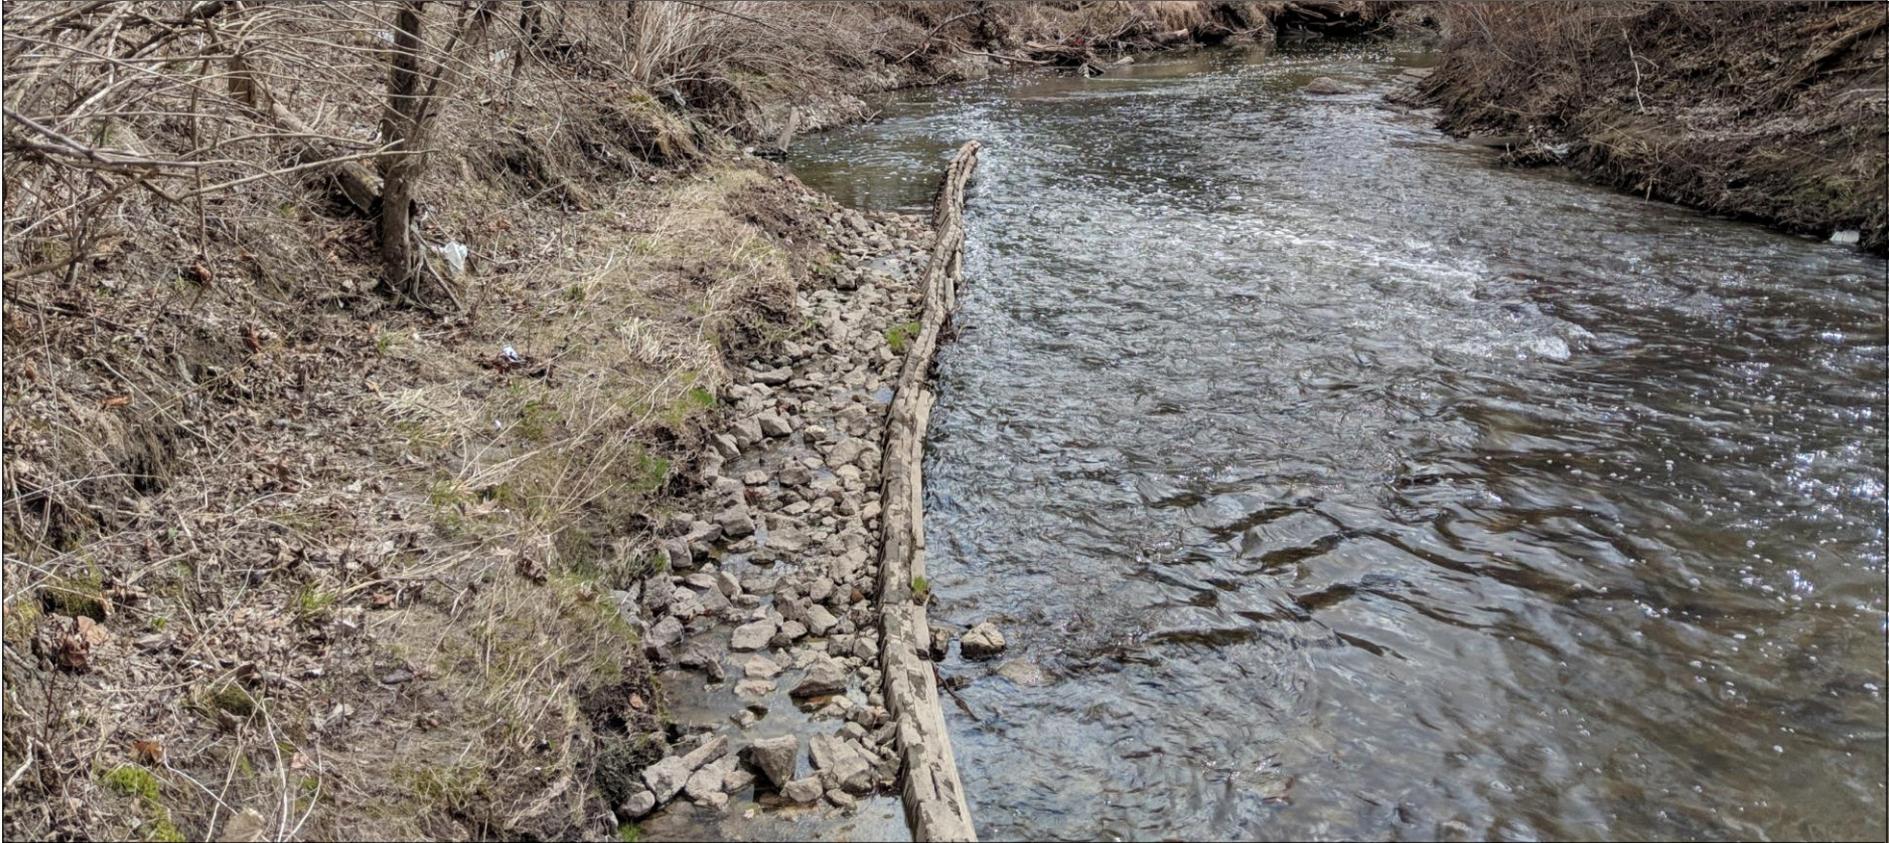
Site 24	TRCA ID: DR05.9	Likelihood: High	Consequence: Moderate	Risk: High
		Recommended Action(s): Remove Existing Structure and Restore Channel – Sheet pile erosion protection ineffective and redundant. Coordinate with Sites 21, 22, 25, 26 and 44.

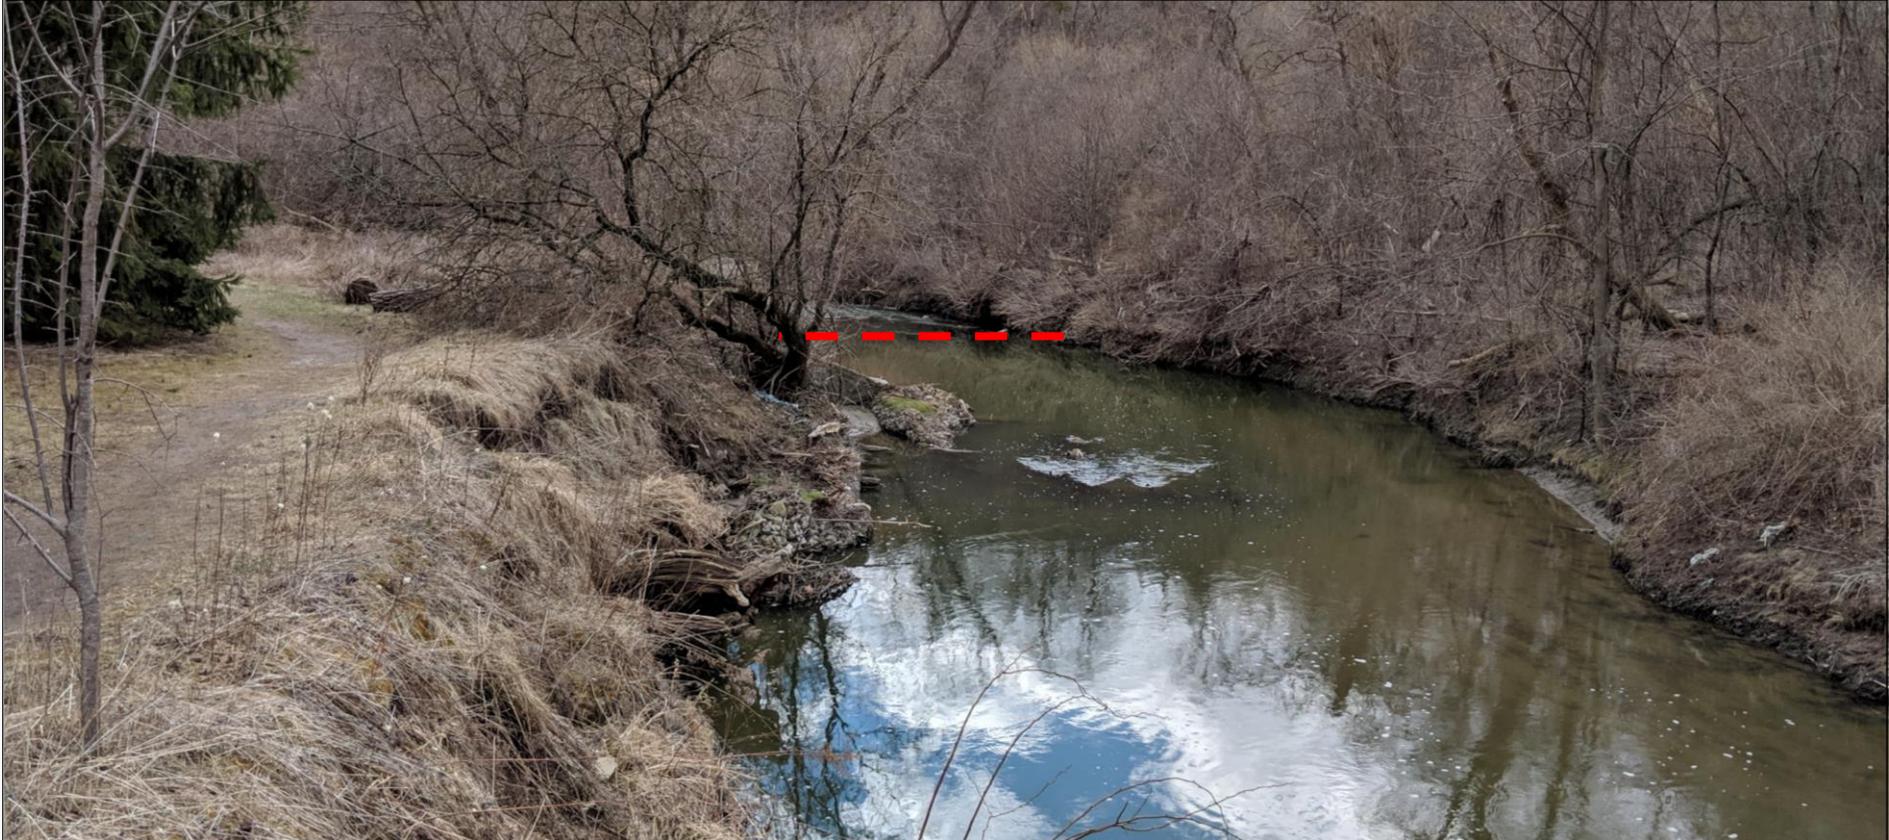
Description:
 A sanitary pipe crosses beneath the channel with no erosion protection along the bed or banks. The high outer (left) bank of the sharp meander contains flow greater than bankfull flow, concentrating erosive energy within the channel. In addition, the upstream bank protection has concentrated erosive energy along the bed, creating a long and deep pool that extends over the crossing. The depth of cover ranged from 1 m to 1.5 m in 1957. Flow: foreground to background.

Site 26	TRCA ID: DRR221-03	Likelihood: High	Consequence: High	Risk: Very High
		Recommended Action(s): Construct New Structure – Construct a riffle over the pipe crossing, subject to an existing conditions survey confirming unacceptable depth of cover.

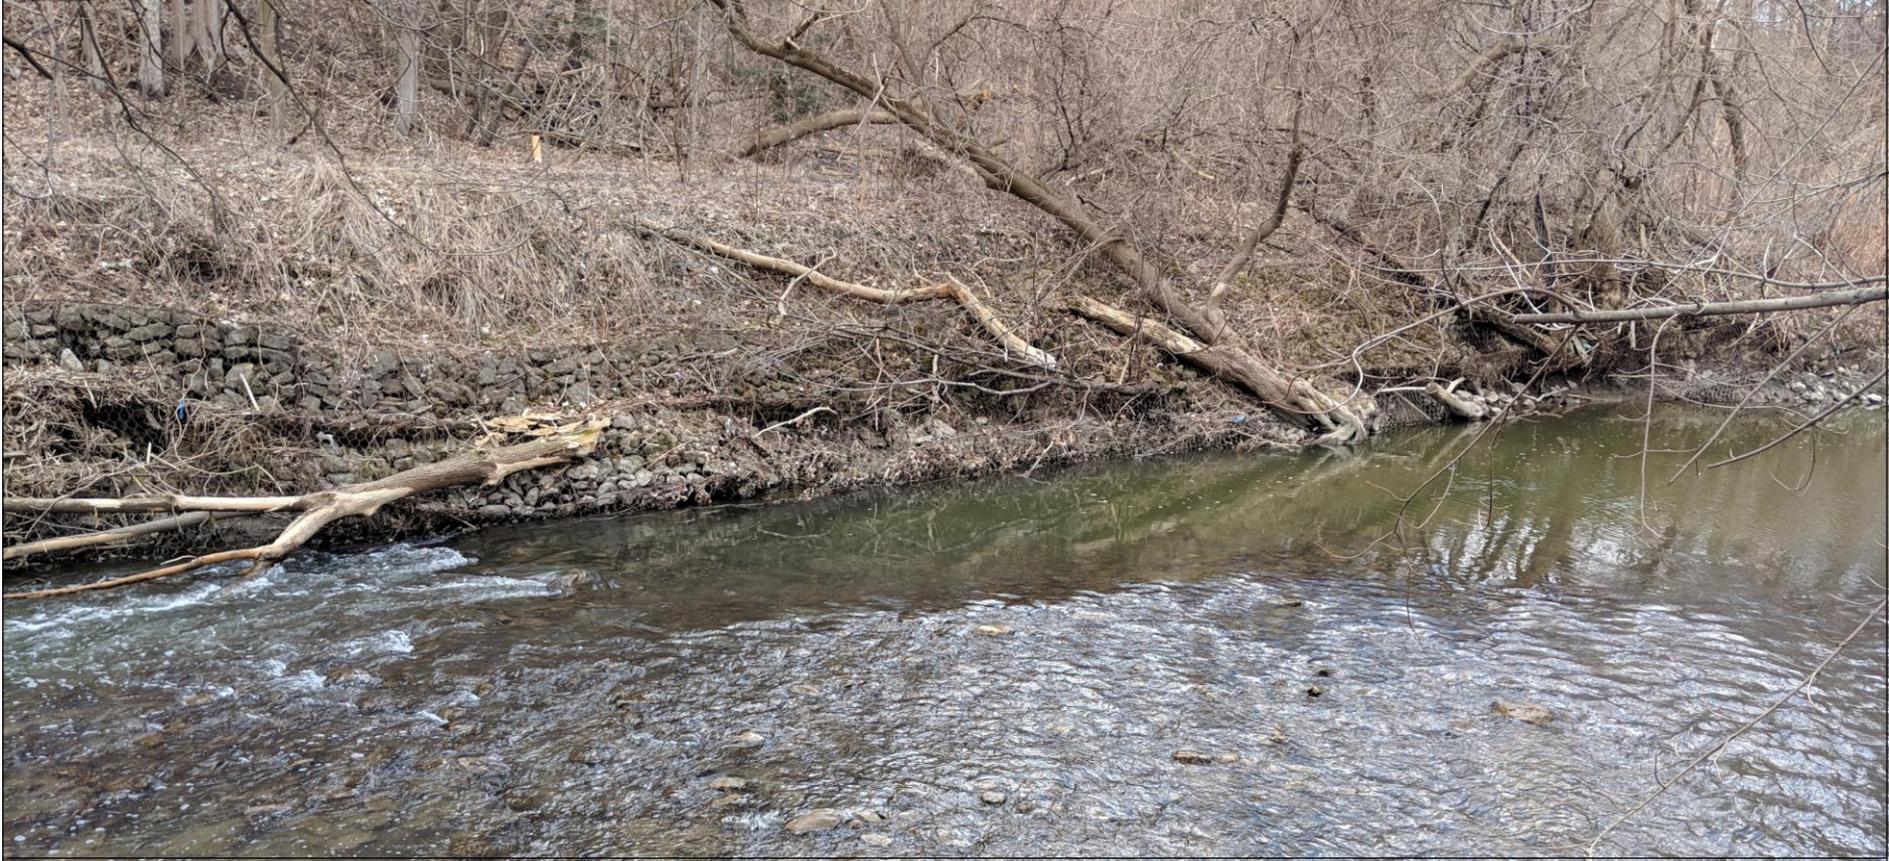
<p>Site 27</p>	<p>TRCA ID: n/a</p>	<p>Likelihood: Moderate</p>	<p>Consequence: Low</p>	<p>Risk: Low</p>
		<p>Recommended Action(s): Abandon Existing Structure – no infrastructure at risk.</p>

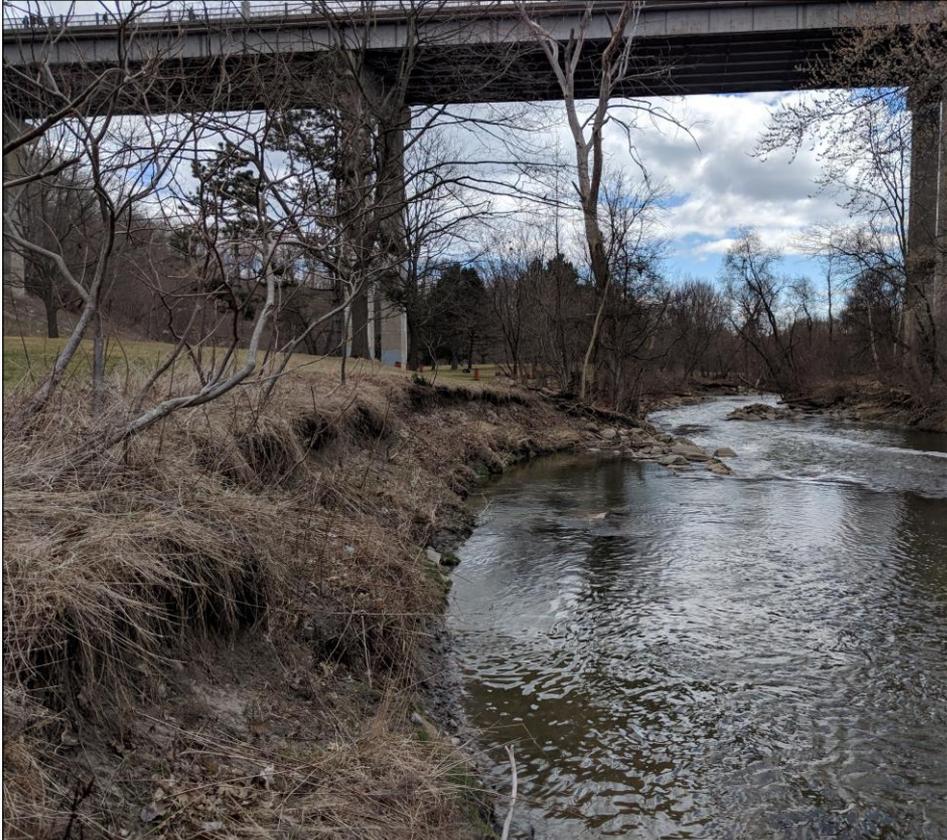
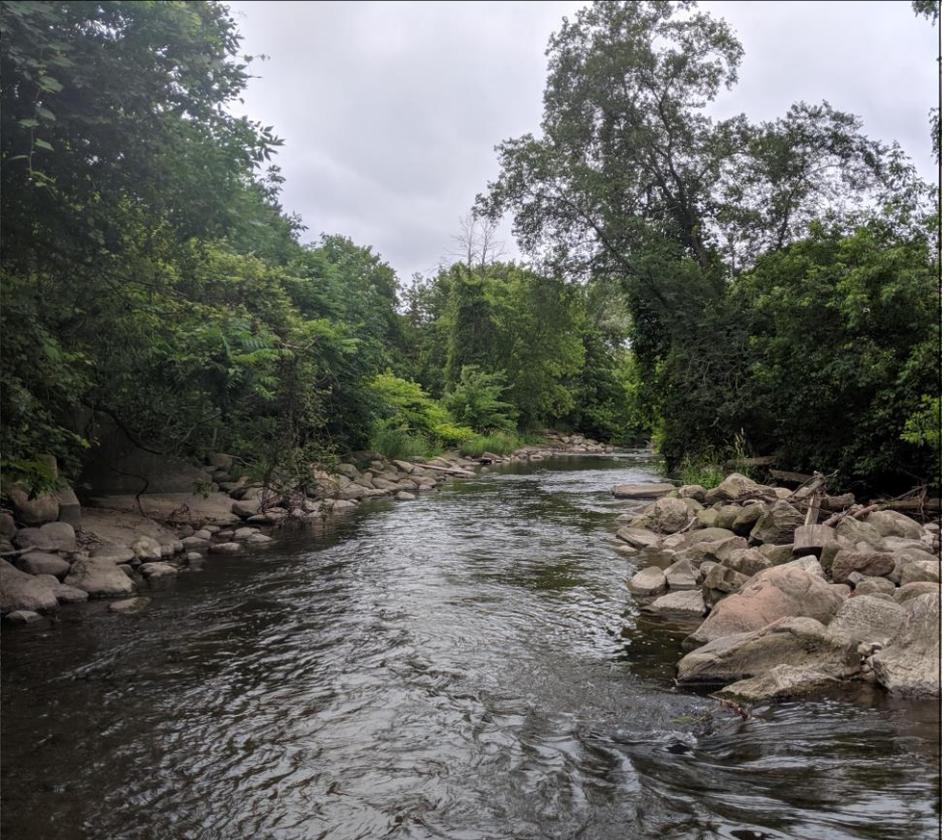
<p>Site 28</p>	<p>TRCA ID: n/a</p>	<p>Likelihood: High</p>	<p>Consequence: High</p>	<p>Risk: Very High</p>
		<p>Recommended Action(s): Repair Existing Structure – Rehabilitate upstream extent of boulder revetment.</p>

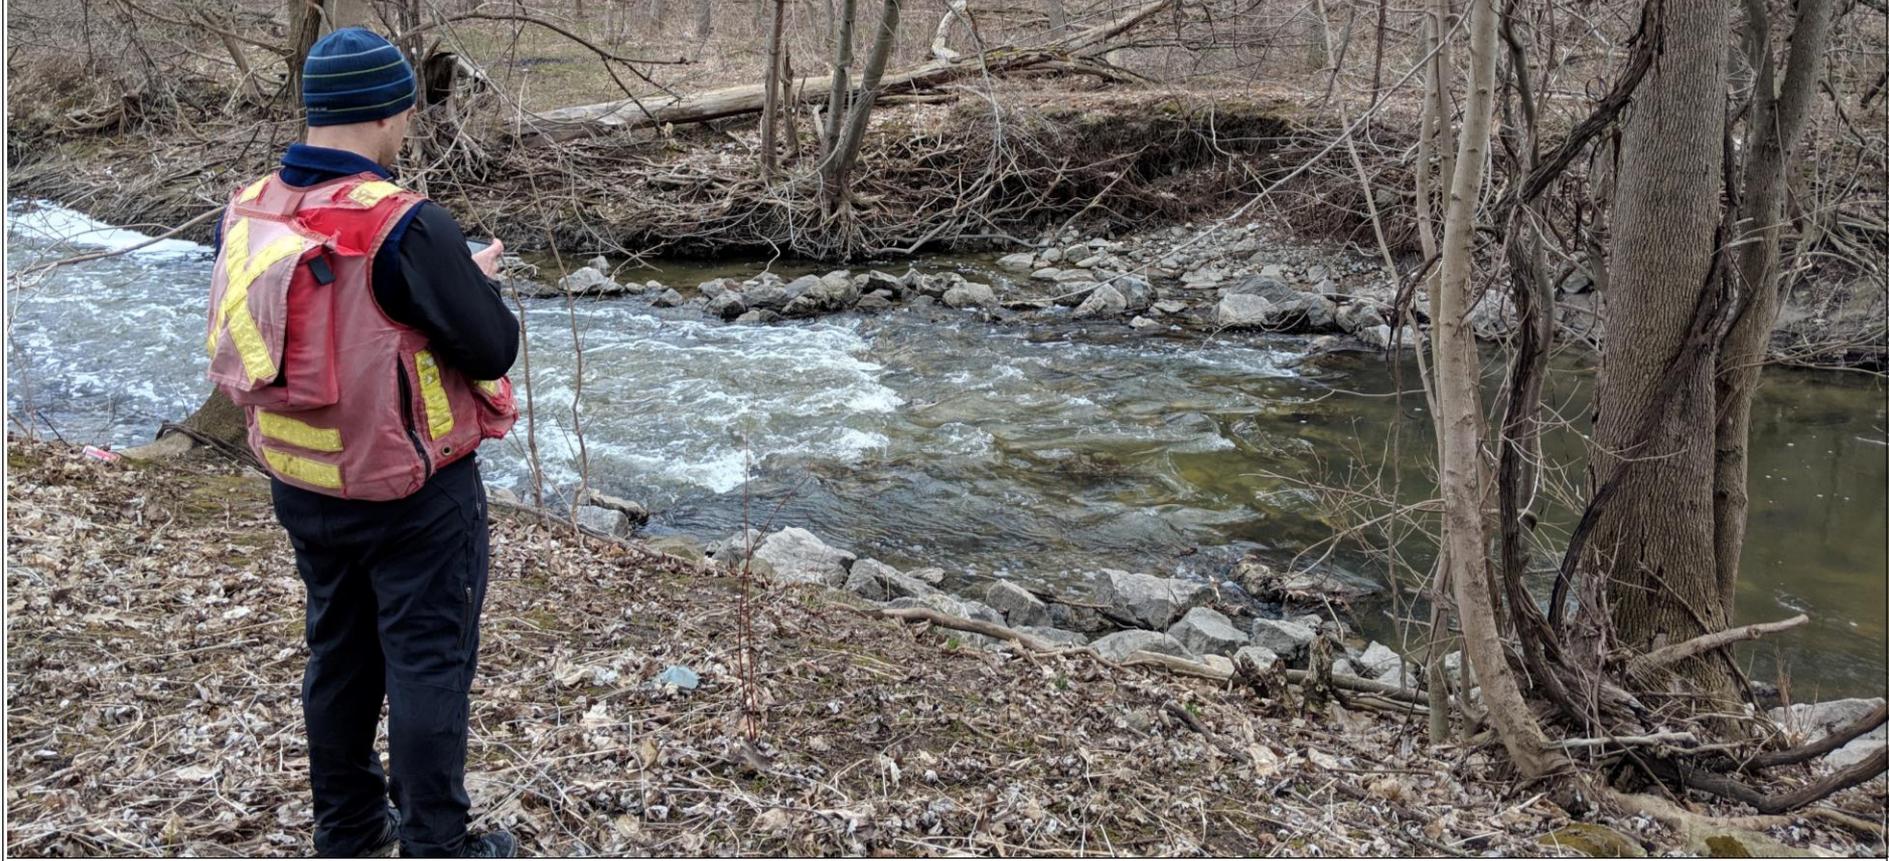
Site 35	TRCA ID: Grade control	Likelihood: Low	Consequence: Moderate	Risk: Low
		Recommended Action(s): Repair Existing Structure – Slight channel widening or embedment of stone to be included in repair to minimize potential for outflanking.

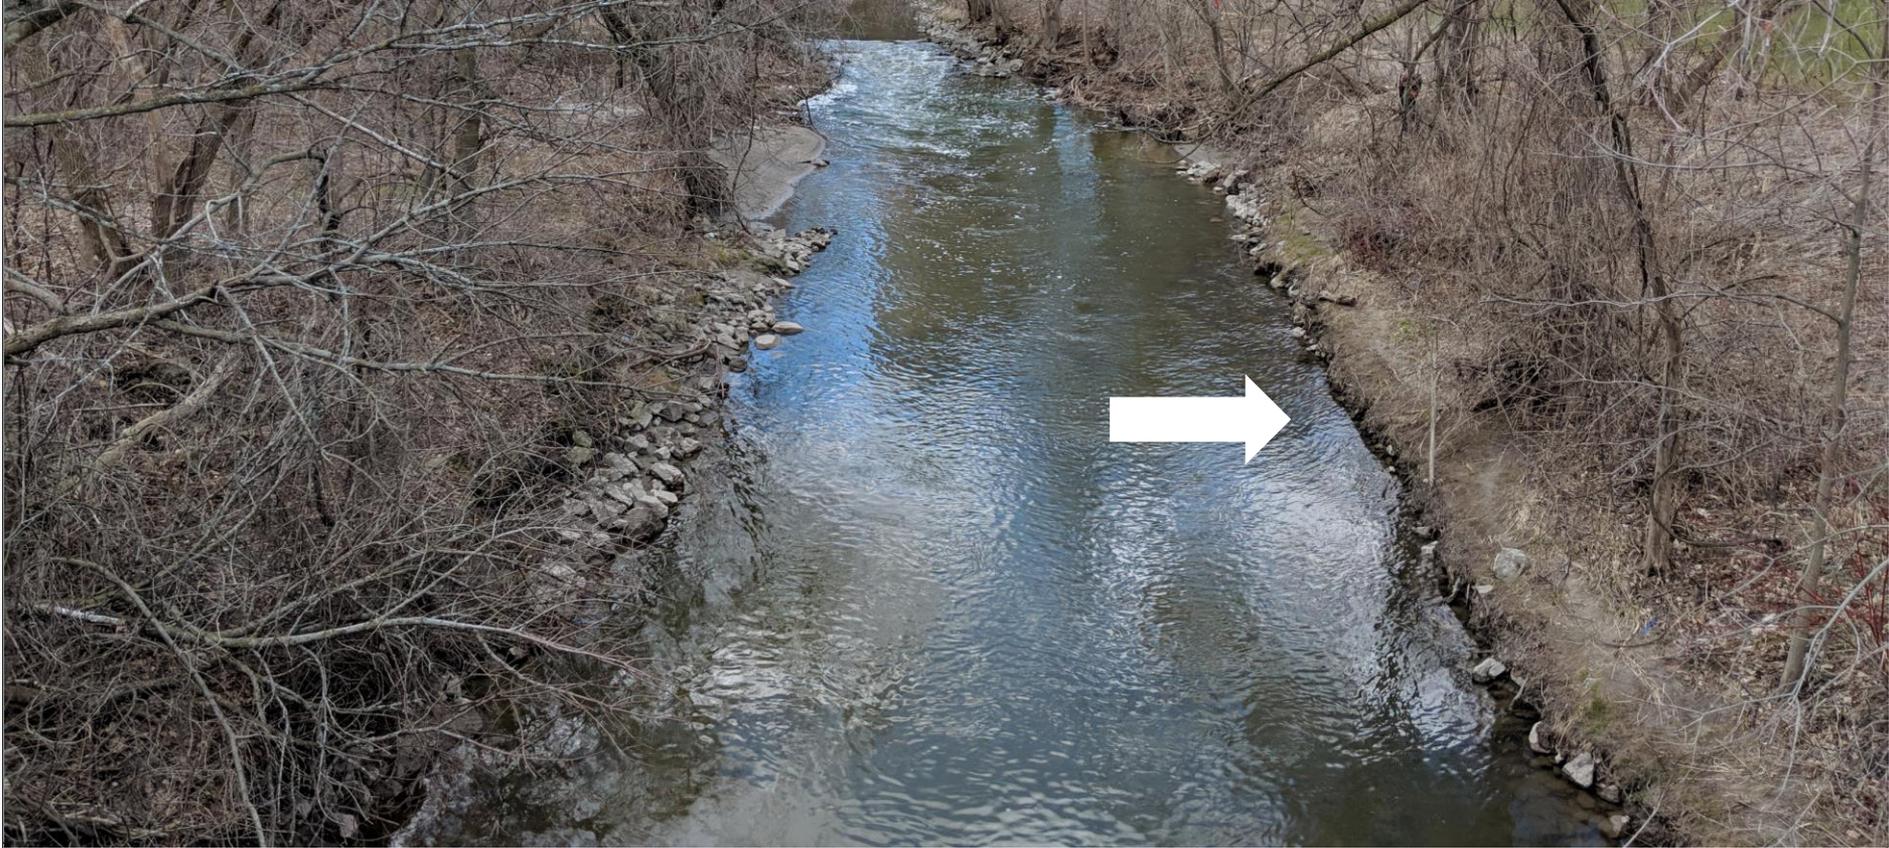
Site 36	TRCA ID: DR05.3	Likelihood: Moderate	Consequence: Moderate	Risk: Moderate
		Recommended Action(s): Do Nothing – Continue to monitor for deterioration and scour above protection.

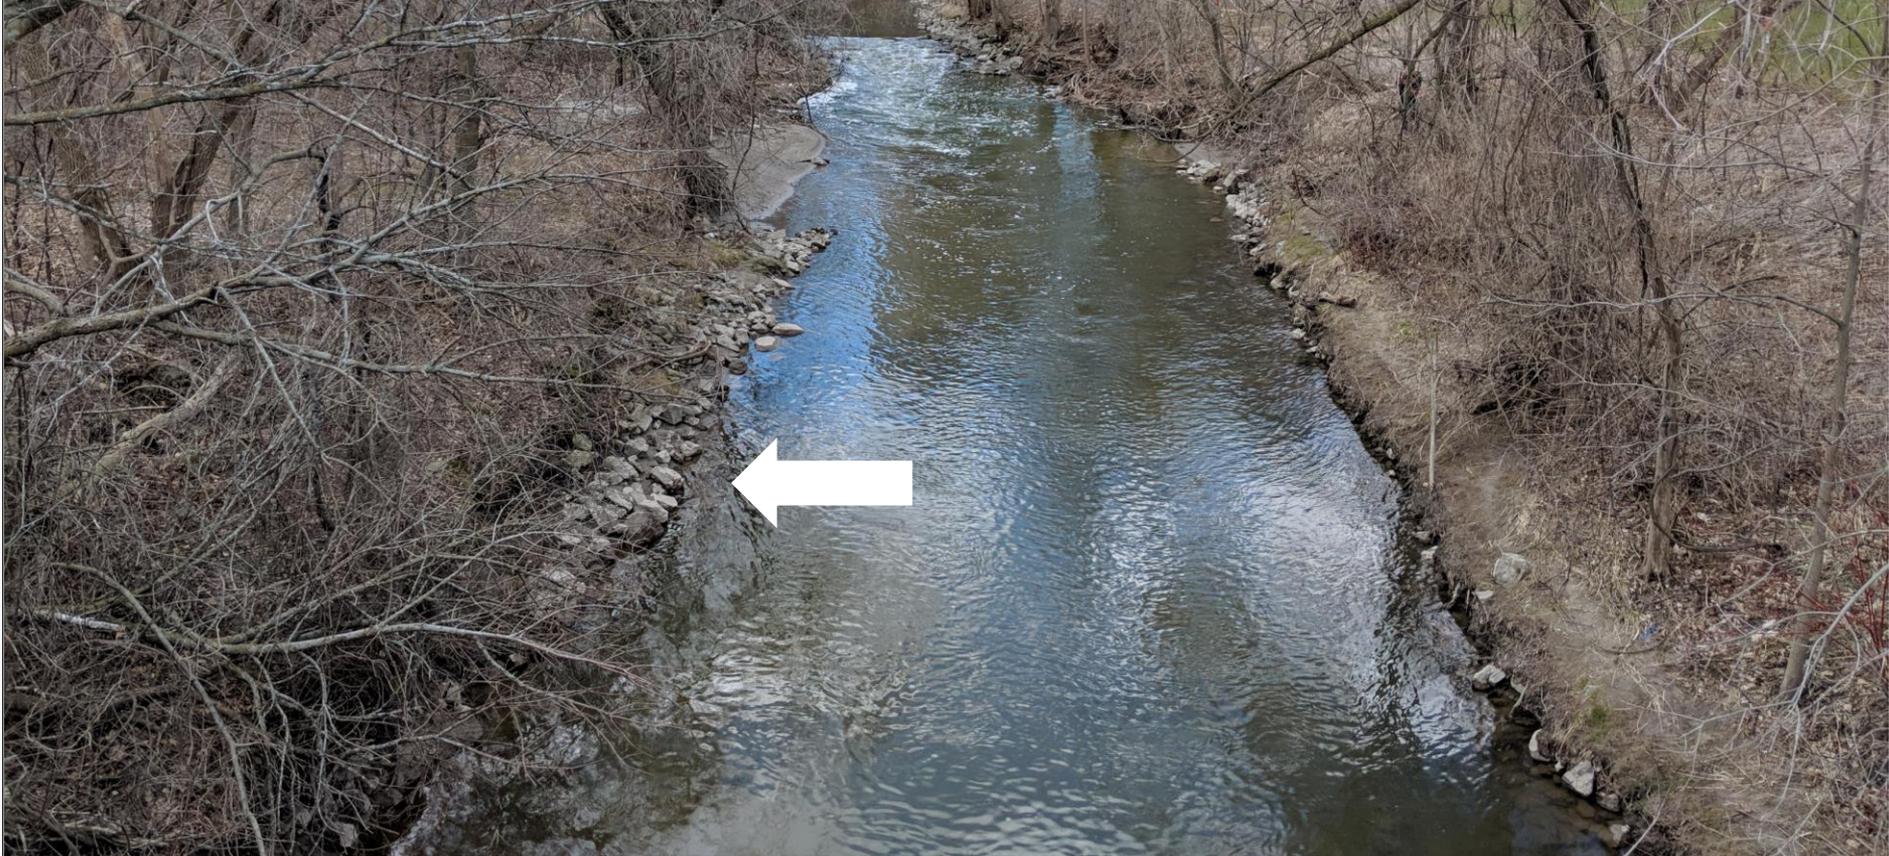
<p>Site 37</p>	<p>TRCA ID: DR05.2</p>	<p>Likelihood: Moderate</p> <p>Recommended Action(s): Do Nothing – Continue to monitor for deterioration and scour above protection.</p>	<p>Consequence: Moderate</p>	<p>Risk: Moderate</p>
-----------------------	-------------------------------	--	-------------------------------------	------------------------------
