West Don River at E.T. Seton Park – Detailed Fluvial Geomorphic Analysis and Erosion Risk Assessment

Contract # 10009019

Toronto and Region Conservation Authority

October 2, 2019

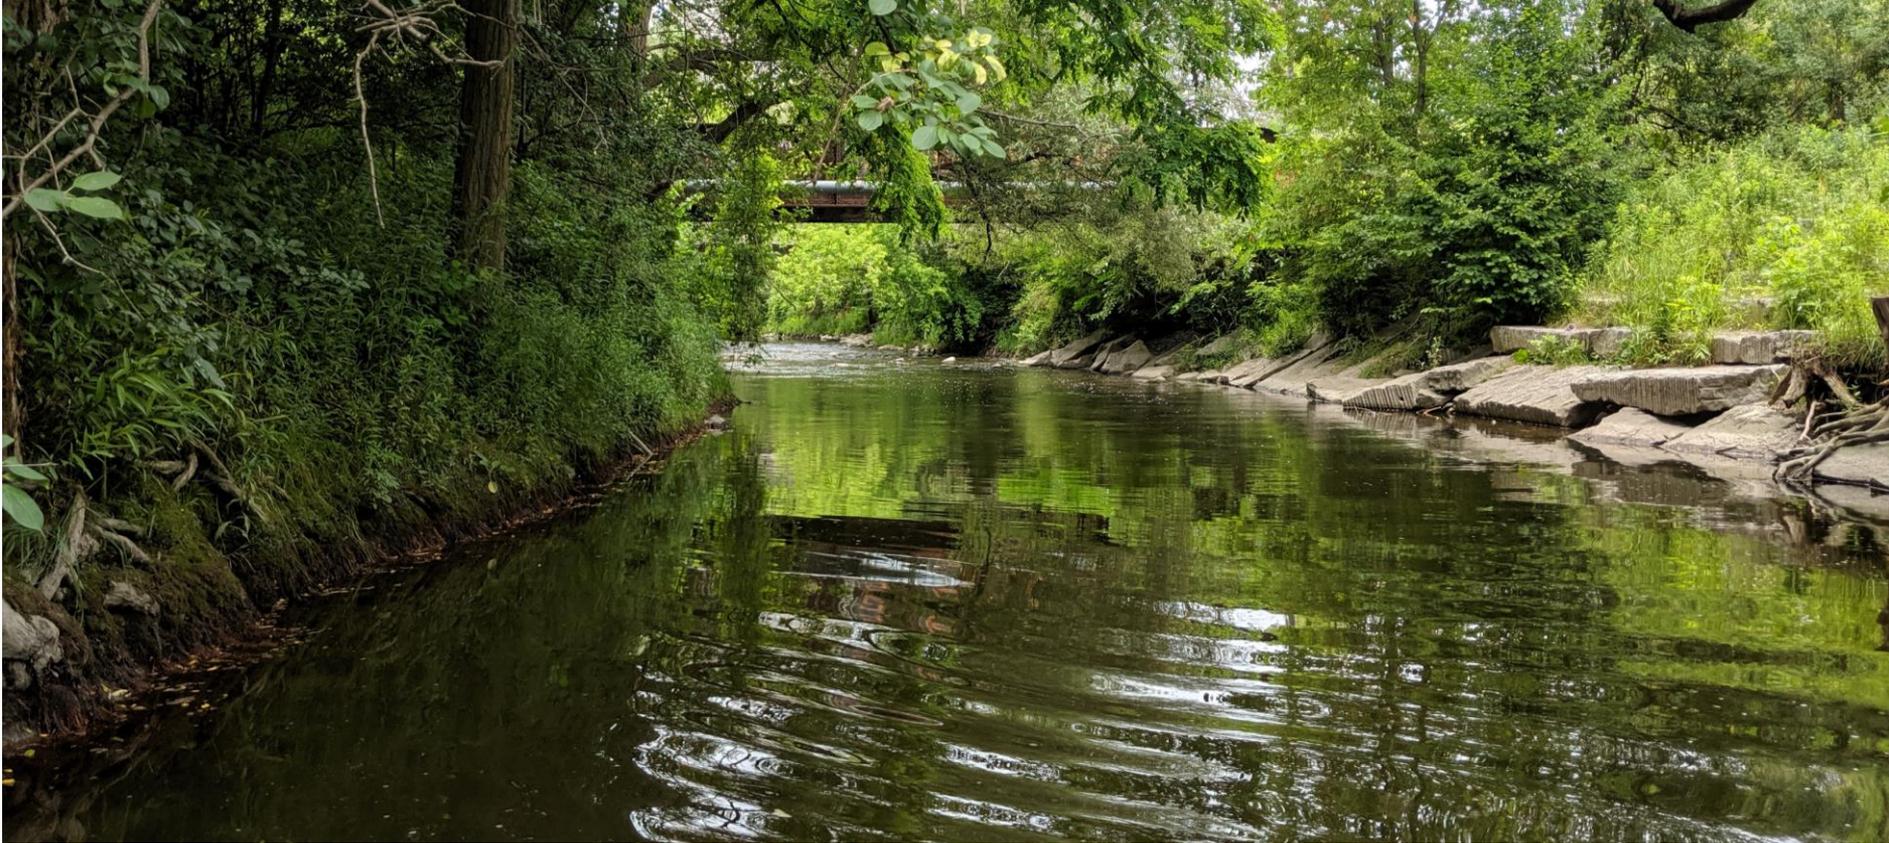
<p>Site 38</p>	<p>TRCA ID: DR05.1</p>	<p>Likelihood: Low</p> <p>Recommended Action(s): Do Nothing – Continue to monitor for outflanking and scour around concrete slabs.</p>	<p>Consequence: High</p>	<p>Risk: Moderate</p>
-----------------------	-------------------------------	--	---------------------------------	------------------------------
