**MARINE ARCHAEOLOGICAL ASSESSMENT
BACKGROUND RESEARCH AND
GEOTECHNICAL SURVEY
FOR THE
GIBRALTAR POINT EROSION CONTROL
PROJECT
LAKE ONTARIO SHORELINE ON THE LAKEWARD
SIDE OF THE TORONTO ISLANDS
ENVIRONMENTAL ASSESSMENT
CITY OF TORONTO**

**License # 2016-13
March 1, 2017**

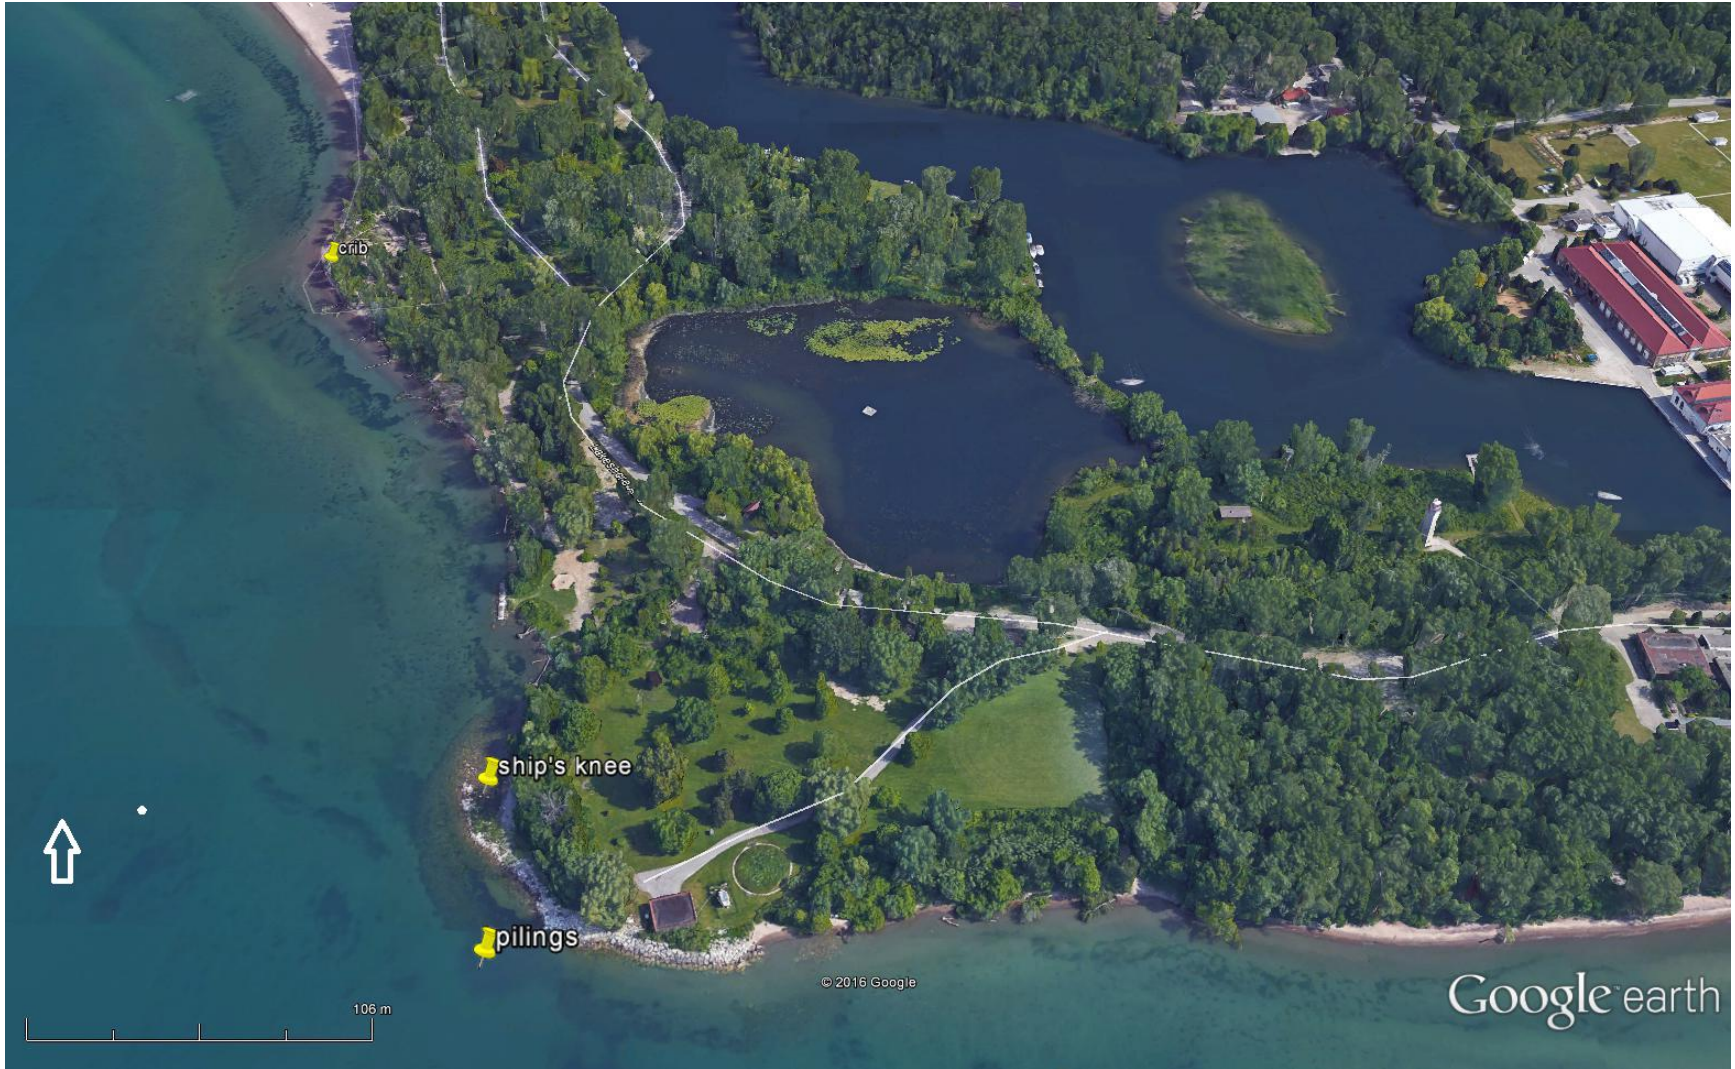
Figure 24: Location of Cultural Finds

The crib was located at 43° 36' 55.09"N, 79° 23' 29.04"W (Figure 24, 28 and 29) The crib was marked by two pilings that were at the lakeward end of the crib with a wood face and long wooden sections along both of the sides of the crib, and

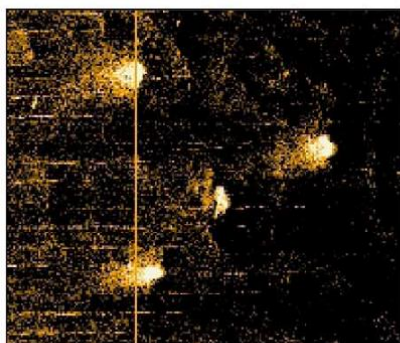
Figure 25: Target S48

Target S48 - Pilings

Group: Group 1
Description: S48 was located using side scan sonar, and could also be seen from the surface. S48 is made up of 3 pilings and a rock.
Latitude: 4336.7151,N
Longitude: 07923.3785,W
Depth: --- m
Created: 14/OCT/2016, 11:26:54
Position Set: 14/OCT/2016, 11:26:40
Dive Number: N/A
Diver/Operator Name: Boat

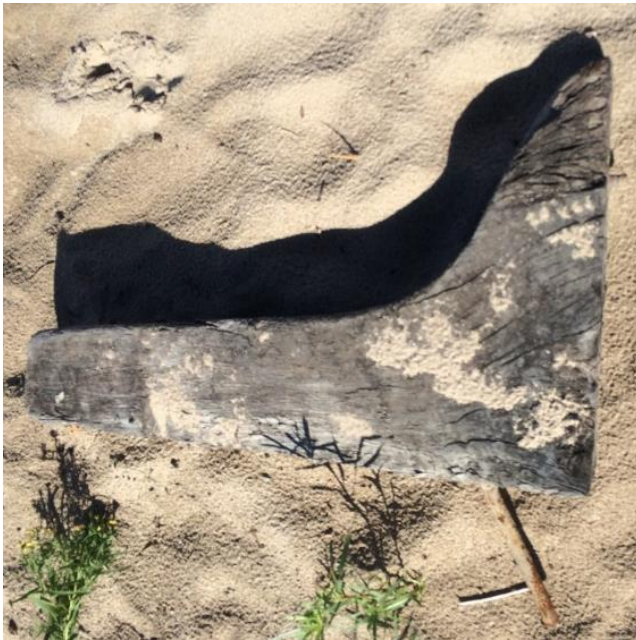
Figure 26: Ship's Knee as Found in Area

The snorkel survey did not detect any nearshore cultural features, other than the one that was partially onshore (crib). The shoreline walk, however, did locate not only the stone filled crib but also a ship's knee (Figure 24, 26 and 27). The latter was not *in situ*, however, based on its' weight, it is likely that it came from an area not more than 100 metres distant. There was no indication of any additional ships parts in the area, which might indicate they have already been removed, or are buried either on land or under the lakebed sediments. The location of the

- It is recommended that curation of the hanging knee be managed by the Toronto Region and Conservation Authority as the possible remnant of the 1868 ship, the **Jane Ann Marsh**;

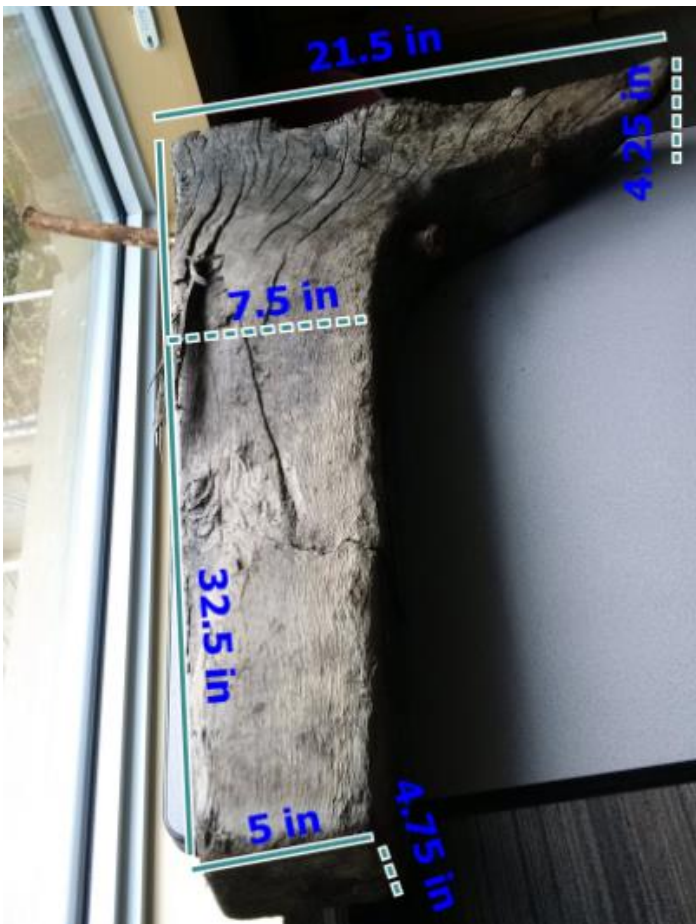
Figure 27: Measurements of the Ship's Knee (courtesy of TRCA)

knee was noted (43° 36' 45.17"N, 79° 23' 23.13"W). Along its two length's, the ship's knee measured approximately 32.5" by 21.5" (note: inches are used as the imperial system of measurement was used to construct ships). On each of the flat sides there is an iron bolt. There are presumably additional bolt holes in the knee for additional bolt placement. The bolts were driven through the wood, with a head at one end (the outside) and the other "clenched" that is a washer or flat ring that is placed on that end and the end then hammered over. Small bolts or spikes could be clenched by bending/hammering the sharp end over. But usually what is seen on Great Lake wrecks are the washered end hammered over to achieve a tight fastening. According to the "Rules Relative To The Construction of Lake Sail and Steam Vessels (Board of Lake Underwriters 1866) bolts for knees on vessels of 50 – 200 tons would be 5/8" diameter, and 3/4" diameter for vessels of 250-300 tons. Knees were to be "fastened with a bolt every seven inches, the bolts in the arms to be driven through and clenched (ibid: 8). "All through-bolts must be driven from the outside and clenched. Locust tree-nails may be substituted for through-bolts, and they must be driven through and wedged" (ibid: 12). TRCA personnel recovered the knee and transferred it to the City of Toronto, Museums and Heritage Services for permanent curation. This particular knee has metal bolts. As to the type of wood used for the construction of the knees, these were usually made of white oak or tamarack. The 1876 version of the "Rules" (International Board of Lake Underwriters 1876: 44) states that all wooden knees were to be of roots or limbs [it is likely that the traditional crook of a tree limb may have been in limited supply by 1876], or "of machine-bent manufacture [suggesting steamed wood]. This knee appears to have been constructed from the crook of a natural tree, and is probably constructed of white oak. The 1876 Rules further states that diameter of knee bolts for different ship tonnage: for ships of 100 tons had knee bolts measuring 5/8" diameter; 175 tons – 3/4" diameter; 275 tons – 3/4" diameter; and 400 tons – 7/8" diameter. The diameter of the knee bolts from the recovered knee is .8", with a head diameter of 1.2". This fits with a ship of about 350 tons. It should be noted that the "Rules" pertain to both American and Canadian ships. The long side of the knee is the vertical outside face. There is no information in either the 1866 or 1876 "Rules" with regards to the thickness of the knee, but the overall size of the piece, definitely defines it as a hanging knee. The configuration of the knee and the bolt size suggest that it comes from a vessel of substantial size, possibly upwards of 130' in length. The only vessel with recorded lengths in the marine background research with similar dimensions is the **Jane Ann Marsh** of 1868. Her tonnage of 257 could meet the criteria of the bolt size, however, it is possible (albeit a slim possibility) that another ship of similar dimensions was also wrecked in this area and not reported. The relationship between tonnage and bolt size is supported by tables in Desmond's (1919: 21) book on wooden ship building.

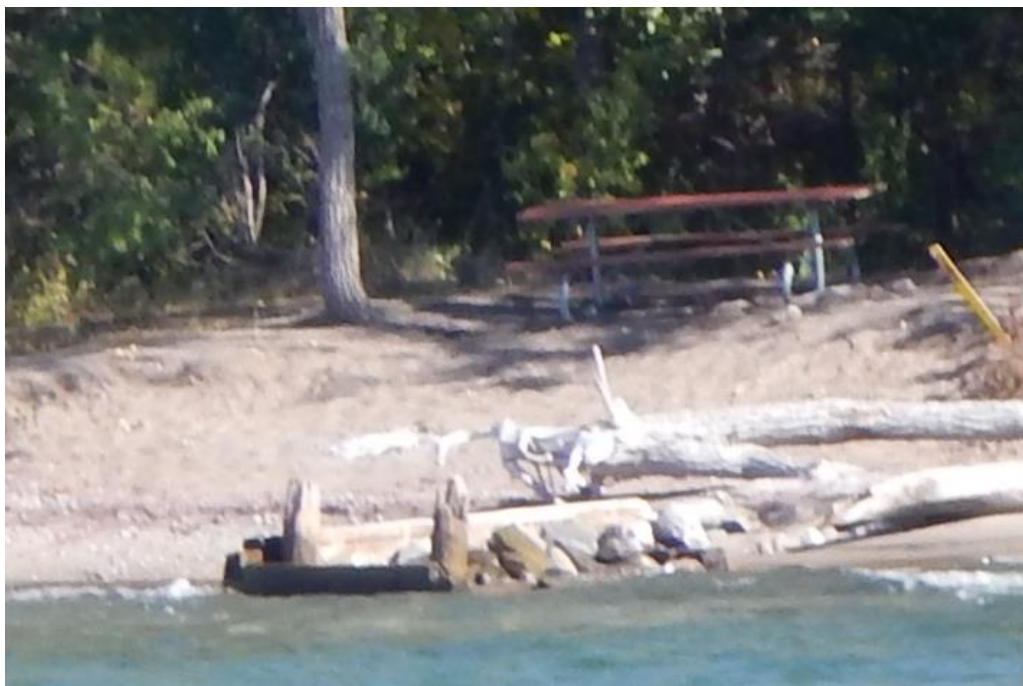
Figure 28: Cribwork

filled with stone. The crib did not extend beyond the single crib, and it was located at the interface of the beach and water, and extended slightly into the water. There was no evidence of any additional crib work further out into the water. There was no evidence of the superstructure in the area. Earlier google earth imagery dating from September of 2009 does not show a crib in this area, however, given the nature of the shifting sands, it may have been buried then.

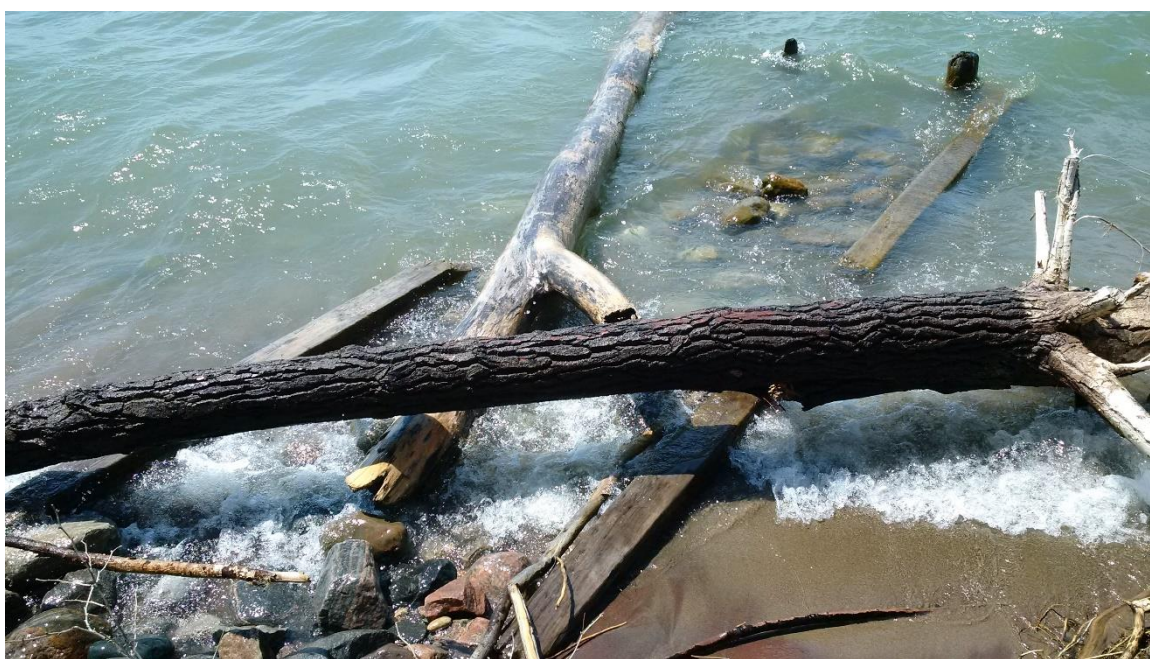
Figure 29: Cribwork (courtesy of TRCA)

Figure 29 however shows very sharp wood edges, which would, if the structure was of an early date, have shown water wear (smooth edges). The date of the crib is possibly late, however, as a date cannot be ascertained through historic maps of the area, as a minimum, obtaining accurate drawings of the crib is recommended.

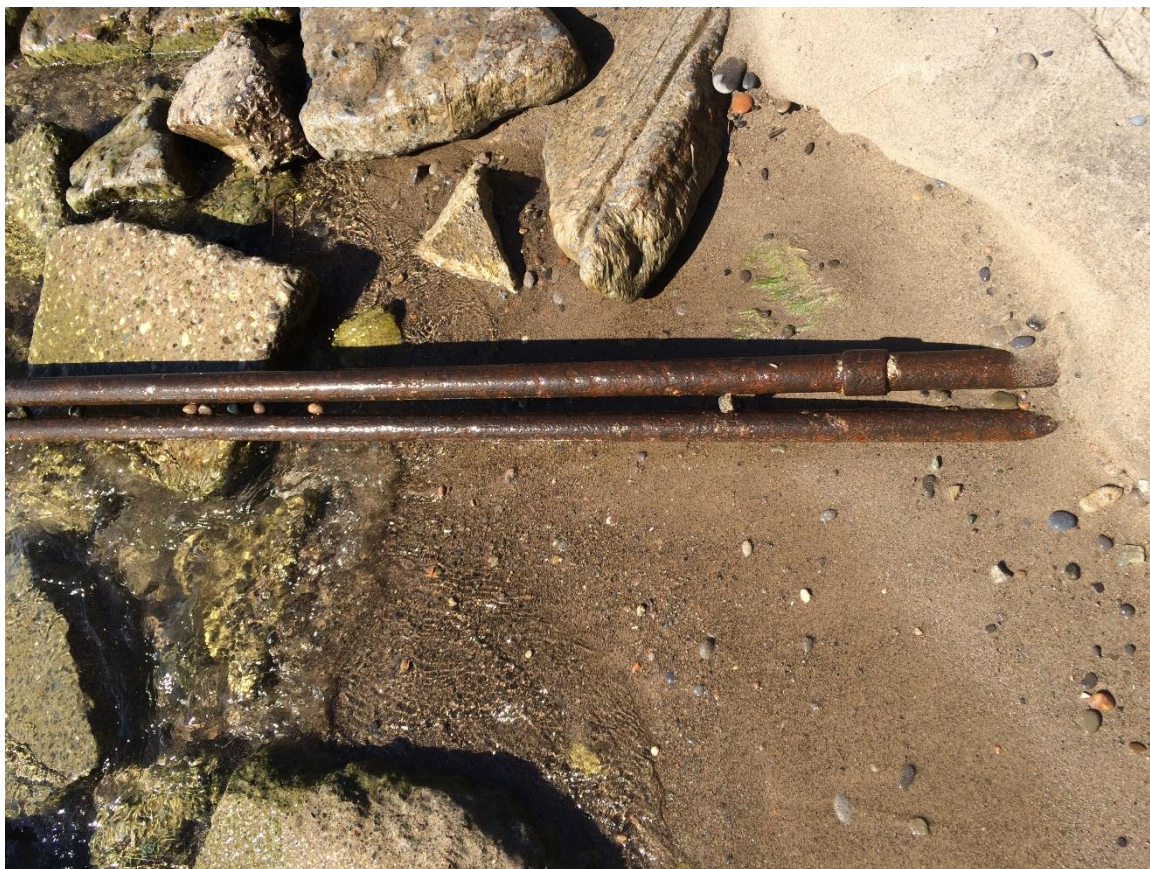
Figure 30 – Pipeline Extending from Shore

In addition to the two cultural finds near or onshore, two pipes were also observed. These were partially buried and extended from onshore into the water and was buried. The exposed interface was located at 43° 36' 43.43"N, 79° 23' 18.44"W (Figure 30). The pipeline is considered to have no cultural heritage value or interest.

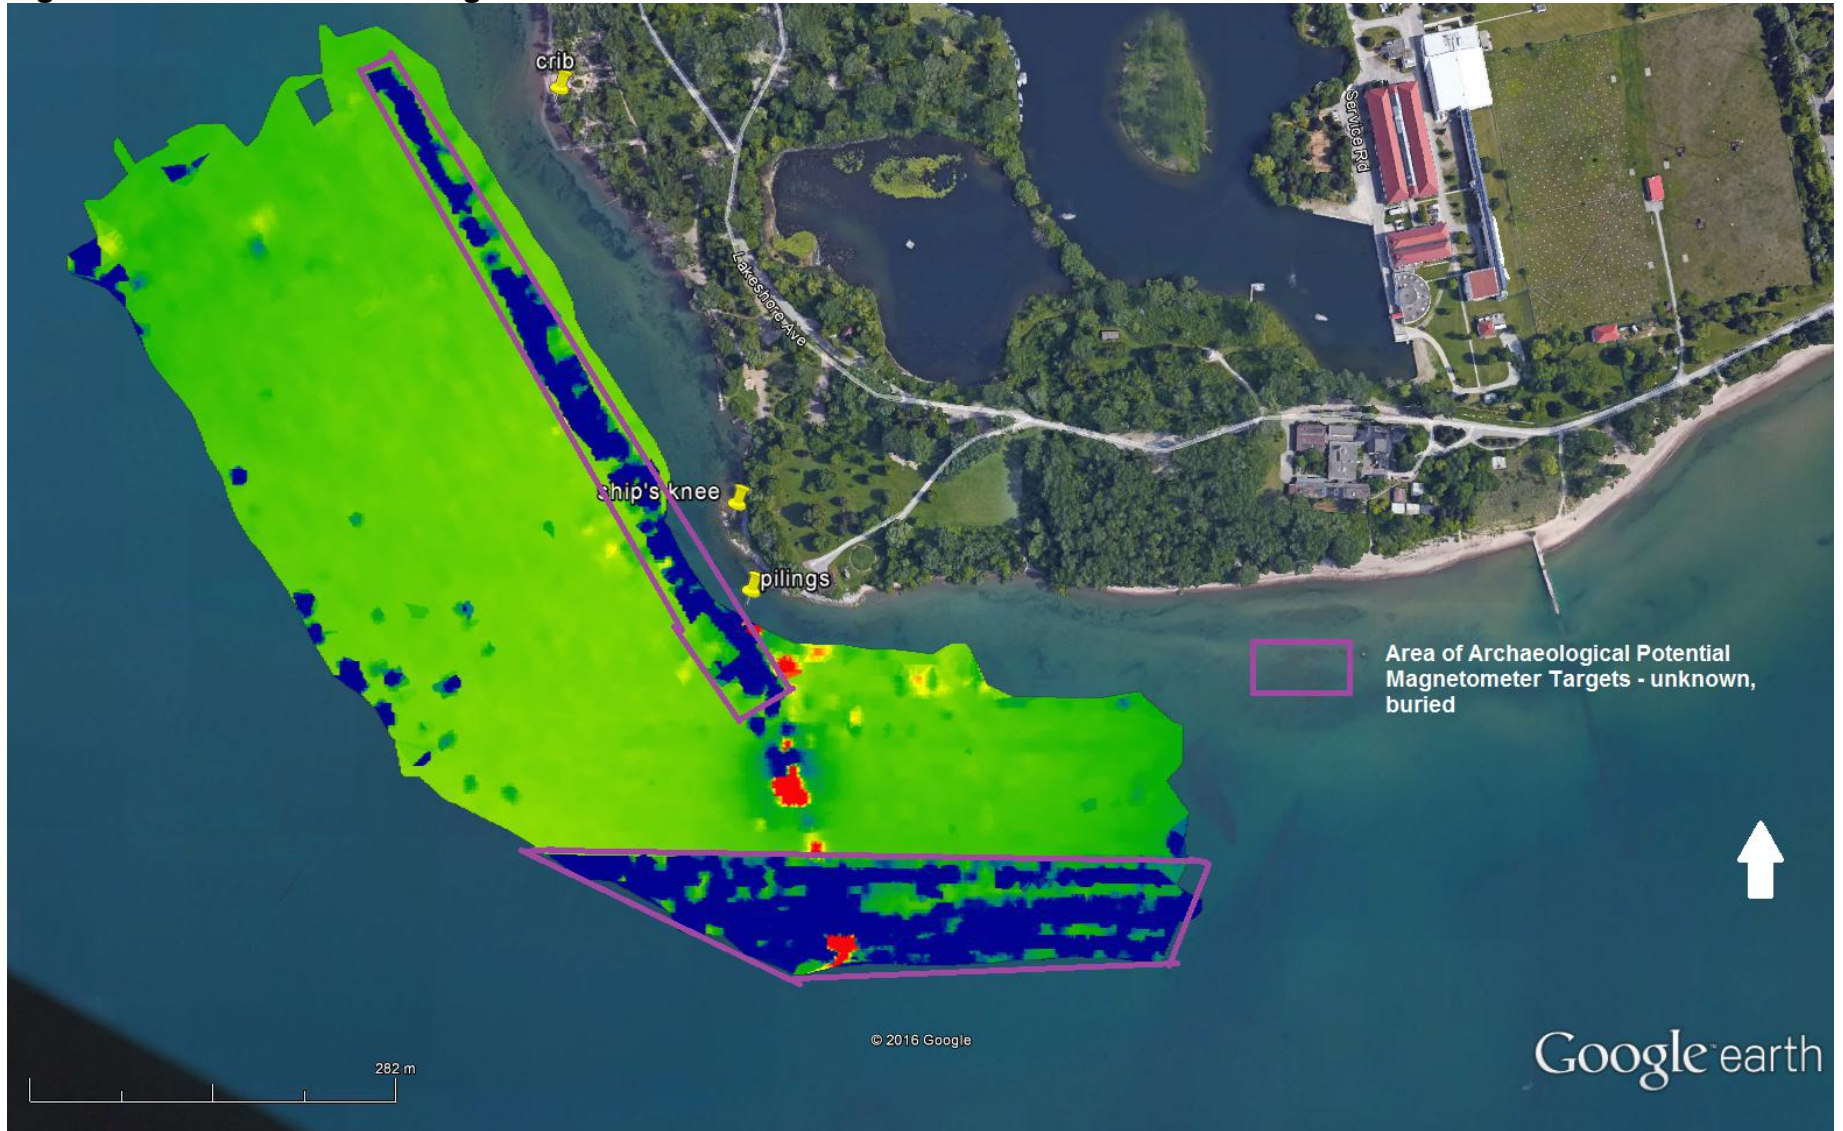
Figure 36: Areas of Archaeological Concern

The magnetometer survey, as expected based on historic background research, has many targets. While some of these are small targets (based on gradient), other targets have large areas located in the southeast end of the magnetometer survey (refer to Figures 32 and 33) and also along the shoreline in the northeast area of the area (refer to Figures 34 and 35). It is possible that buried ship material lies beneath the buried lake sediments in these areas. It is also possible that these targets reflect construction debris or refuse, rather than cultural material, or that buried sediments contain a high degree of ferrous material which caused the magnetometer readings to be so high. The burial of these targets makes it impossible to determine which of the above, or combinations of the above, are valid. Figure 36 illustrates the areas of archaeological concern that are addressed in the recommendations. The area closest to shore, running at an approximate orientation of northwest to southeast lies in the 1.5 - 2 metre depth range. This area generally lies offshore about 100 metres. The second area of concern lies from 200 to 260 metres offshore and occupies the 3 to 4 metre depth contour.

- The Marine Archaeology Study Area (MASA) (where magnetometer readings are high) may contain buried cultural material. If development in any of these areas is proposed where bottom sediments will be disturbed (laying of stone), it is recommended that a licensed archaeologist be present during development construction, and if there is to be spoil removed from the area, that the archaeologist observe the spoil for possible cultural materials (Figure 36);
