# STATE OF THE WATERSHED REPORT:

## HIGHLAND CREEK WATERSHED

**AUGUST, 1999**

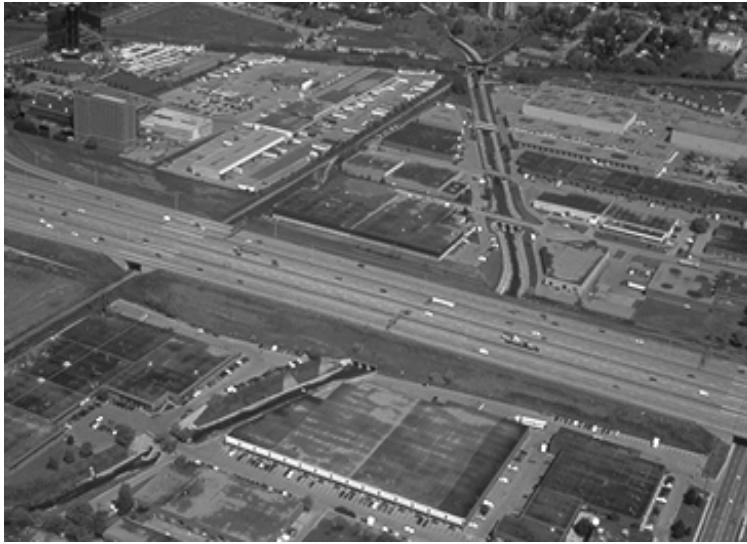
*Highway 401 corridor through the Highland Creek watershed*

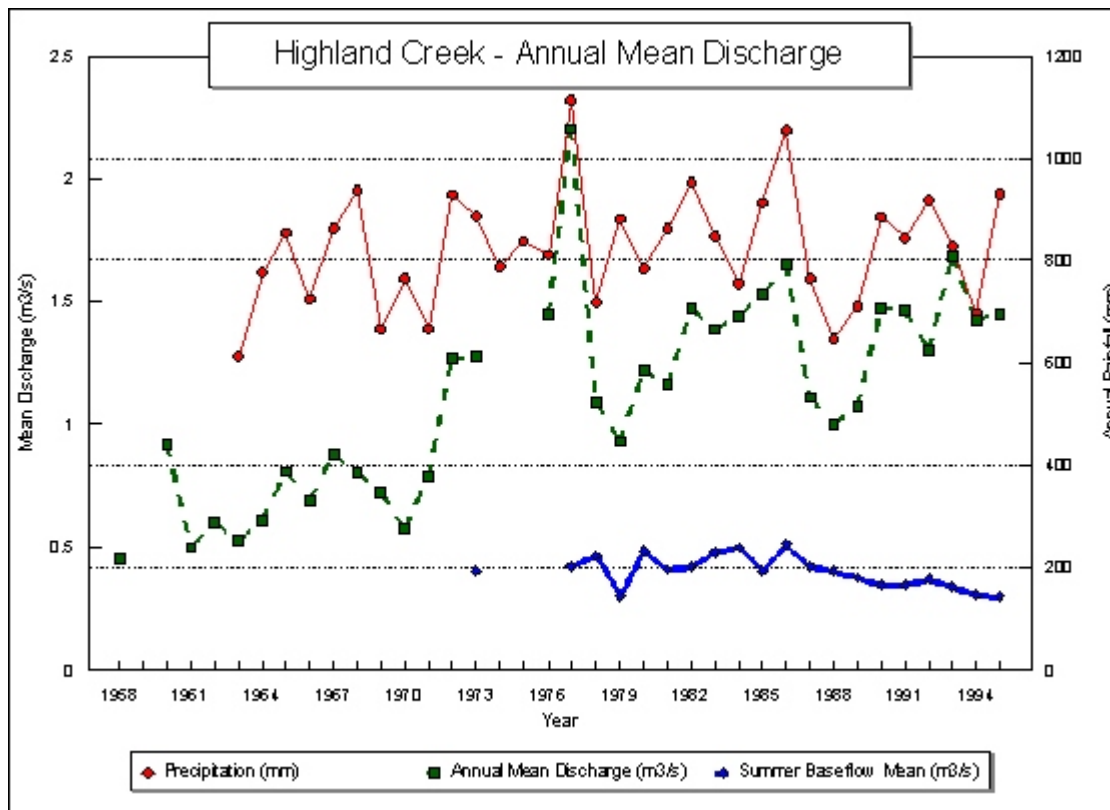
**FIGURE 8: Highland Creek Annual Mean Discharge - 1958 to 1995**

The most dramatic increase in mean annual discharge and total flow can be observed after 1970 when development began to accelerate in the watershed. This change in land use tends to result in a reduction of infiltration, surface depression storage, and evapotranspiration. The consequence of which is higher amounts of surface runoff. The urban infrastructure of channels, roads and sewers, contain and transport the runoff more efficiently to the receiving streams, resulting in a shift in the response of urban stream systems to runoff events. As a result, there is a more rapid hydrologic response to storm events, typified by large, rapid flows during these events. The linkage between precipitation rates, the annual mean discharge, and total flow is most particularly evident in the years after urban land uses began to dominate the watershed particularly in the 1980s and 1990s.

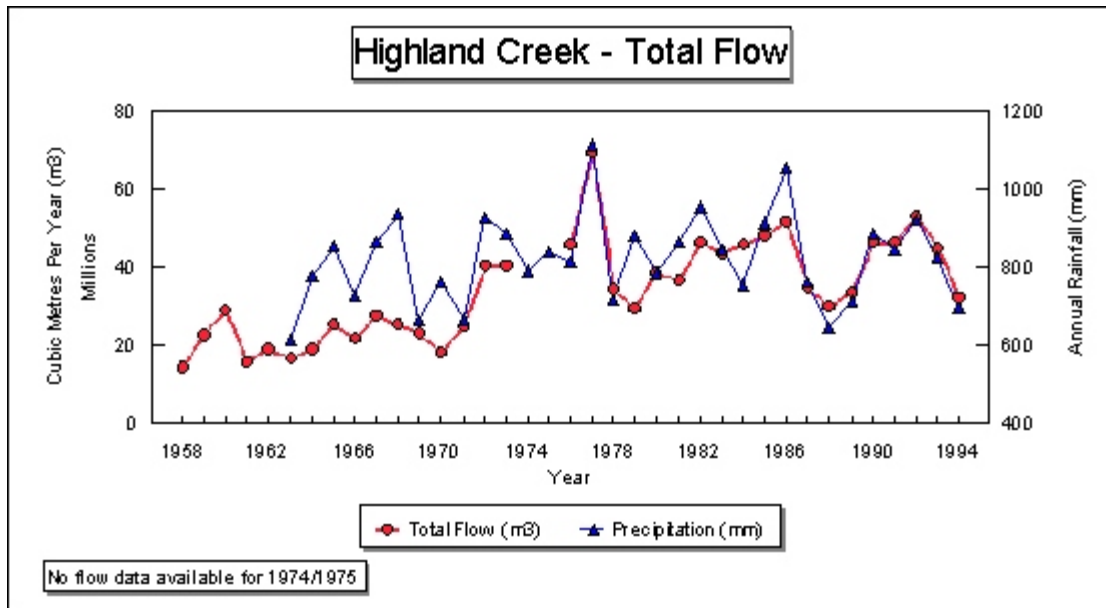
FIGURE 9: Highland Creek Yearly Total Flow - 1958-1995

The change in the hydrologic flow regime experienced through urbanization results in changes within the watercourses as they expand and deepen to accommodate the increase in the flow rates that they must carry. While the expansion of the low flow channels occurs throughout the system, the speed and degree of change is dependent largely upon the material through which the channel must flow. In the lower portions of the Highland Creek, below the Lake Iroquois shoreline, the sandy soils are experiencing a much more rapid adjustment. The widening and deepening which has, and is occurring, also results in a disconnection of the low flow channel from its floodplain.

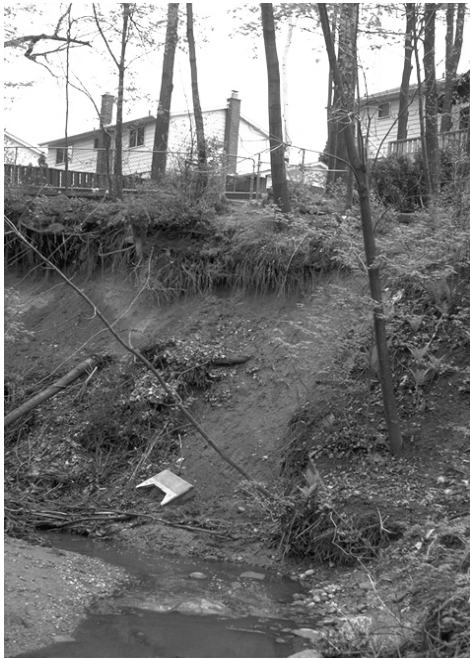
*Erosion along Highland Creek*

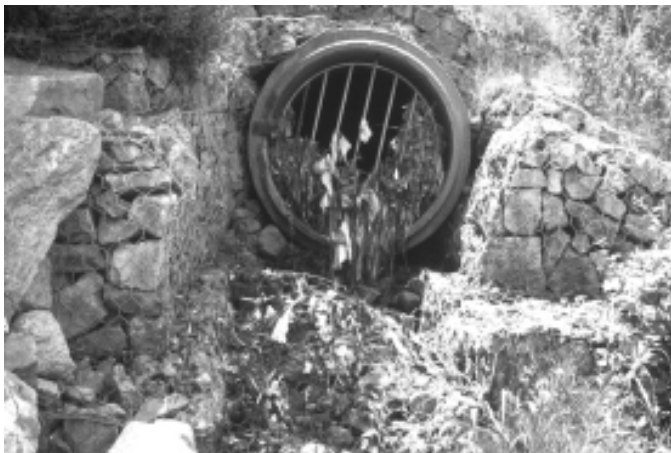
According to a report from Metro Works, the greatest proportion of major problem outfalls during 1992-1995 were in the industrial sector (TRCA, 1998d). During 1992-1993, the sources of these problems were found to be associated with two major incidences of poor housekeeping and one major spill incident. During 1994-1995 (the most recent report), Highland Creek had three major incidents of cross connection, seven incidents of spills, and four incidents of dumping. Based on these investigations, it was deemed that no outfalls in the Highland Creek watershed warranted "priority status" for extensive efforts to trace pollutants to source.

*Stormsewer outfall discharging into the Highland*

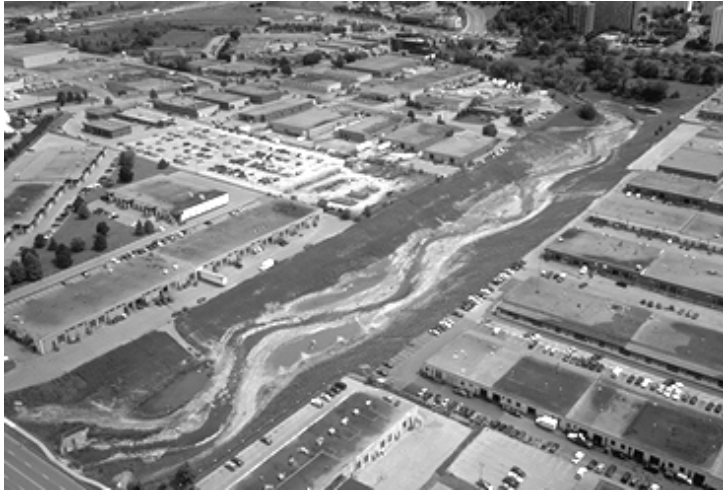
The Markham Branch Restoration Project, developed to rehabilitate a portion of the Markham Branch of Highland Creek, was undertaken by the former City of Scarborough Works Department (CCL, 1994). The restoration work was carried out on the section of the creek between Highway 401 and Markham Road. Originally, this branch of the creek extended south of Ellesmere Ave in a large meander, but this was modified in the late 1960s to facilitate the construction of industrial development in the area. The creek was straightened and channelized through the area. After this work was carried out, the creek was largely devoid of any habitat with virtually no forest cover, other than an old apple orchard located near Markham Road. The channel was mostly confined with limited access to the floodplain. The water is degraded, mostly as a result of stormwater, and during site visits before the project was begun no fish were

*Markham Branch Regeneration Project, June 1999*
