**BLUFFER'S PARK SOUTHWEST HEADLAND AND BEACH MAJOR MAINTENANCE
PROJECT**

CITY OF TORONTO

CLASS ENVIRONMENTAL ASSESSMENT FOR REMEDIAL FLOOD AND EROSION
CONTROL PROJECTS

PROJECT PLAN

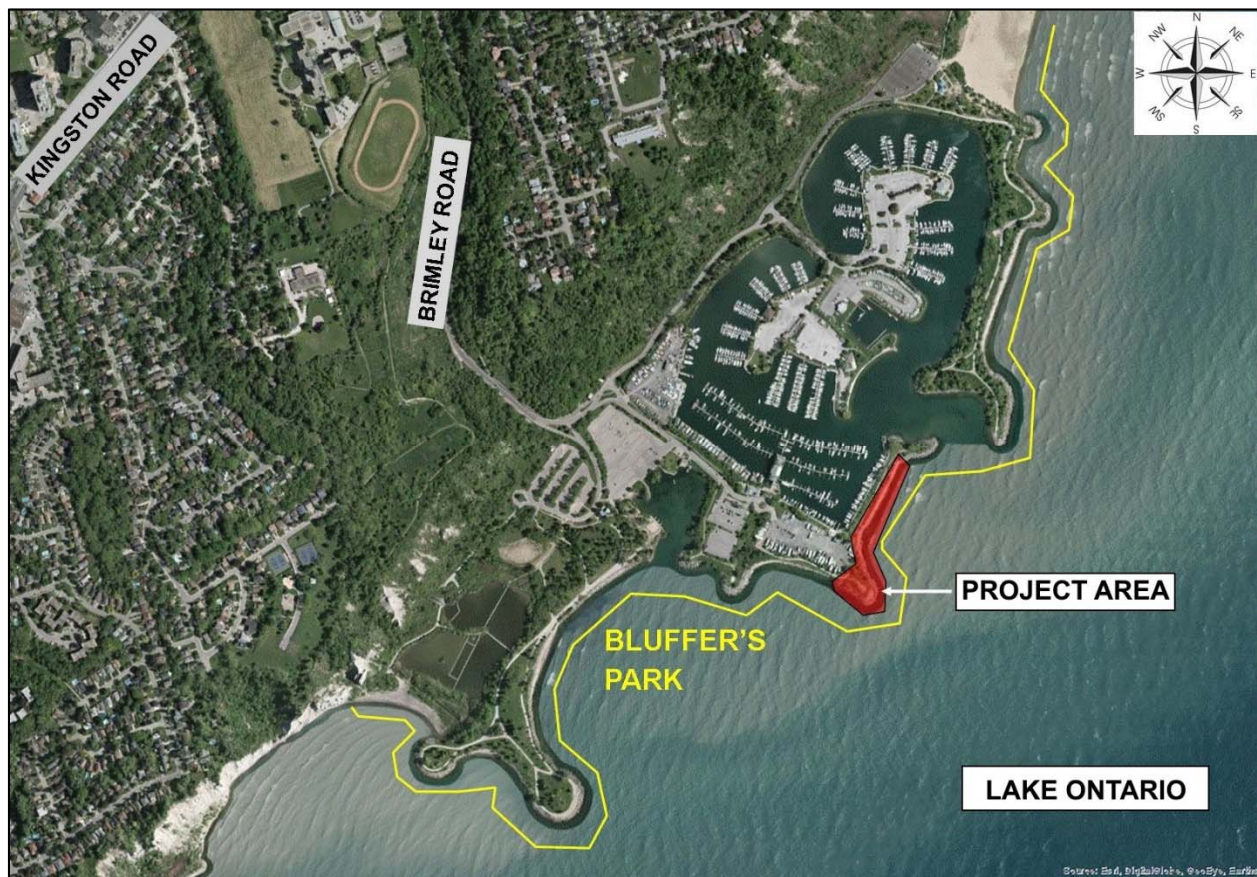
Figure 1. Location of Bluffer's Park and the Project Area. *Source: TRCA, 2016.*

Toronto and Region Conservation Authority (TRCA) has proposed to undertake the repair and remediation of two erosion control structures located in Bluffer's Park, along the shoreline of Lake Ontario in the City of Toronto (**Figure 1**). The project limits include the southwest headland and beach located near Bluffer's Park Marina, stretching approximately 250 m along the shoreline. The headland and beach landform contains and protects Bluffer's Park Marina. The headland consists of large armourstone and smaller rocks used as filter material. The beach is made of sand, cobble and rubble, backed by a sandy backshore. The area above the structures is mostly lawn or parking lots. This area of Bluffer's Park is gated and generally only accessible by marina users and staff.

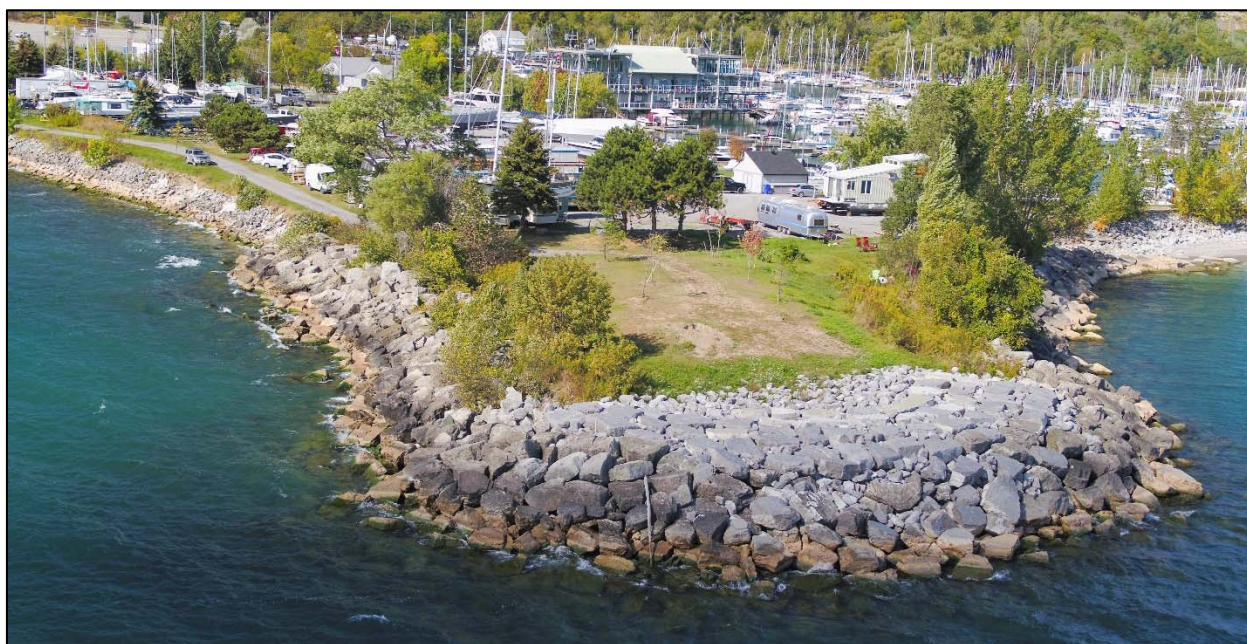
The headland, shown in **Figure 3**, consists primarily of large armourstone and is 31 m wide with a linear length of 165 m. The headland shows many signs of instability, including toe instability, lack of consistent double layer placement of armourstone in various areas, lack of sufficient filter layering below the primary armourstone, an oversteepened structure slope, and wave overtopping. These deficiencies were noted during a Shoreline Conditions Review by Shoreplan Engineering in 2010 (**Appendix A**). Since this review, TRCA's ERMP has further identified outflanking of the headland on the northeast limit of the structure and scouring at the southwest limit, as well as slumping and voids behind the top of the structure (**Figure 4**). In 2016, TRCA undertook interim maintenance works to improve headland stability until the final solution can be implemented (**Figure 5**).

Figure 3. Conditions of headland in October 2017. *Source: TRCA, 2017.*

A Shoreline Conditions Review undertaken by Shoreplan Engineering in 2010 stated that the instability of the headland was likely caused by a combination of toe instability, lack of consistent double layer placement of armourstone in various areas, lack of sufficient filter layering below the primary armourstone, an oversteepened structure slope, and wave overtopping. Preliminary identified solutions included modification of the existing structure or a complete reconstruction utilizing existing material when possible and supplementing with new material as required. In 2016, TRCA undertook interim maintenance works to improve headland stability until the final solution can be implemented.

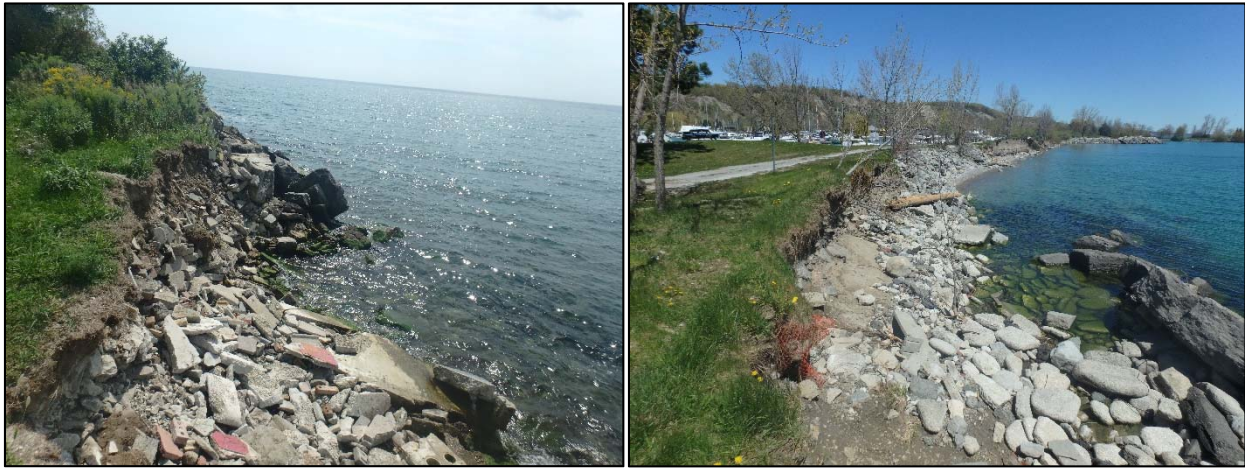
Figure 4. Scouring at the southwest limit (left) and outflanking and scouring at the northeast limit (right).
Source: TRCA, 2017.

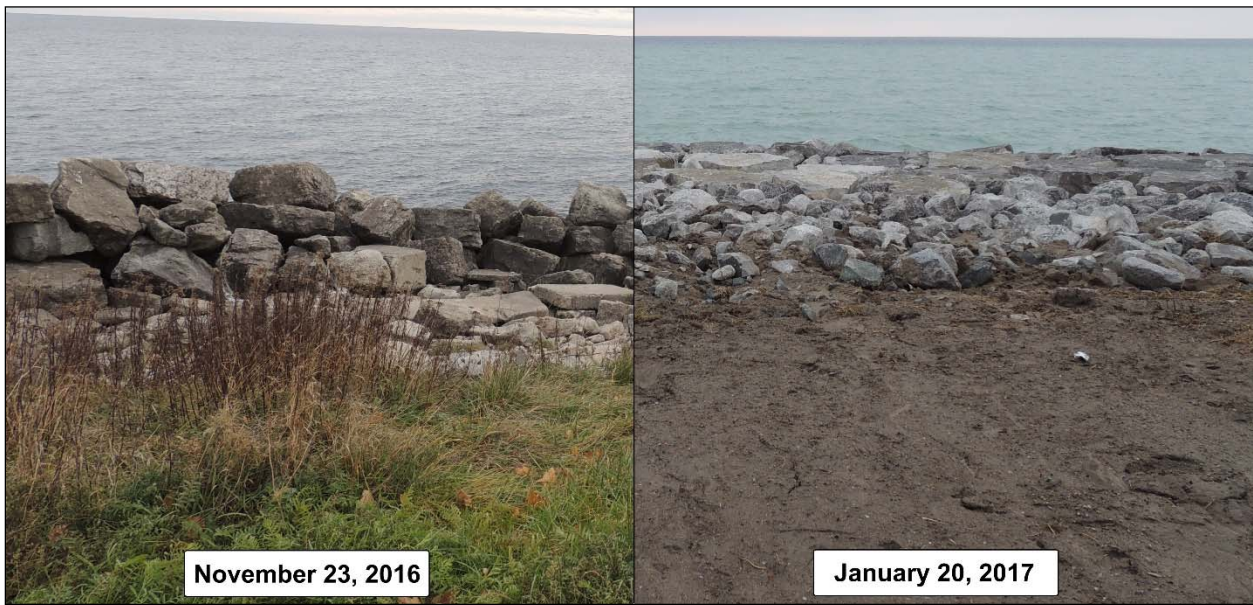
Figure 5. Headland before and after interim maintenance. Source: TRCA, 2017.

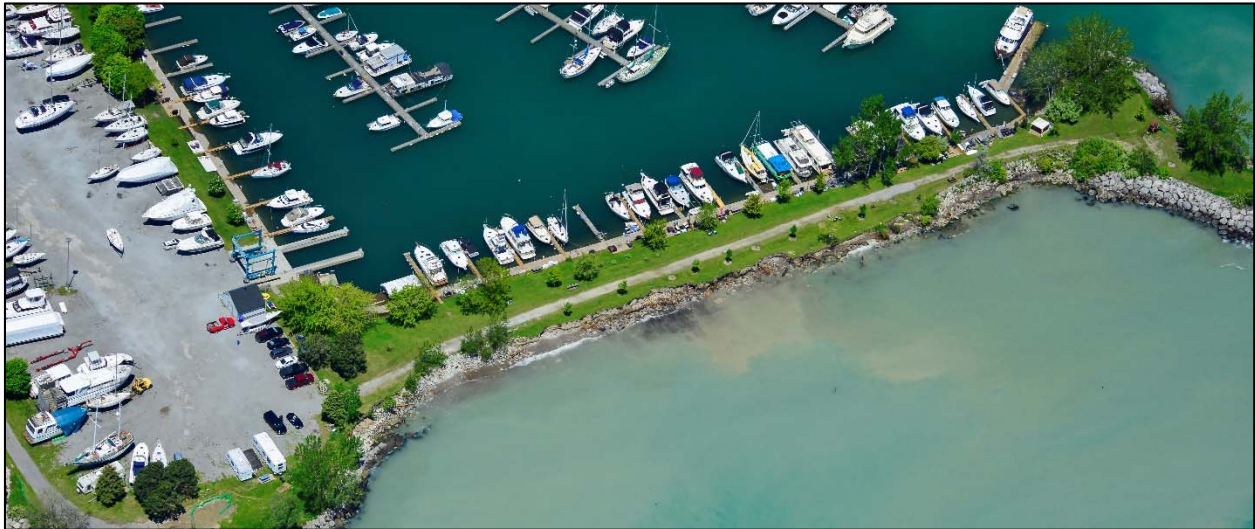
The beach, shown in **Figure 6**, measured 194 m long and 6 m wide at the time of its initial construction, and included sand, rip rap and armourstone material. The beach has experienced significant erosion along its sandy backshore; the Shoreline Conditions Review (Shoreplan Engineering Limited, 2010) attributed this erosion to a lack of coarse material to provide stability as well as a limited beach width to dissipate waves before reaching the back portion of the bank. In May of 2017, TRCA measured the scoured backshore as being 4 m from the informal path. At the time, Lake Ontario was experiencing record high lake levels which impacted the Bluffer's Park shoreline and the erosion control structures within the Project Area. Between November of 2016 and August of 2017, the backshore eroded substantially enough that one park bench and at least five mature trees were lost (**Figure 7**).

Figure 6. Aerial view of beach area and marina. *Source: TRCA, 2017.*

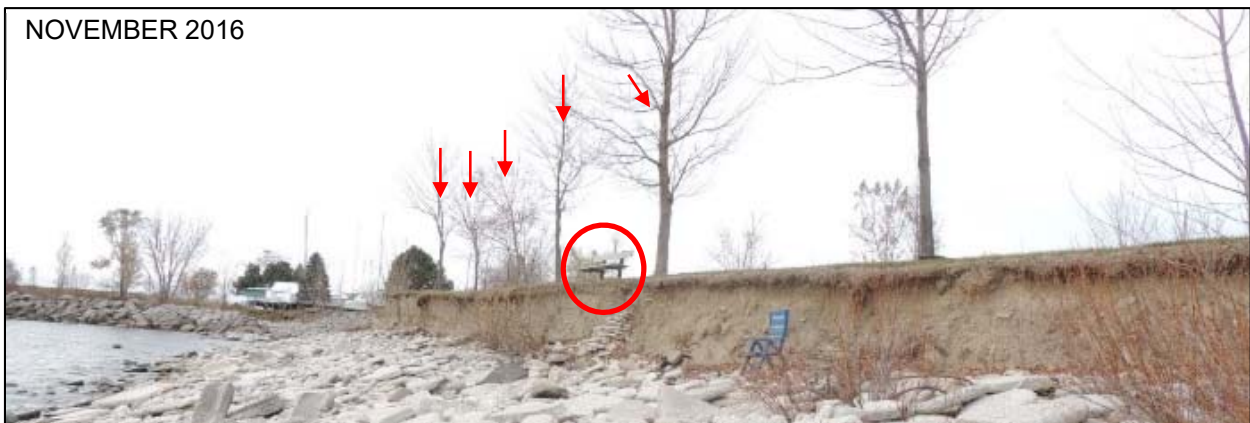
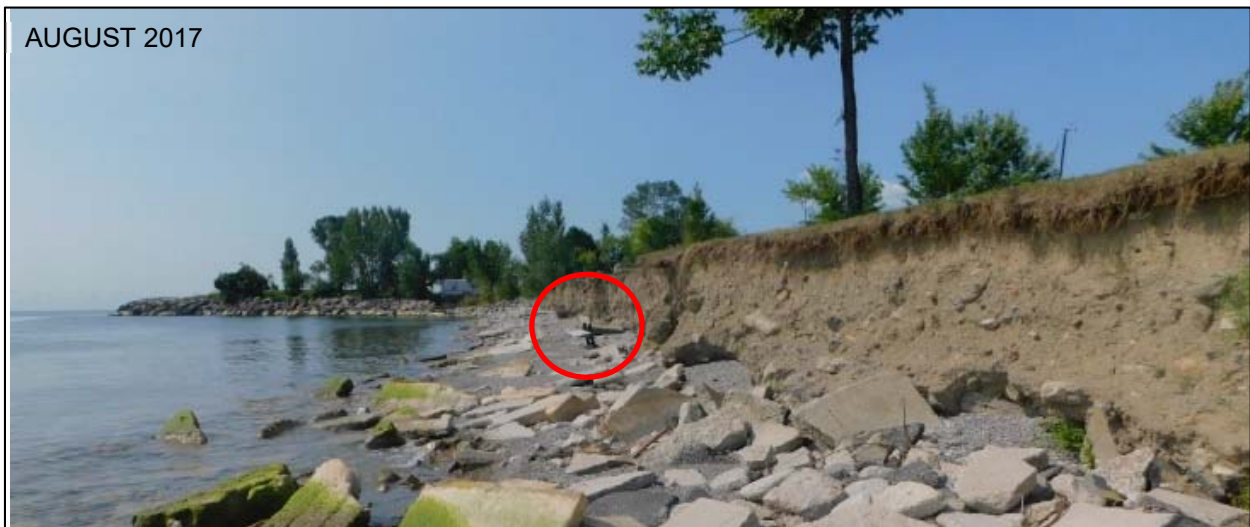
Figure 7. Erosion of the backshore occurring between November 2016 (top) and August 2017 (bottom). The arrows indicate trees that have been lost since November 2016, and the circle shows the position of the bench. *Source: TRCA, 2017.*

According to the 2010 Shoreline Conditions Review, this headland receives some of the strongest waves along the Toronto shoreline. Based on TRCA monitoring records, the backshore of the beach has been receding regularly. In 2014, the backshore was 7.4 m away from an informal park path, while in spring of 2017, that distance had reduced to 4.0 m. The record high water levels on Lake Ontario in 2017 have further eroded the backshore since the last formal inspection. Continued erosion of the backshore could eventually cause a breach into the Bluffer's Park marina, rendering it unusable.

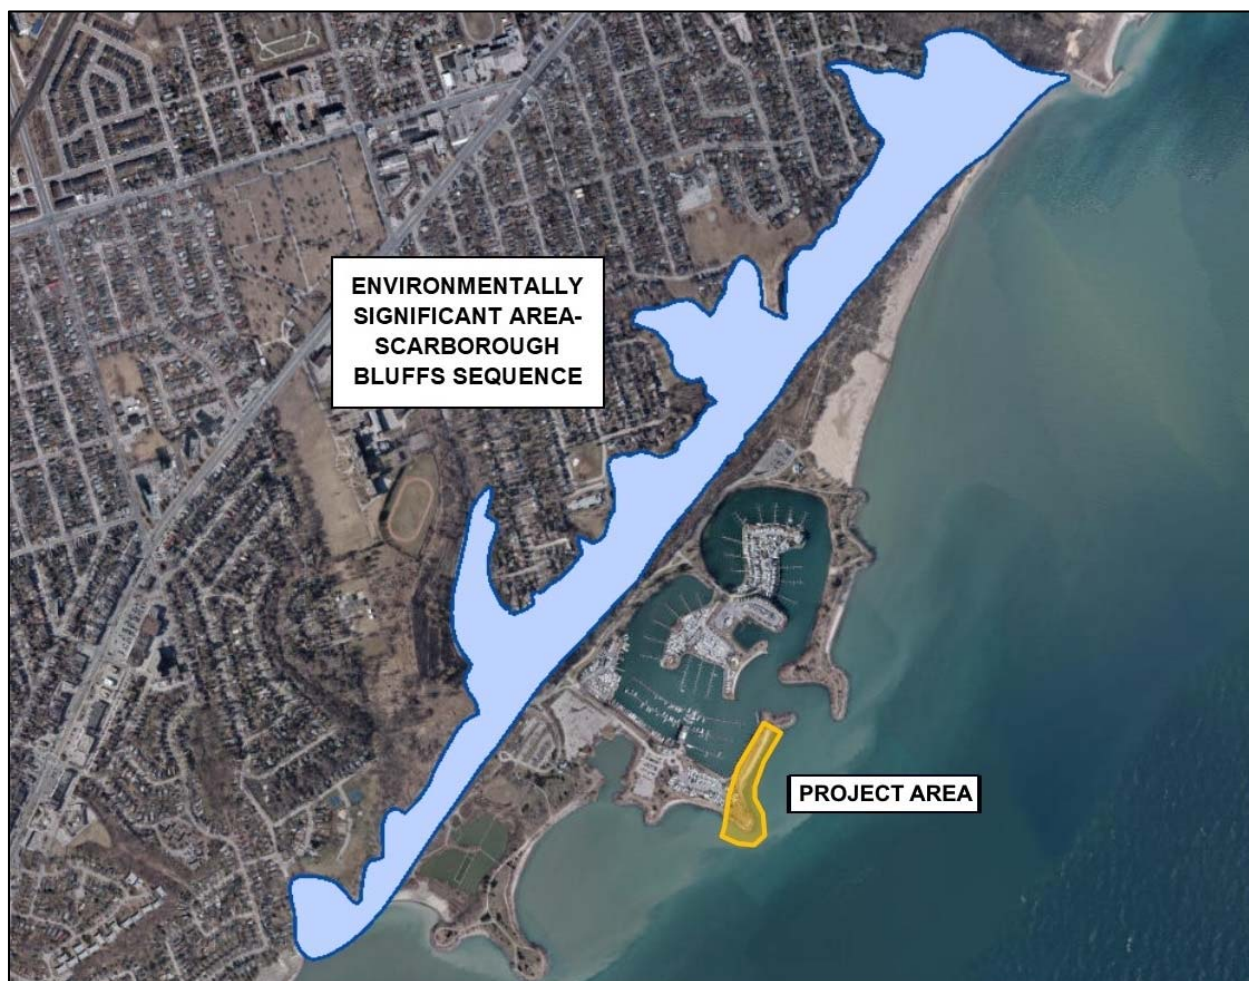
Figure 9. ESAs near the project site. *Source: TRCA, 2018.*

ESAs are defined as areas of land that meet one or more certain physical or biological criteria. The physical criterion is that the area must contain rare or high quality landforms. The only ESA that meets this physical criterion located near the project site is the Scarborough Bluffs Sequence (**Figure 9**) (Toronto and Region Conservation Authority (TRCA), 2018).

The Project Area is located within Bluffer's Park, which is adjacent to the ESA; however, the Project Area is on the shoreward side of the park and is not near the bluffs. Therefore, any work being carried out within this area should not affect the ESA.

The only ESA located near the Project site is the Scarborough Bluffs Sequence (**Figure 9** in section 3.1.1), which meets all of the above biological criteria.

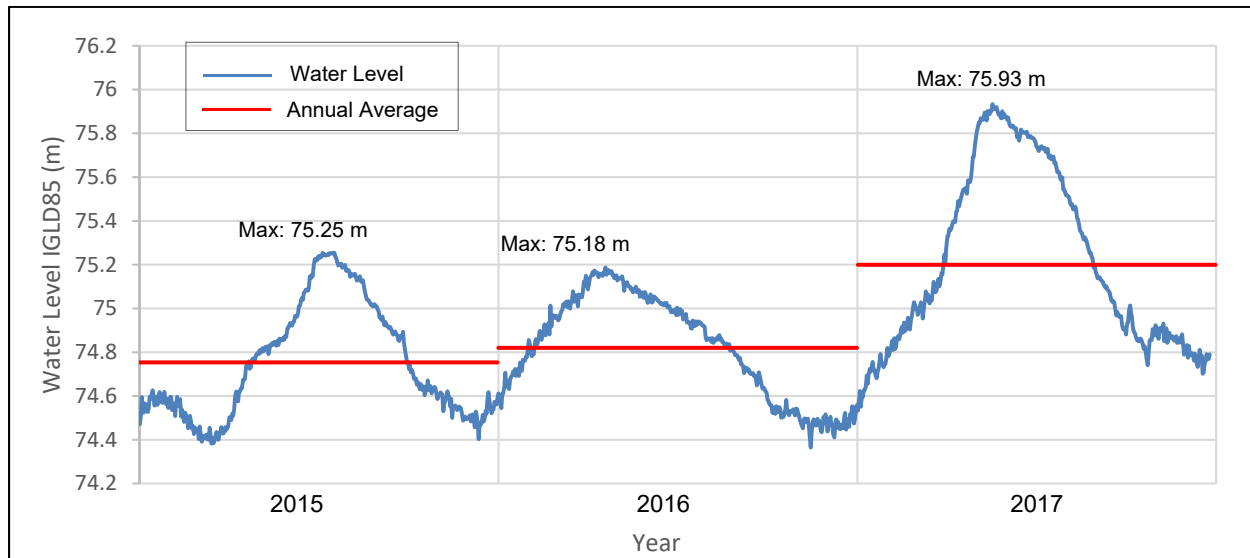
In 2017, Lake Ontario experienced record high lake levels, which can be seen in the graph below. The maximum water level was recorded as 75.93 m, which is more than 0.6 m higher than the maximum water levels for the preceding two years. The high volumes of water caused flooding of several areas within the City of Toronto and exacerbated erosion in many locations. The beach (WF22.12) within the Project Area experienced accelerated erosion throughout the spring and summer of 2017.

Figure 12. Lake Ontario water levels for 2015-2017, including annual averages. Water levels were measured hourly and are presented here as daily averages. *Source: DFO, 2018*

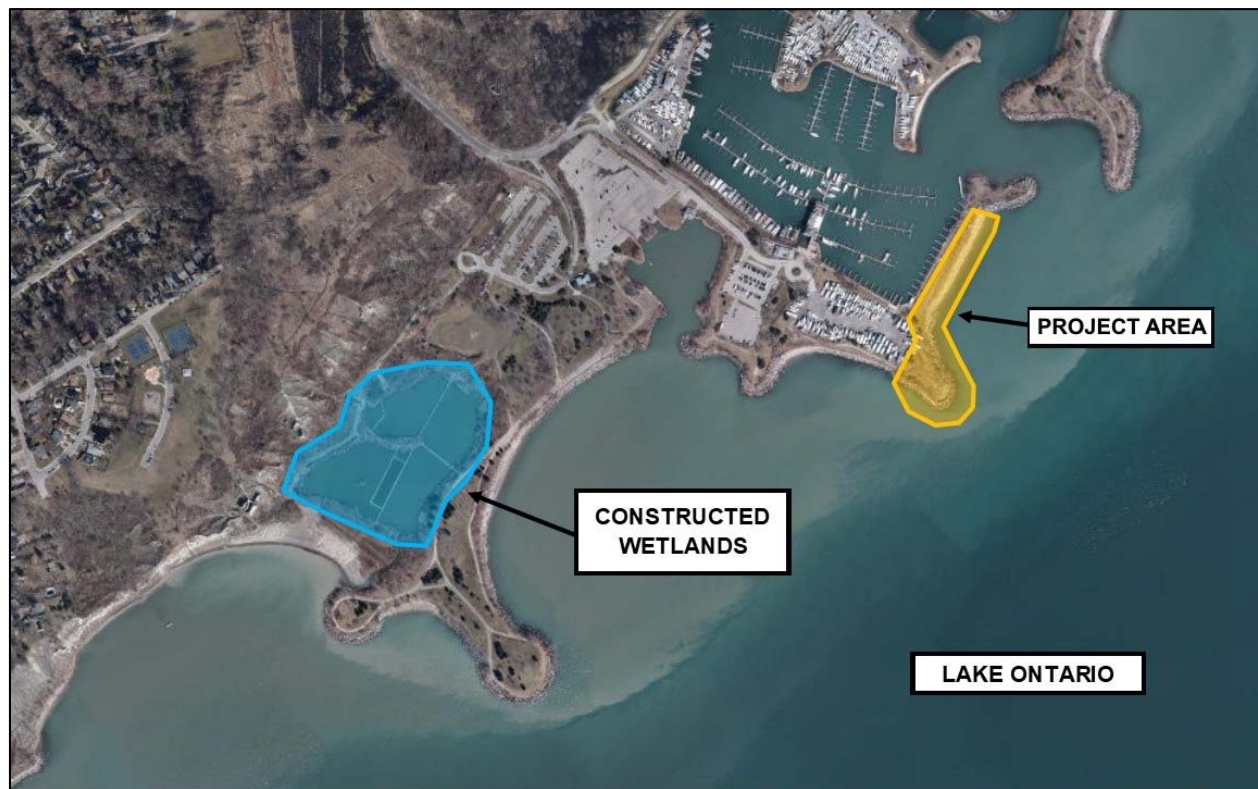
Figure 16. Constructed coastal wetlands in Bluffer's Park and location of Project area. *Source: TRCA, 2017.*

The nearest wetlands to the project site are the Bluffer's Park constructed wetlands to the west (**Figure 16**). This is a series of five wetland cells, known as the Dunker's Facility, designed to naturally treat stormwater before it drains into Lake Ontario as well as provide coastal wetland habitat for local wildlife (Ontario Streams, n.d.). The wetlands are approximately 550 m away from the Project site and will not be affected by any project activities.

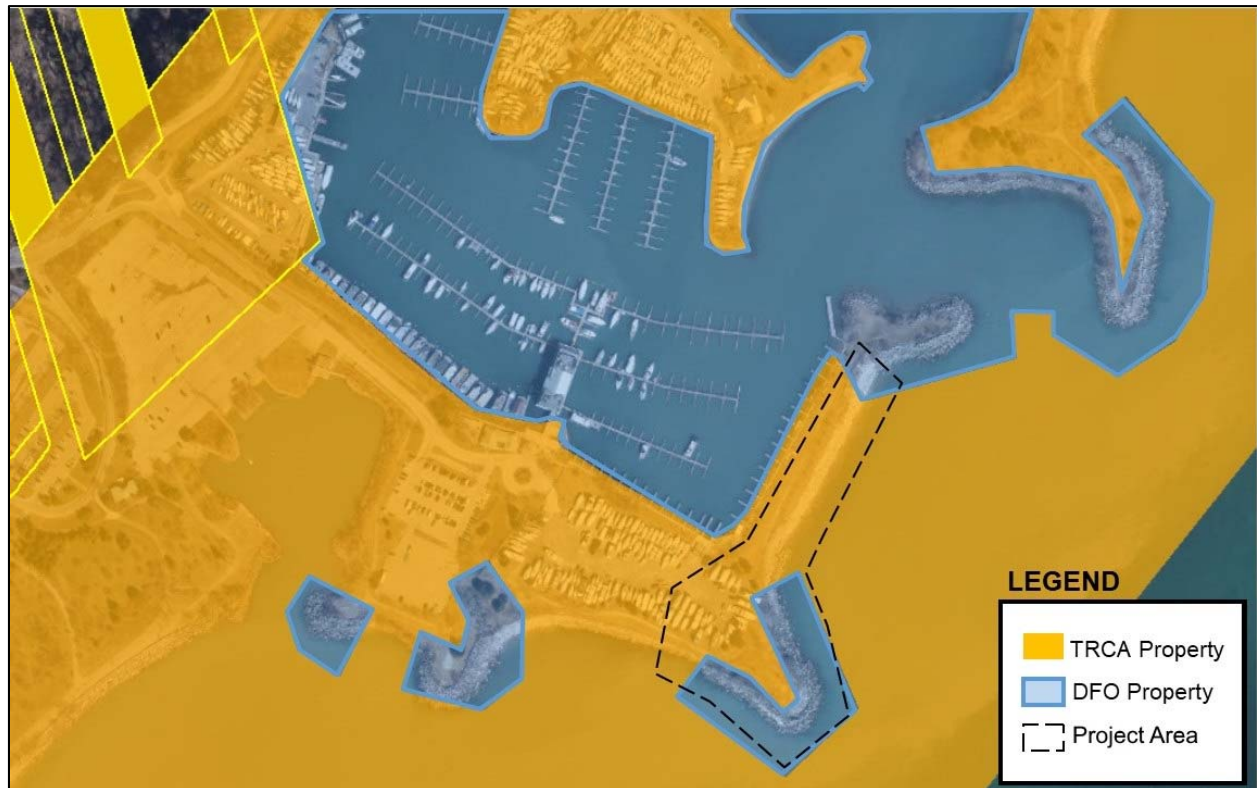
Figure 19. Property ownership of Bluffer's Park and the Project Area. *Source: TRCA, 2018.*

The land portion of the park is mostly owned by TRCA while the marina waters and headlands are owned by DFO (**Figure 19**) (Toronto and Region Conservation Authority (TRCA), 2018). In particular, the headland within the Project Area is owned by DFO, while the beach is mostly TRCA-owned with a small area at the east limit being DFO property. The work being done on both the beach and the headland will have a direct impact on DFO property, however, DFO is aware of the Project is involved in the review process.

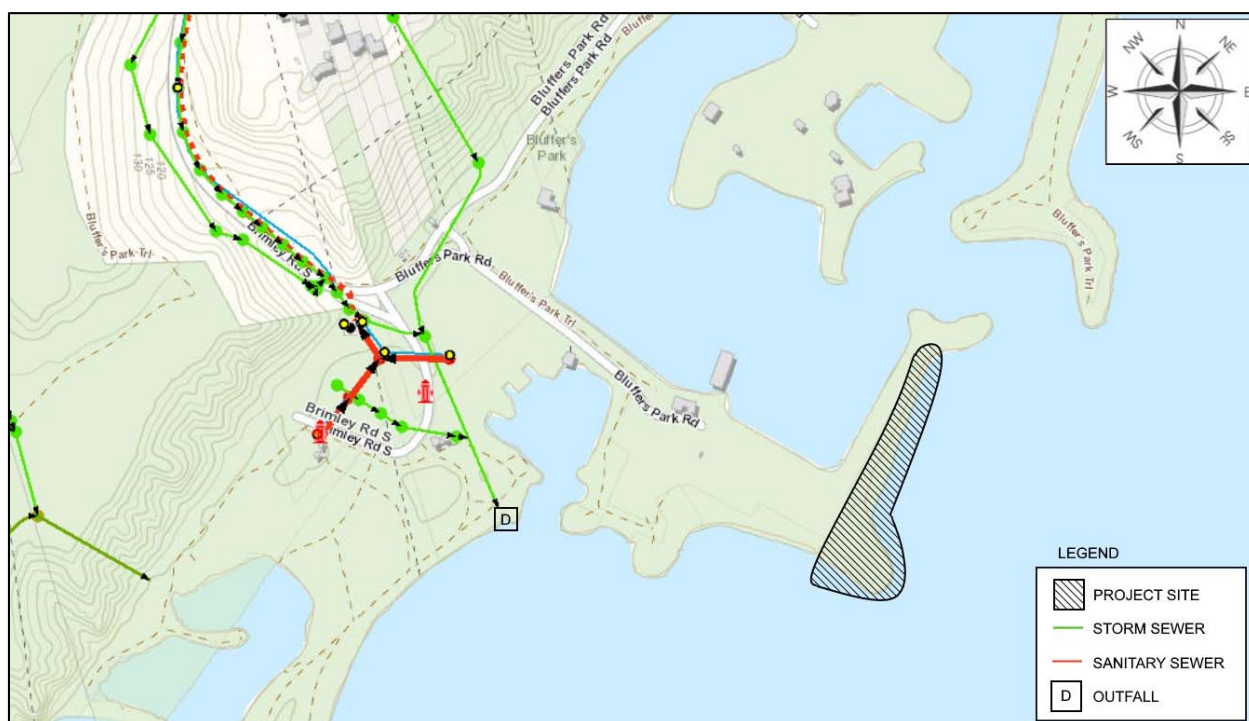
Several City of Toronto stormwater sewers drain through the western side of Bluffer's Park, near the base of Brimley Road South (**Figure 20**). These drains service Brimley Road South, the Bluffer's Park western parking lots and several residential areas at the top of the bluffs. This drainage system has an outfall in Bluffer's Park, south of the western parking lots. The Project Area is located east of the outfall and any work undertaken will not affect the sewer system.

Figure 20. City of Toronto sewer infrastructure near the Project Area. *Source: City of Toronto, 2018.*

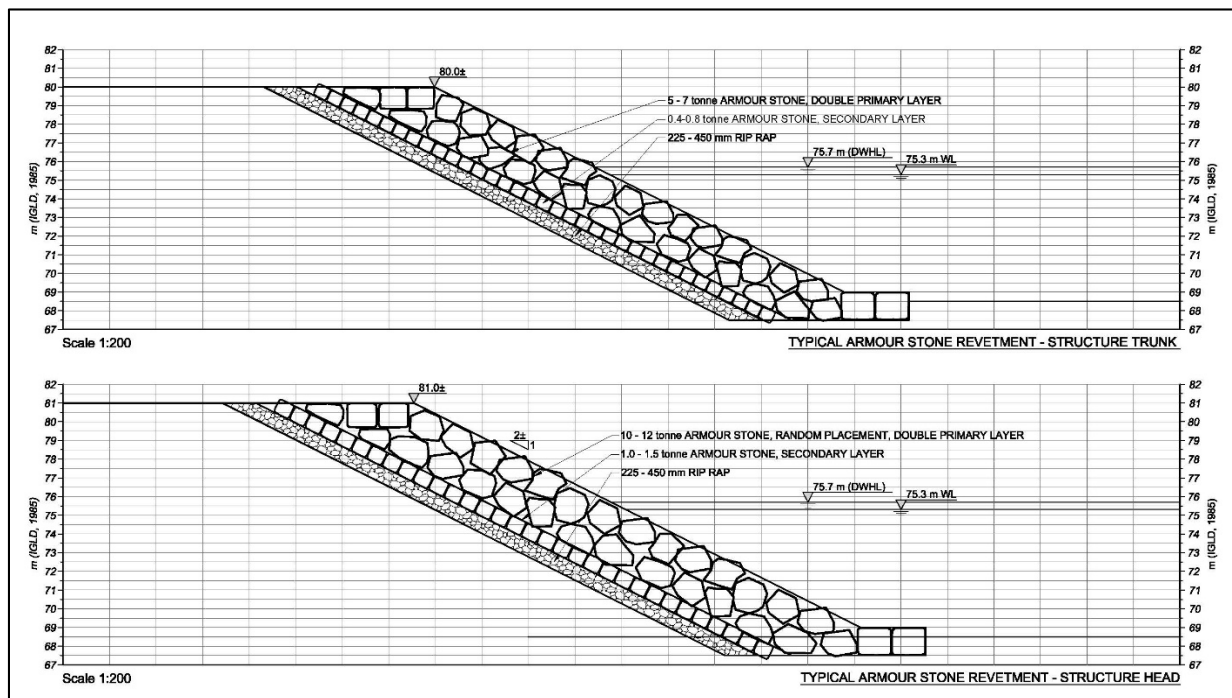
Figure 22. Concept design cross-sections for Option 1B, headland reconstruction. *Source: Shoreplan Engineering, 2017.*

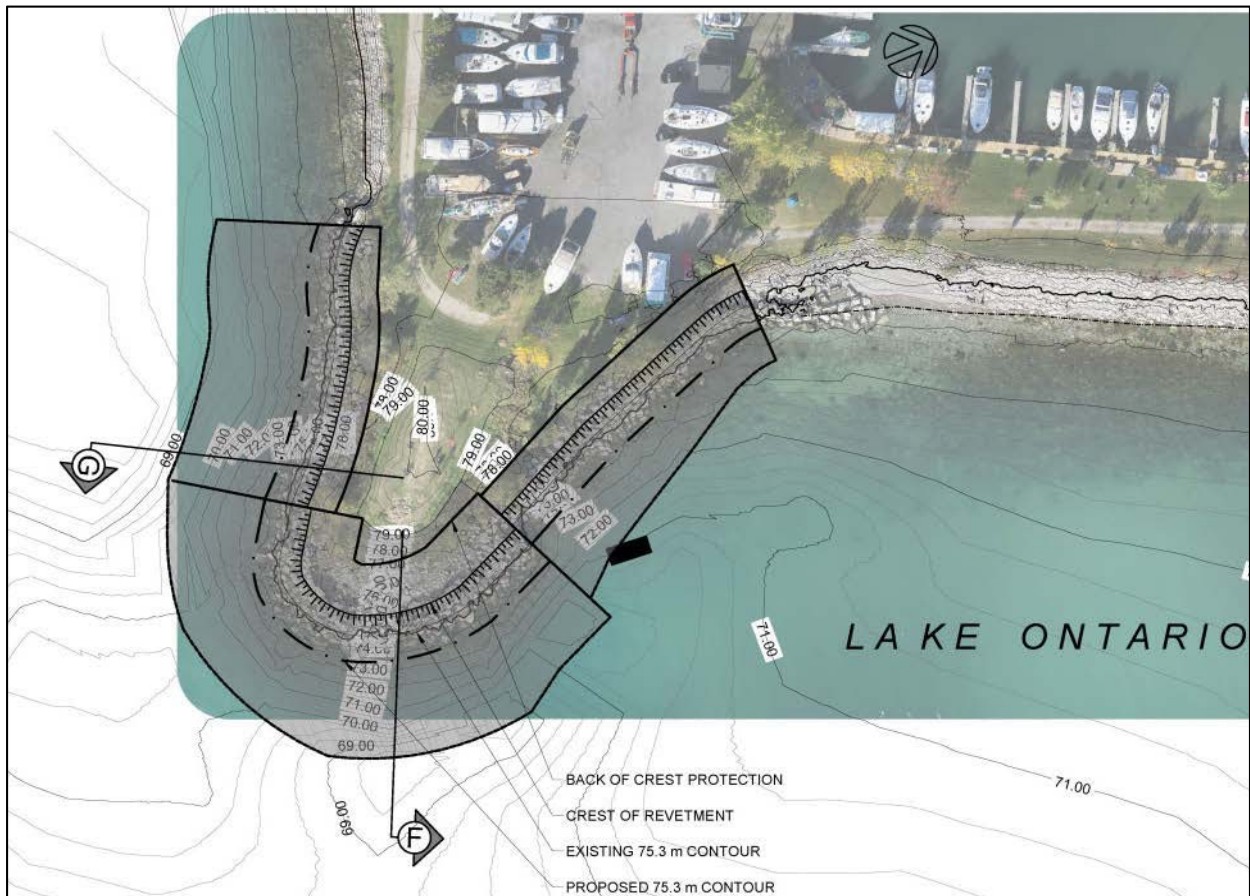
Option 1C involves leaving the existing headland revetment in place and adding a second layer of armourstone overtop (**Figure 23** and **Figure 24**). The crest of the structure will not increase in height but it will be extended inland to reduce damage from wave overtopping. The backshore would remain at risk of minor damage during extreme storm events.

Figure 23. Concept design plan view for Option 1C - repair headland. *Source: Shoreplan Engineering, 2017.*

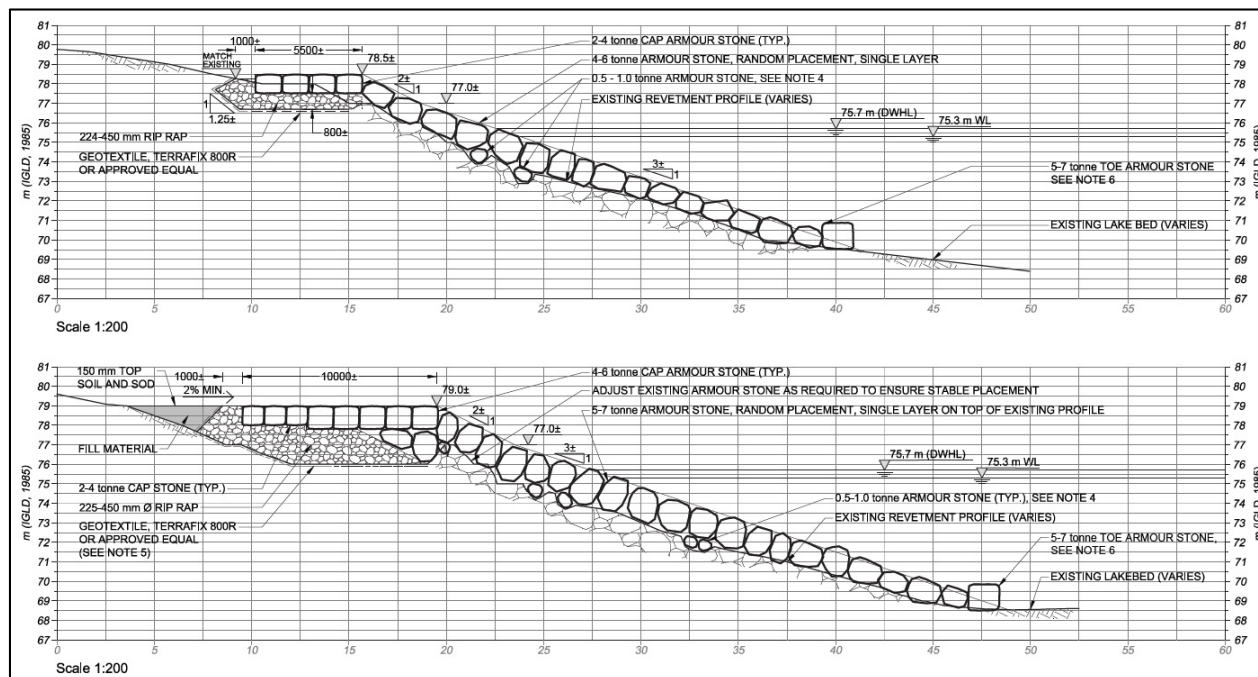
Figure 24. Concept design cross-sections for Option 1C - repair headland. *Source: Shoreplan Engineering, 2017.*

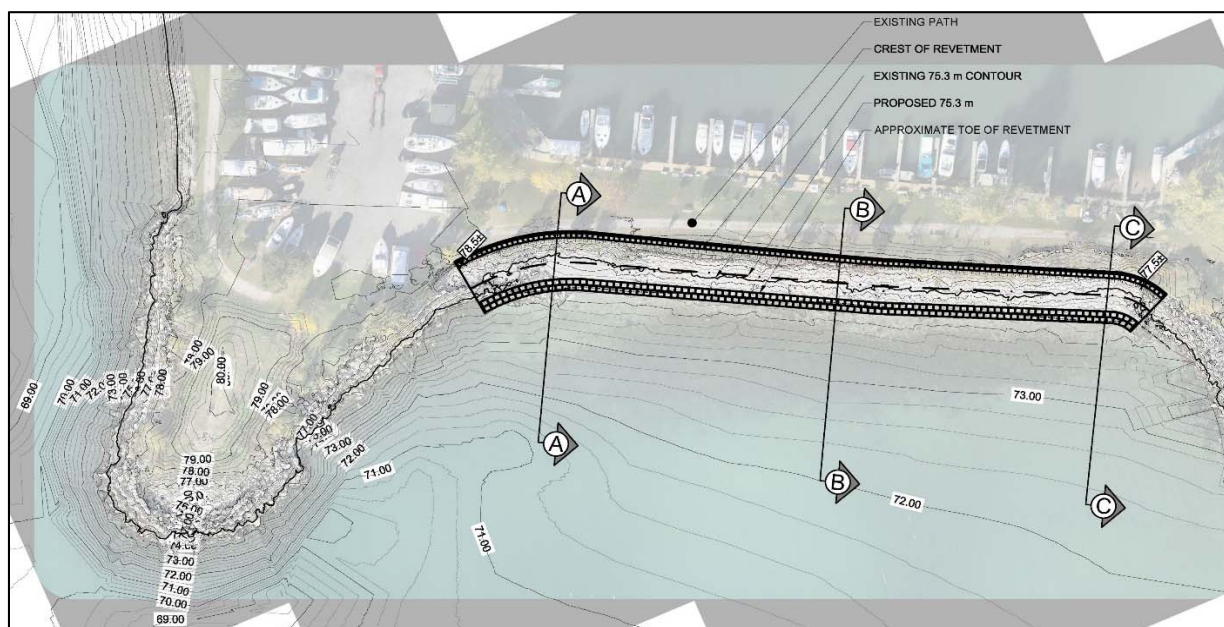
Option 2B involves the construction of a new revetment along the backshore of the beach to absorb the impact of waves, protecting the existing bank, trail, and marina (**Figure 25** and **Figure 26**). The revetment would be made of armourstone and have a crest slightly higher than the existing bank. This design would allow for the placement of an optional cobble berm at the base of toe of the revetment. The revetment option would not provide access to the water.

Figure 25. Concept design plan view for Option 2B - Armourstone Revetment. Source: Shoreplan Engineering, 2017.
