Wildlife Road Ecology Citizen Science

Monitoring Study

Heart Lake Road Provincially
Significant Wetlands
Brampton ON

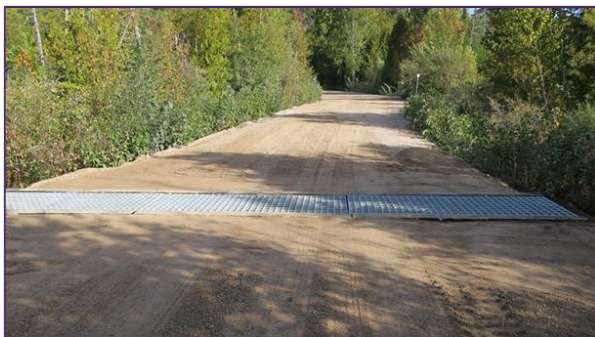
Figure 1: Bruce Peninsula National Park ecopassage
(Photo courtesy of Parks Canada)

Mitigation infrastructure that protects biodiversity and SAR from the threats of roads has become more common across Ontario. Agencies such as Parks Canada, Ontario Parks, the Ministry of Transportation of Ontario (MTO) and municipalities are seeking solutions to reduce threats from roads, improve habitat connectivity, and allow wildlife safe passage across the landscape (Figs. 1 to 7).

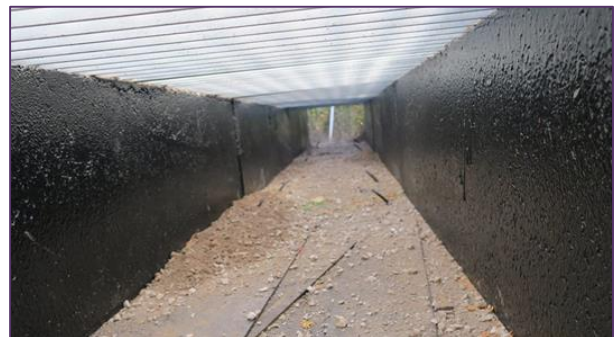
Figure 2: Bruce Peninsula National Park grated ecopassage
(Photo courtesy of Parks Canada)

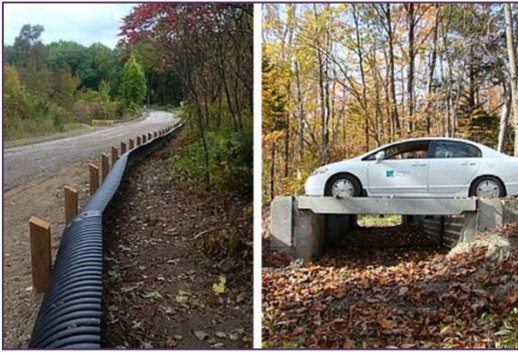
Figure 3: Ontario Parks SAR snake road mitigation
(Photo courtesy of Ontario Parks)

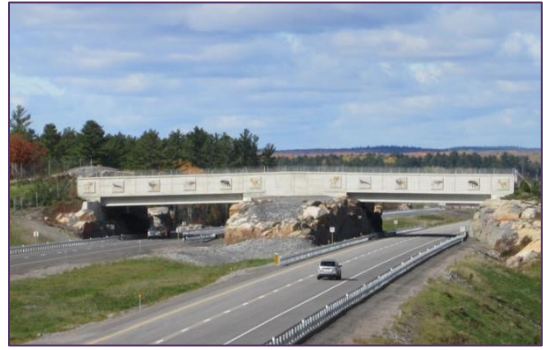
Figure 4: MTO wildlife overpass Hwy #69
(Photo courtesy of Ministry of Transportation Ontario)

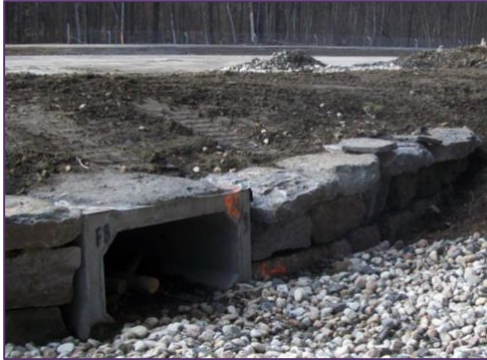
Figure 5: Wildlife passage/fence, Terry Fox Dr, City of Ottawa
(Photo courtesy of Dillon Consulting Ltd)

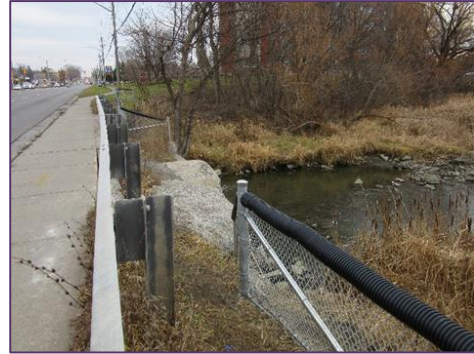
Figure 6: Turtle exclusion fence, City of Kingston (Photo courtesy of Mandy Karch)

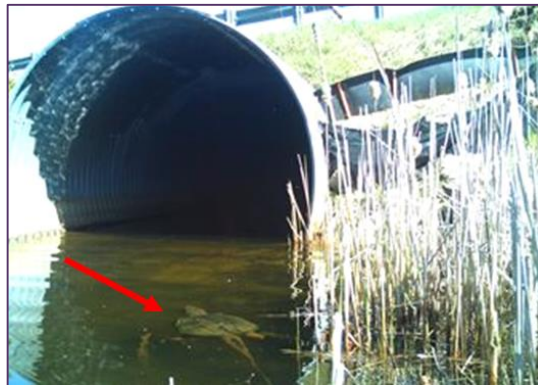
Figure 7: Remote camera data, snapping turtle under road
(Photo courtesy of Lake Simcoe Region CA)

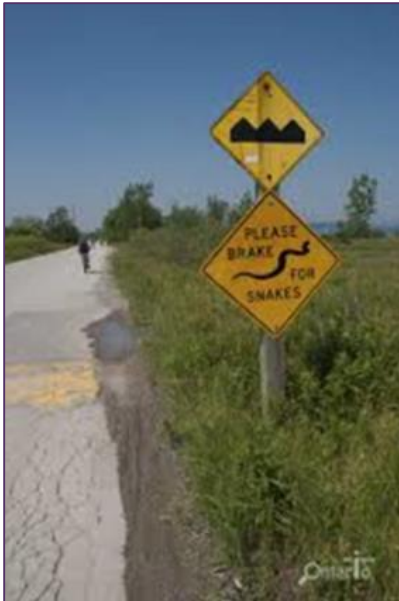
Figure 8: Example of road mitigation at Tommy Thompson Park

In collaboration with municipal partners, TRCA has taken the lead on road ecology initiatives within its jurisdiction. Some of these initiatives include ‘Brake for Snakes’ signs (Fig. 8) and speed bumps at Tommy Thompson Park (TTP), intended to slow cyclists and encourage visitors to watch for snakes at TTP, basking habitat creation at King’s Mill Park in the Humber River Watershed, and developing planning policies such as *The Crossings Guidelines for Valley and Stream Corridors*. These methods assist in working towards protecting sensitive ecosystems and wildlife within urban settings.

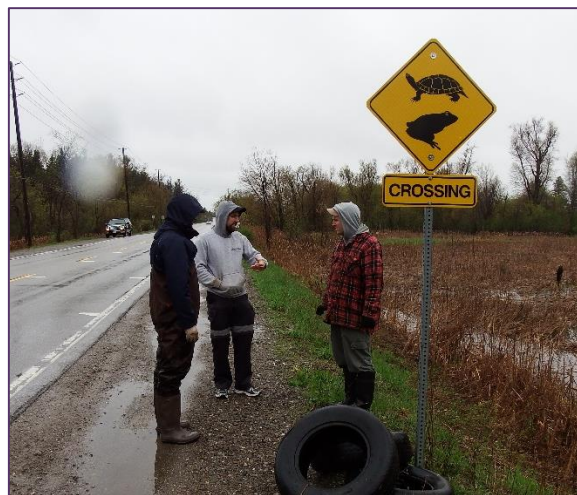
Figure 9: TRCA staff beside the wildlife crossing sign on Heart Lake Road

The Heart Lake Road Ecology Citizen Science Monitoring Project would not exist without the dedicated concern and outcry from local residents, who reached out to TRCA and CoB after reporting numerous turtle fatalities on Heart Lake Road in 2010. As an immediate response, turtle crossing signs (Fig. 9) were installed alongside Heart Lake Rd in an effort to educate drivers and reduce traffic.

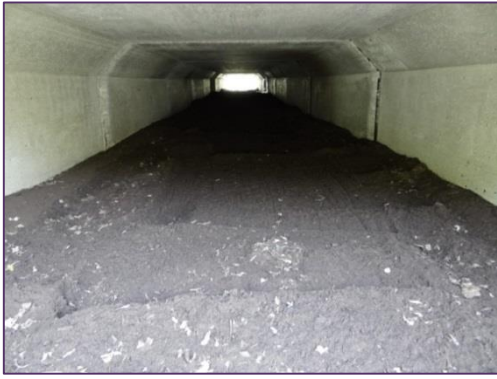
Figure 11: Oversize culvert as wildlife passage

Dedicated wildlife passages are intended to safely attract and allow wildlife to cross roads and access fragmented habitat for breeding, feeding, and migration. Wildlife passage design details, including construction materials, placement, entry features, lighting, moisture levels, and length, all interplay to determine if target wildlife species will successfully enter and pass through. Following a lengthy investigation process and consultation with project partners, in April of 2016, CoB and TRCA decided to install a concrete dedicated wildlife passage of suitable dimensions for local herpetofauna and mammals (Figs 11-16) at Hotspot #3.

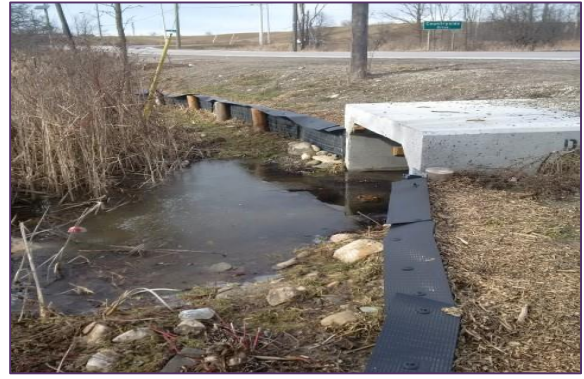
Figure 12: Dedicated wildlife passage and wildlife directional fencing

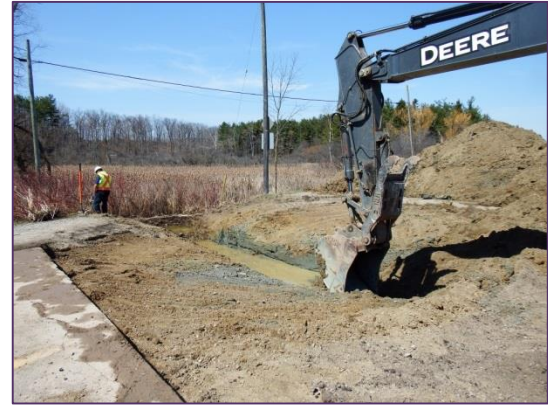
Figure 14: CoB digs trench at Heart Lake Road to install passage

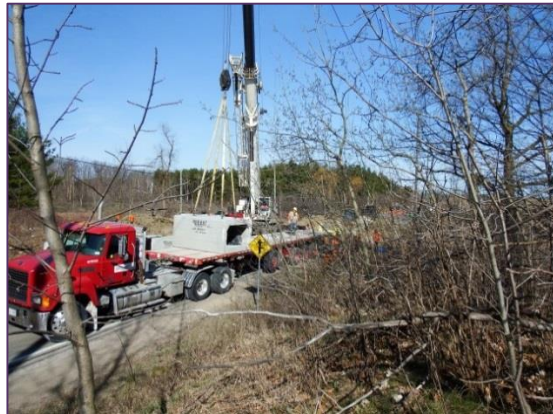
Figure 15: Oversized concrete culvert sections at site

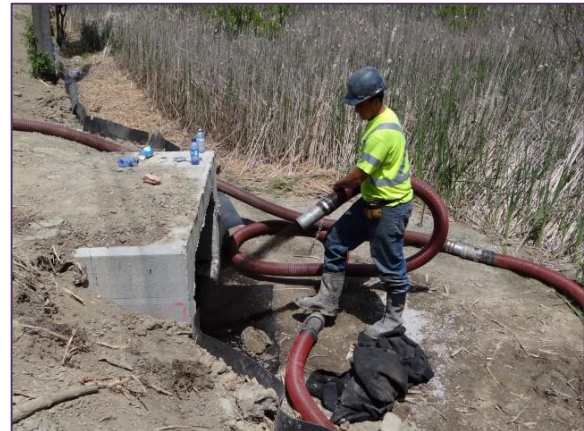
Figure 16: Soil/mulch substrate being "blown" into passage

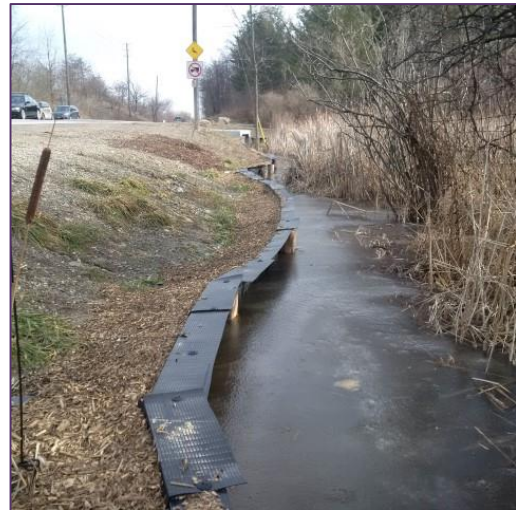
Figure 18: Animex fencing banked with mulch leading to passage

The design details of exclusion and directional fencing should be specific to the landscape and target species. Fencing design, construction materials and installation methods are changing and improving as studies that monitor and report on *in situ* projects are conducted (Baxter-Gilbert et al. 2015, Ashpole et al. 2016). For this project, a total of 330 metres of Animex wildlife fencing (Fig. 17) was installed alongside the wildlife passage to exclude herpetofauna from the road in the mitigation area and encourage them to use the dedicated wildlife passage (Fig. 18).

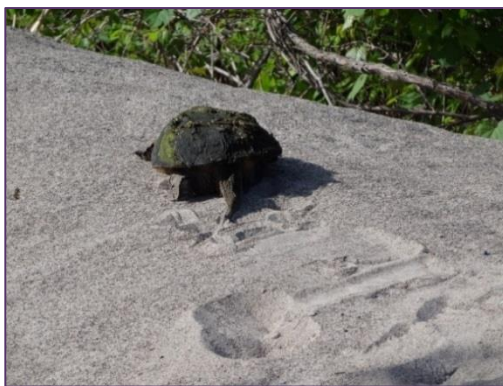
Figure 19: TRCA installation of turtle on nesting beach

Since mitigation restricted access for female turtles nesting on the gravel roadside, nesting mounds were installed by the TRCA (Figs. 19 and 20) on both sides of the mitigated areas on May 11 to 13, 2016. The

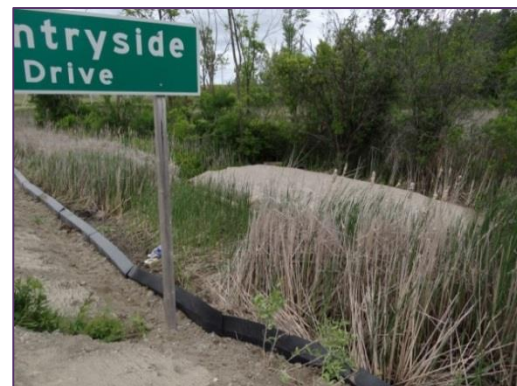
Figure 20: TRCA installed turtle nesting beach on east side of Heart Lake Road

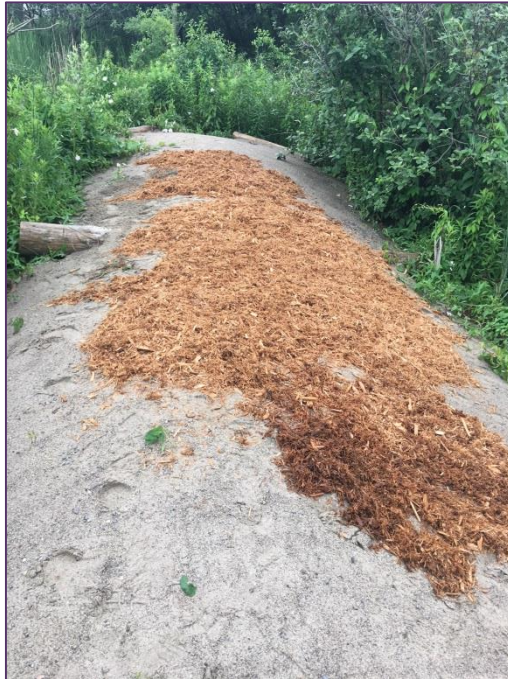
Figure 21: Cedar chip mulch spread on top of Heart Lake Road turtle nesting beach

In 2017, cedar chip mulch was incorporated on the nesting mounds in order to provide variation in the digging substrate for gravid females (Fig. 21). This was in response to numerous observations by TRCA staff and volunteers of turtles nesting in mulch piles at Heart Lake Conservation Area.

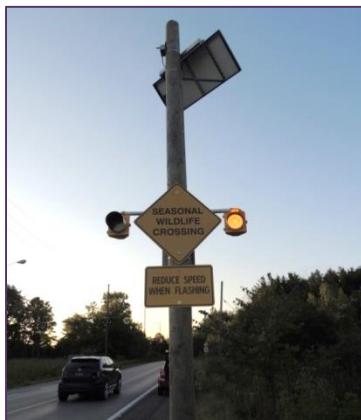
Figure 25: CoB solar-powered, flashing seasonal wildlife crossing sign

In 2016, new signs were installed to raise awareness and alert public to potential small wildlife on roads (Figs. 23 and 24). An enhanced seasonal, motion activated (sensitive to approaching vehicles) wildlife crossing sign (Fig. 25) equipped with solar-powered amber flashing lights was chosen to help influence motorists' behaviour (i.e. proceed cautiously and watch for wildlife on the road). Use of this type of temporary passive sign with flashing lights has been shown to reduce motorist speed in some cases (Hedlund et al. 2003) but signage should not be used as a substitute for more permanent and effective mitigation (i.e. dedicated wildlife passage and exclusion fencing) where deemed necessary.

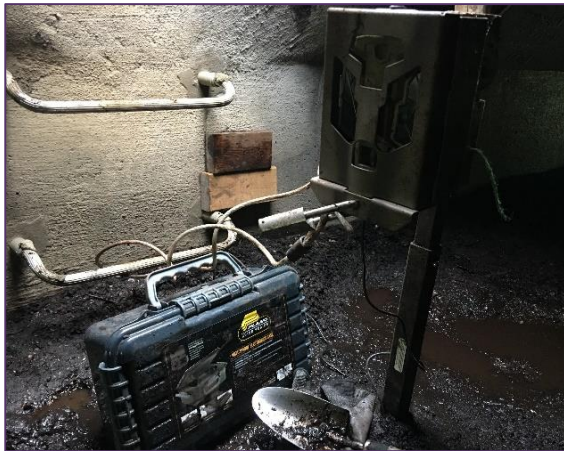
Figure 27: Trail camera setup inside the wildlife passage

TRCA staff installed a wildlife camera at the midway point inside the passage on June 6, 2017. The camera was set to take a burst of three photos upon detection of wildlife movement. The camera was housed in a locked security box, secured on a four-legged stand, with leg bases sunk into the organic substrate lining the bottom of the passage. The lock-box was tethered to an aircraft cable anchored to the ladder inside the passage (Fig. 27).

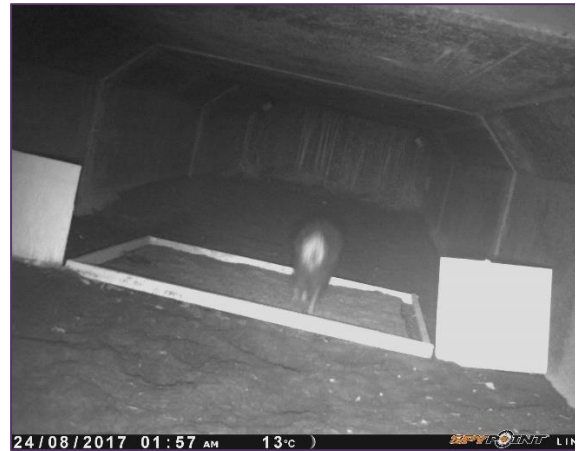
Figure 28: Striped Skunk walking through the installed sand trap

Shortly after installation, a sand trap was installed inside the passage within camera sight, in an effort to increase animal detection probability. Plastic trays were filled with sand substrate and laid end to end. Wooden barriers were erected to guide animals passing through towards the sand trap (Fig. 28). The sand trap was checked for new animal tracks whenever maintenance on the wildlife camera was required (i.e. changing the battery, switching out the memory card, adjusting the camera angle). During camera maintenance, oxygen and carbon monoxide levels were monitored from within the passage in accordance with safety protocol.

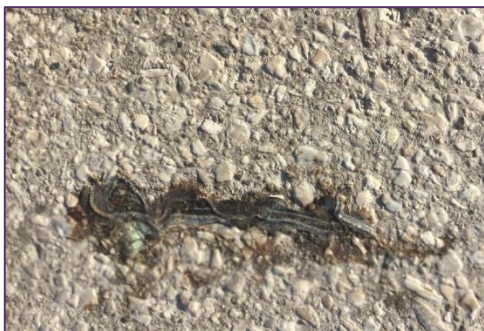
Figure 31: Unknown snake species WVC

As shown in Table 4, volunteers recorded 272 unknown (UNKN) where identification of animal group is established, but not the species (Fig. 31). As shown, the image is a snake fatality but was not able to be confirmed precisely as an eastern gartersnake or other species. Other recordings of UNKN are primarily blood stains or completely decimated and unrecognizable remains (Fig. 32). Overall, the number of unidentifiable remains speaks to the velocity of vehicles along Heart Lake Road.

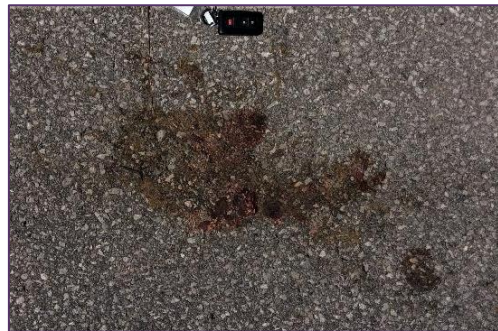
Figure 32: WVC evidenced by blood stains on the road

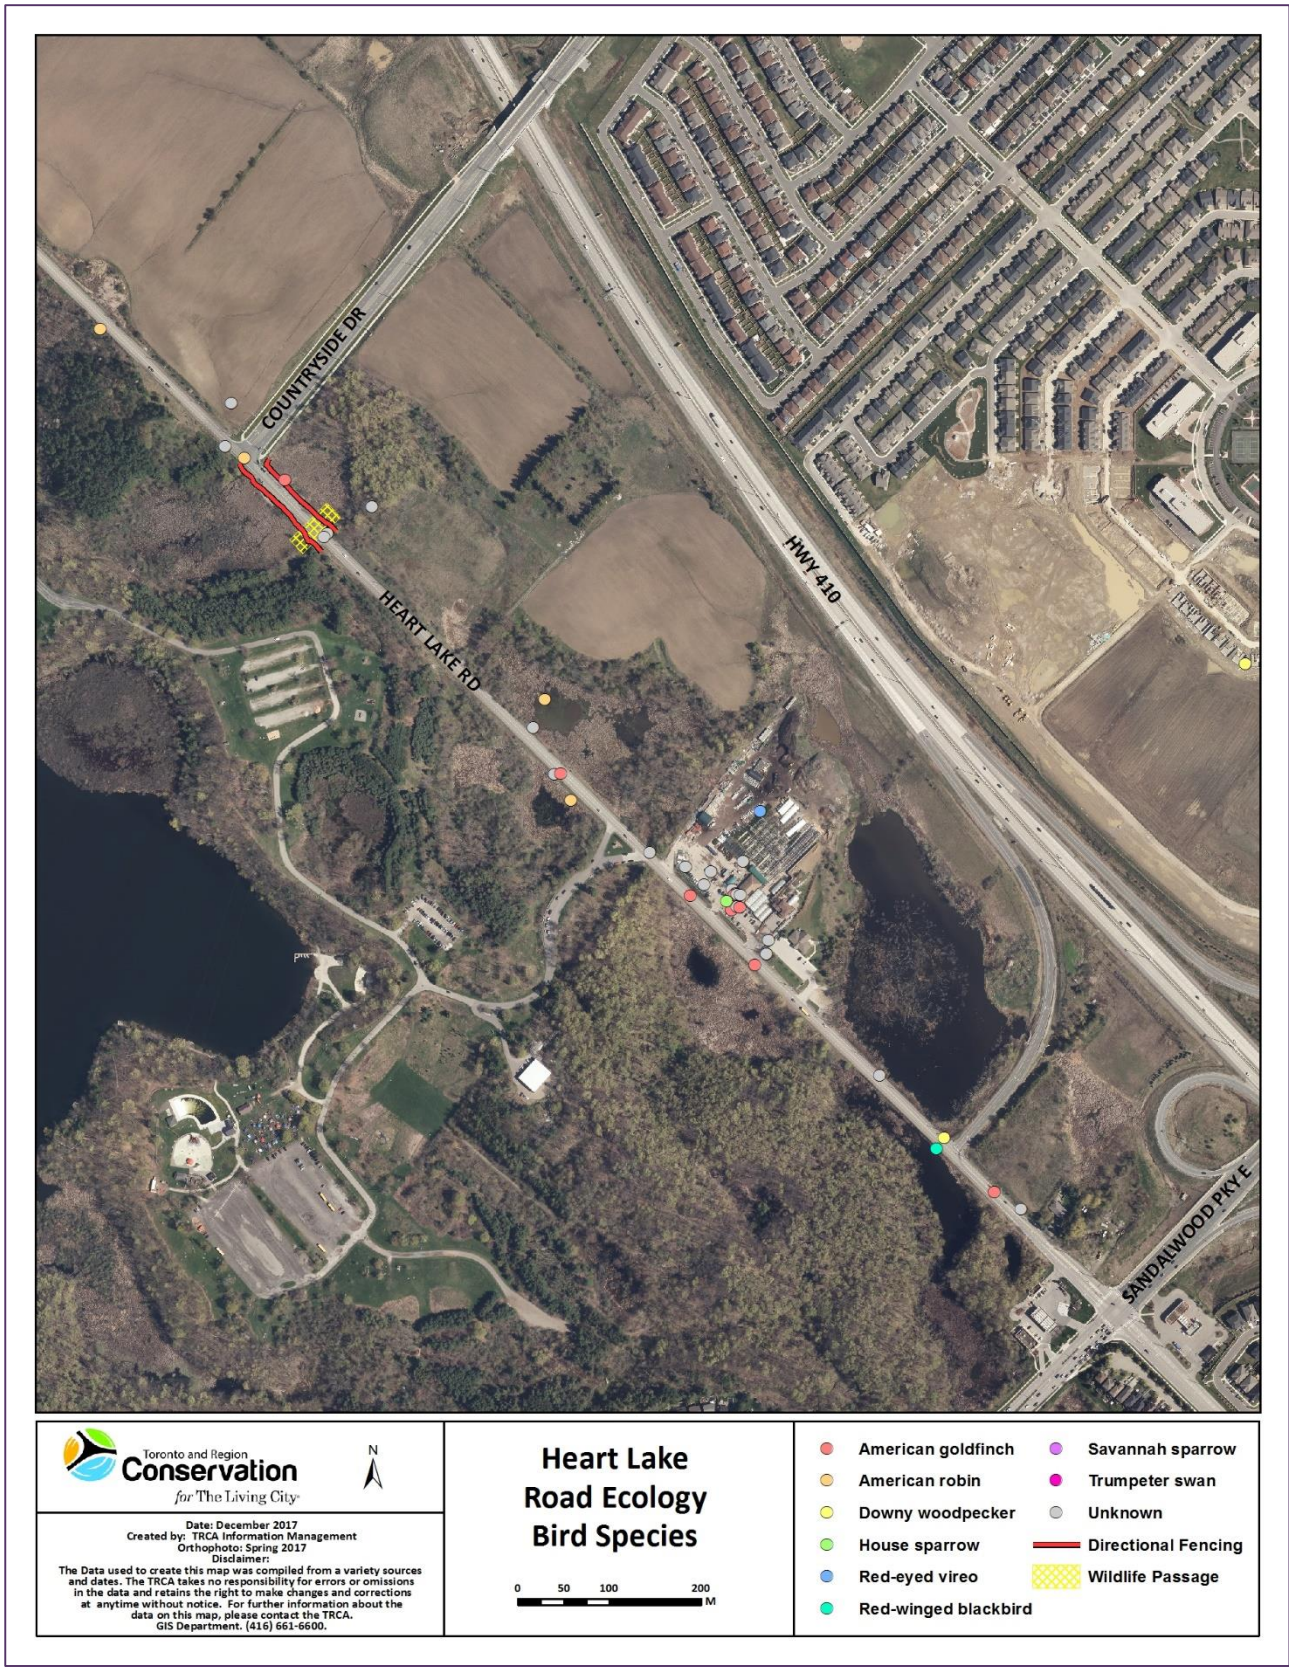
Figure 34: Map of all Bird WVCs along Heart Lake Road

An increase in bird fatalities were observed with 52 birds involved in WVCs in 2017, an increase from the 15 bird WVCs reported in 2016. One of the bird fatalities was a Trumpeter swan, a species that was once at risk of extirpation in North America but has since been recovered through human intervention. The Animex directional fencing was not designed to prevent birds from accessing the road, which explains why birds are still being hit by vehicles in the mitigated area (Fig. 34).

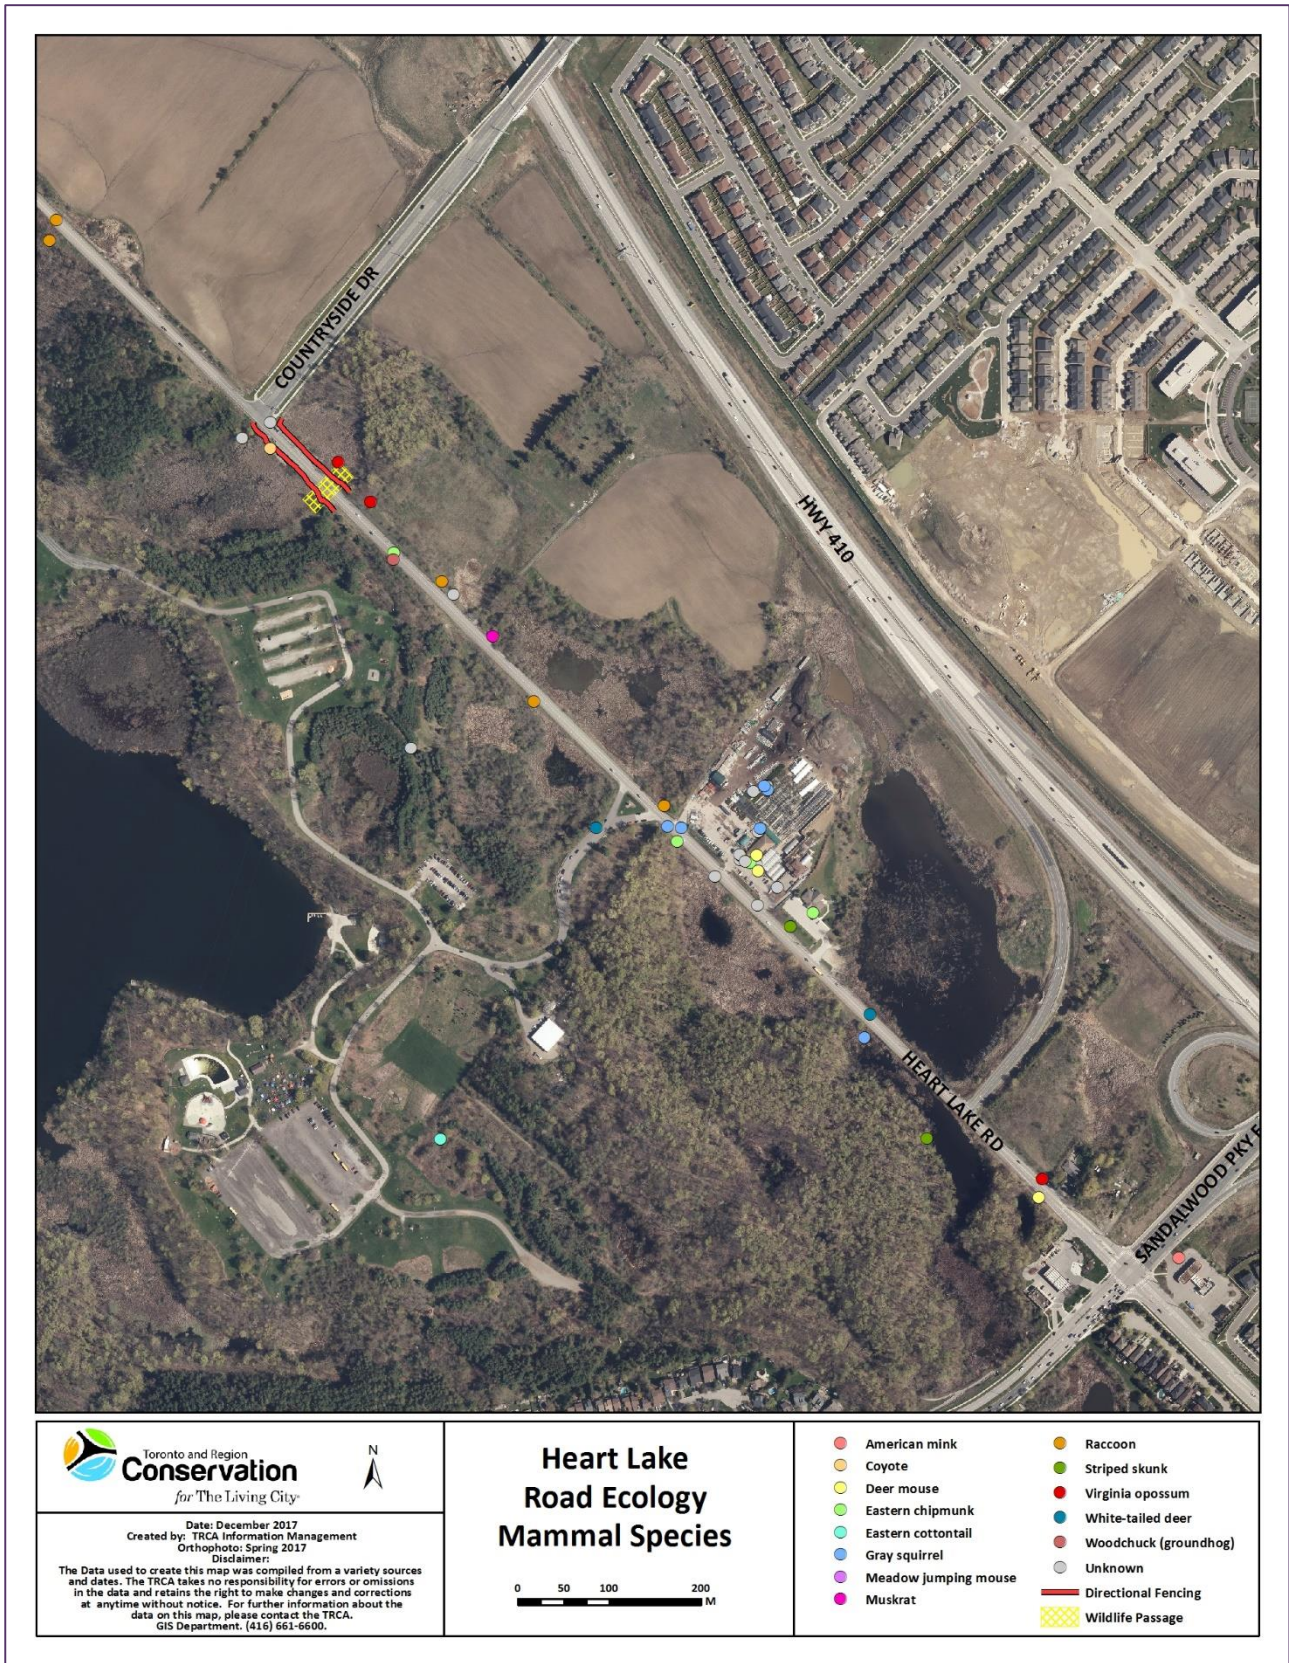
Figure 36: Map of all Mammal WVCs along Heart Lake Road

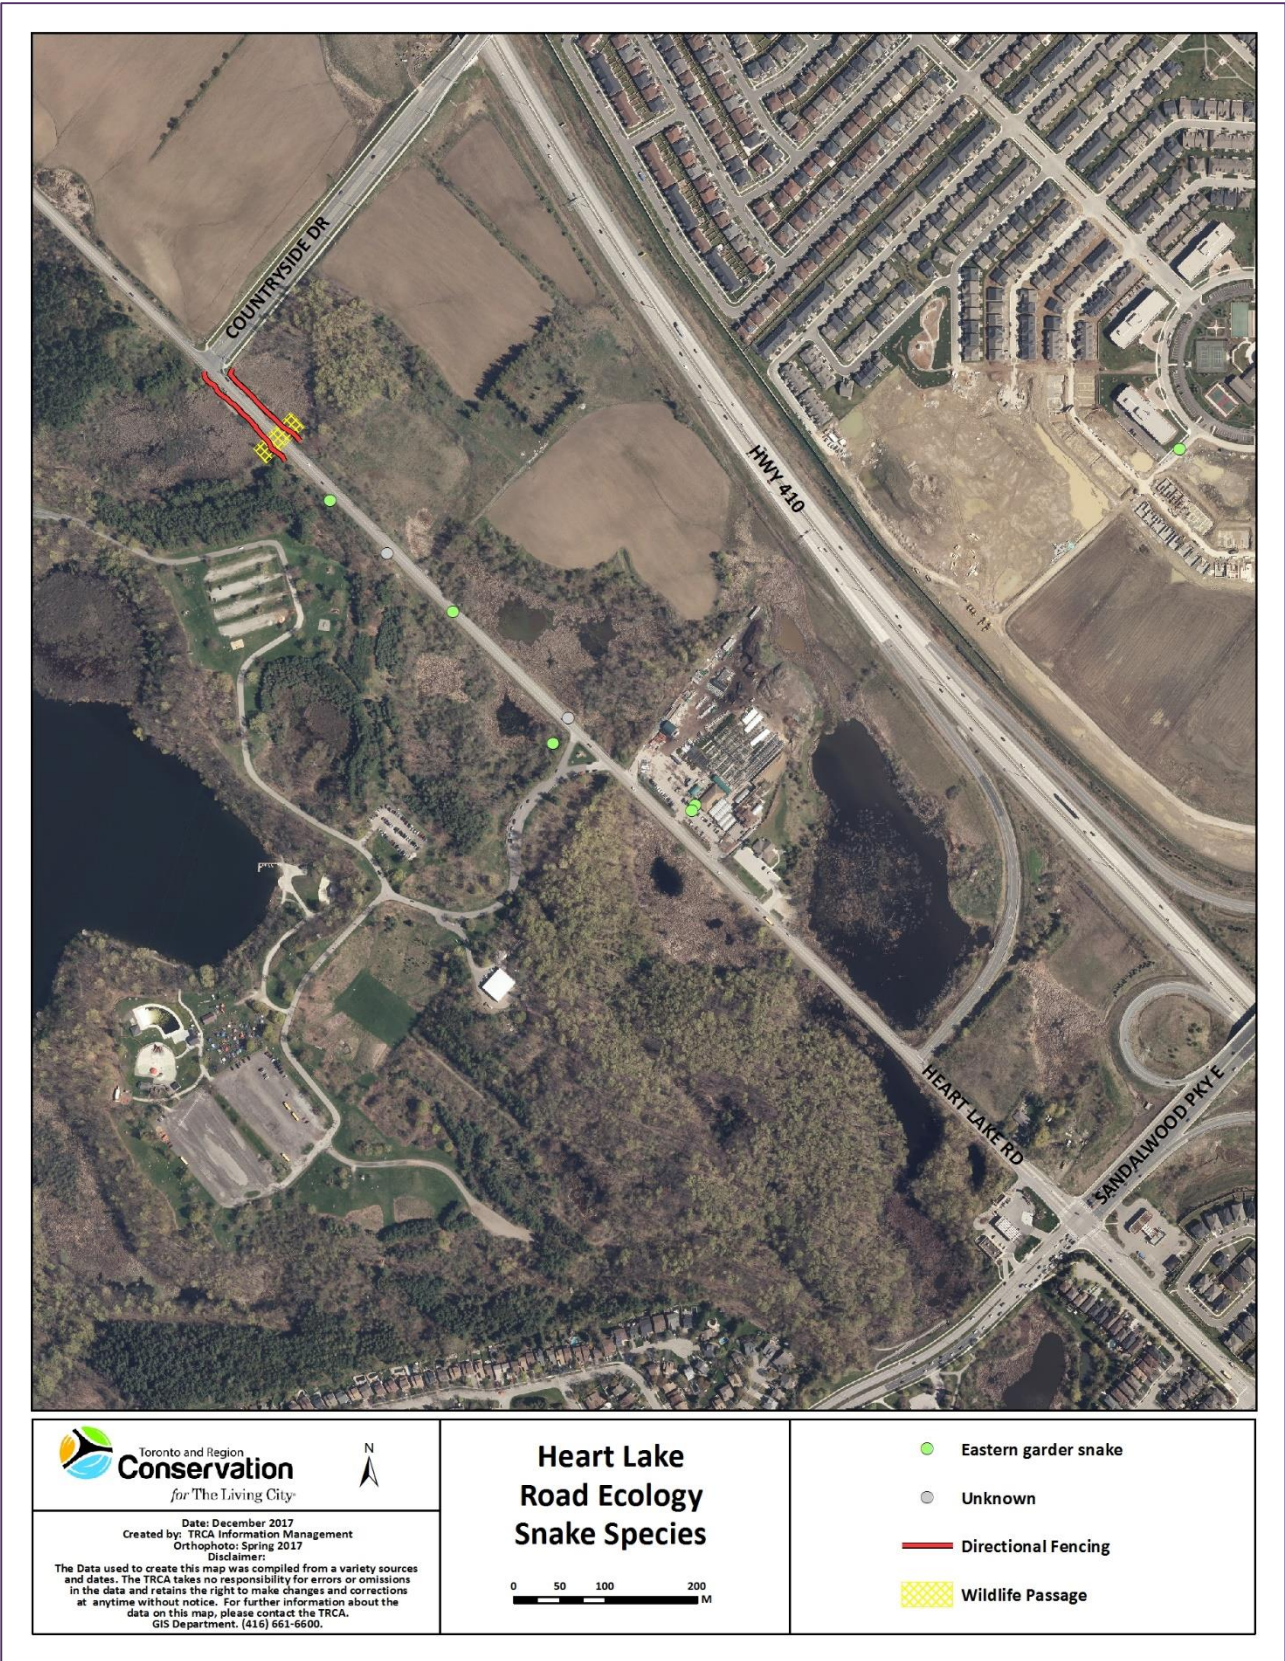
Figure 37: Map of all Snake WVCs along Heart Lake Road

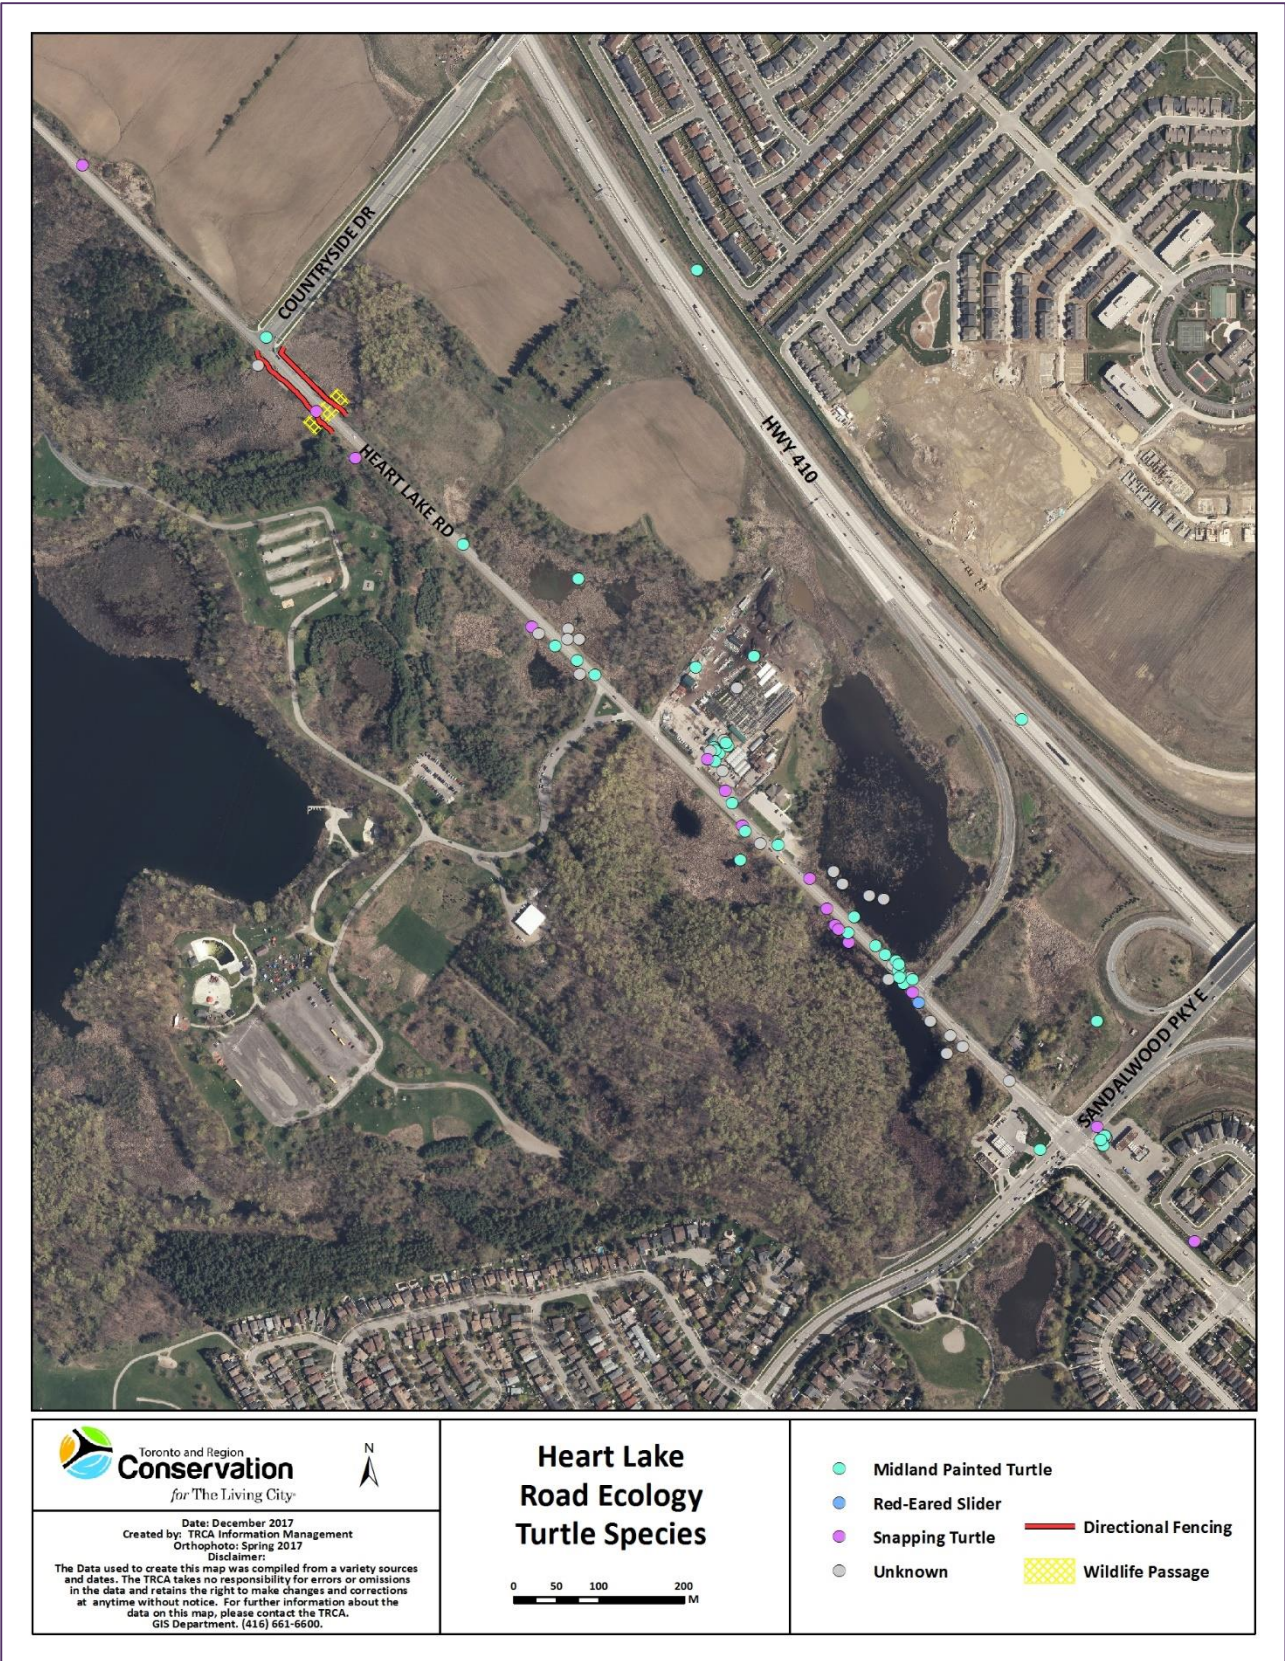
Figure 38: Map of all Turtle WVCs along Heart Lake Road

The 75 turtle-related WVCs observed this year are most concerning (Fig. 38). The increase from 28 turtles found in 2016 to 75 turtles found this year may have been a result of the summer drought in 2016, leading to non-existent water levels in both east and west wetlands north of HLCA entrance. Turtles that migrated out of the dry wetlands in 2016 may have returned this year with replenished water levels, contributing to the increase in turtle WVCs. As of April 2018, the Committee on the Status of Endangered Species in Canada (COSEWIC) had designated all native Ontario turtles as at-risk populations.

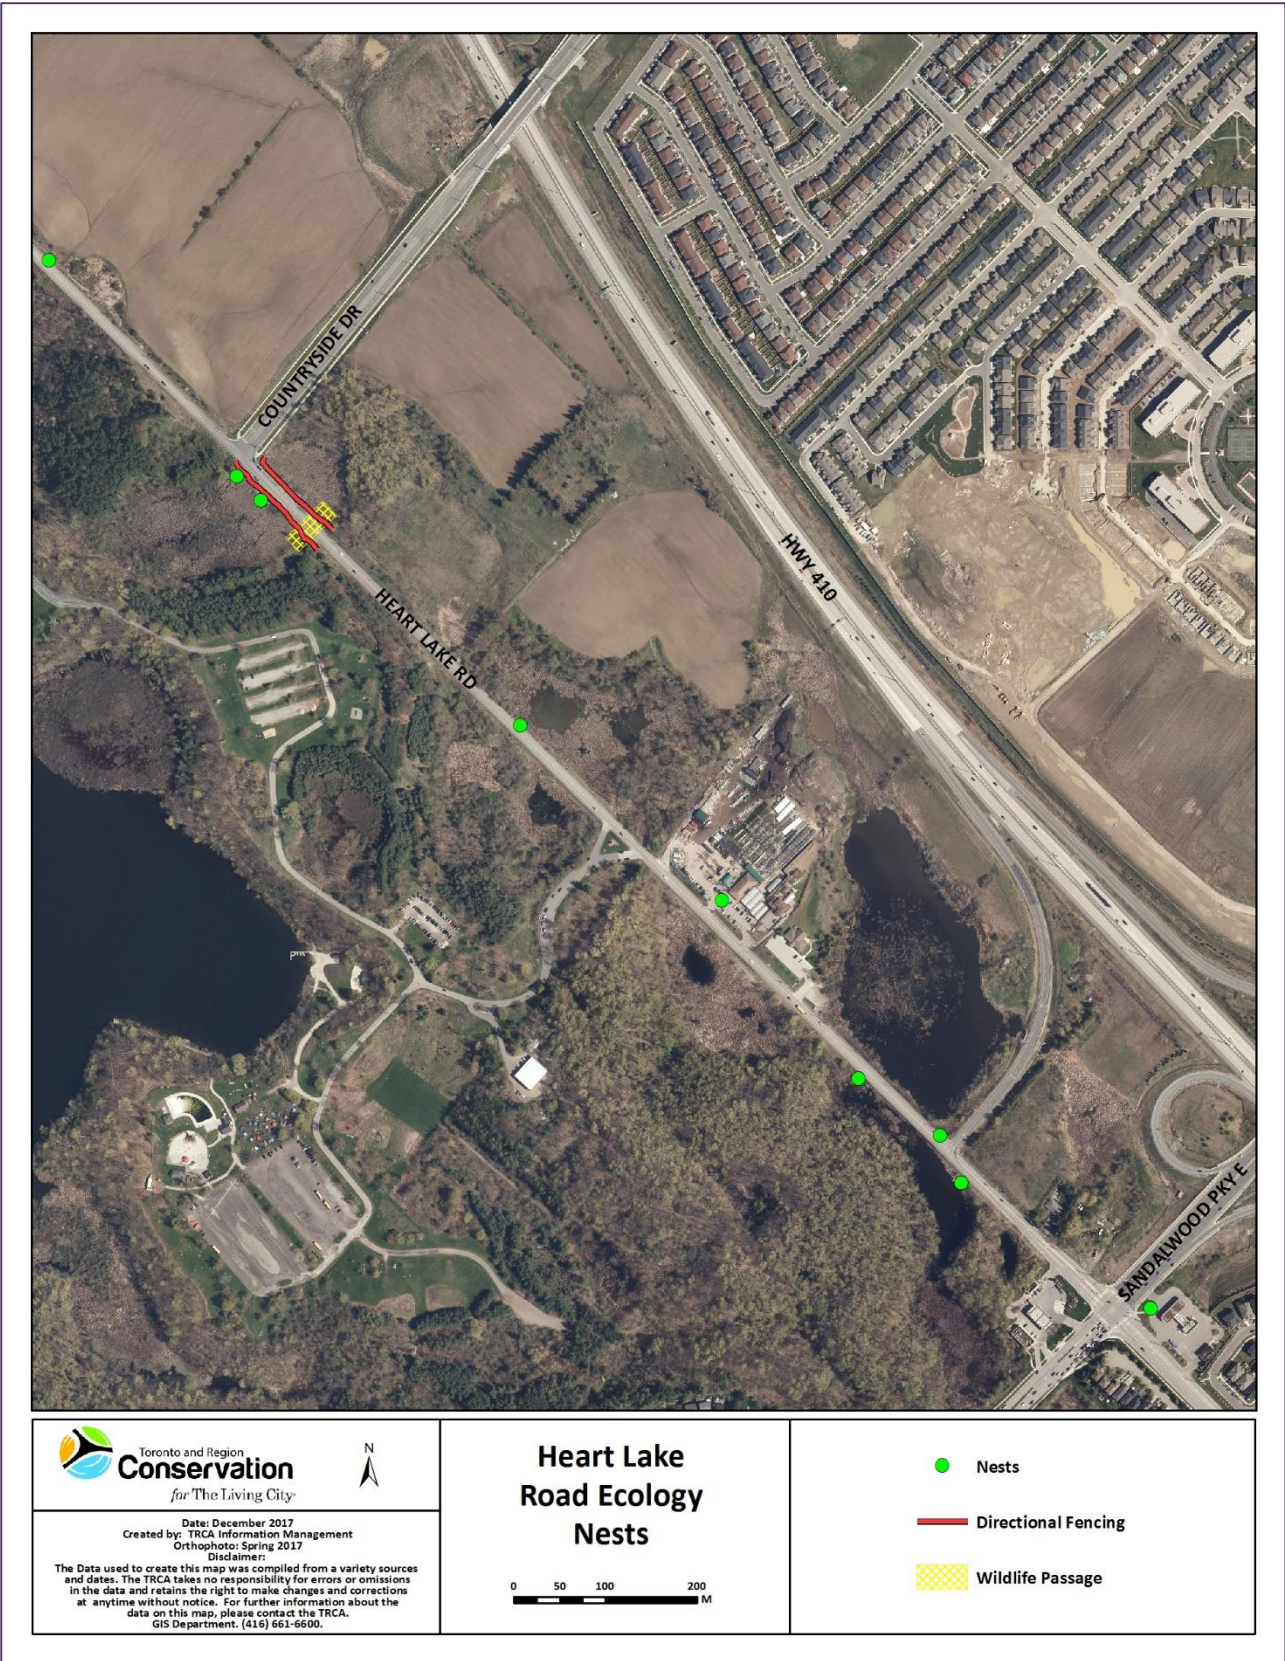
Figure 39: Map of all turtle nests found along Heart Lake Road

Volunteers discovered approximately 12 turtle nests along Heart Lake Rd, however this number might be incorrect due to discrepancies in how the nests were reported. Some volunteers may have reported multiple nests into one record, or reported the same nest twice after observing predation. Volunteers were instructed to flag potential nests on roadsides in an effort to reduce the chances of nests being recorded multiple times. Technical issues with GPS locations occurred in areas where larger numbers of nests were observed (west side of Heart Lake Road throughout hotspot #1), resulting in some nests recorded not being displayed on the map (Fig. 39).

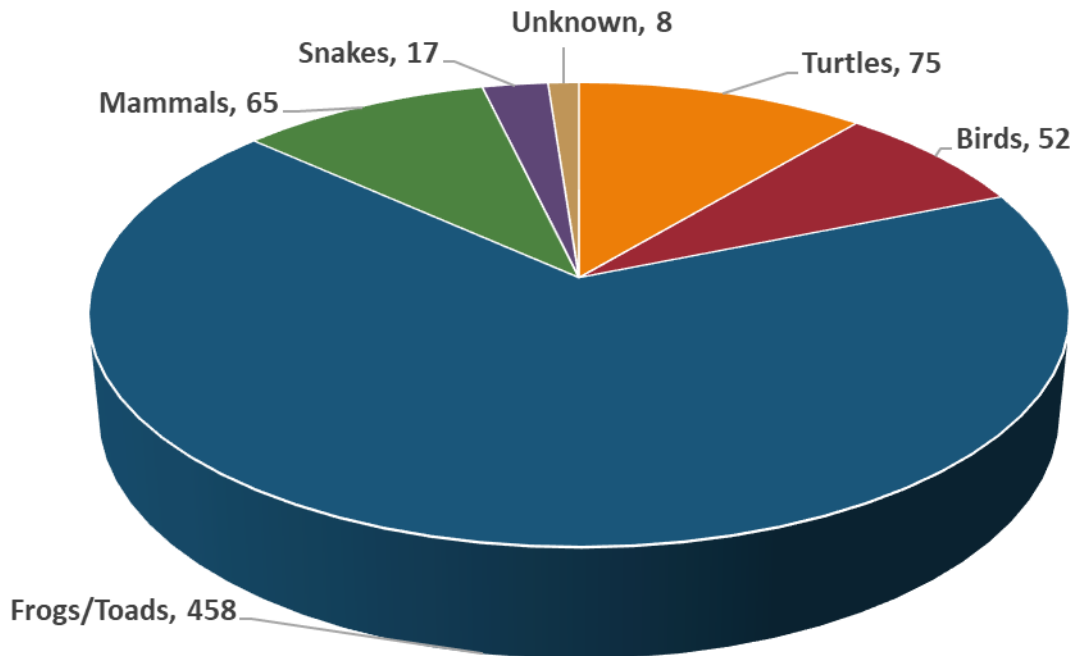
Figure 40: Heart Lake Road Fatalities 2017

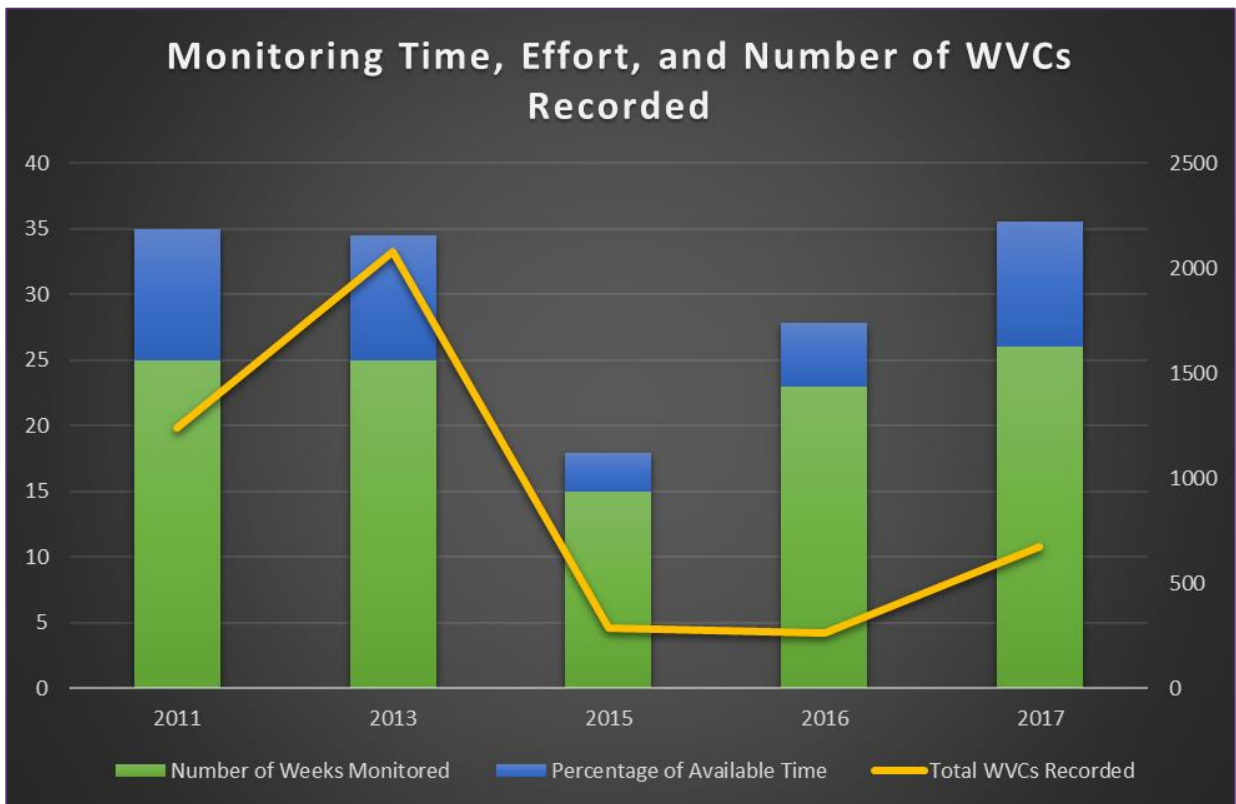
Figure 41: Annual comparison of monitoring time, effort, and relation to number of WVCs observed

The number of WVCs recorded in 2017 was reduced, indicating installed mitigation measures are effective at reducing wildlife road mortality.

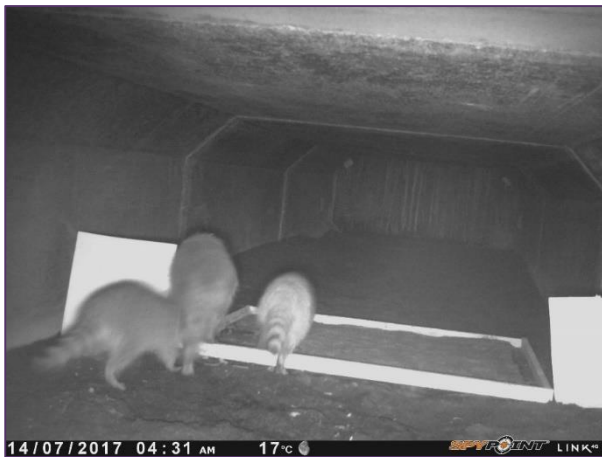
Figure 42: Family of raccoons walking through the wildlife passage

Photos collected from inside the wildlife passage confirm that animals were using the passage as intended. As previously mentioned, the camera was set up to take a burst of three photos whenever the sensor detected movement. Over twenty weeks, a total of 455 photos captured animals using the dedicated wildlife passage. All photos taken were of mammals, with a majority capturing raccoons (Fig. 42). Species photographed included: raccoons, grey squirrels, striped skunks, eastern cottontails, Virginia opossums, and American minks.

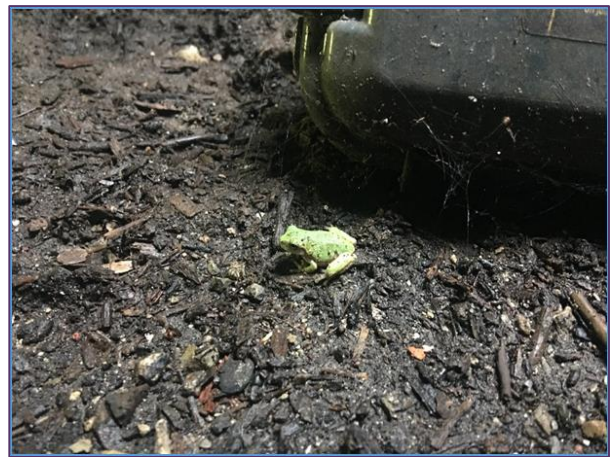
Figure 43: Grey tree frog found in the wildlife passage on August 17, 2017

Despite a lack of photographic evidence, herpetofauna are still using the passage, and may not be getting detected on the camera due to size. While performing routine maintenance on the trail camera in mid-August, TRCA staff noticed a grey tree frog in the middle of the passage that was too small to have been detected on the camera, or to have made an imprint in the sand trap (Fig. 43). Volunteers and staff have noted a number of leopard frogs at the entrance of the passage on several occasions. Other detection strategies (i.e. photos taken at constant intervals or video surveillance, etc.) will need to be implemented next season to ensure wildlife presence in the passage is better represented.

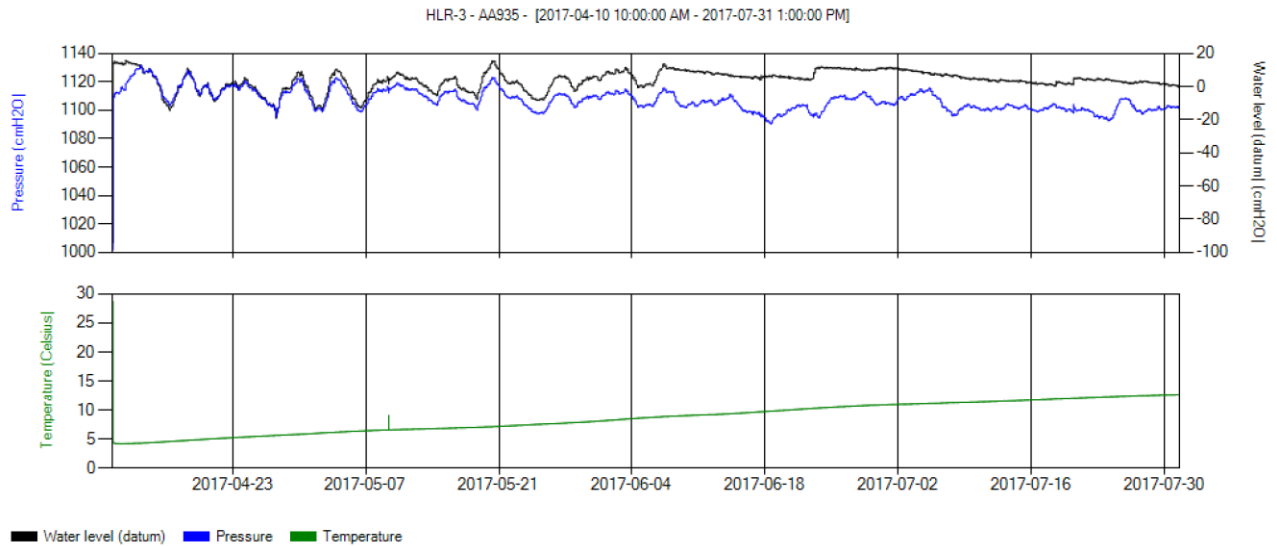
Figure 47: Heart Lake Road wetland vegetation, June 2017

Hydrology well (HLR-3) displayed water level readings that slowly increased over the summer, until it plateaued, with only slight variations in mid-June (Fig. 47). This well was located within ten metres of the entrance to the wildlife passage and these readings suggest possible water flow through this area.

Results downloaded from hydrology monitoring wells at Heart Lake Road had abnormalities requiring attention for 2018. One of the hydrology wells monitored (HLR-2) had poor air circulation. This resulted in pressure not being equalized between the inside and the outside of the well. Water level data, the primary metric and reason to monitor, was unreliable.
