# ETOBICOKE AND MIMICO CREEKS WATERSHEDS

## Technical Update Report Executive Summary

2010

Prepared by:  
Toronto and Region Conservation Authority

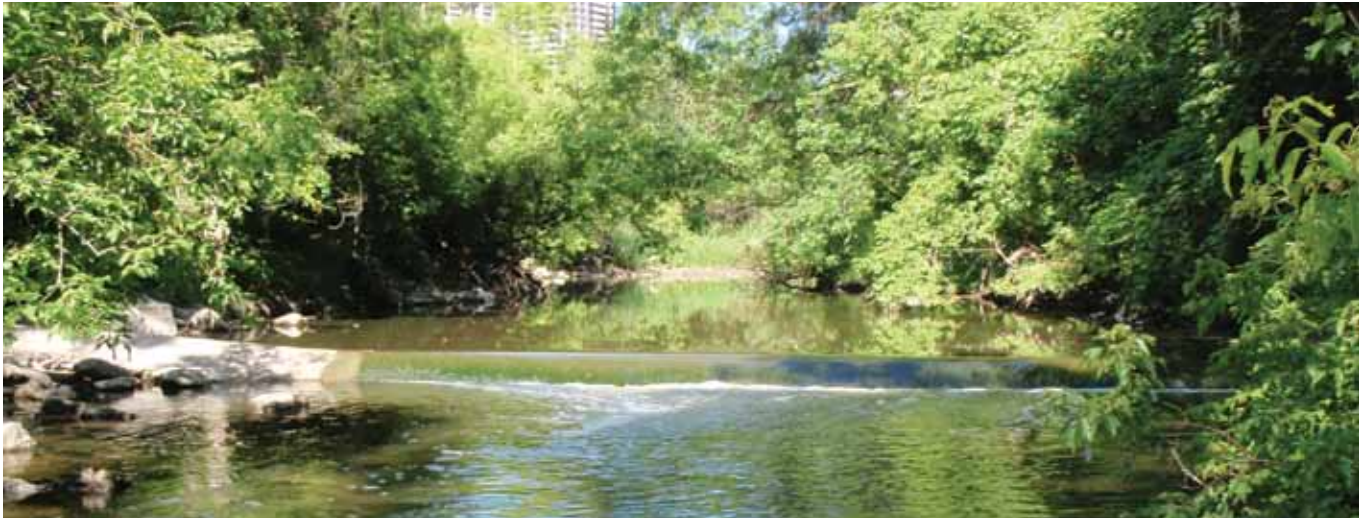
Fish Barrier north of Meadowvale Drive

- The assessment confirmed the presence of 338 **instream structures** along 57.2 km of watercourse.
- Of the 338 instream structures, 145 are **barriers** to non-jumping fish species, and of those, 126 barriers prevent passage of jumping species.
- **Habitat fragmentation** is a result of typical physical barriers, but also high flow velocities, damaged infrastructure and/or engineered instream works, major transportation infrastructure (i.e. highways and railway crossings), and garbage pollution.
- Reconnecting Lake Ontario to the Mimico Creek headwaters would require a lot more effort as compared to Etobicoke Creek, due to the numerous barriers that exist. Therefore, the most immediate gains in Mimico Creek would likely be measurable in the lowest reaches by mitigating the first few barriers to allow native species from Lake Ontario to become better connected with the watershed.

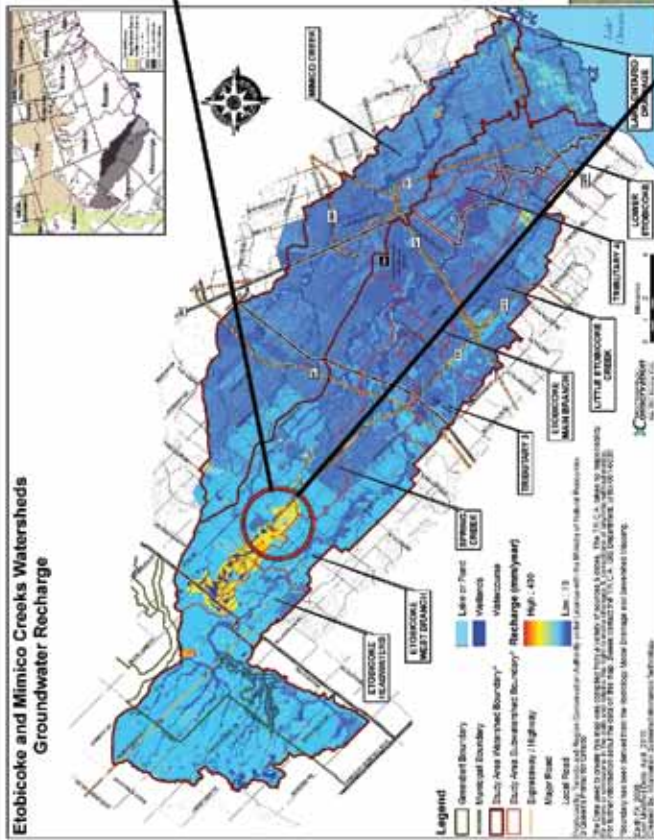
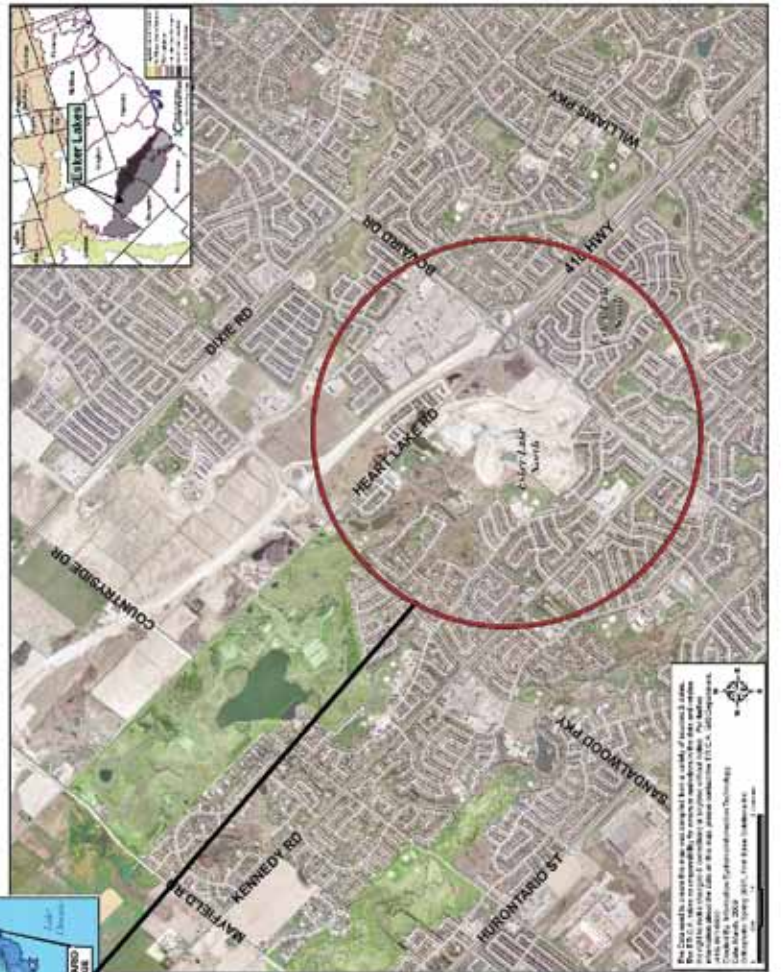
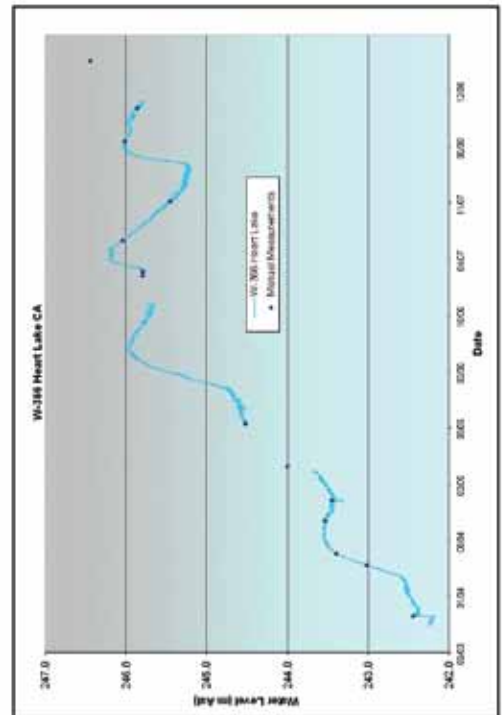
# Appendix 2: Area Potentially Affected by Rebounding Groundwater Levels

**Brampton Esker - Drinking water supply (1950s-60s);  
Source of sand and gravel (1960s-2004)**

- Groundwater **flow direction** is primarily from the headwater areas in the northwest toward Lake Ontario in the southeast.
- **Groundwater levels** appear to be rebounding in the vicinity of the Brampton Esker in response to cessation of dewatering associated with aggregate extraction, posing implications for the design of subsurface infrastructure, increased baseflow in the West Branch of Etobicoke Creek, stormwater management pond operations, and long term pumping (See Appendix 2).

1. Manage the rebounding groundwater levels and their effects, as necessary, in the vicinity of the former Brampton Esker aggregate pits:
  - a) Undertake more monitoring of groundwater levels in this vicinity;
  - b) Assess hydraulic capacity of outlet pipe from Major Oaks Park pond;
