Heart Lake Road Ecology and Turtle Population Study

December 2018

Executive Summary

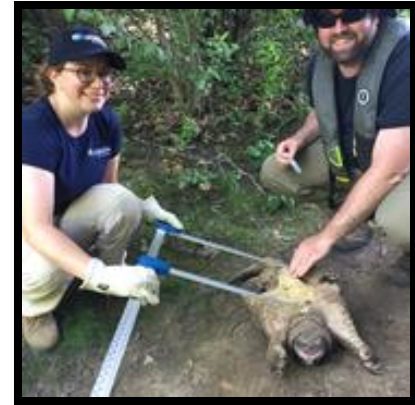
FIGURE 3. SCUTES OF CARAPACE (UNIVERSITY OF MARYLAND 2014), ANATOMY OF PLASTRON (SCIENCERAY 2008), TRCA STAFF MEASURING PLASTRON OF A SNAPPING TURTLE.

Upon collection, each turtle captured over the study period was processed according to this protocol. Turtles were weighed and checked for damage which was noted for future reference. Plastron and carapace, length width and depth were measured (Figures 3). The pre-cloacal length was measured from the posterior most point of the plastron to the middle of the vent (cloaca). An additional measurement of the length from the middle of the plastron to the end of the plastron was recorded for snapping turtles as this length is shorter than pre-cloacal length in males. Length of the longest front nail was measured on painted turtles since males have longer nails than females. These characteristics as well as a displaying feature on snapping turtles were used to determine the sex of each turtle. Turtles were also classified into three age categories; hatchling, juvenile and adult.

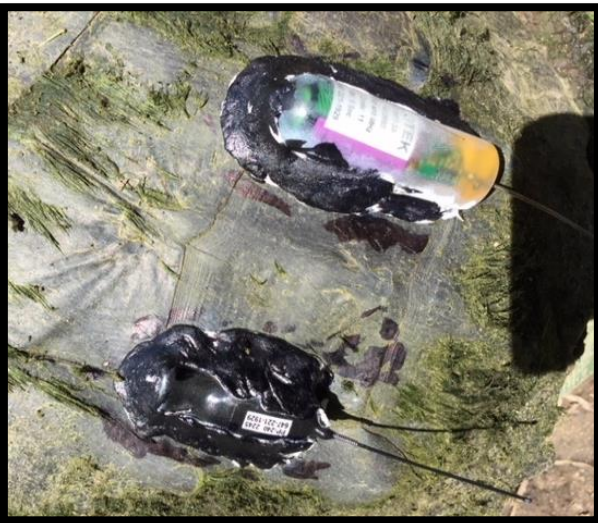
FIGURE 6. VHF (WHITE) AND GPS UNIT (BLACK) ATTACHED TO THE MIDDLE OF THE CARAPACE OF A SNAPPING TURTLE.

Select gravid (with eggs) female snapping turtles were tagged with a ATS W510 GPS/VHF Integrated transmitter, weighing 65g (weight in air) with dimensions 50mmx40mmx10mm (Figure 6). Transmitters were attached to the posterior portion of the carapace using super glue. Once dry, a layer of Waterweld epoxy putty was used to encase and secure the transmitter to the shell. This method provided a smooth surface to prevent the transmitter from being caught on vegetation or wood debris. The epoxy was coloured using a permanent marker to match the colour of the device more closely with the general colour of the carapace. Transmitters were attached at the original capture site and allowed to dry no longer than within 12 hours of capture. All transmitters except one was removed at the end of the study. The last transmitter will be removed in March of the following year after turtles emerge from hibernation. A GPS unit was also attached to allow researchers to study turtle movements between wetlands.

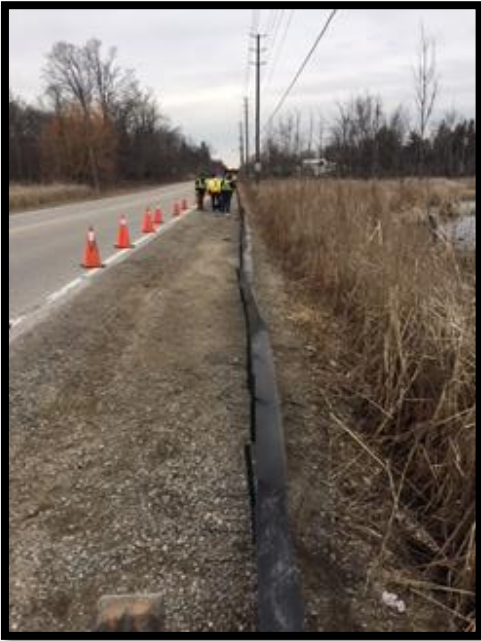
FIGURE 7. TEMPORARY FENCING INSTALLED ALONG HEART LAKE ROAD.

Temporary wildlife directional fencing was installed by City of Brampton on segments of HLR adjacent to wetlands on April 3 to 9, 2018. A total of 957.2 meters of temporary fencing was installed on both sides of HLR between Sandalwood Pkwy and Countryside Dr (Figure 7).

Animex fencing panels (dimensions 3mm x 610mm x 2.5m) were used in the temporary fencing. T-bars were pounded into the ground and used as support posts for fencing panels, which were zip tied to T-bars. Ends of fencing segments were installed so they curved back into the wetland, to encourage wildlife travelling along the fence in search of a way across the road, to return to the wetland upon reaching ends of fencing segments (Figure 8).

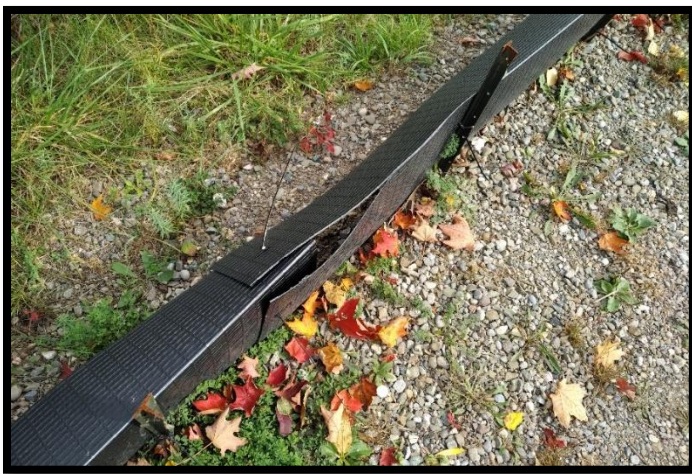
FIGURE 9. TEMPORARY WILDLIFE DIRECTIONAL FENCING WITH MINOR DAMAGE.

TRCA staff also spent a day in October walking along the temporary fence, recording the number of damaged fencing panels that would allow wildlife to access the road (Figure 9). These locations were recorded and repairs were made to any minor damages with zip ties. Any instances of major fencing damages were photographed and recorded. The distances of WVCs from fence malfunctions was analyzed in ArcMap using the “Near” function.

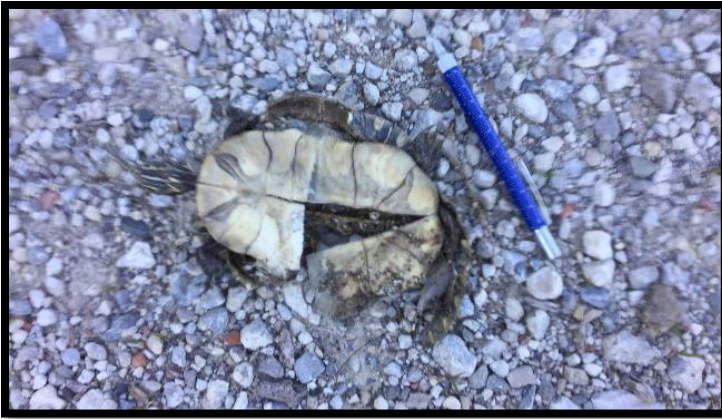
FIGURE 10. WILDLIFE-VEHICLE COLLISION WITH OBJECT FOR SCALE.

Staff and volunteers adhered to strict safety protocols following guidelines from the Ministry of Transportation. Teams, with two to four people conducted monitoring during daylight hours and only in dry conditions. Monitoring sessions involve walking along the study area on both sides of the road, in the direction of incoming traffic. Traffic spotters continuously monitored road conditions and incoming traffic while data collectors searched the road and shoulder for evidence of WVCs. Upon location of a WVC, safety cones were set up so and were visible to oncoming traffic without impeding traffic flow. Type of observation, number of wildlife affected and species of WVC were recorded using Survey123 Data Application on the citizen scientist’s smartphone or tablet (Appendix H). Photos were taken with an object placed adjacent to the WVC as a scale object and appended to the survey (Figure 10). Location data taken from the smartphone or tablet was also attached.

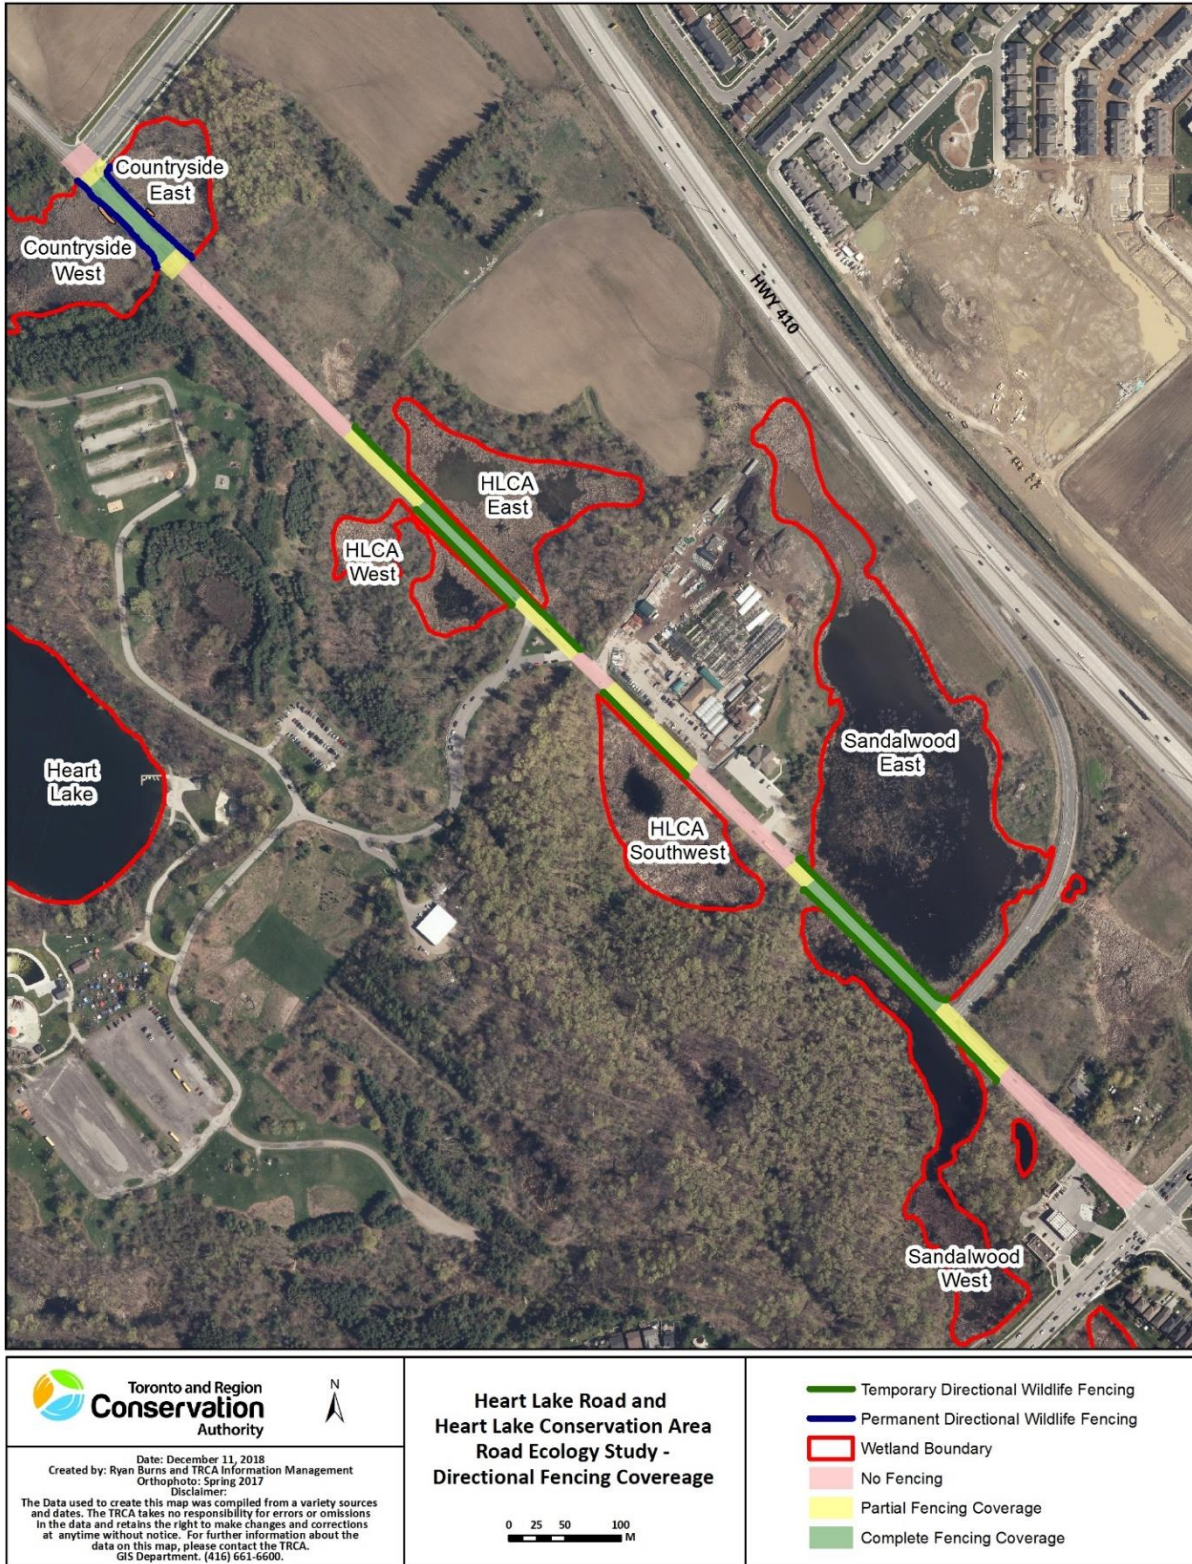
FIGURE 11. COMPLETE, PARTIAL AND NO FENCE COVERAGE ALONG HEART LAKE ROAD IN 2018.

A second t-test was conducted at a 95% significance level to see if numbers of WVCs observed in areas protected by directional fencing (permanent and temporary) were significantly lower than areas with either partial or non-existent fencing (Figure 11).

Overall, date results show that fencing is most effective at significantly reducing the number of WVCs when installed on both sides of the road. Certain taxa such as birds, frogs and toads were not affected by the fence because they can either fly or hop over the fence. Generally, these WVCs were found throughout HLR. Meanwhile, turtle, snake and mammal WVCs were significantly lower within areas where fencing was consistent along the road compared to areas with either partial or no fencing.

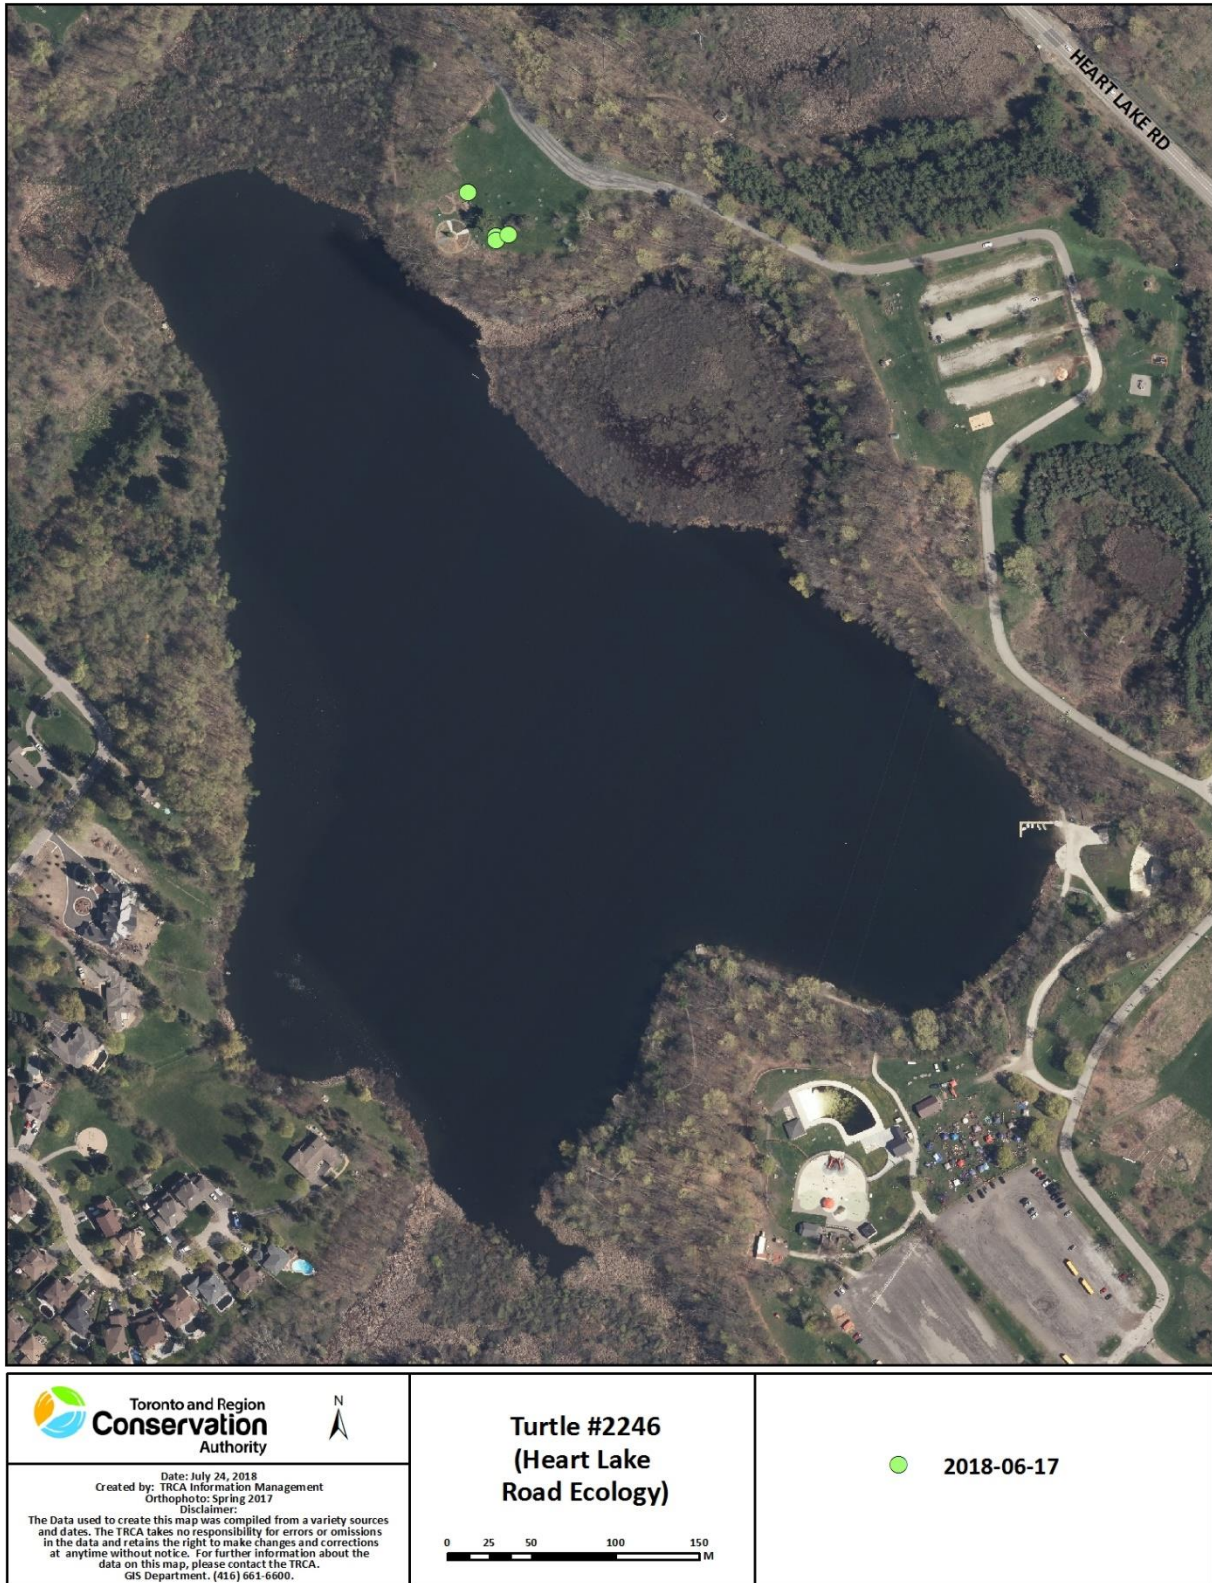
FIGURE 14. GPS LOCATIONS OF COMMON SNAPPING TURTLE MOVEMENT IN HEART LAKE.

animal is above the water, so will only record a location if a turtle is basking or if it is on land. Movement locations were recovered from two trackers in Heart Lake, one for a map turtle and one for a snapping turtle (Figures 13 and 14 respectively). The map turtle was very active and its location was detected in various areas of the lake as well as laying her eggs along the park road in a picnic area. The snapping turtle was only detected leaving the water to nest in the Medicine Wheel garden.

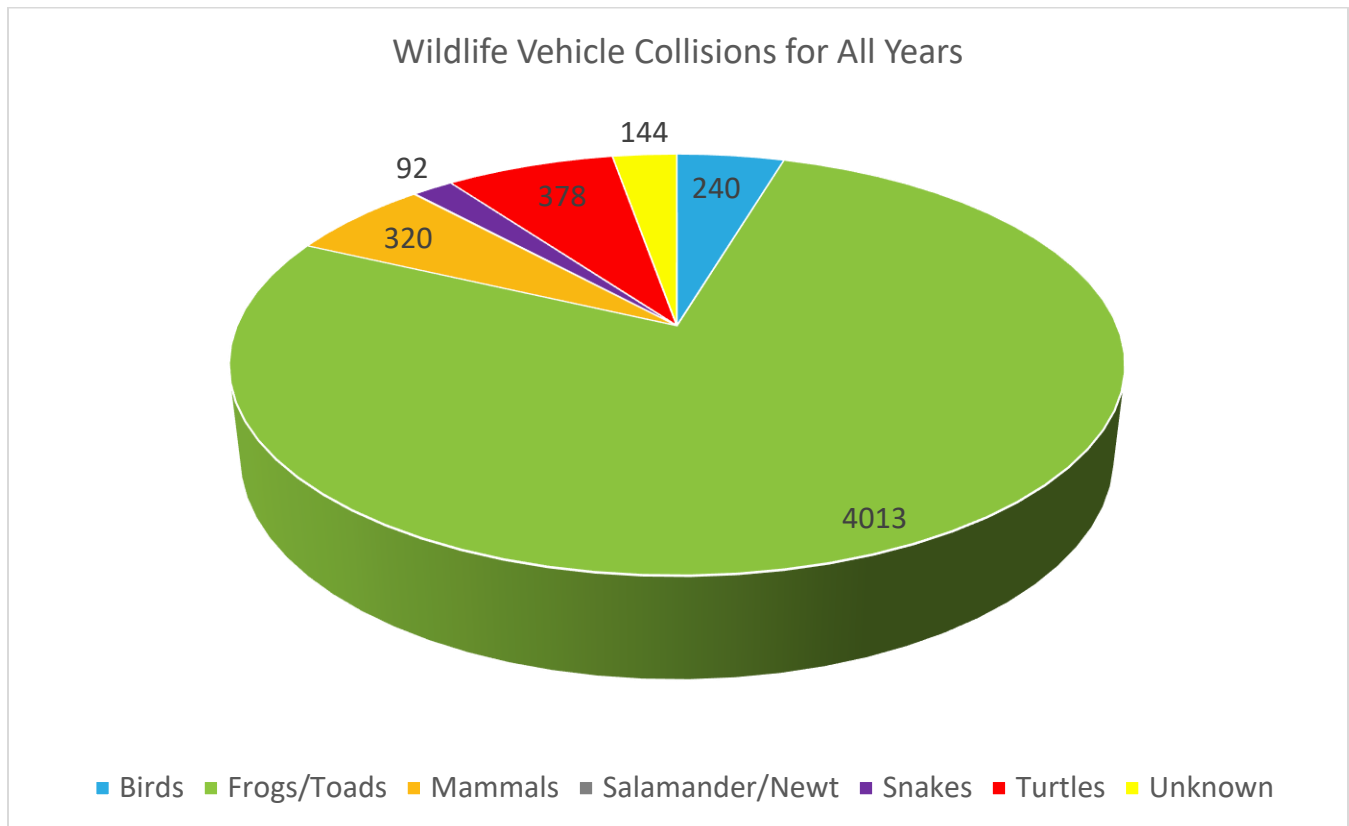
FIGURE 15. WVCs RECORDED BY CITIZEN SCIENTISTS ALONG HEART LAKE ROAD FROM 2011, 2013, 2015, 2016, 2017 AND 2018.

Through HLREMP studies (2011, 2013, 2015, 2016, 2017, 2018), citizen scientists have observed a total of 5,189 WVCs, including 4013 frogs/toads, 378 turtles, 320 mammals, 240 birds, 144 unknowns and 92 snakes (Figure 15).

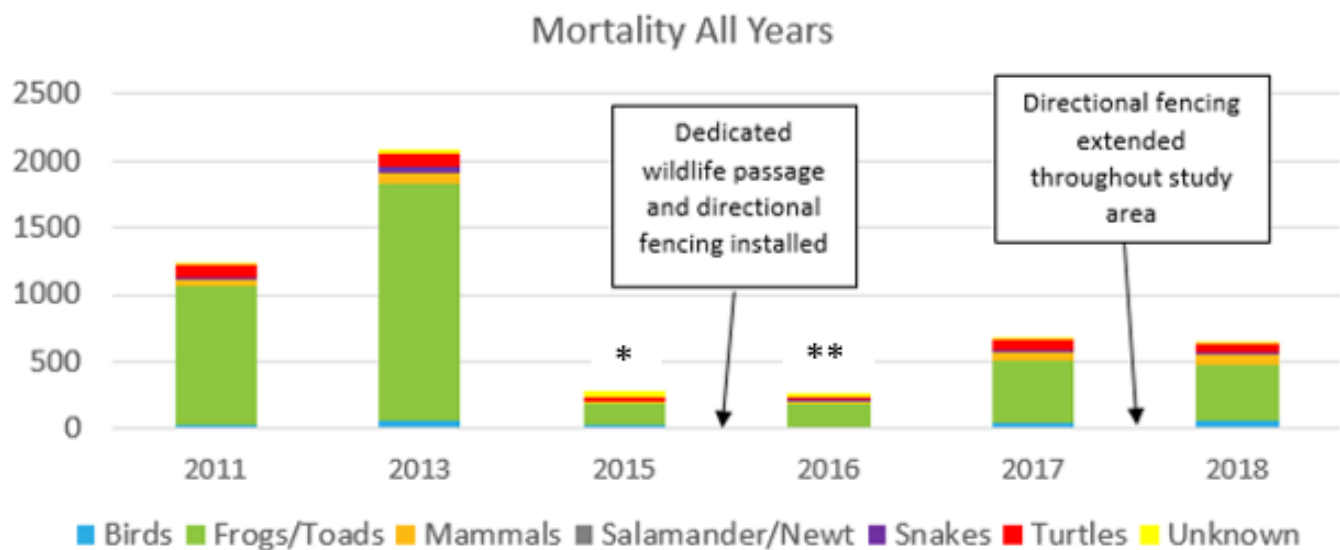
FIGURE 16. WILDLIFE-VEHICLE COLLISIONS ALONG HEART LAKE ROAD DURING ALL YEARS MONITORED.

An overview of all road mortality observed throughout the duration of the project, with notable mitigation events highlighted can be found in (Figure 16).

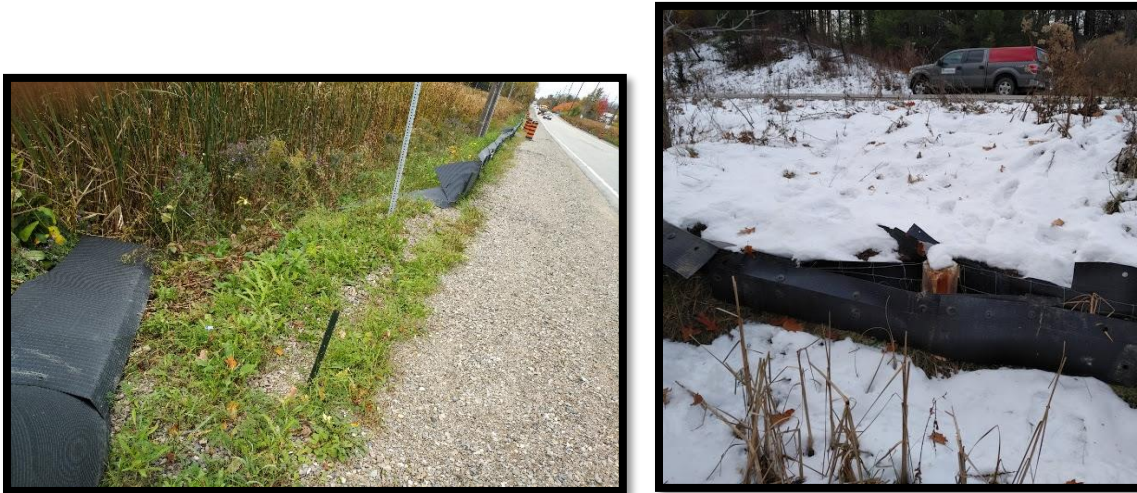
FIGURE 24. DAMAGE TO TEMPORARY FENCING AND PERMANENT FENCING ALONG HEART LAKE ROAD IN 2018.

Staff evaluated fencing integrity at the end of the season and found 16 damaged panels (Figure 24), and 108 malfunctions including gaps or breaks found in the temporary fencing that would allow small wildlife to pass through. About 10 malfunctions were found in the permanent fencing. When analyzing distances of WVCs to fence malfunctions, it was found that 78.5% of WVCs occurred within 20 meters of a malfunction (Figure 25).

Maintaining fence integrity is critical as any structural failure (i.e. holes, gaps, slack walls, overgrown vegetation, etc.), may compromise effectiveness of a mitigation strategy (Baxter-Gilbert et al. 2015). Some case studies have shown that a poorly maintained fence is comparable to no fencing (Markle et al. 2017 and Van der Ree et al. 2007). Given the large number of malfunctions, proper maintenance should be completed to ensure longevity and success of temporary fencing.

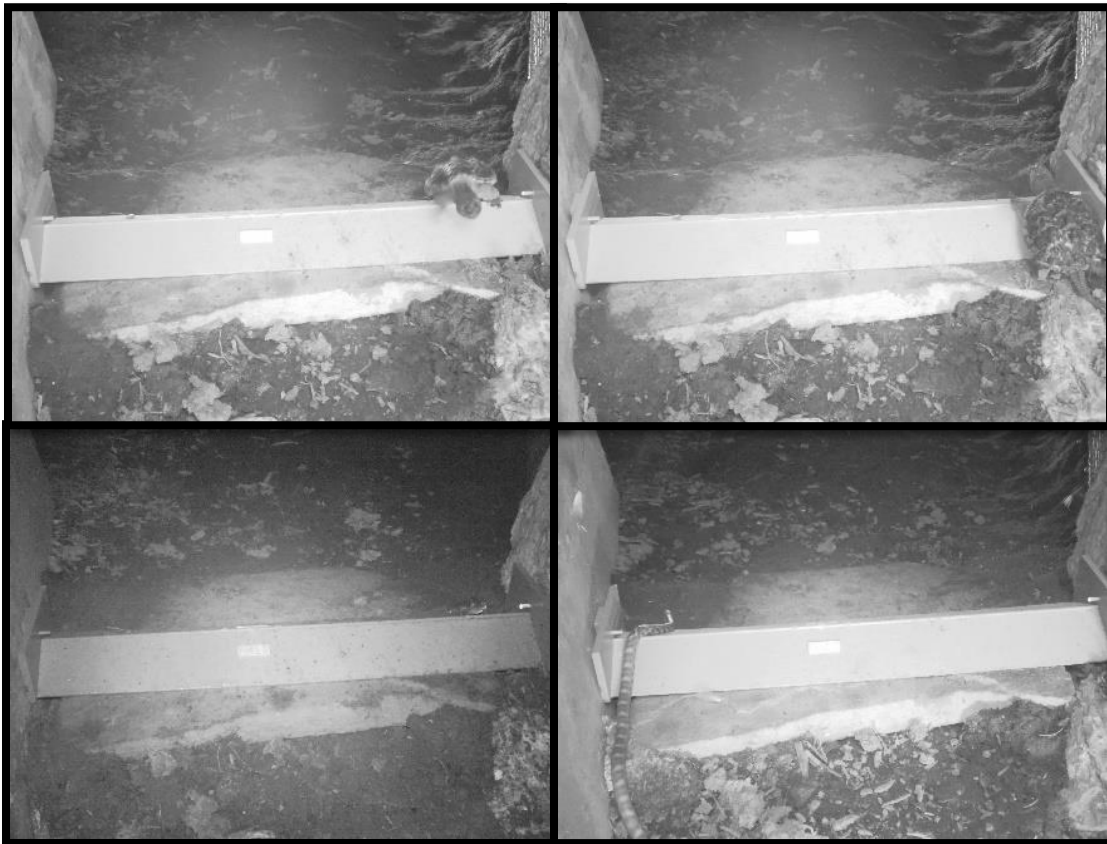
FIGURE 26. 2018 HOBBS ACTIVE LIGHT TRIGGER CAMERA SHOWS IMAGES OF A SNAPPING TURTLE HATCHLING (TOP LEFT AND RIGHT), A FROG (BOTTOM LEFT) AND A MILK SNAKE (BOTTOM RIGHT).

The camera with the HALT laser trigger had more total wildlife detections and was able to detect more species compared to the motion-triggered PIR cameras (Table 8). PIR cameras were able to capture photographs of large mammals including skunks, raccoons and a vole. In contrast, the HALT system captured photographs of mammals in addition to small, cold blooded species including a juvenile snapping turtle, frogs and a milk snake (Figure 26). For a list of species detected by each camera refer to Appendix J.

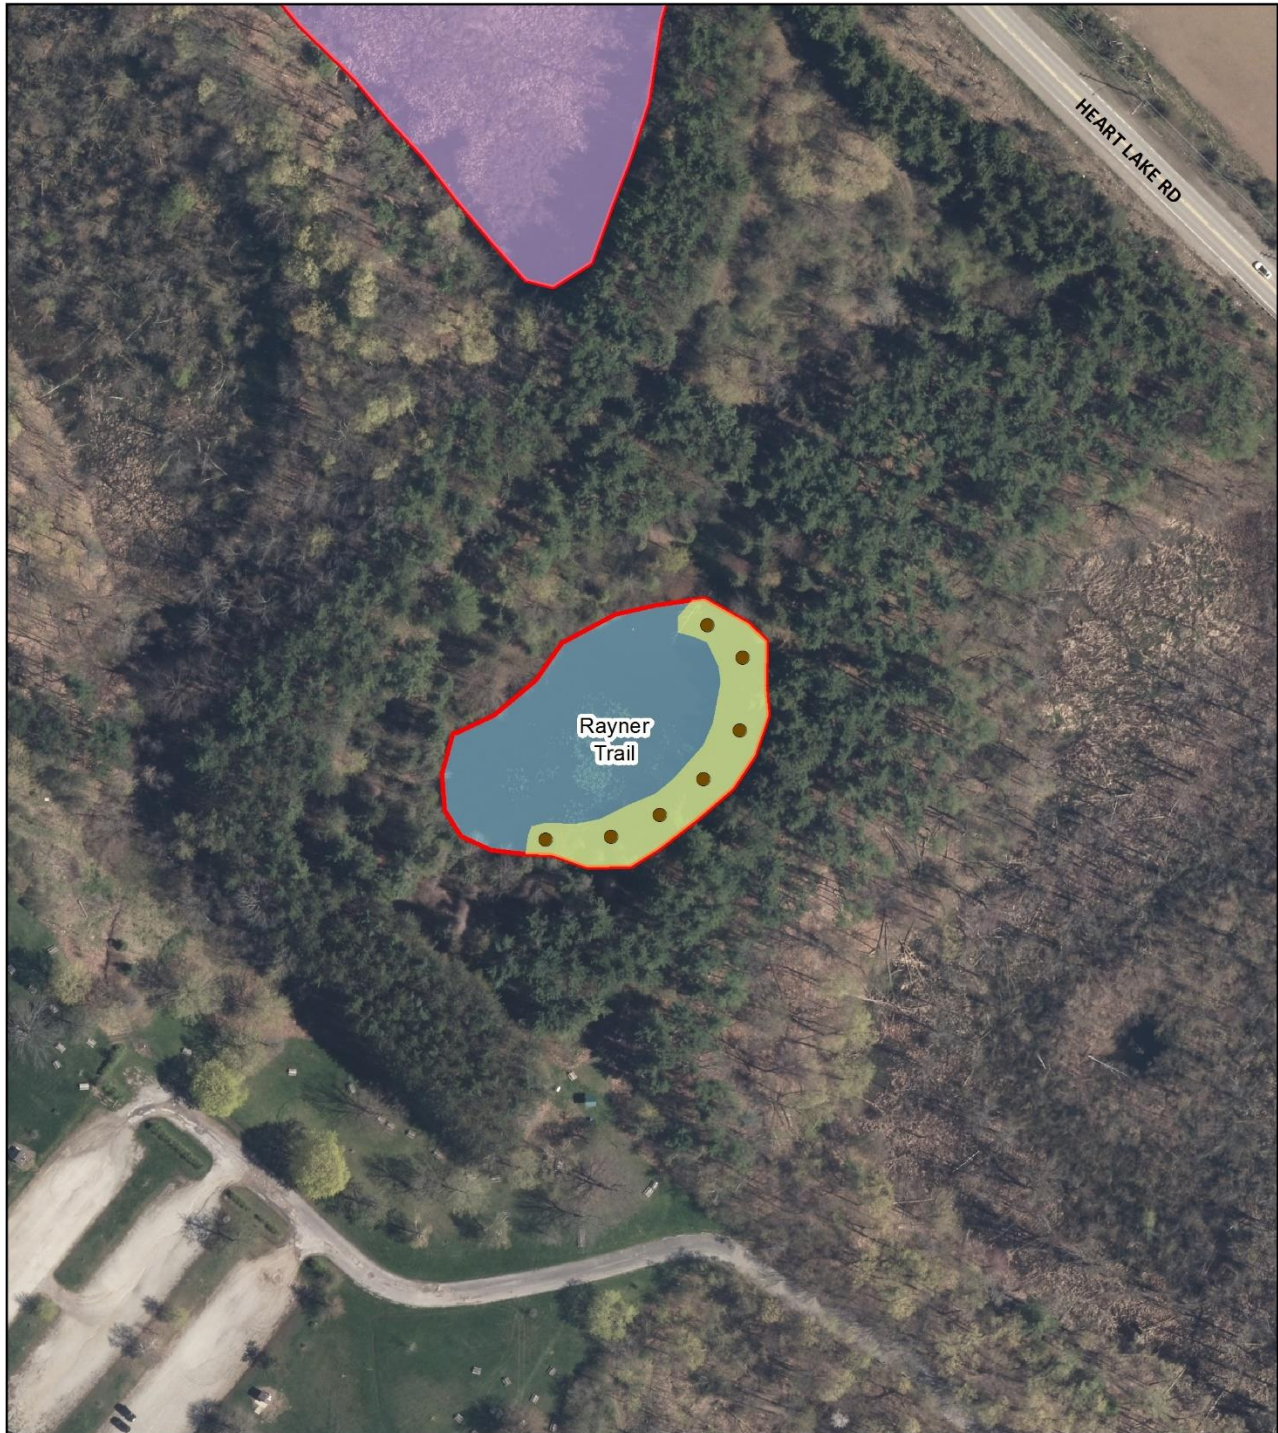
<p>Toronto and Region Conservation Authority</p>	<p>Heart Lake Road Provincially Significant Wetlands and Heart Lake Conservation Area</p>	<ul style="list-style-type: none"> Trap Locations Wetland Boundary Open Water Study Area Wetlands not Surveyed in 2018
<p>Date: December 11, 2018 Created by: Ryan Burns and TRCA Information Management Orthophoto: Spring 2017 Disclaimer: The Data used to create this map was compiled from a variety of sources and dates. The TRCA takes no responsibility for errors or omissions in the data and retains the right to make changes and corrections at anytime without notice. For further information about the data on this map, please contact the TRCA. GIS Department. (416) 661-6600.</p>	<p>Turtle Population Study - Rayner Trail Wetland</p>

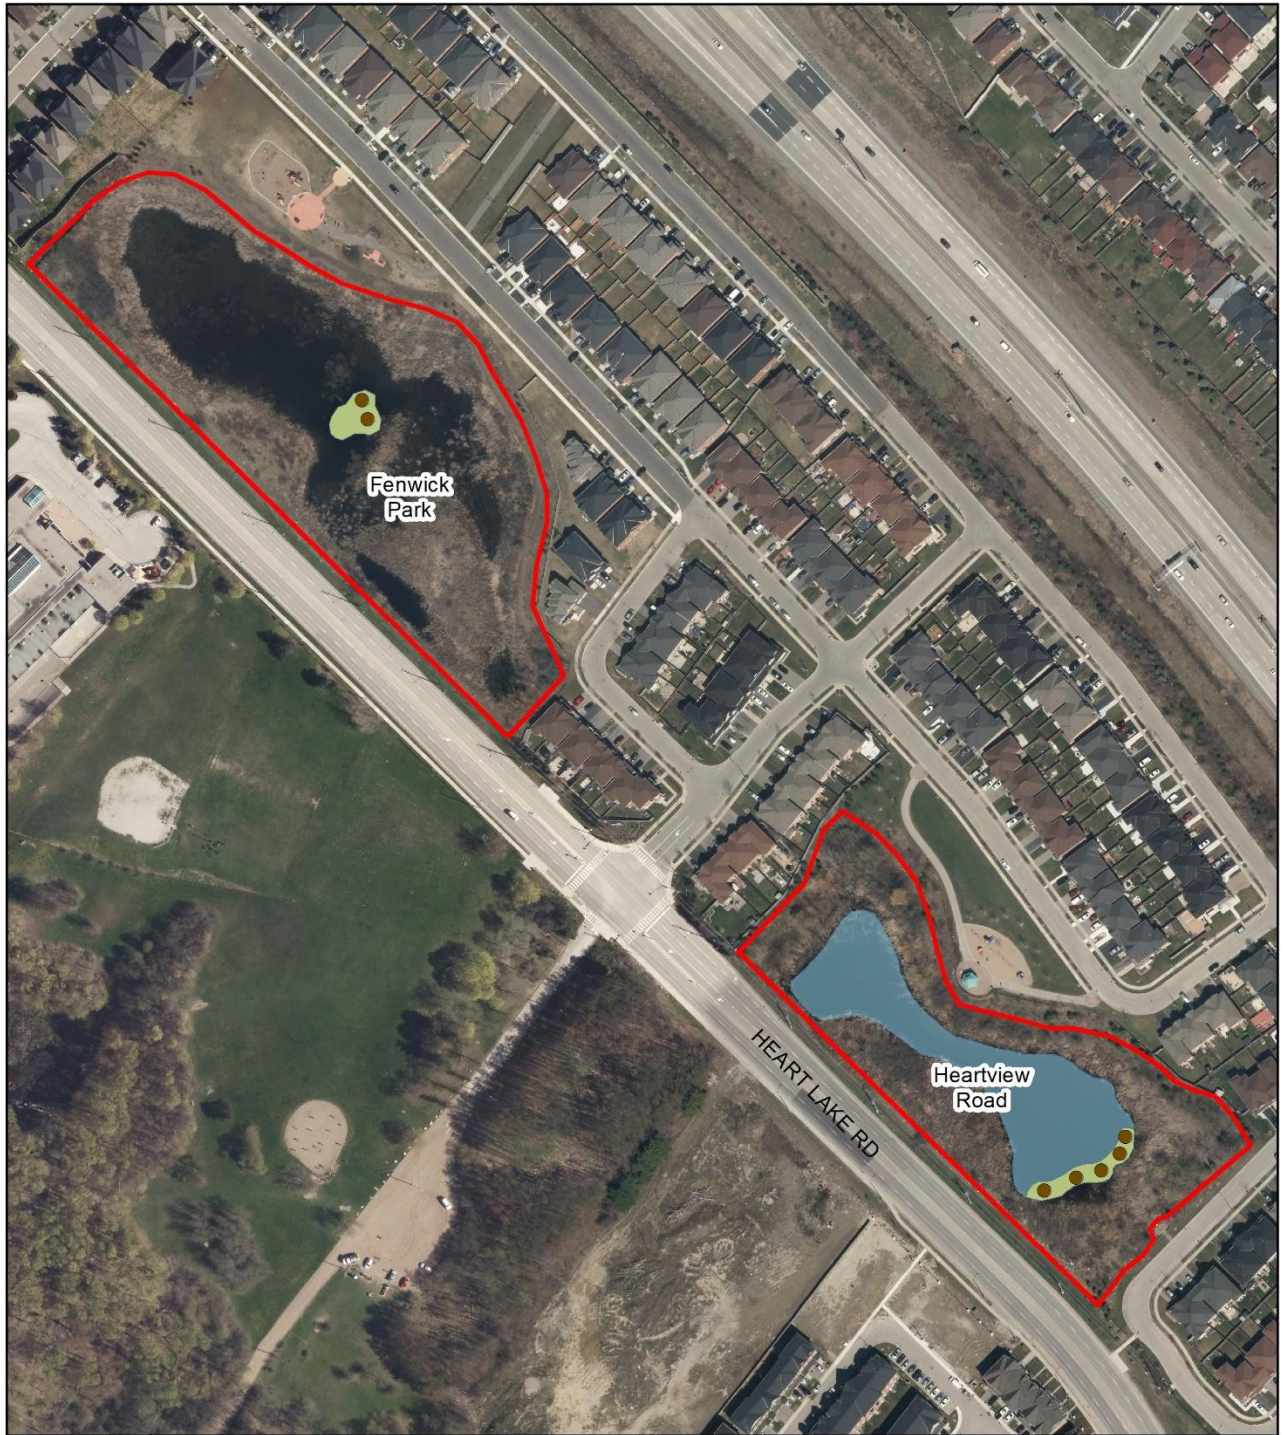
<p>Toronto and Region Conservation Authority</p>	<p>Heart Lake Road Provincially Significant Wetlands and Heart Lake Conservation Area Turtle Population Study - Fenwick Park and Heartview Road</p>	<ul style="list-style-type: none">

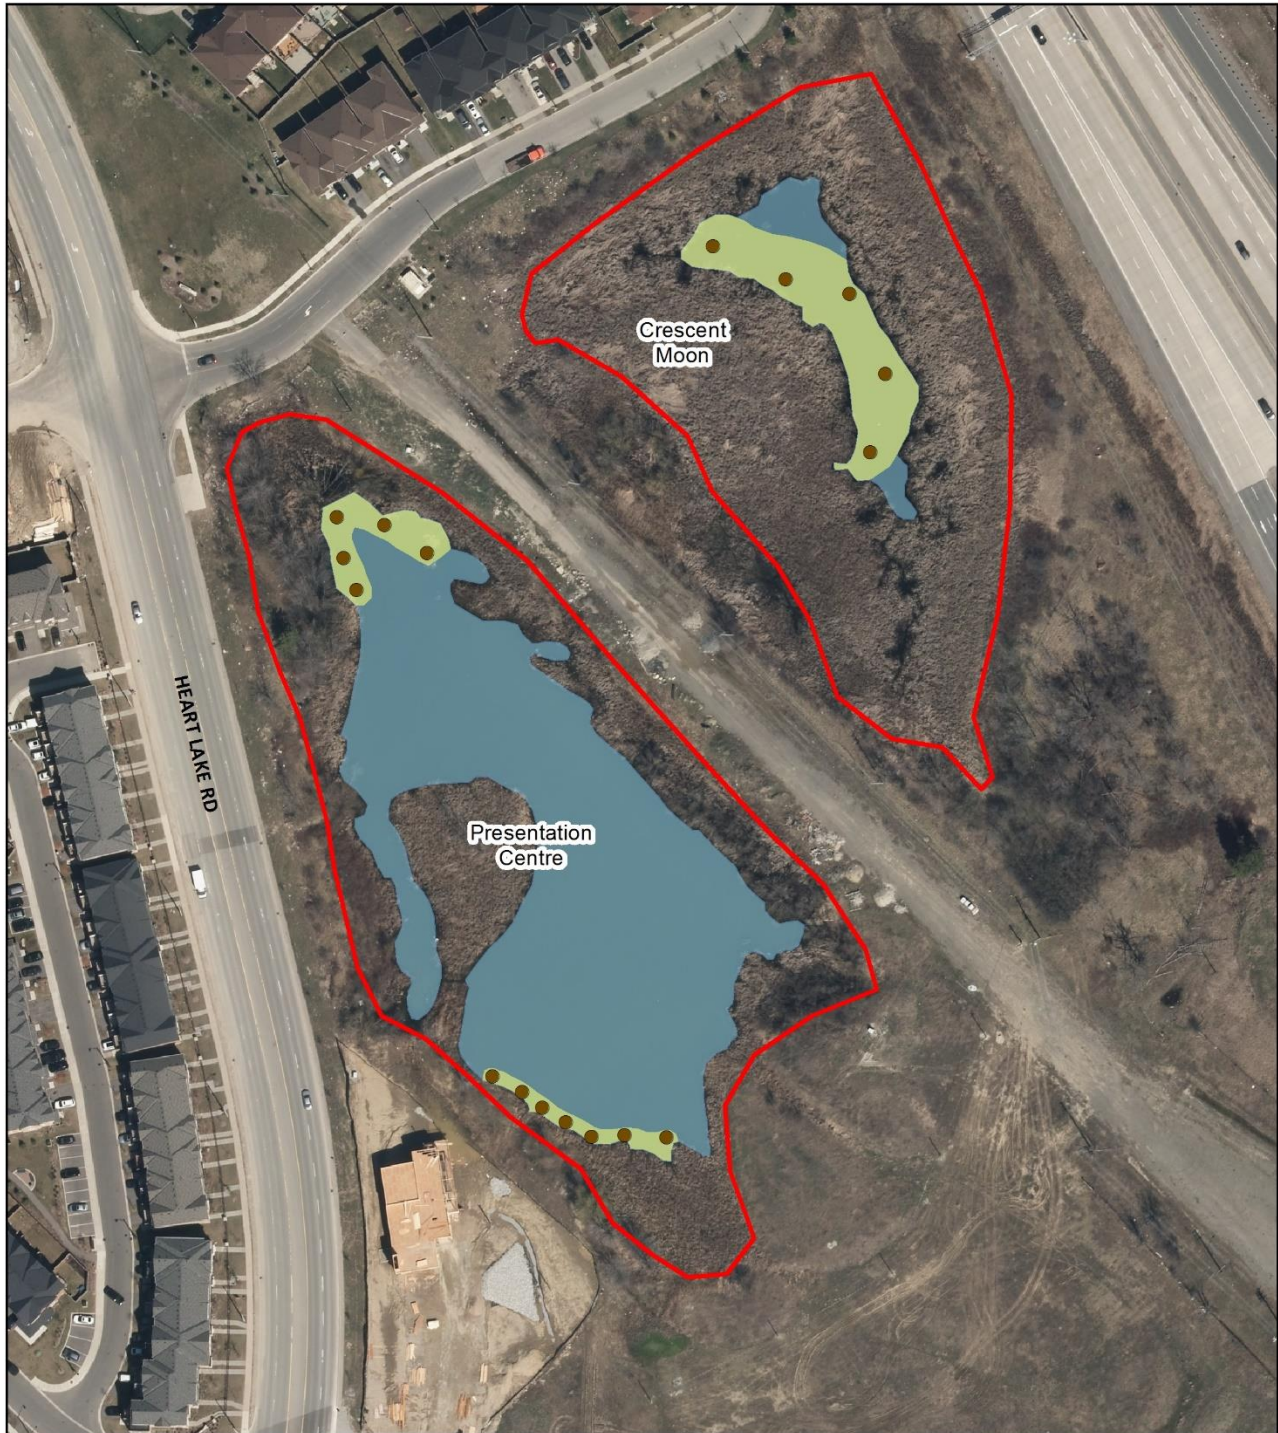
<p>Toronto and Region Conservation Authority</p>	<p>Heart Lake Road Provincially Significant Wetlands and Heart Lake Conservation Area</p> <p>Turtle Population Study - Crescent Moon and Presentation Centre</p>	<ul style="list-style-type: none"> Trap Locations Wetland Boundary Open Water Study Area
<p>Date: December 11, 2018 Created by: Ryan Burns and TRCA Information Management Orthophoto: Spring 2017 Disclaimer: The Data used to create this map was compiled from a variety of sources and dates. The TRCA takes no responsibility for errors or omissions in the data and retains the right to make changes and corrections at any time without notice. For further information about the data on this map, please contact the TRCA, GIS Department. (416) 661-6600.</p>	<p>0 12.5 25 50 M</p>
