Appendix H
Structural Conceptual Design Reports

CONCEPTUAL DESIGN REPORT

Jane Street Bridge

Structure No. 091

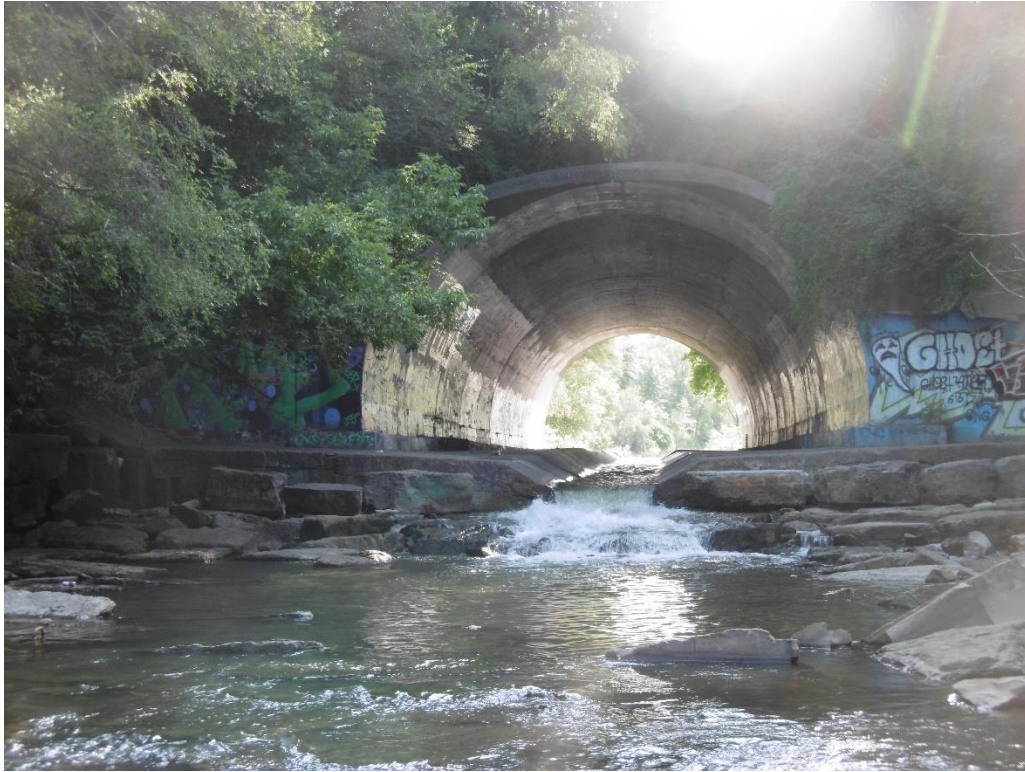
Figure 1: West Elevation

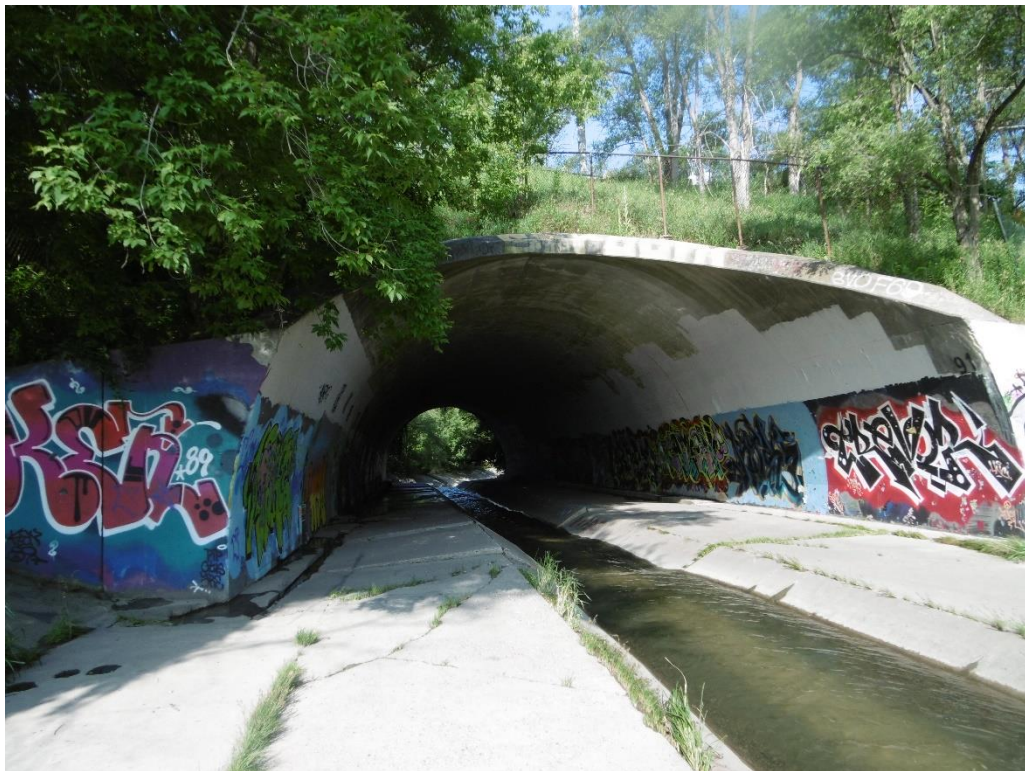
Figure 2: East Elevation

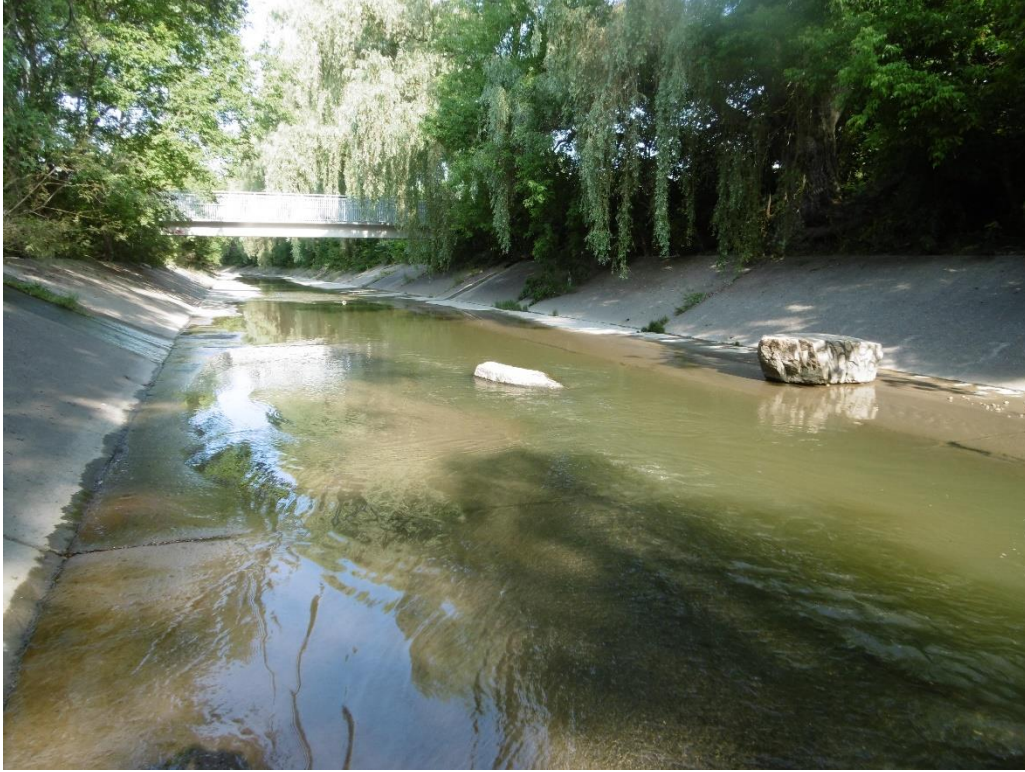
Figure 3: Downstream Channel

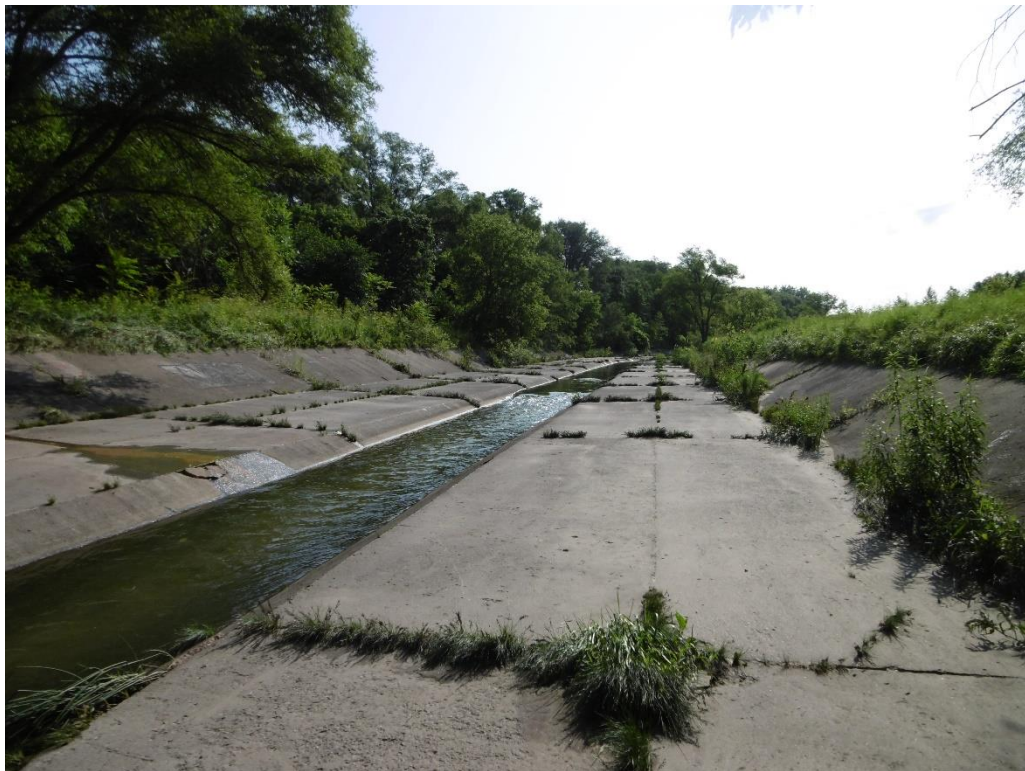
Figure 4: Upstream Channel

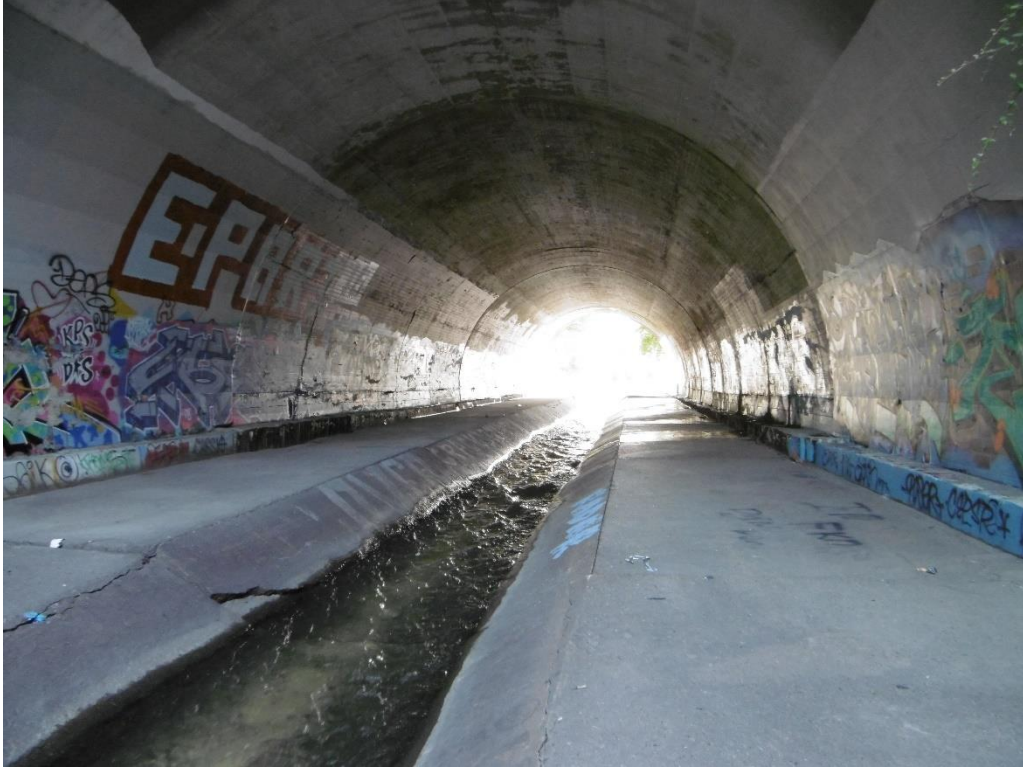
Figure 5: Culvert Barrel

The Jane Street Culvert over Black Creek is a 57.25m long cast-in-place concrete arch structure with a 10.7m span and is located on Jane Street approximately 70m south of the Alliance Avenue intersection. The culvert carries four lanes of traffic (two in each direction) with a posted speed of 50 km/hr. Traffic volumes as of 2017 were found to be approximately 11,823 AADT. There are sidewalks and guiderails on each side of the roadway. Based on the existing drawings, the existing roadway width is 15.24m (50'), including the gutter, plus another 3.048m (10') on each side for the curb, sidewalk, steel beam guide rail (SBGR), and another 0.6096m (2') offset behind the SBGR before the ground starts sloping down. The total is 21.336m 'flat' before ground slopes on either side. There is approximately 6.0m of earth fill on top of the culvert and the watercourse flows from east to west through the culvert. It is suspected that there may be embedded utility ducts within each sidewalk.

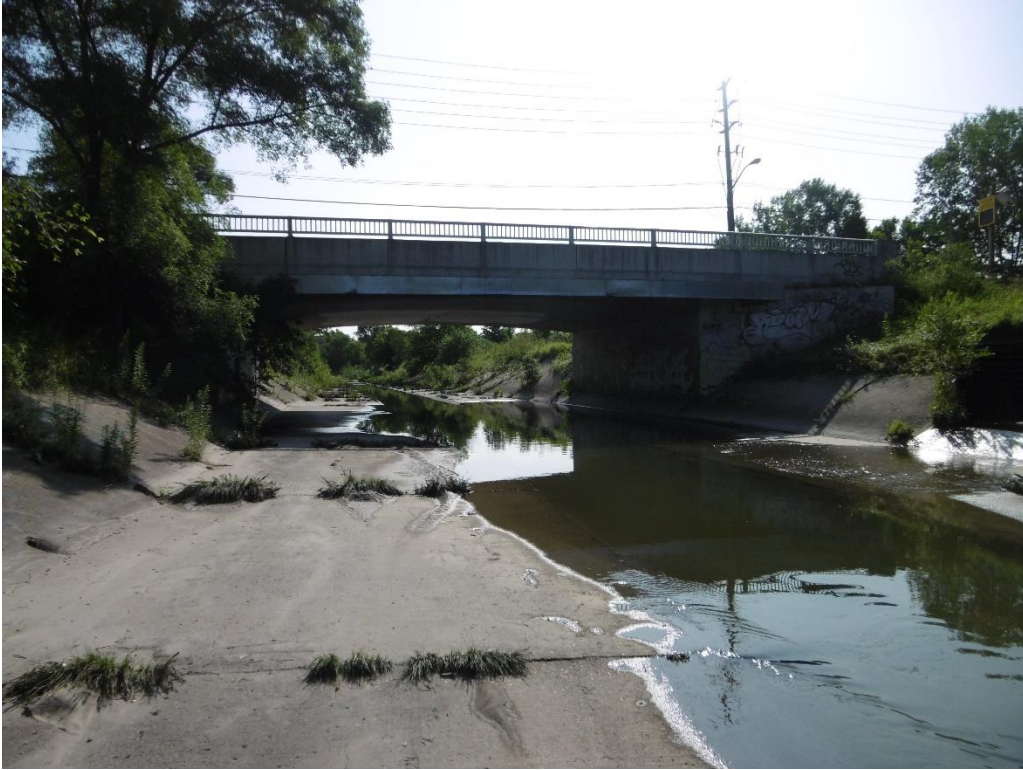
Figure 1: West Elevation

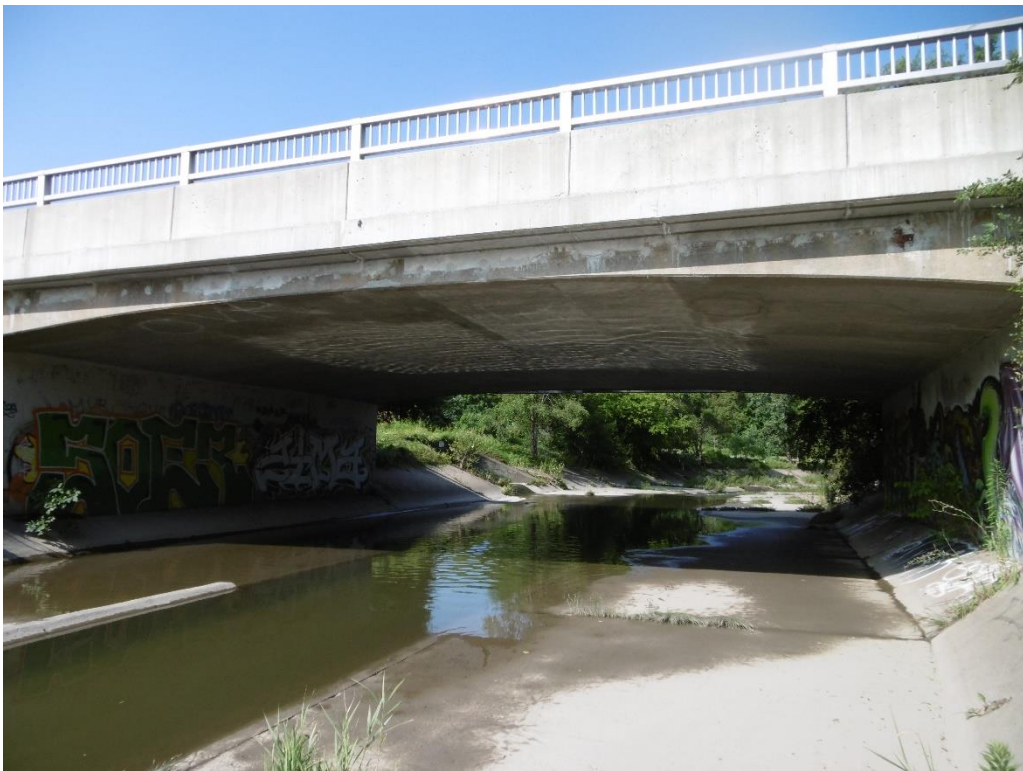
Figure 2: East Elevation

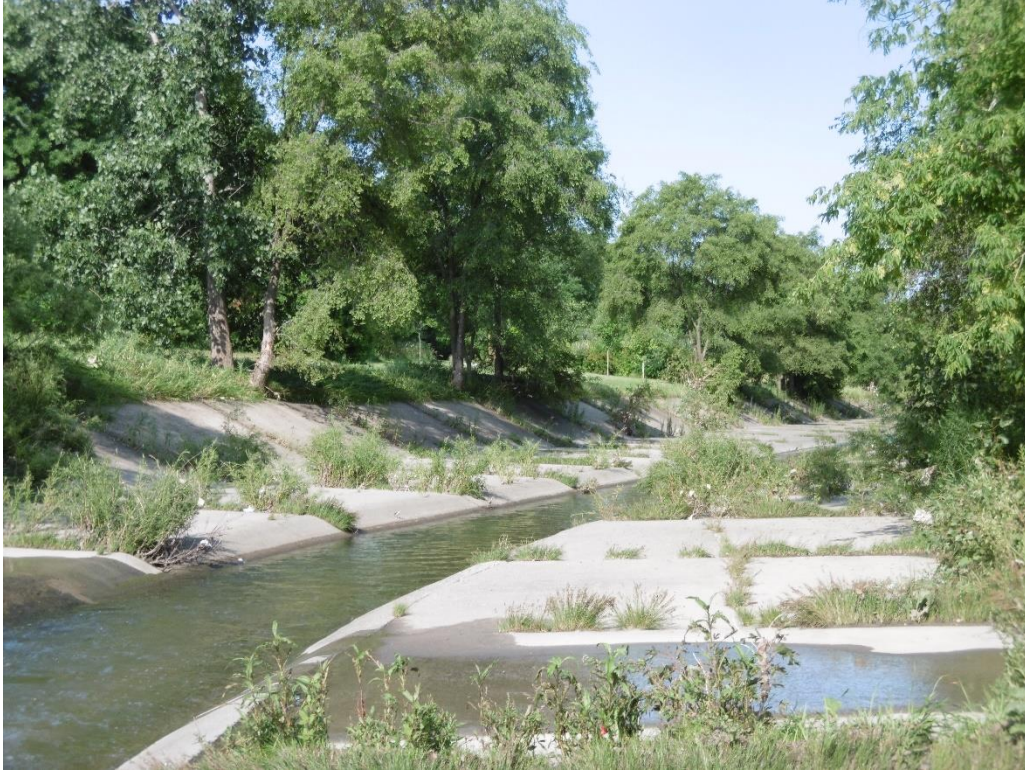
Figure 3: Downstream Channel

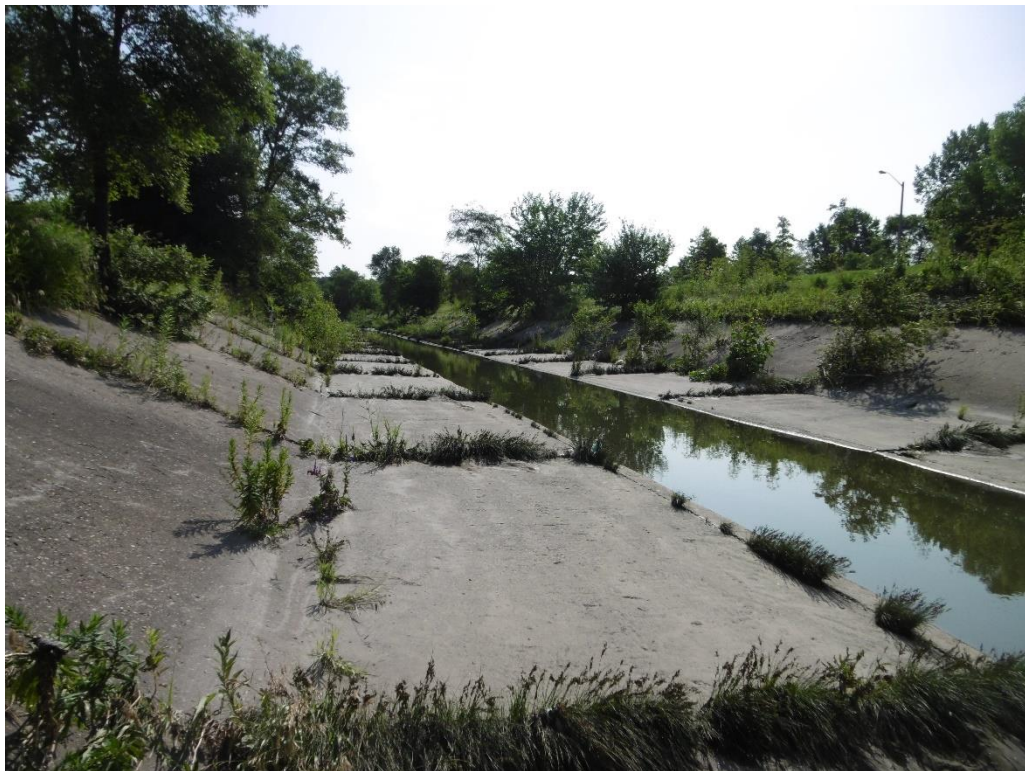
Figure 4: Upstream Channel

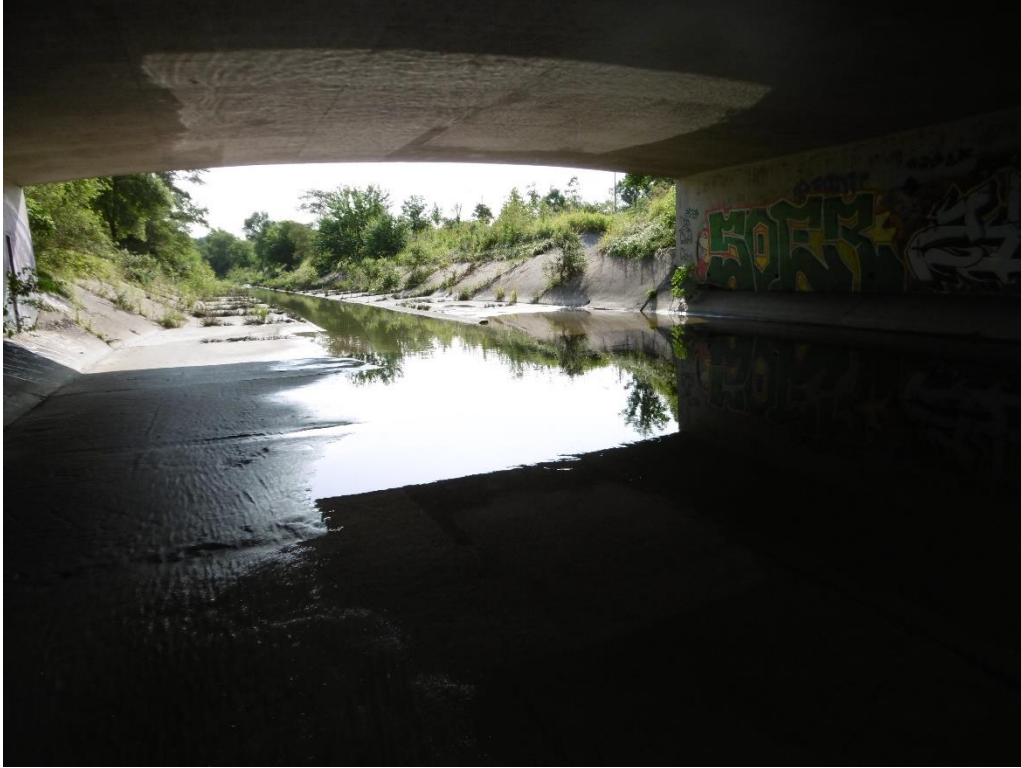
Figure 5: Bridge Soffit

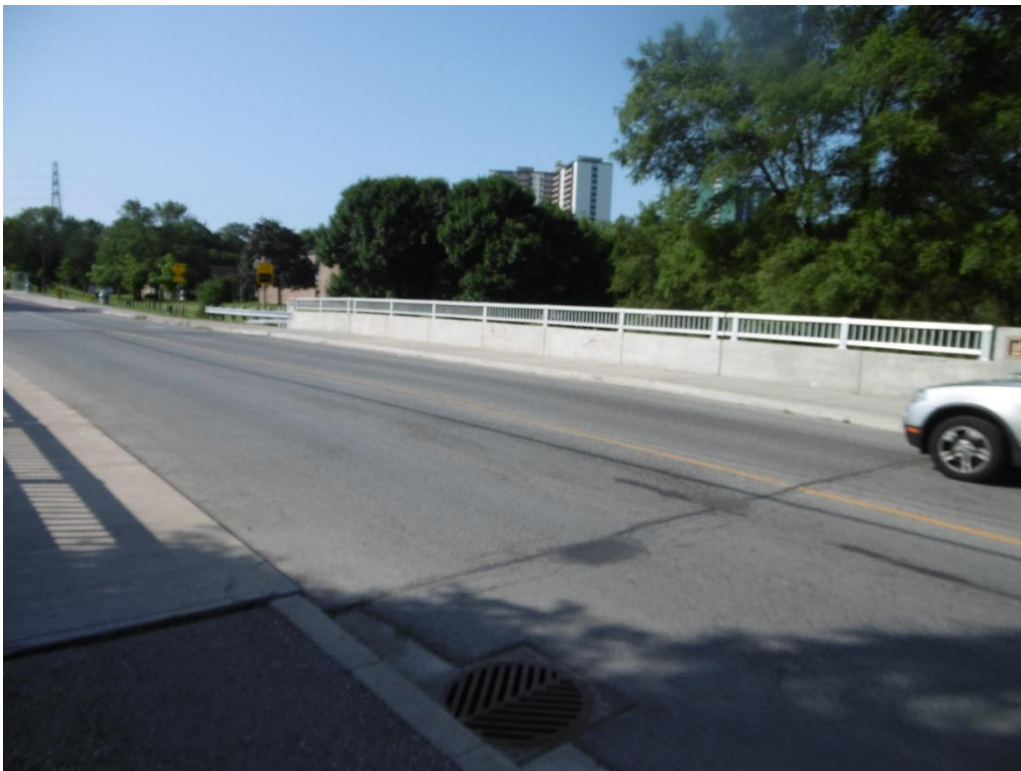
Figure 6: Wearing Surface

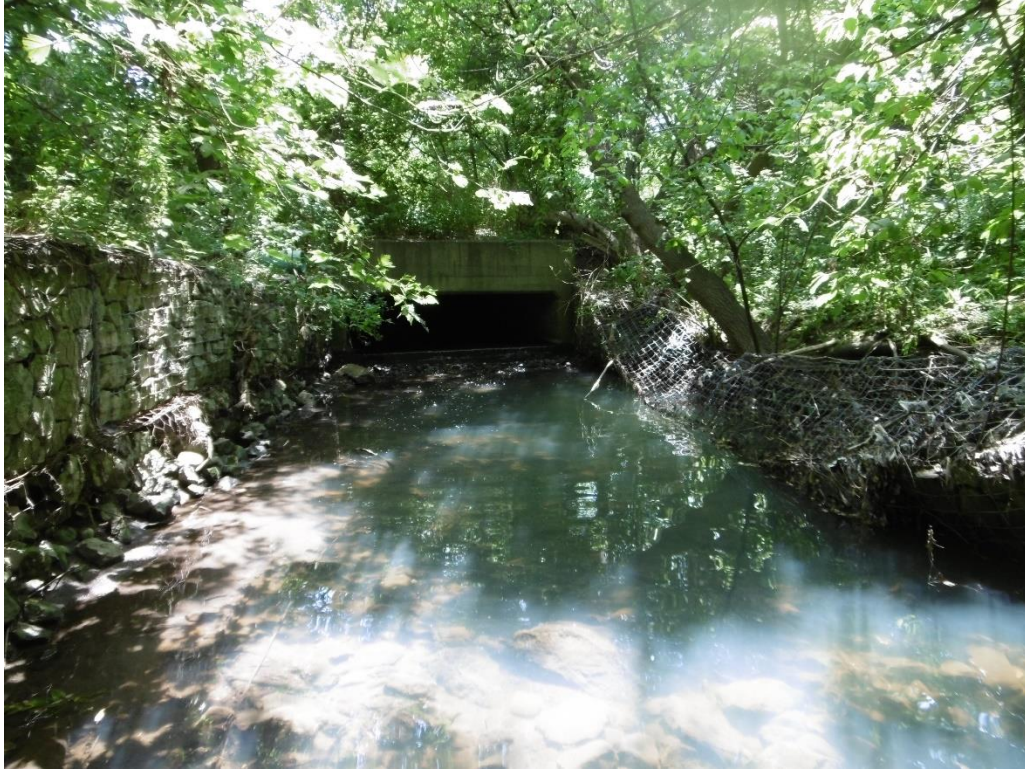
Figure 1: West Elevation

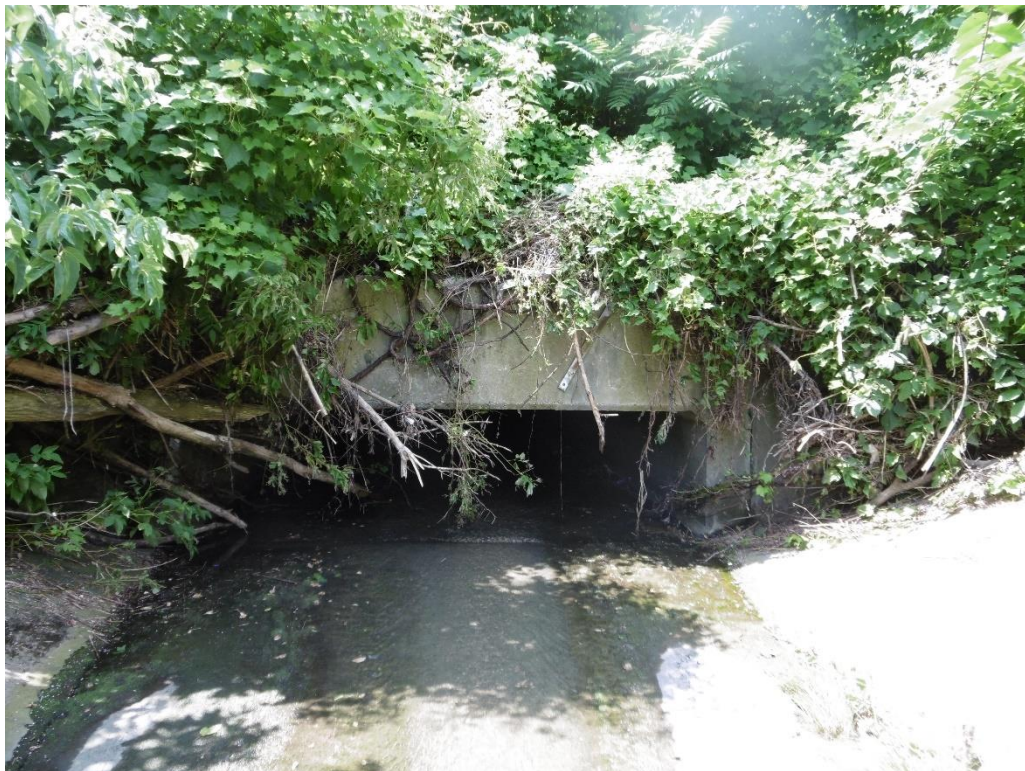
Figure 2: East Elevation

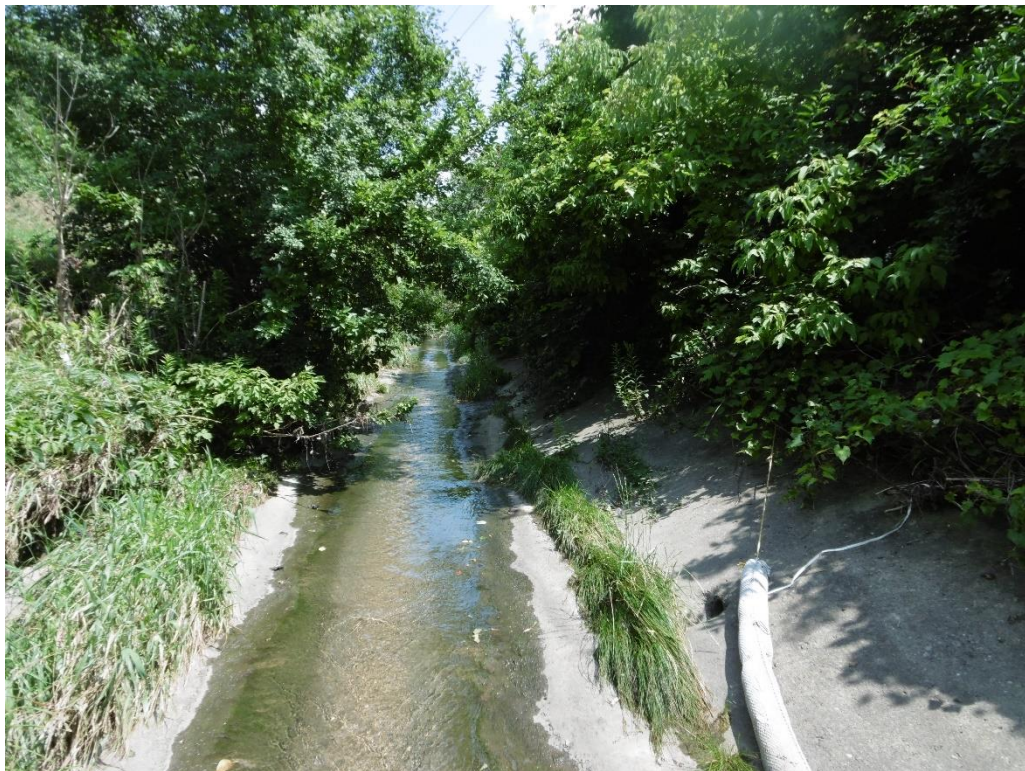
Figure 4: Upstream Channel

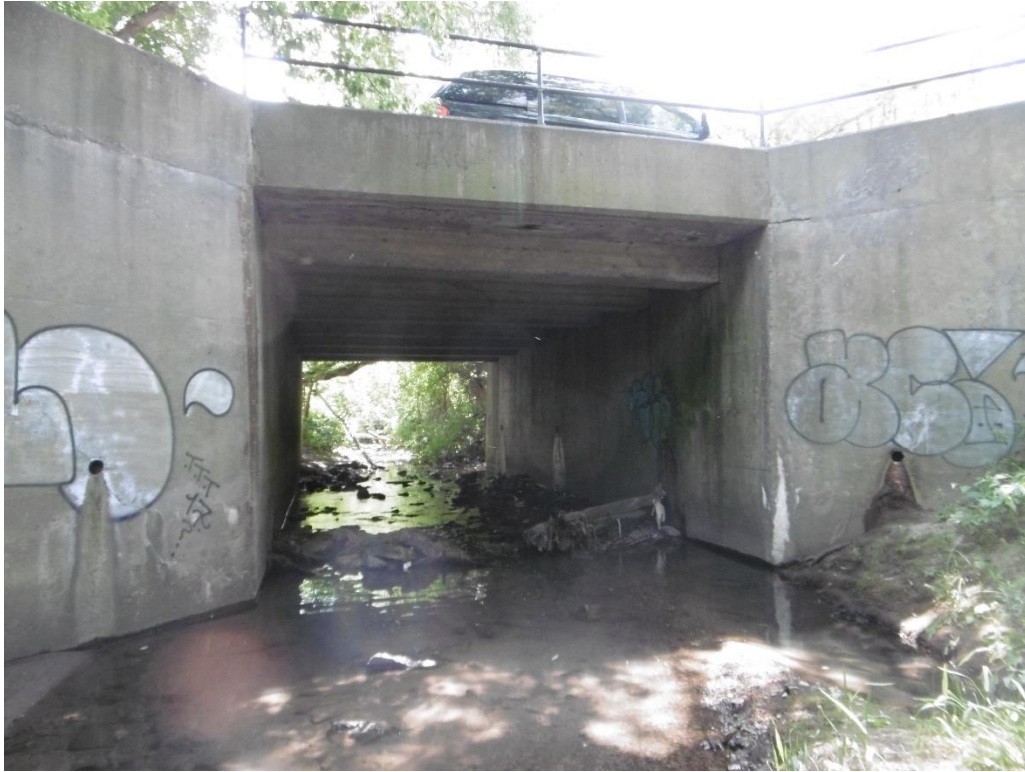
Figure 1: North Elevation

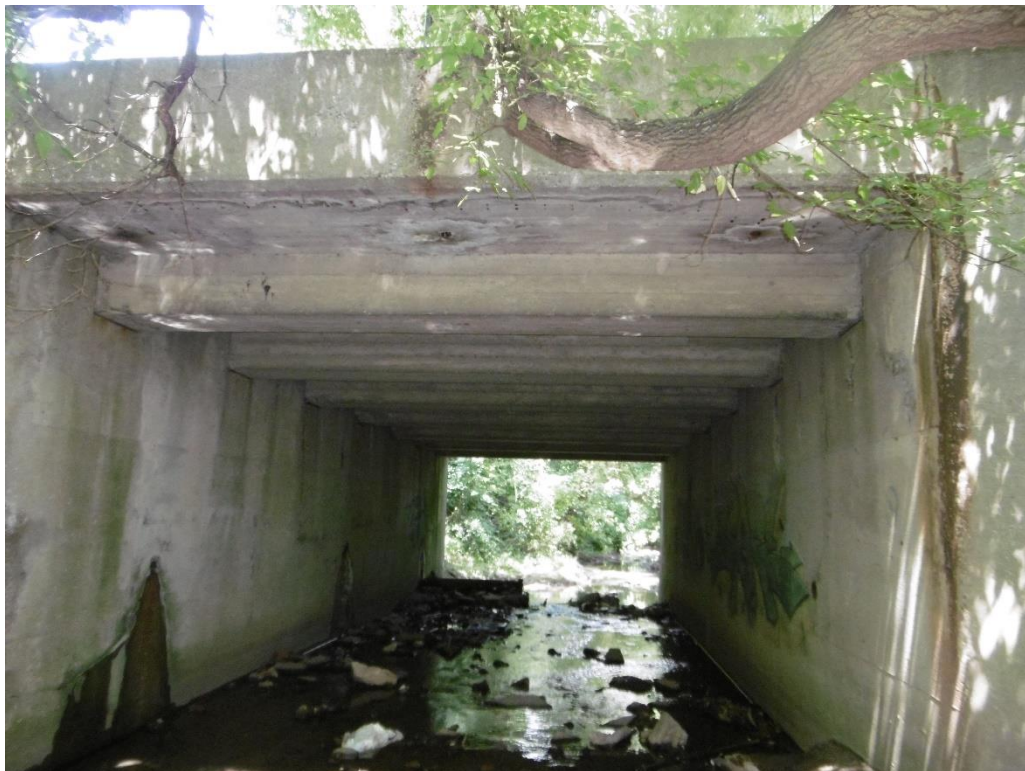
Figure 2: South Elevation

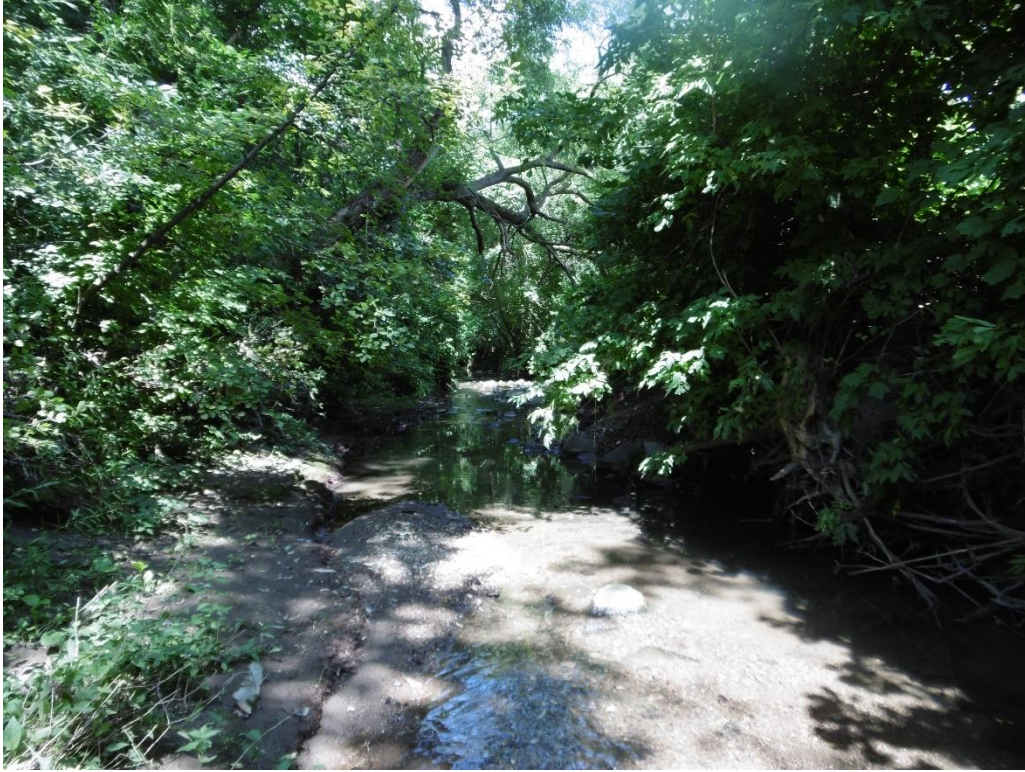
Figure 3: Downstream Channel

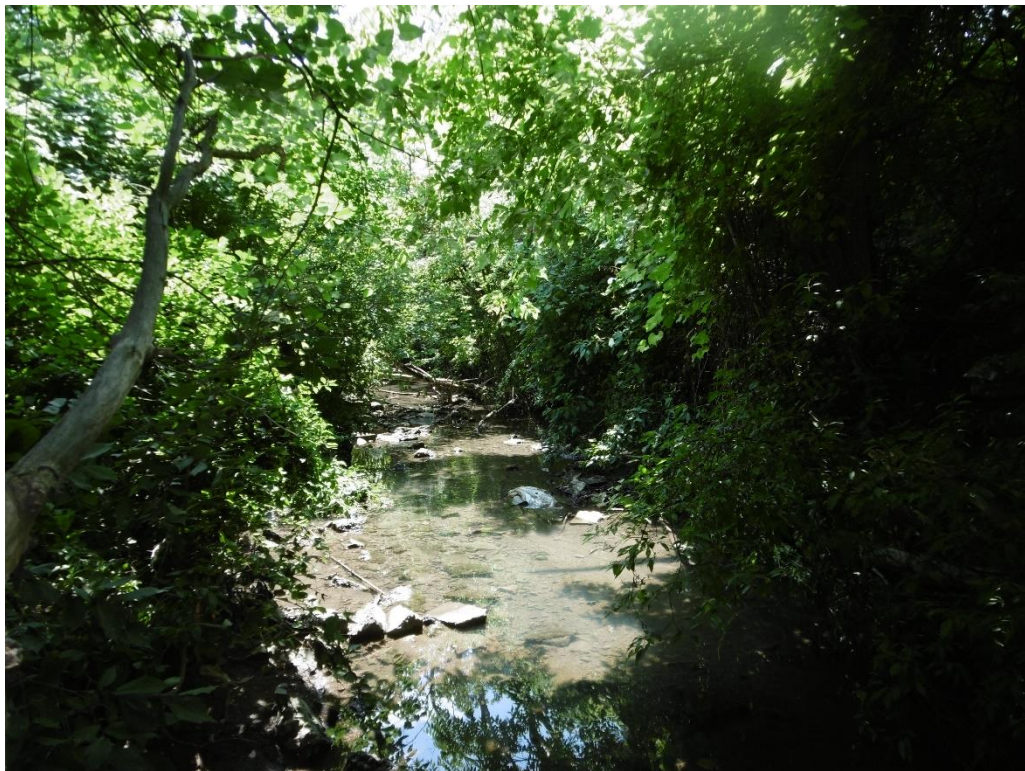
Figure 4: Upstream Channel

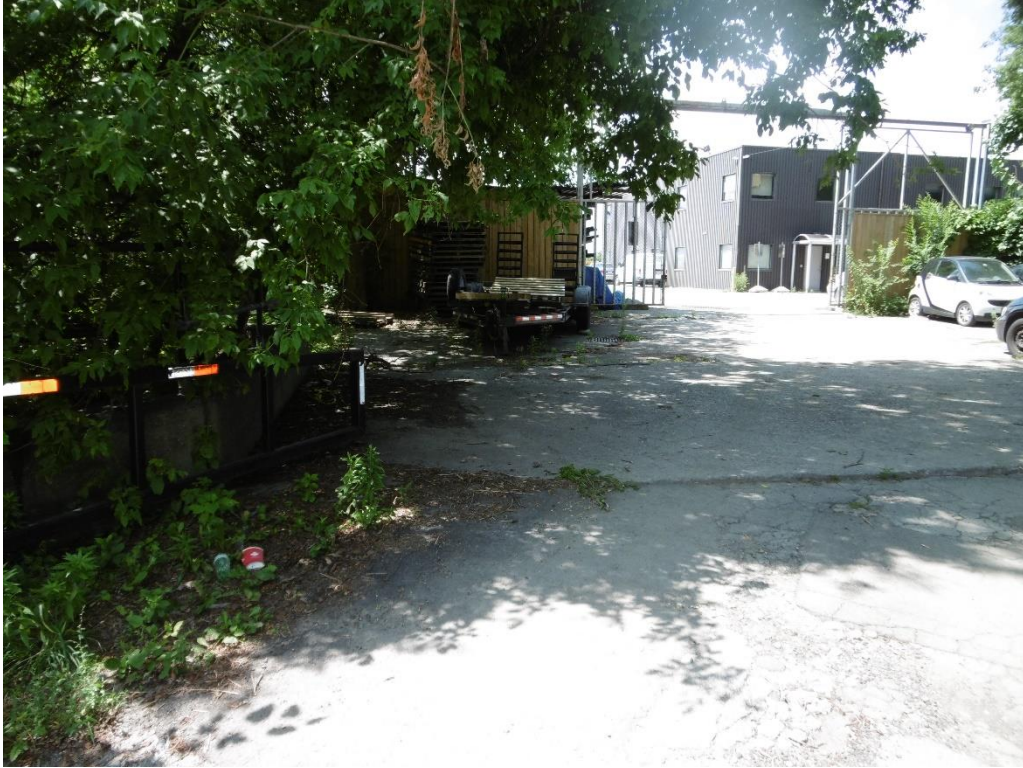
Figure 5: Wearing Surface

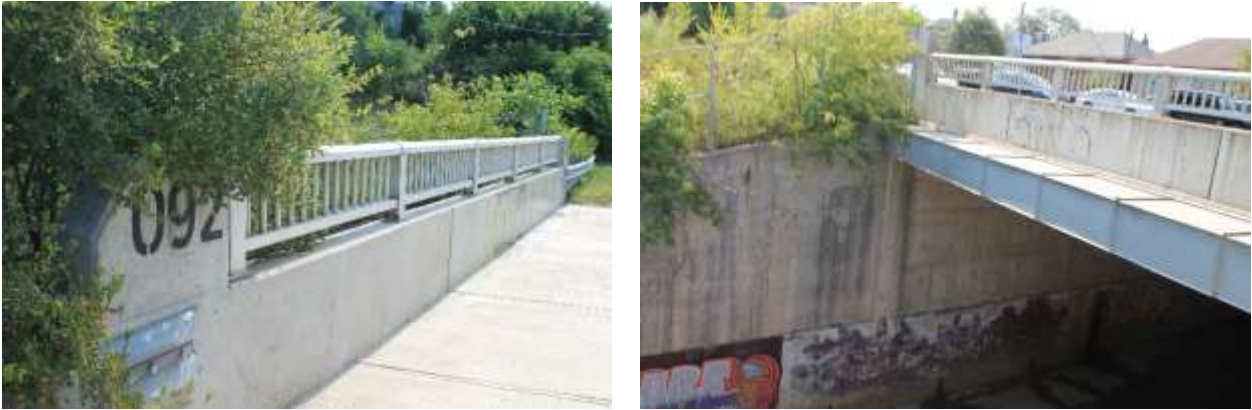
Figures 29 & 30: (left) View of parapet and railing looking north-east from intersection of Weston Road and Black Creek Drive (right) View of northeast retaining wall, soffit and barrier exterior
(Source: MHBC, 2019)

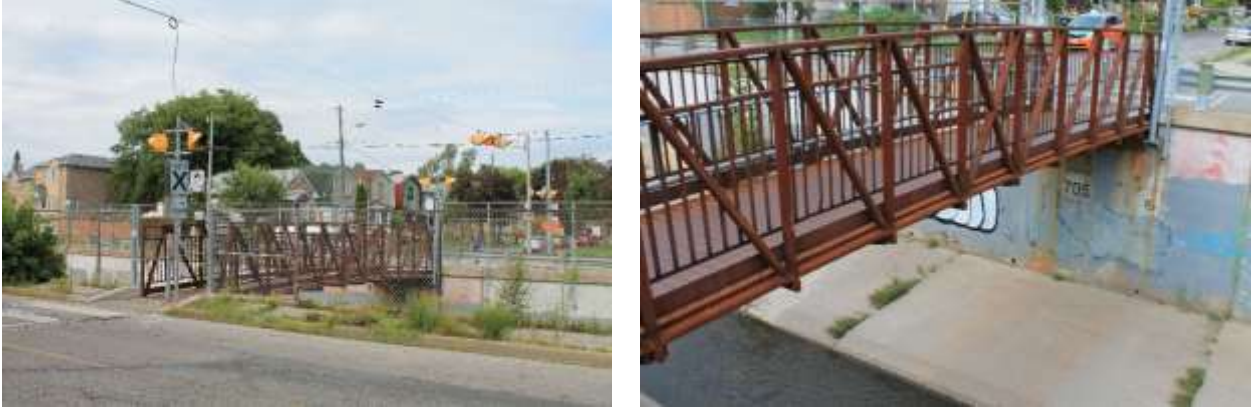
Bridge ID No. 705, also known as the 'Humber Boulevard Pedestrian Bridge over Black Creek' can be described as a steel Half-Through Truss bridge. The bridge includes a steel deck top, galvanized steel railing on the truss, box/trapezoidal stringers (beams) as well as cast-in-place concrete abutments and retaining walls. The bridge does not have a plaque, but a construction marker identifies it as 'Eagle Bridge' (possibly the mark of a construction or engineering company).

Figures 31 & 32: (left) View of north elevation of truss and approach (right) View of west abutment and retaining wall, north elevation of truss and railing. (Source: MHBC, 2019)

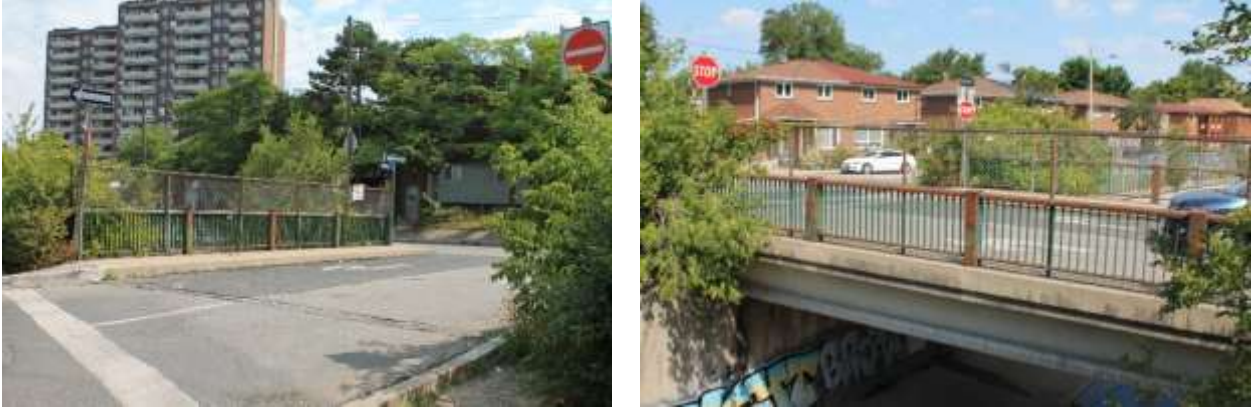
Bridge ID No. 703 is also referred to as the Humber Boulevard over Black Creek Bridge. The bridge is designed as an I-Beam and Girder road bridge, constructed in 1975. The bridge is similar in its design with the adjacent bridge (ID No. 704). Bridge ID No. 703 includes a cast-in-place concrete deck and asphalt deck top, cast-in-place concrete sidewalk, curb, and median as well as a galvanized steel post and panel railing. Precast concrete girders are located below the bridge deck. The bridge also features cast-in-place concrete abutments and reinforced concrete retaining walls.

Figures 33 & 34: (left) View of west approach asphalt surface, sidewalk, railing, and chain-link fence, (right) View of south elevation railing, abutment, and soffit (Source: MHBC, 2019)

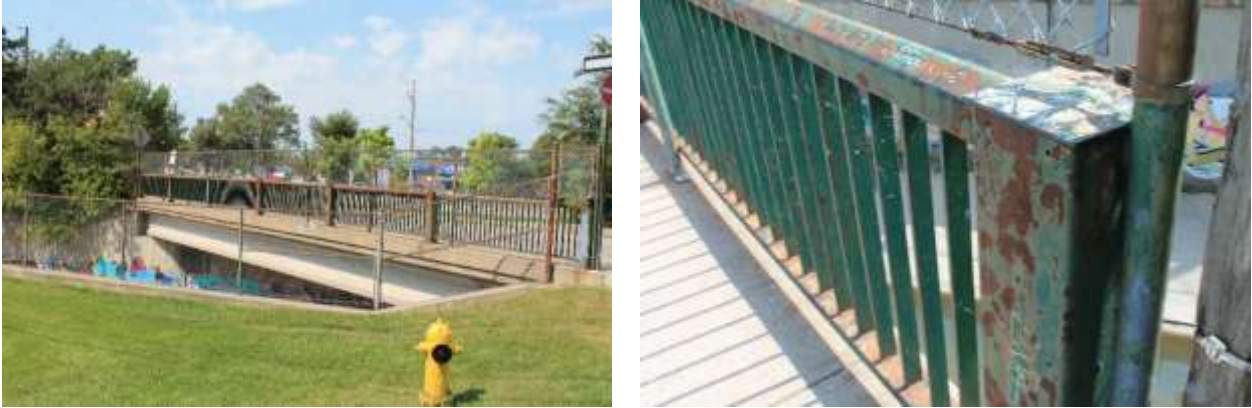
Figures 35 & 36: (left) View of north elevation of bridge railing and soffit, from Humber Boulevard, (right) Detail view of Galvanized steel post and panel railing (painted green, evidence of corrosion) (Source: MHBC, 2019)

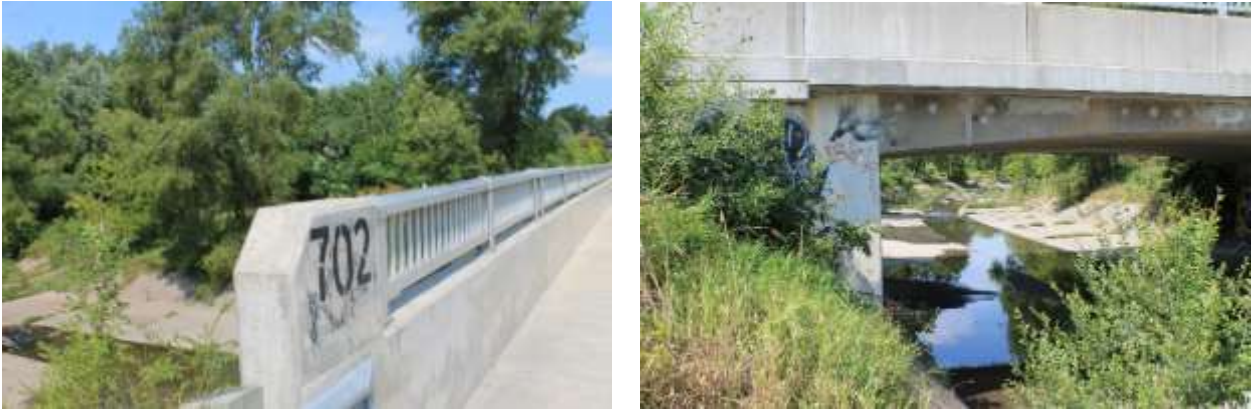
Figures 37 & 38: (left) View of west parapet wall and railing, (right) View of east elevation abutment, wingwall, and soffit from channel embankment (Source: MHBC, 2019)

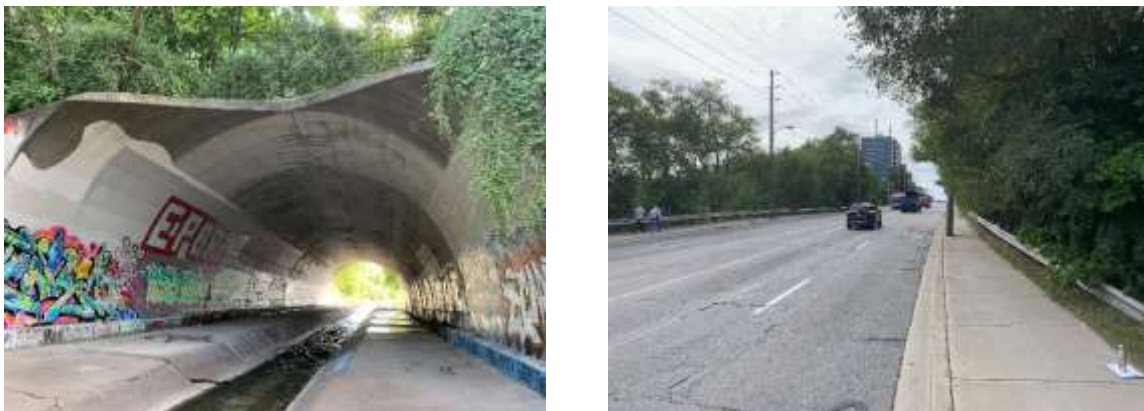
Culvert ID No. 091 is also known as the 'Jane Street over Black Creek' Culvert. The culvert was constructed in 1948. The barrel of the culvert was extended at both ends in 1963. The culvert can be described as a barrel arch culvert made of cast-in-place concrete. The structure includes a cast-in-place concrete deck with asphalt deck top. The structure includes steel flex beams in a wood post railing system, which was not readily visible and covered with vegetation. An inspection of this element of this part of the structure was not undertaken due to limited access and safety concerns.

Figures 39 & 40: (left) View of barrel inlet, looking east (right) View of Jane Street looking south over culvert, (Source: MHBC, 2019)

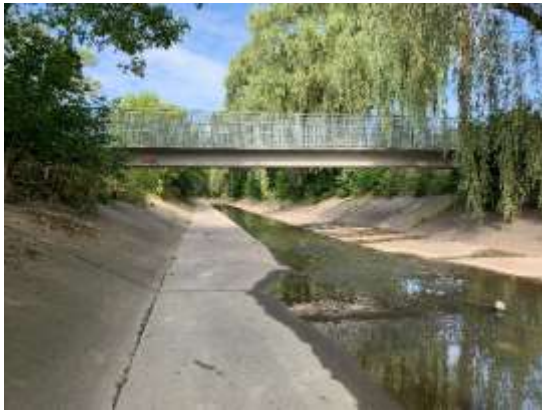
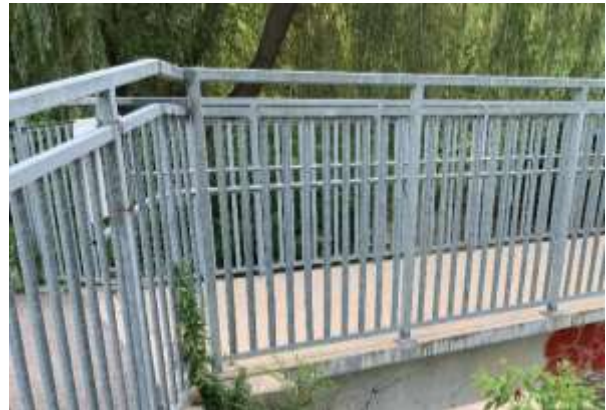
Bridge ID No. 308523 is referred to as the Smythe Park Bridge (no. 2 of 3) and can be described as a T-Beam and Girder bridge constructed in 1980. The bridge is intended for pedestrians only and includes pre-cast concrete elements including the deck top, girders (T-type), abutments, and ballast walls. The existing retaining walls are made of cast-in-place reinforced concrete. The bridge includes a steep post and panel railing system.

Figures 41 & 42: (left) View of west elevation, looking east along Black Creek Channel (right) Detail view of steel railing system (Source: MHBC, 2019)

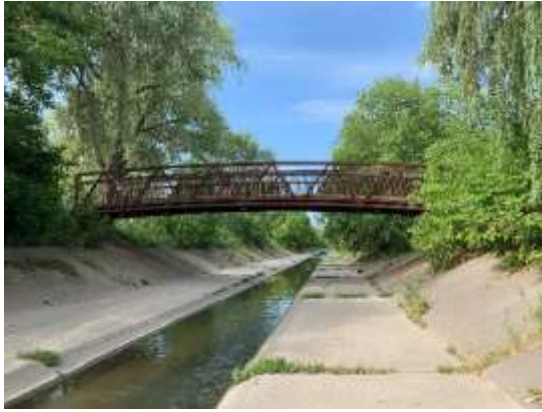
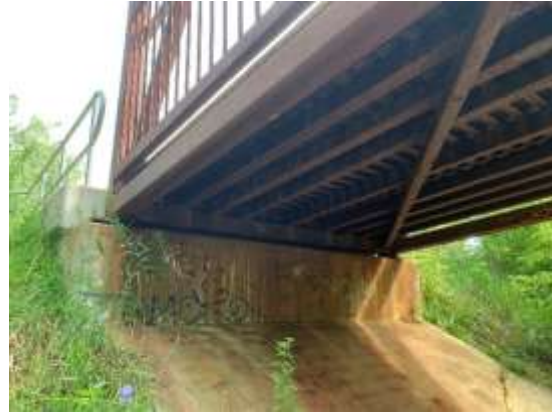
Bridge ID No. 30852 is also referred to as the Smythe Park Bridge (no. 3 of 3) and can be described as a steel half-through truss pedestrian bridge constructed in 2005. The bridge includes a 2-rail steel and wood railing system, steel box/trapezoidal floor beams with cast-in place concrete abutment walls and cast-in-place reinforced concrete wingwalls.

Figures 43 & 44: (left) View of west elevation, looking east from Black Creek Channel (right) View of north abutment, looking north from Black Creek Channel noting steel floor beams/stringer
(Source: MHBC, 2019)

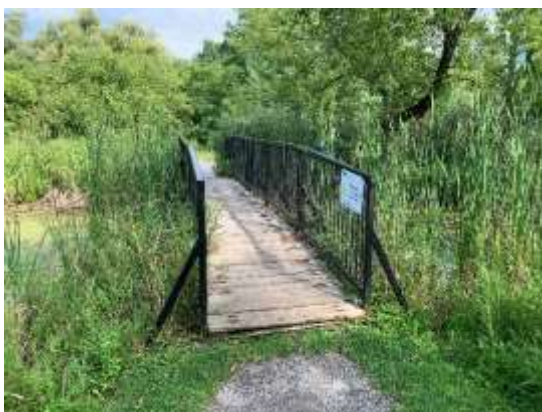
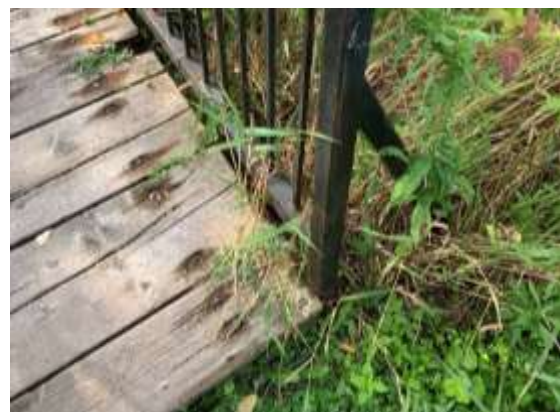
Bridge No. 308521 is also referred to as the Smythe Park Bridge (no. 1 of 3) and can be described as an I-Beam and Girder pedestrian bridge constructed in 2000. The bridge includes a wood plank deck top, steel post and panel railing system, Steel I-Type girders and steel floor beams below the deck. The bridge provides access over a pond south of Black Creek Trail, towards Edinborough Park to the south. The bridge is only visible to those travelling over it. The bridge is located within a densely treed area and its view is obstructed by vegetation surrounding the pond.

Figures 45 & 46: (left) View of bridge looking south from Black Creek Trail, (right) Detail view of wood plank bridge deck and steel railing system, (Source: MHBC, 2019)

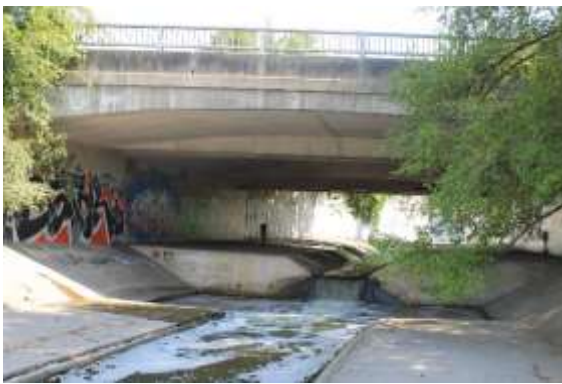
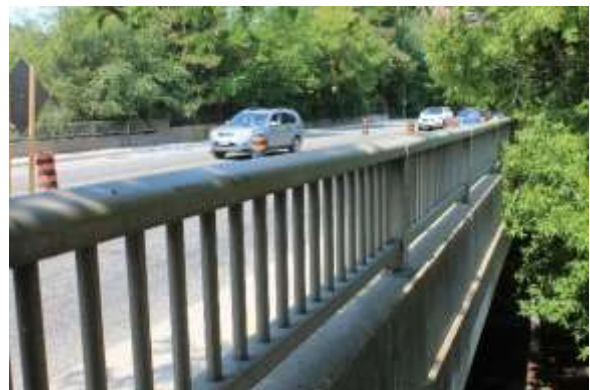
Bridge ID No. 360 is also referred to as the ‘Scarlett Road Bridge’ and provides access along Scarlett Road over the Black Creek Channel. The bridge is situated east of the Lambton Golf & Country Club and west of Smythe Park. The bridge can be described as a cast-in-place concrete Rigid Frame bridge with vertical legs constructed in 1983. The bridge includes cast-in-place concrete deck with asphalt deck top, cast-in-place concrete sidewalks and curbs and cast-in-place parapet walls with aluminium post and panel single railing system. Cast-in-place concrete abutments and reinforced concrete wingwalls are visible looking east and west along the Black Creek Channel.

Figures 47 & 48: (left) View of bridge looking east along Black Creek Channel noting west soffit and barrier exterior wall, (right) Detail view of east railing system and parapet wall, looking north towards Scarlett Road (Source: MHBC, 2019)
