Appendix H
Structural Conceptual Design Reports

CONCEPTUAL DESIGN REPORT

Jane Street Bridge

Structure No. 091

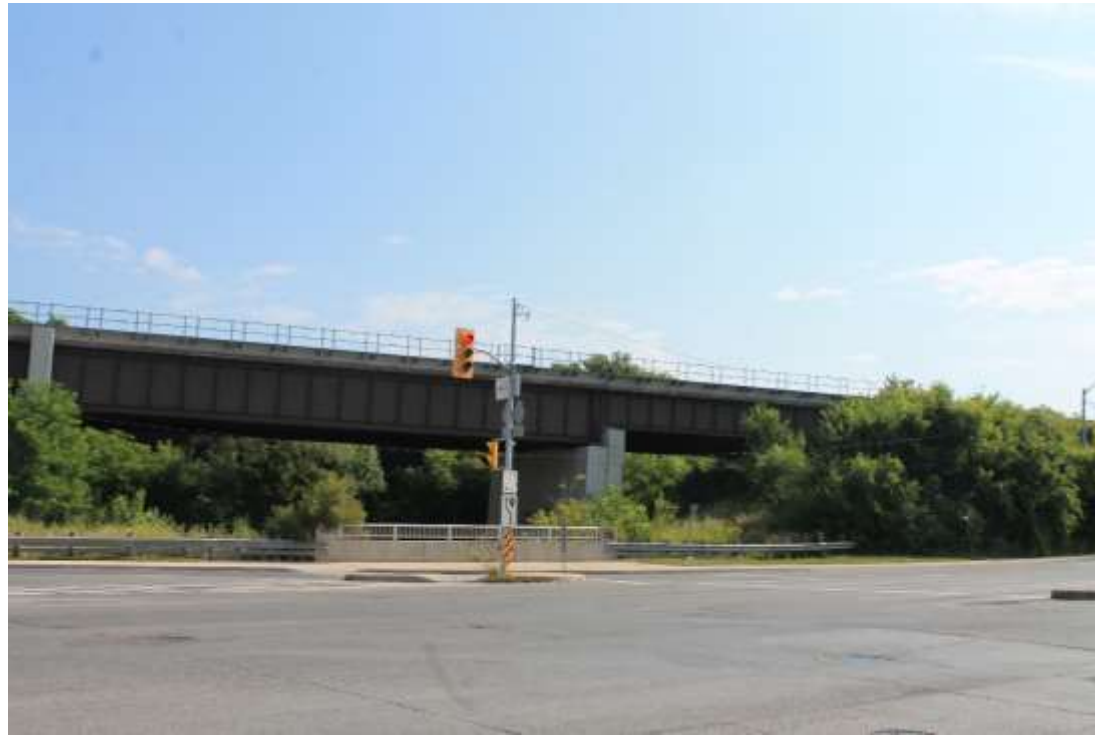
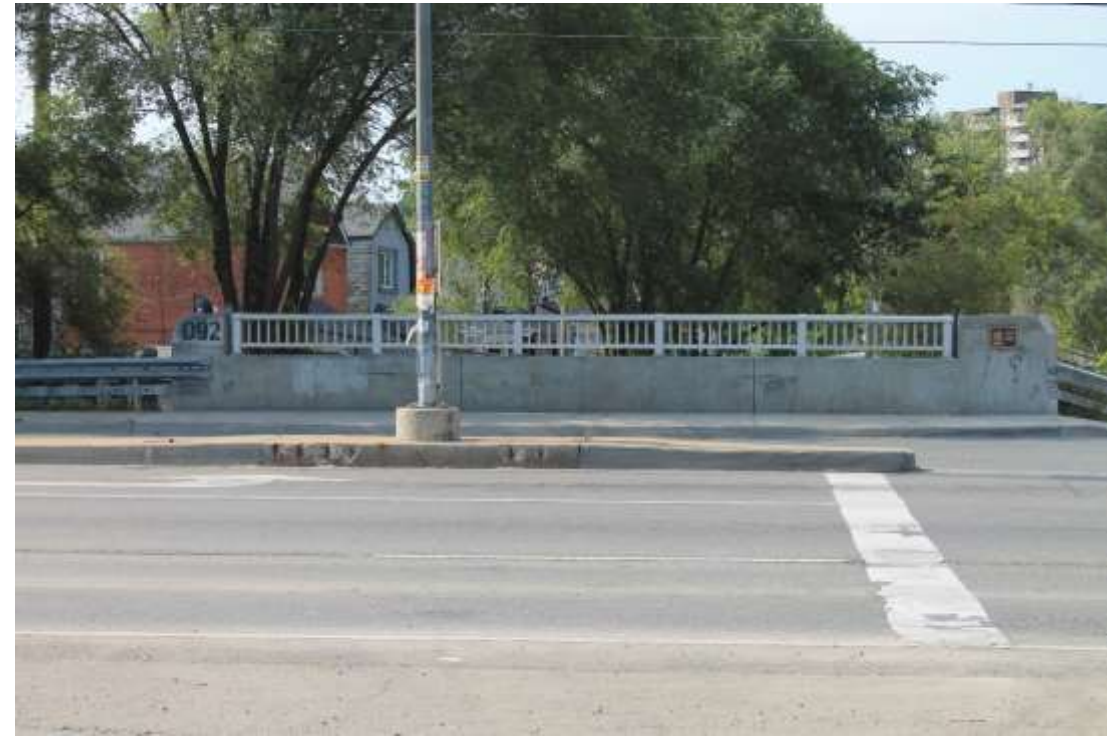
Figures 1 & 2: (left) View of Bridge ID no. 092 looking north-east from south-east corner of Humber Avenue and Weston Road , (right) View of Bridge ID no. 092 looking north from south-west corner of Humber Avenue and Weston Road (Source: MHBC, 2019)

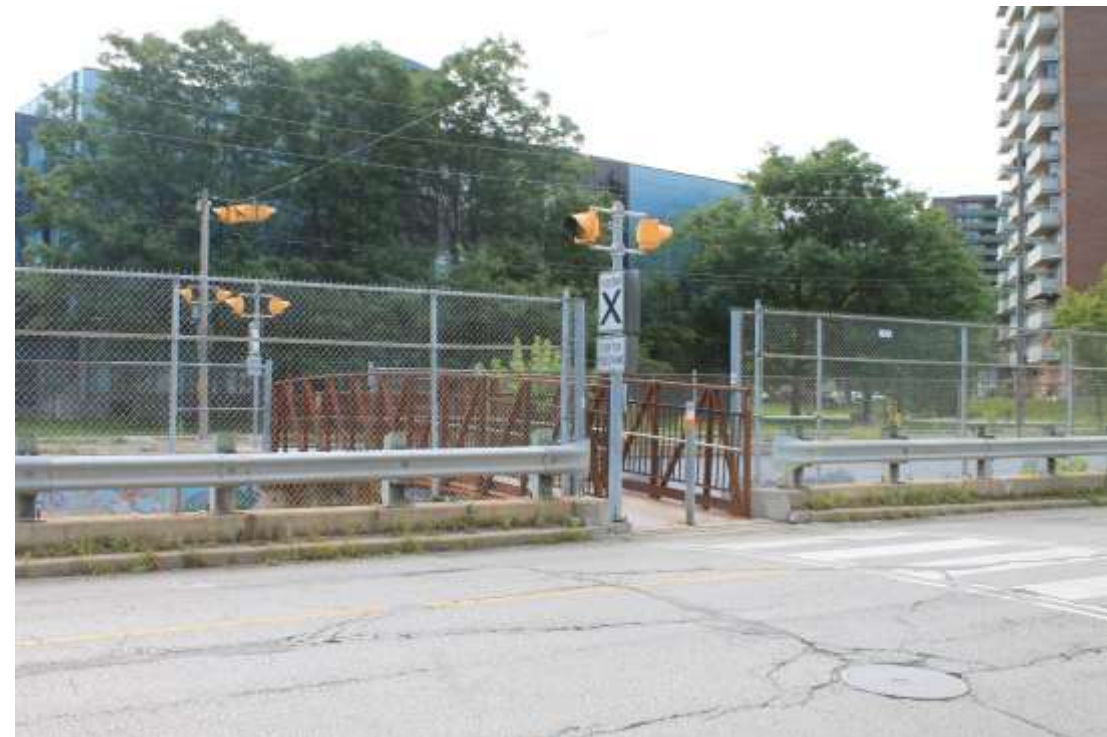
Figures 3 & 4: (left) View of Block Creek Channel looking south-west from south side of Bridge ID no. 092, (right) View of Bridge ID no. 705 looking west from south-east corner of Humber Boulevard and Louvain Street (Source: MHBC, 2019)

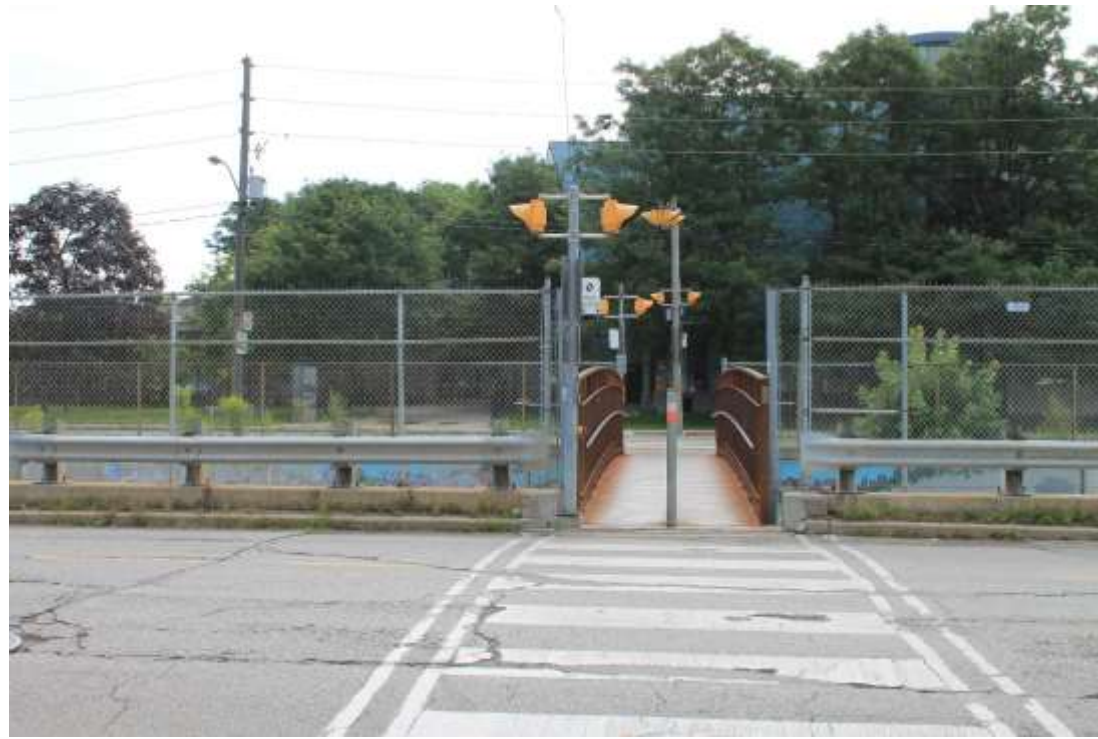
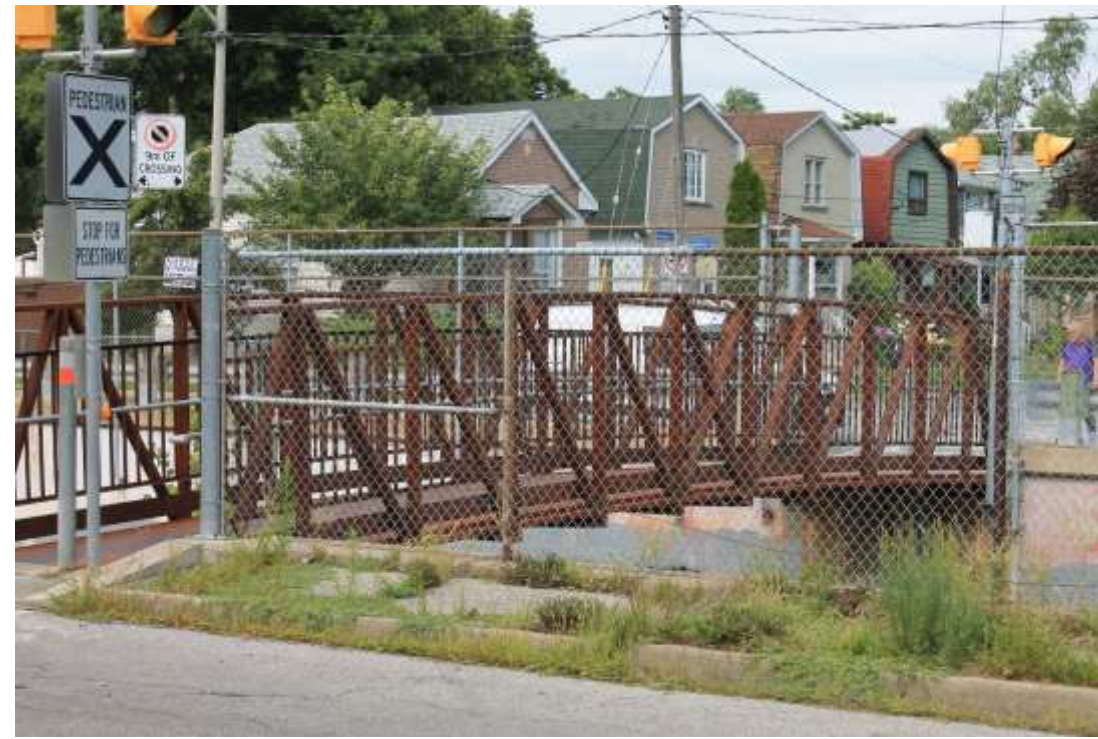
Figures 5 & 6: (left) View of Bridge ID no. 705 looking south-east from the north-west corner of Louvain Street and Humber Boulevard North, (right) View of Bridge ID no. 705 looking south-west from Humber Boulevard South (Source: MHBC, 2019)

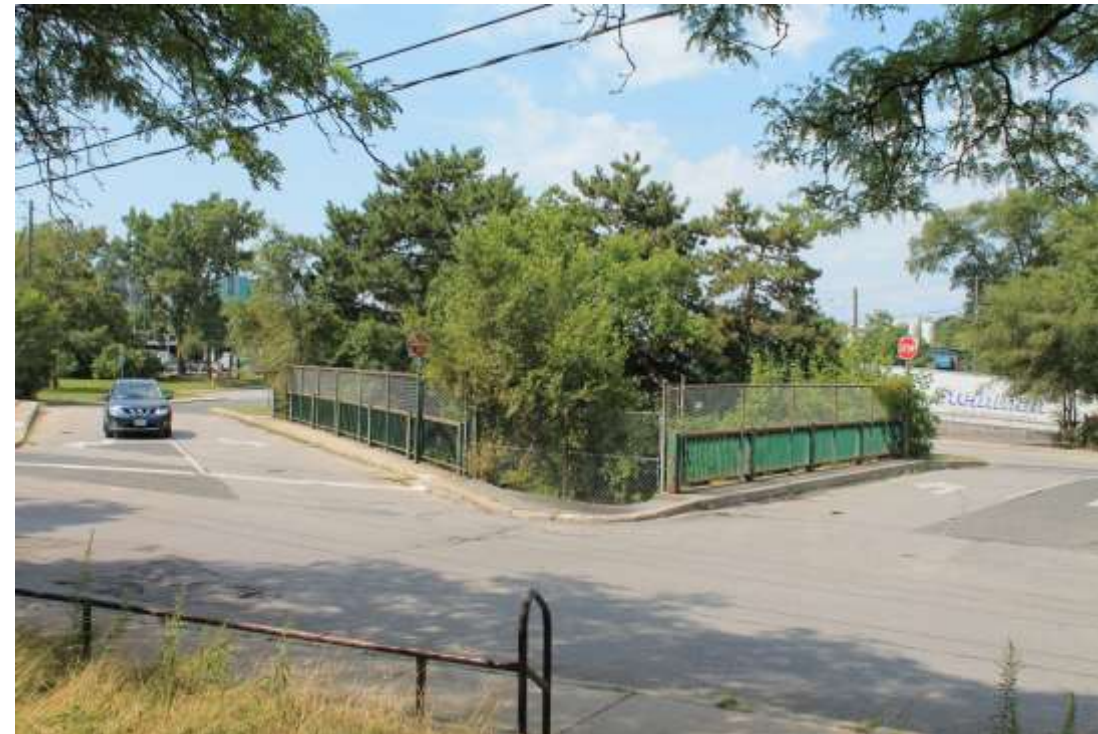
Figures 7 & 8: (left) View of Black Creek Channel looking south-west from Bridge ID no. 705, (right) View of Bridge ID no. 703 looking west from the intersection of Hilldale Road and Humber Boulevard South (Source: MHBC, 2019)

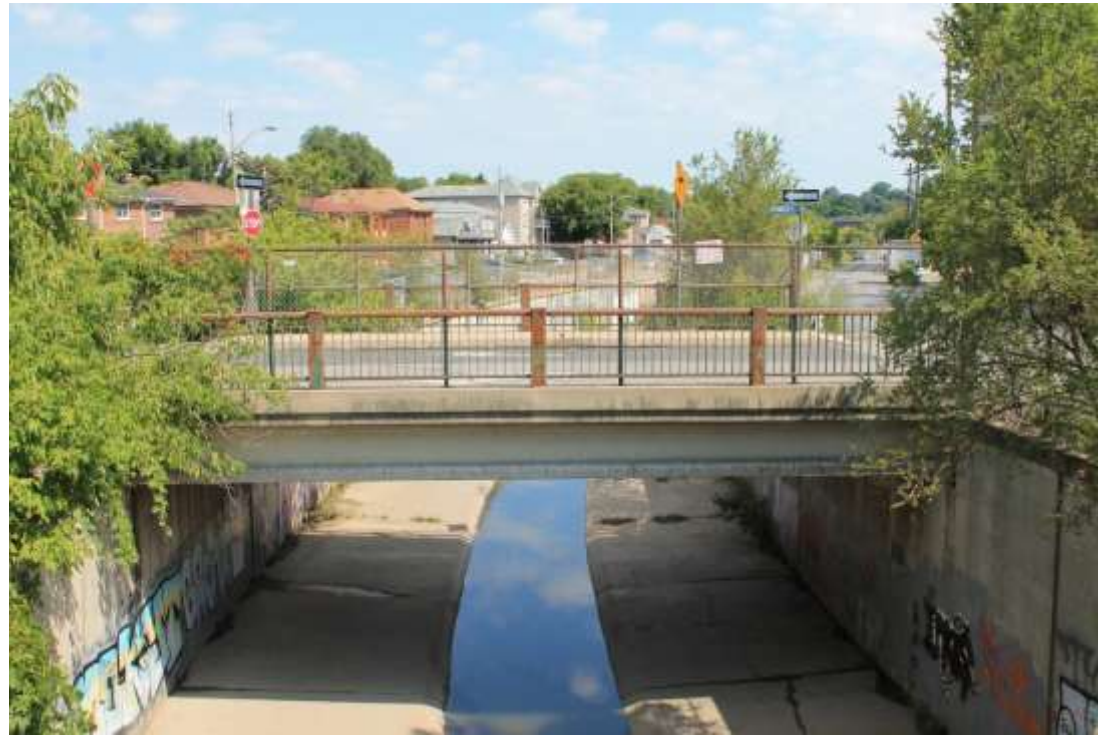
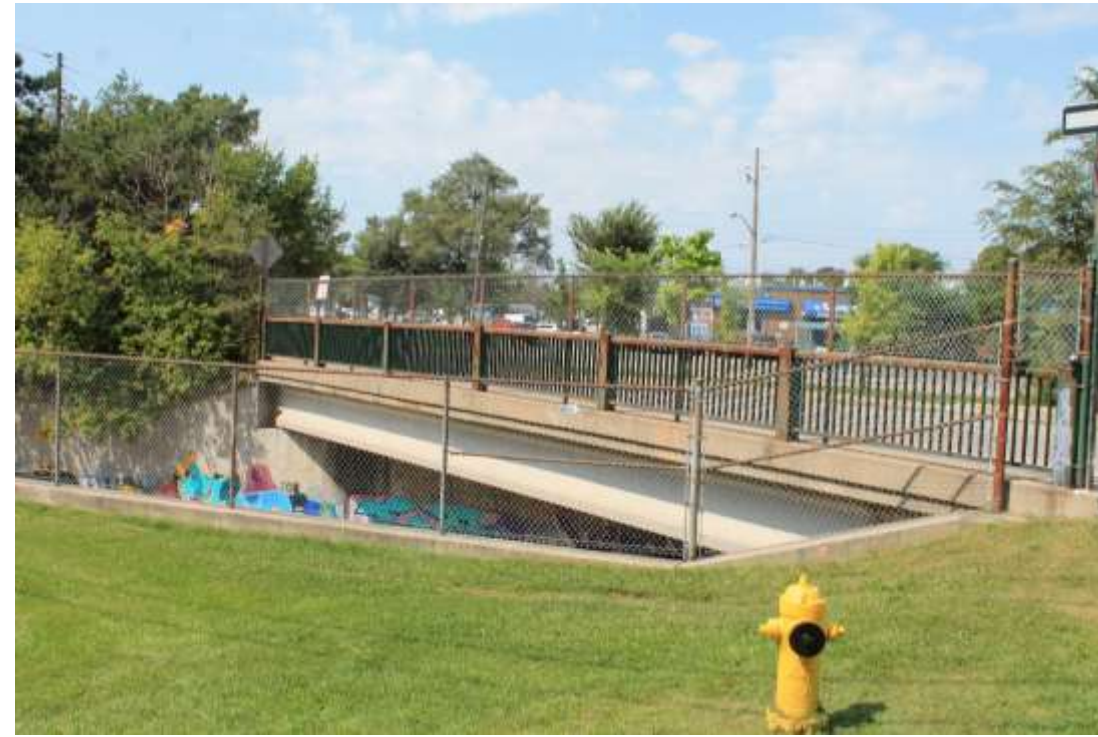
Figures 9 & 10: (left) View of Bridge ID no. 703 looking north from Alliance Avenue, (right) View of Bridge ID no. 704 looking north-west from the corner of Hilldale Road and Symes Road Park Trail/Pathway (Source: MHBC, 2019)

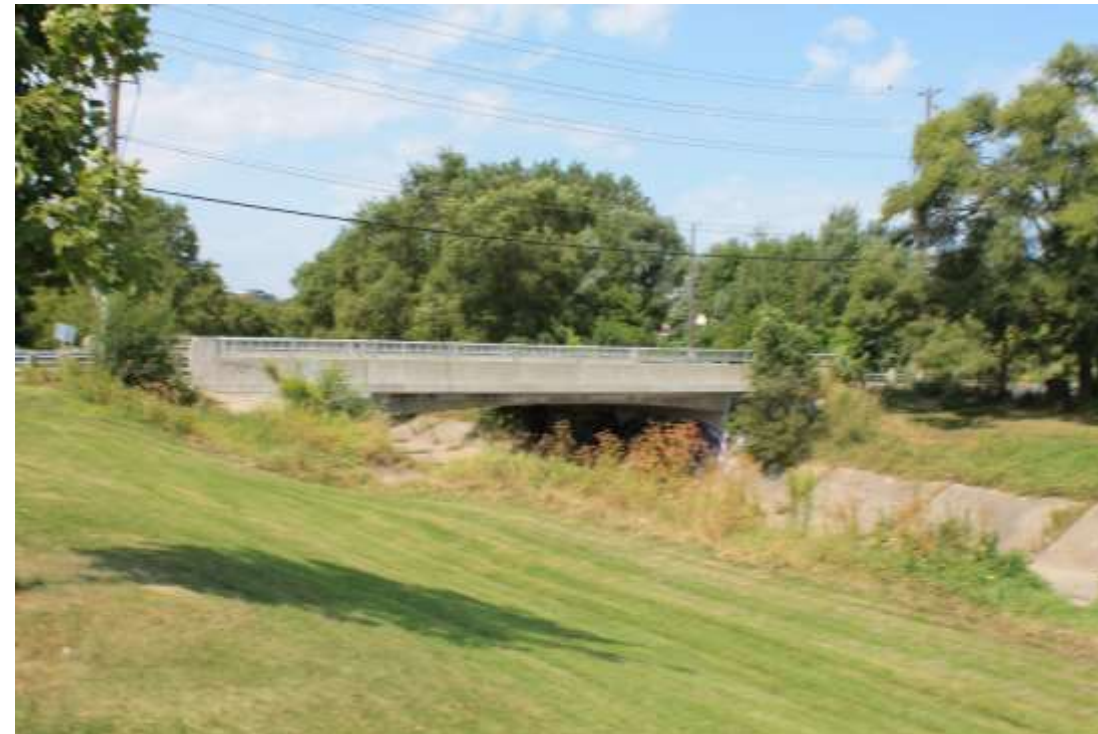
Figures 11 & 12: (left) View of Black Creek Channel looking east from Bridge ID no. 702, (right) View of Bridge ID no. 702 looking west from Rockcliffe Court (Source: MHBC, 2019)

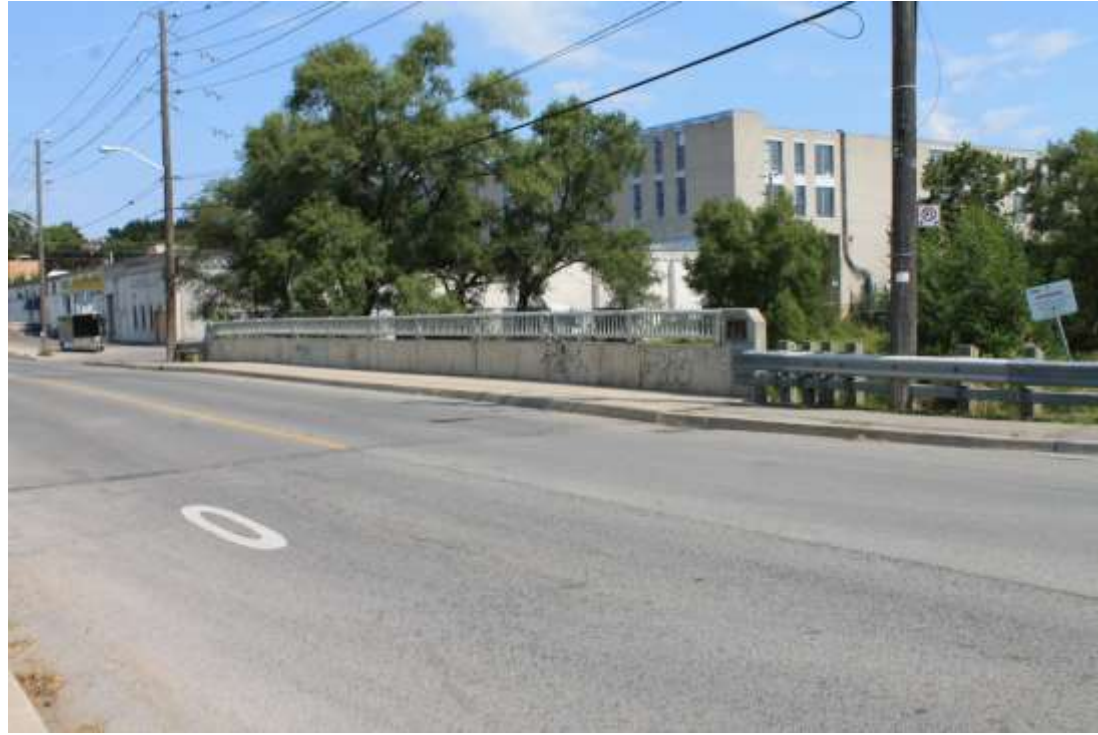
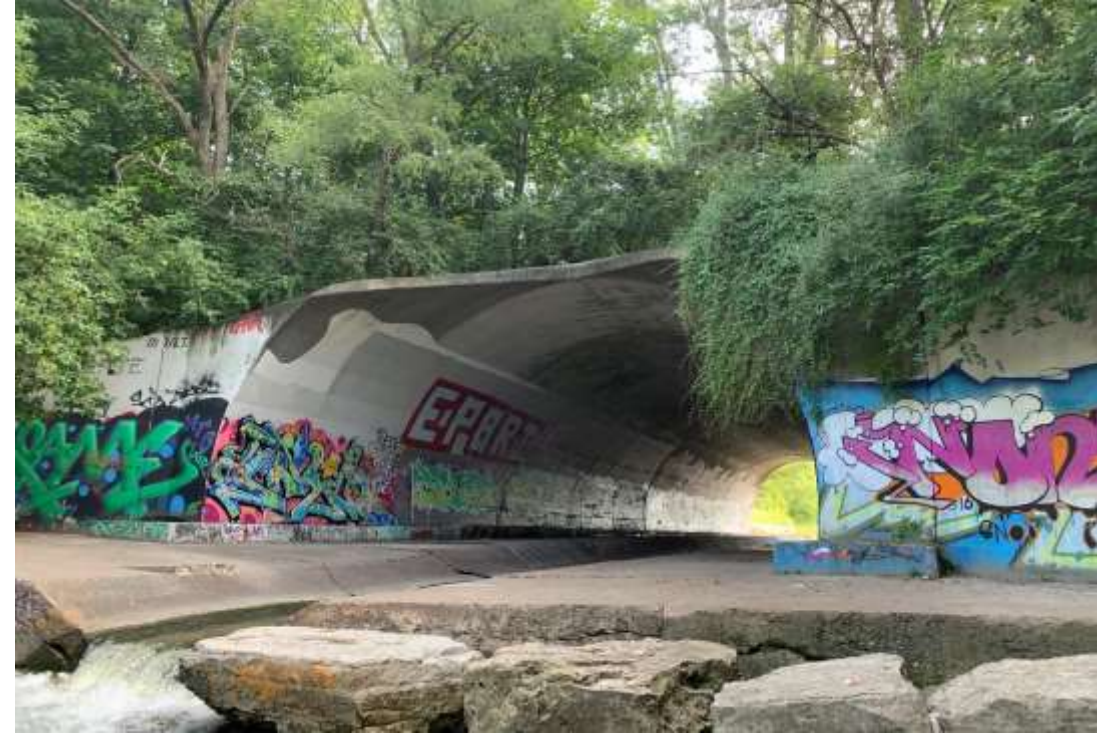
Figures 13 & 14: (left) View of Bridge ID no. 702 looking North from the corner of Rockcliffe Boulevard and Black Creek Trail, (right) View of Culvert ID no. 091 looking north-east from the Black Creek Channel (Source: MHBC, 2019)

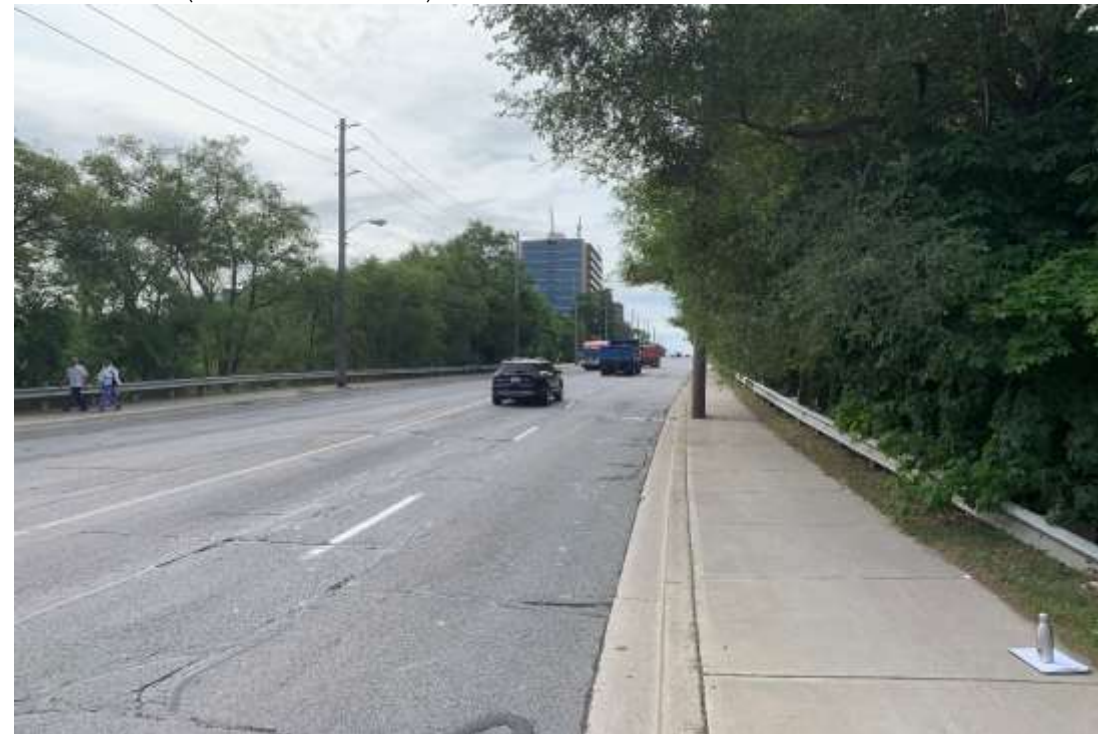
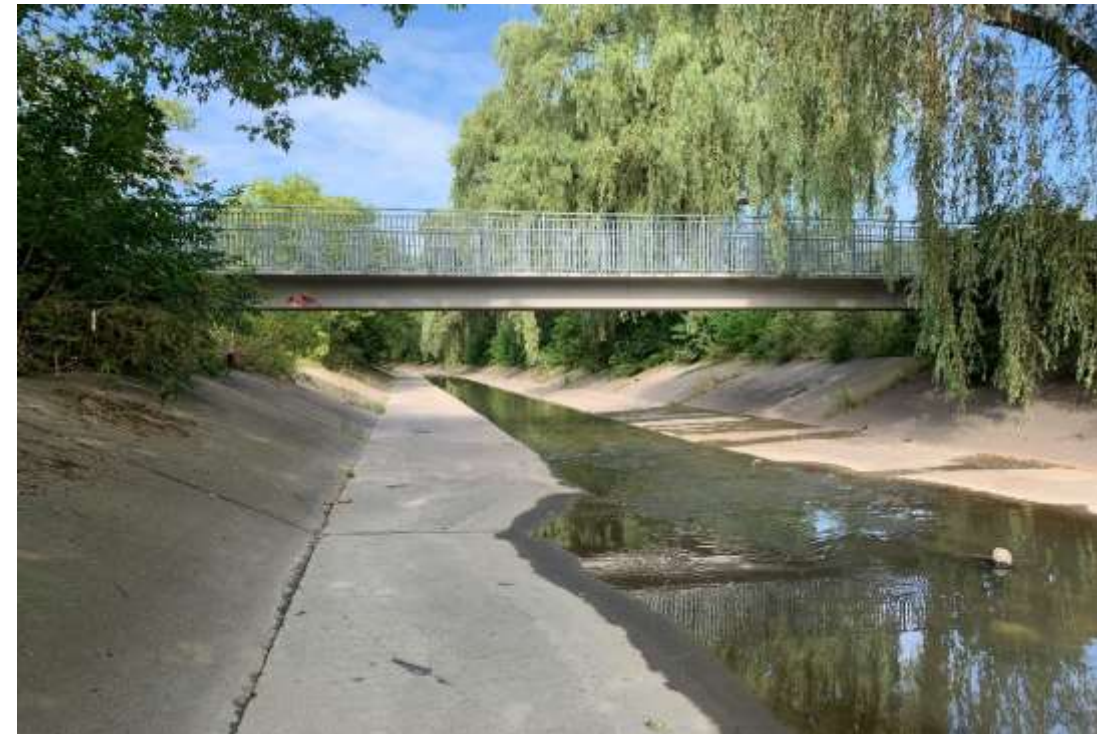
Figures 15 & 16: (left) View of Bridge ID no. 091 looking North down Jane Street, (right) View of Bridge ID no. 308523 looking east from the Black Creek Channel (Source: MHBC, 2019)

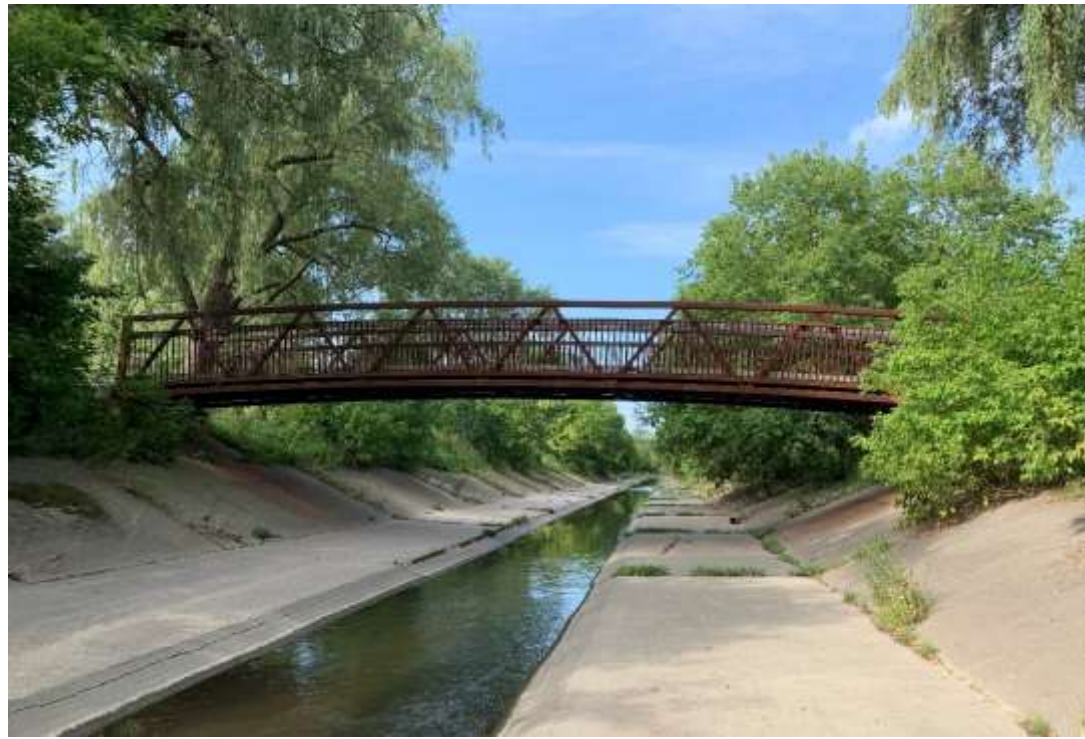
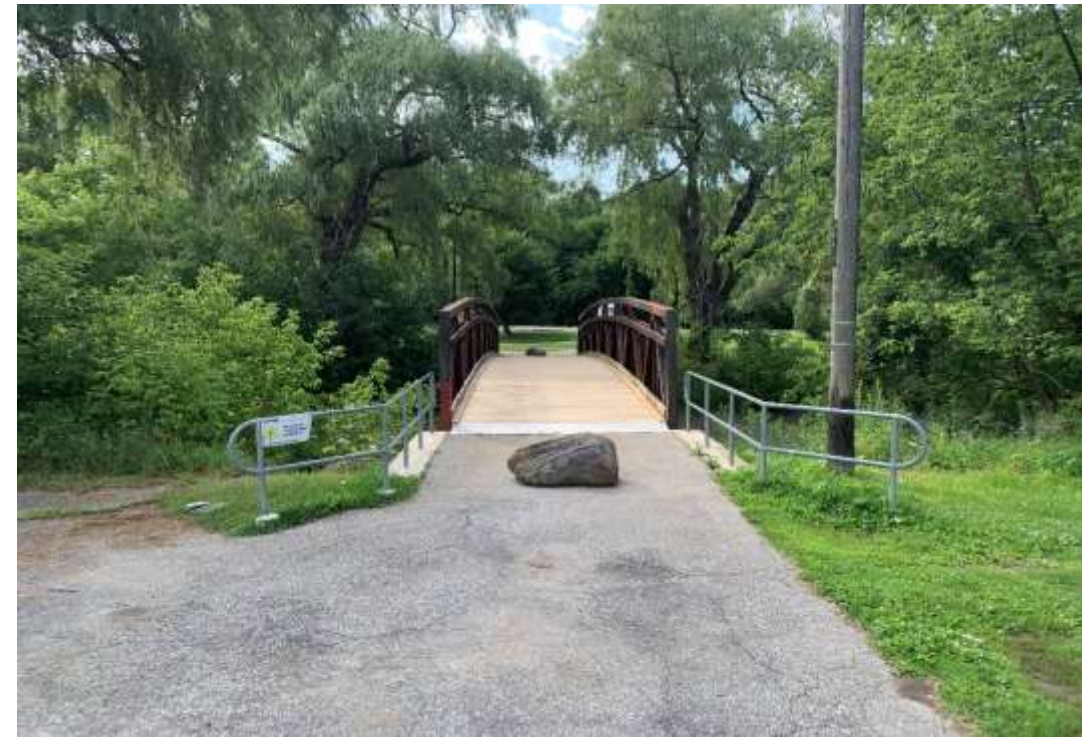
Figures 17 & 18: (left) View of Bridge ID no. 308522 looking south-west from Black Creek Channel, (right) View of Bridge ID no. 208522 looking south from Smythe Park (Source: MHBC, 2019)

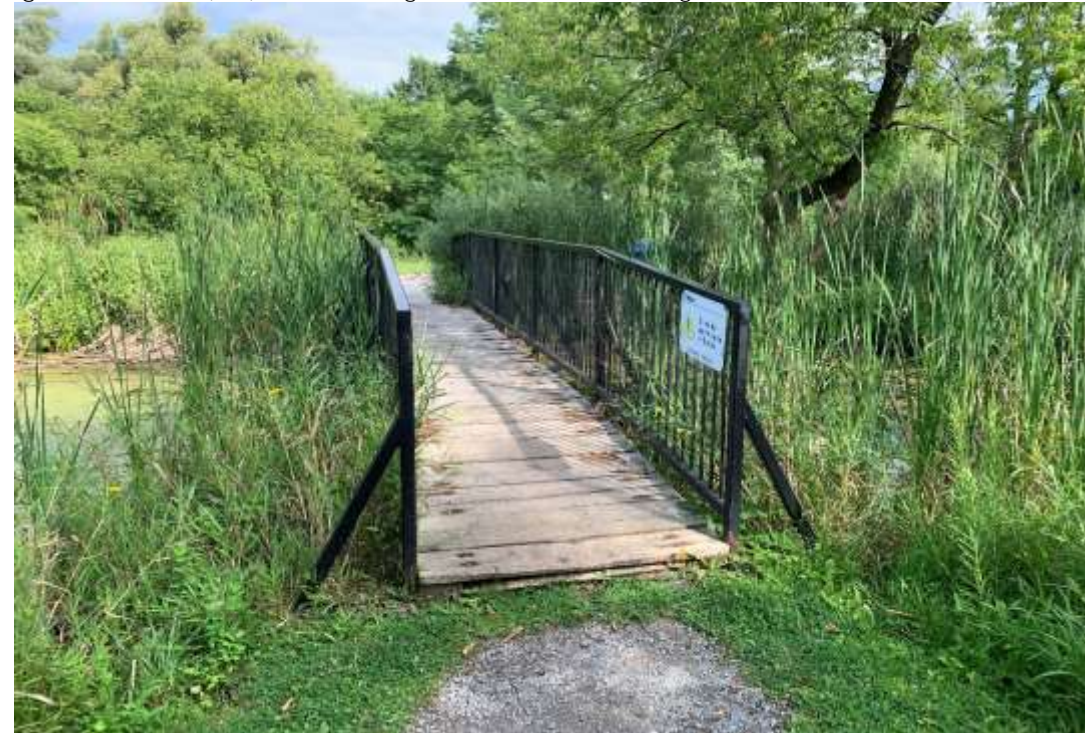
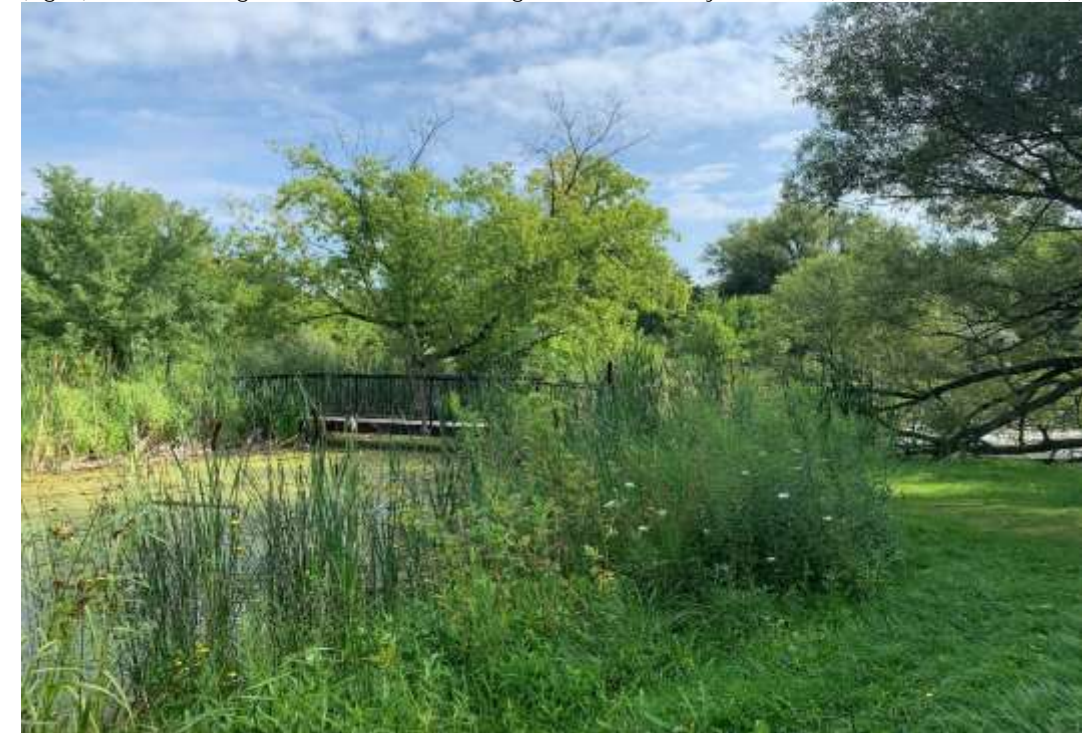
Figures 19 & 20: (left) View of Bridge ID no. 308521 looking north towards Black Creek Trail, (right) View of Bridge ID no. 308521 looking south-west from Black Creek Trail (Source: MHBC, 2019)

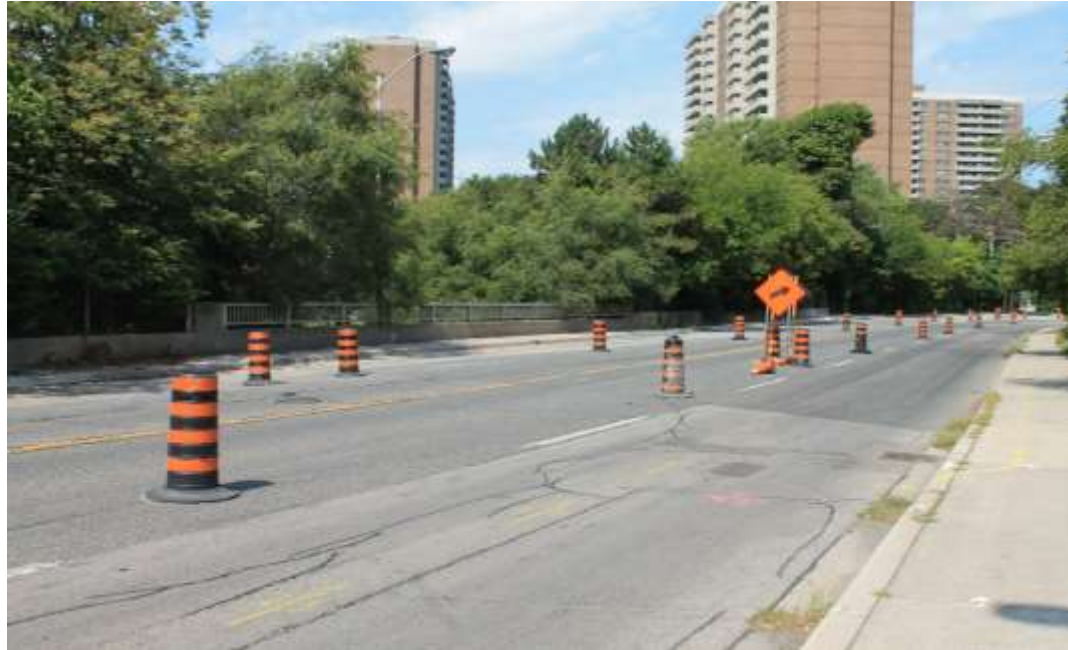
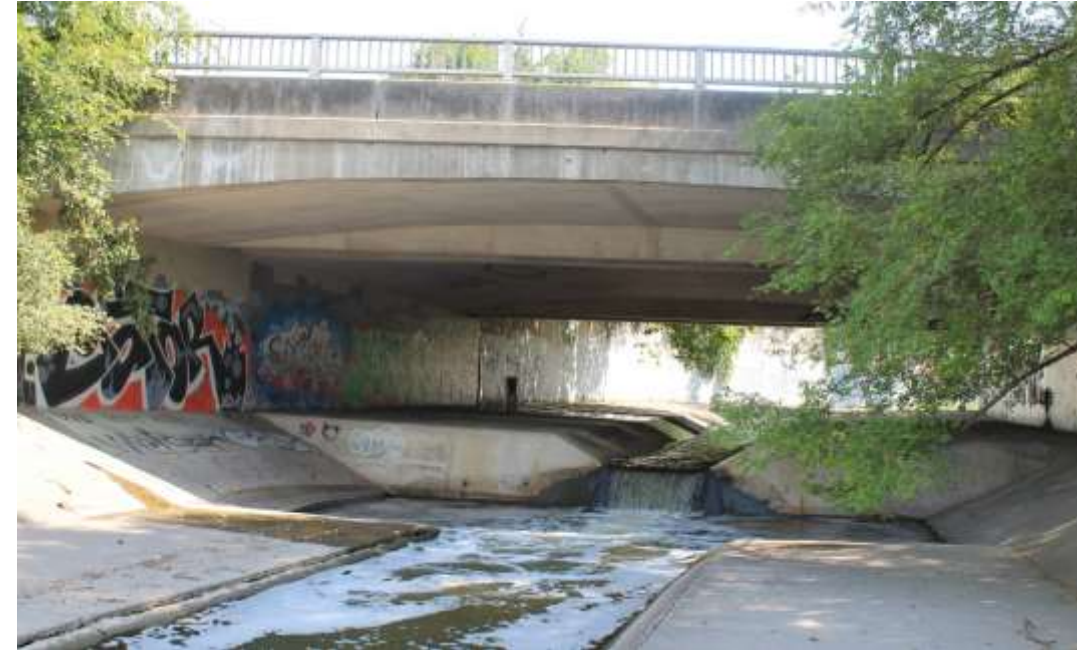
Figures 21 & 22: (left) View of Bridge ID no. 360 looking north-west from Scarlett Road, (right) View of Bridge ID no. 360 and Black Creek Channel looking north-east from Lambton Golf and Country Club (Source: MHBC, 2019)

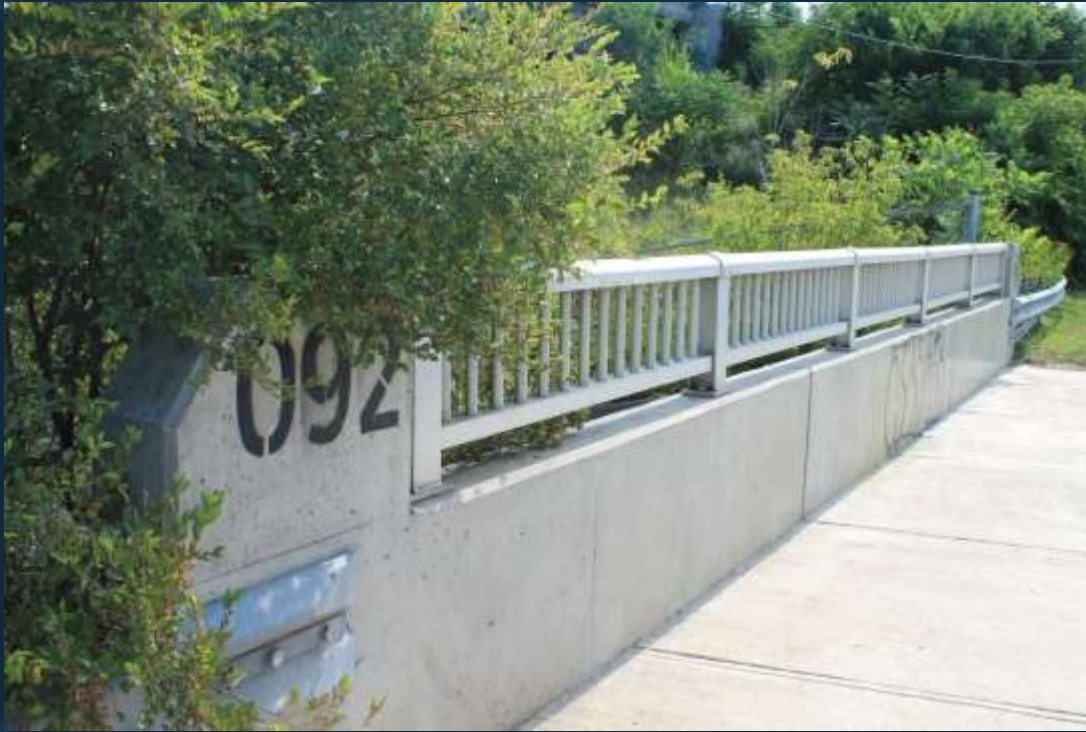
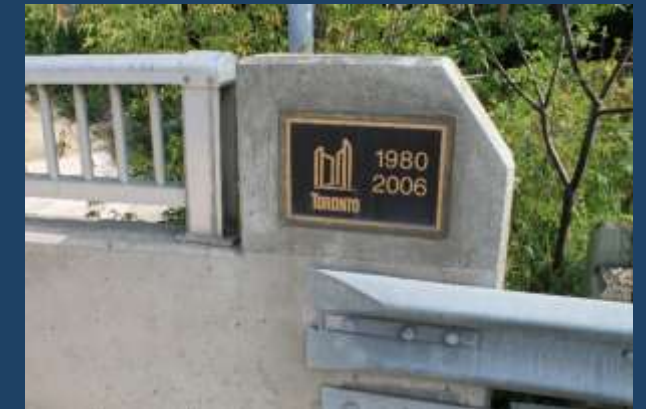
BRIDGE: Road/Vehicular (Rigid Frame, Vertical Legs)

1980 (Repairs in 2006: new Parapet walls, railing system, sidewalk, median)

- Parapet wall with single railing (aluminum post and panels)
- Cast-in-place concrete barriers and abutments, reinforced concrete retaining walls
- Cast-in-place concrete deck, Asphalt deck top
- City of Toronto Plaque '1980, 2006' (original construction date and repairs)

No. While Bridge ID 092 is functionally related to its surroundings as it serves as a crossing along Weston Road over the Black Creek Channel, it is not significant in its functional relationship to the environment. The bridge could be replaced with another of its kind and would not result in impacts to any physical, functional, visual or historical relationships.

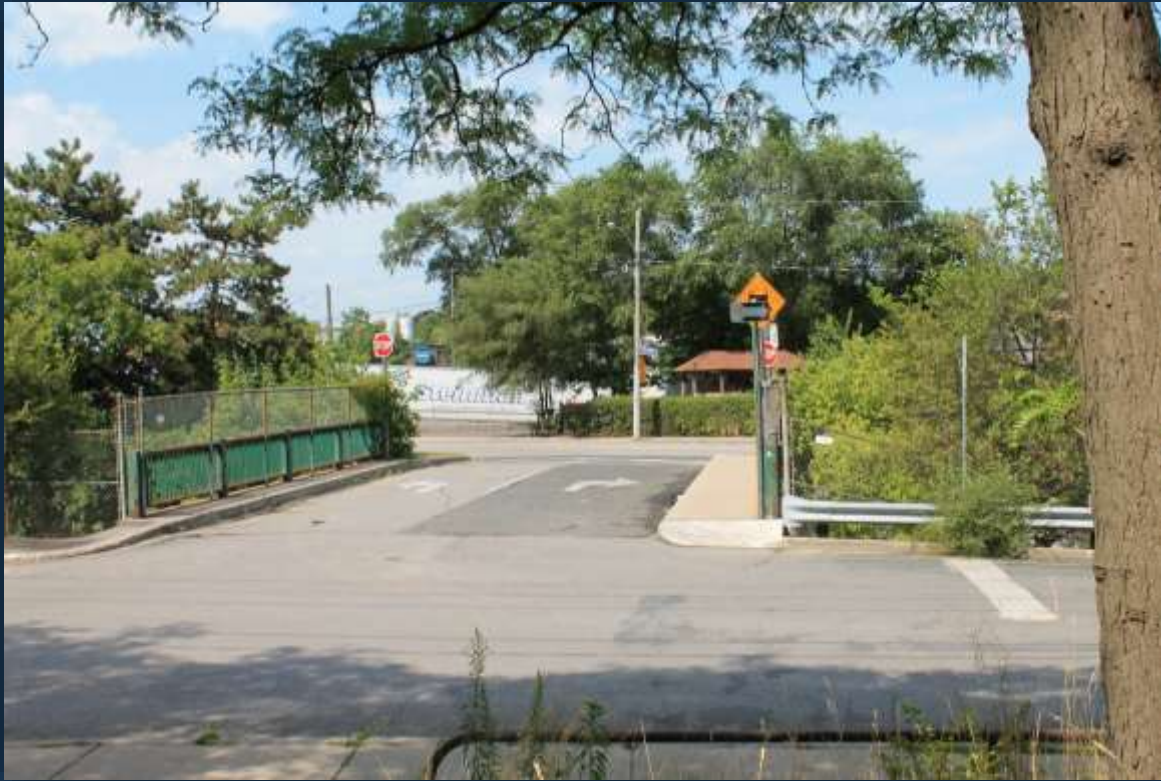
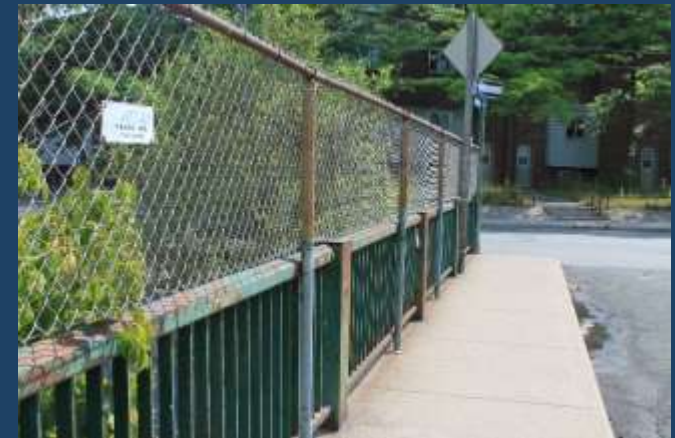
ID 703

BRIDGE: Road/Vehicular (I-Beam/Girder)

- Cast-in-place concrete and asphalt deck
- Cast-in-place concrete sidewalk and median
- Galvanized steel post and panel railing
- Precast concrete girders (below deck)
- Cast-in-place concrete abutments and reinforced concrete retaining walls

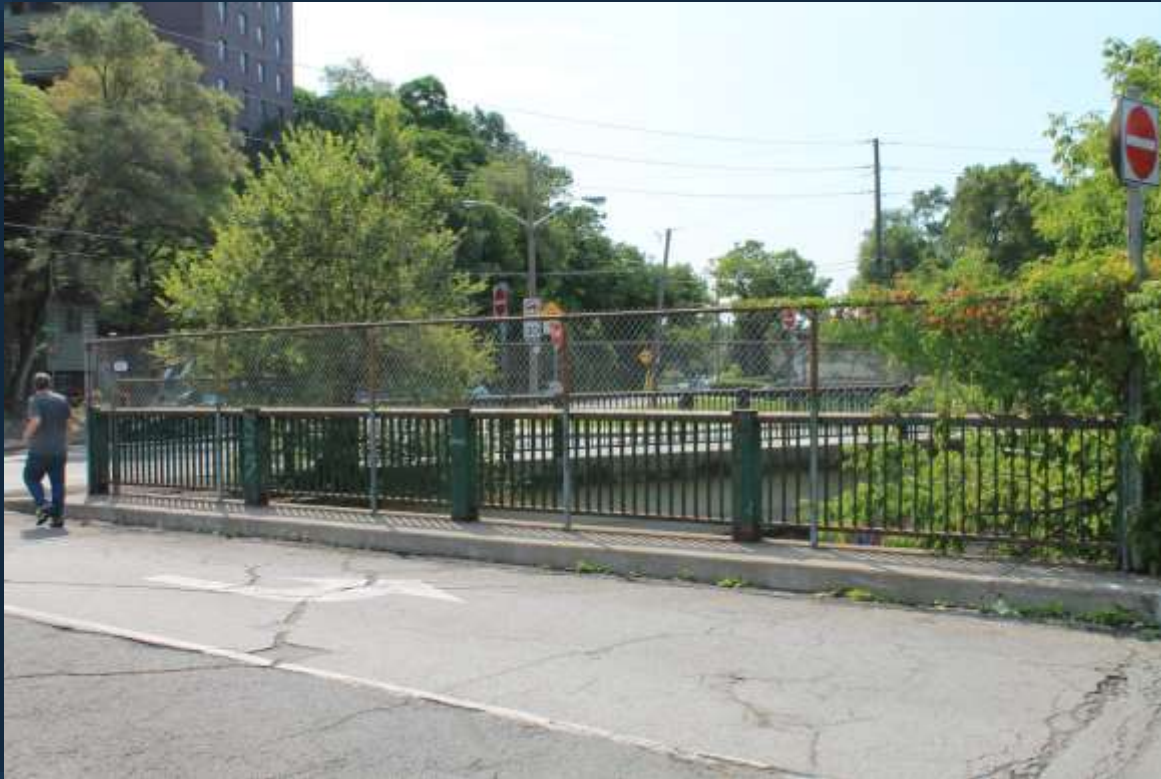
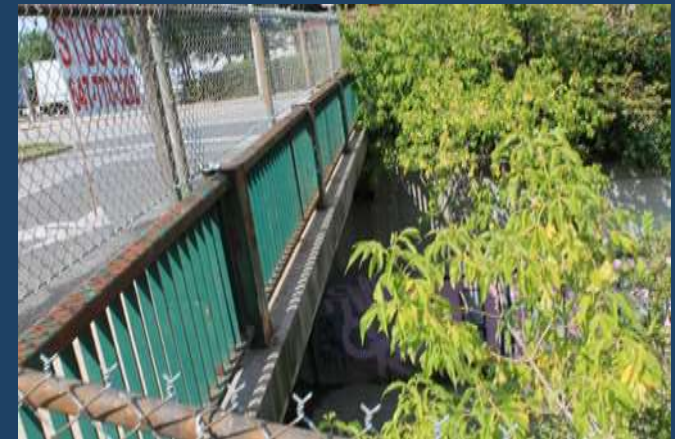
ID 704

Type. BRIDGE: Road/Vehicular (I-Beam, Girder)
Construction Date. 1975
Location. Near intersection of Humber Blvd N., Alliance Ave, Hilldale Road

- Cast-in-place concrete and asphalt deck;
- Cast-in-place concrete sidewalk and median;
- Galvanized steel post and panel railing;
- Precast concrete girders (below deck);
- Cast-in-place concrete abutments and reinforced concrete retaining walls;

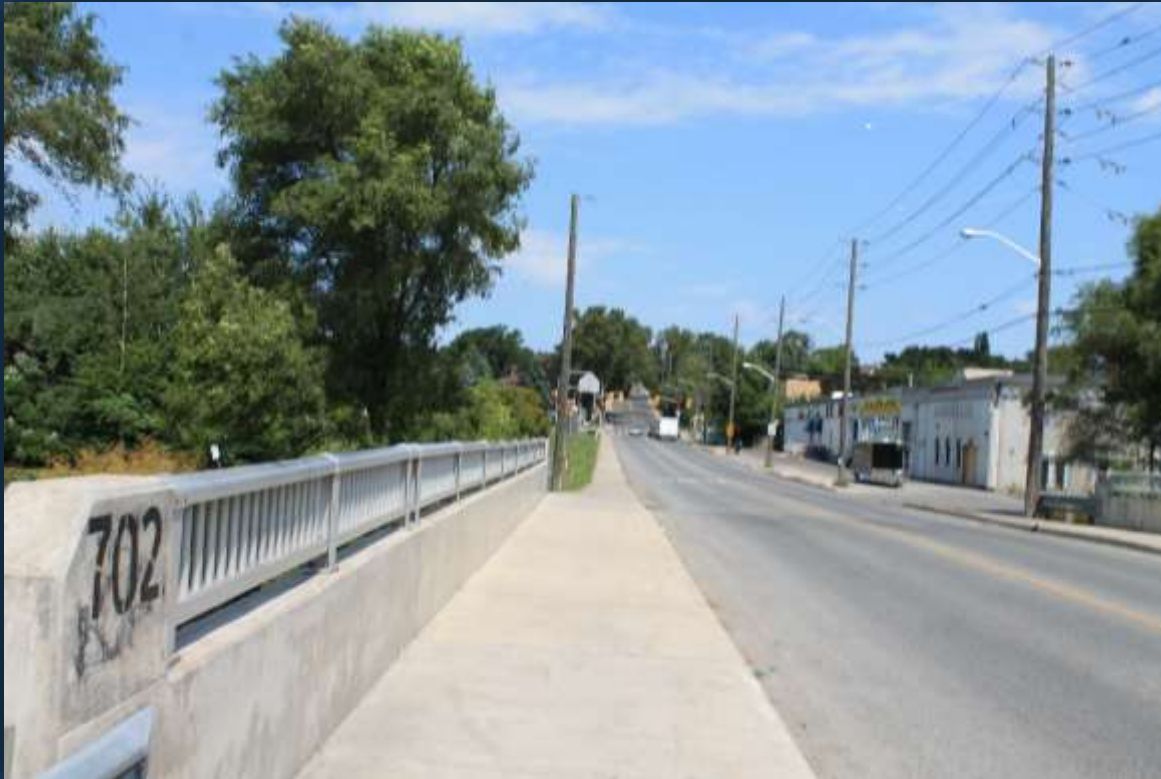
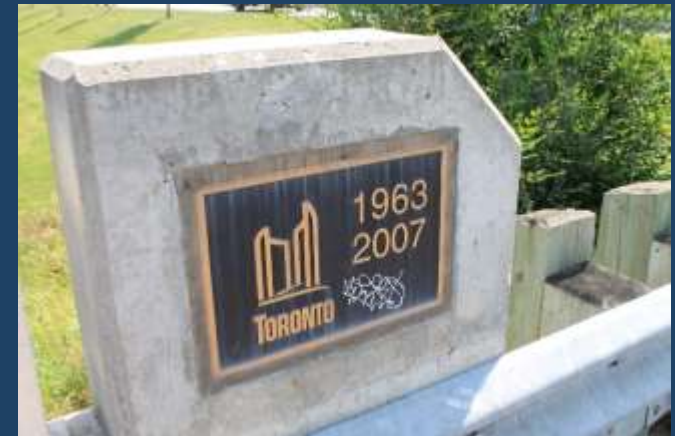
ID 702

BRIDGE: Road/Vehicular (Rigid Frame, Vertical Legs)

1963 (Widened, Repairs to Abutments and Wingwalls, Parapet walls replaced in 2007)

- Cast-in-place concrete and asphalt deck;
- Cast-in-place concrete sidewalk/median/curb
- Cast-in-place concrete barrier and parapet walls with single railing system (aluminum post and panel);
- Cast-in-place abutments
- Toronto Plaque (1963, 2007)

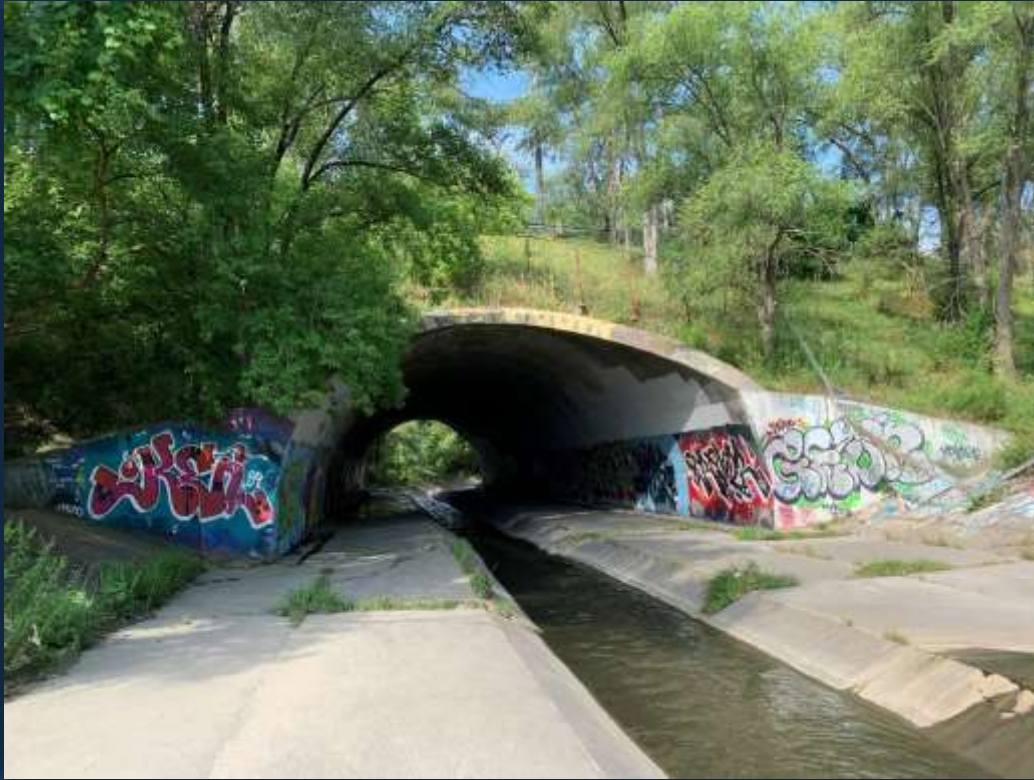
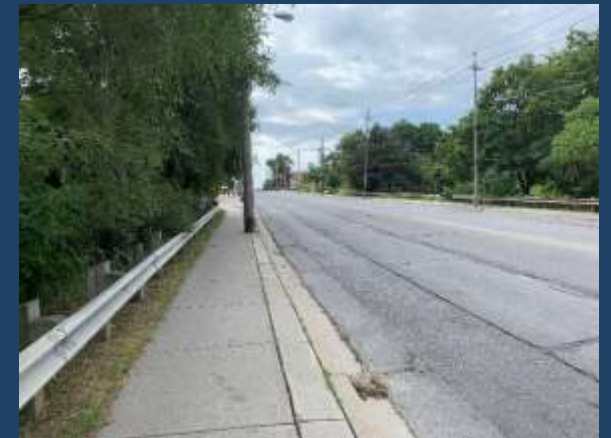
Type. Culvert (Barrel Arch Culvert)
Construction Date. 1948 (1964 Barrel extended at both ends)
Location. Jane Street over Black Creek

- Cast-in-place concrete and asphalt deck
- Cast-in-place concrete sidewalk/curb/median
- Steel flex beam on wood post railing system
- Wood barriers (posts)
- Galvanized steel hand railing
- Cast-in-place concrete culvert (inlet and outlet components at headwall and wingwalls)
- Cast-in-place concrete barrel (arch);

No. While Culvert ID 091 is functionally related to its surroundings as it improves the flow of water of the Black Creek Channel and provides a crossing along Jane Street, it is not significant in its functional relationship to the environment. The bridge could be replaced with another of its kind and would not result in impacts to any physical, functional, visual or historical relationships.
- iii. Is a landmark
