Appendix H
Structural Conceptual Design Reports

CONCEPTUAL DESIGN REPORT

Jane Street Bridge

Structure No. 091

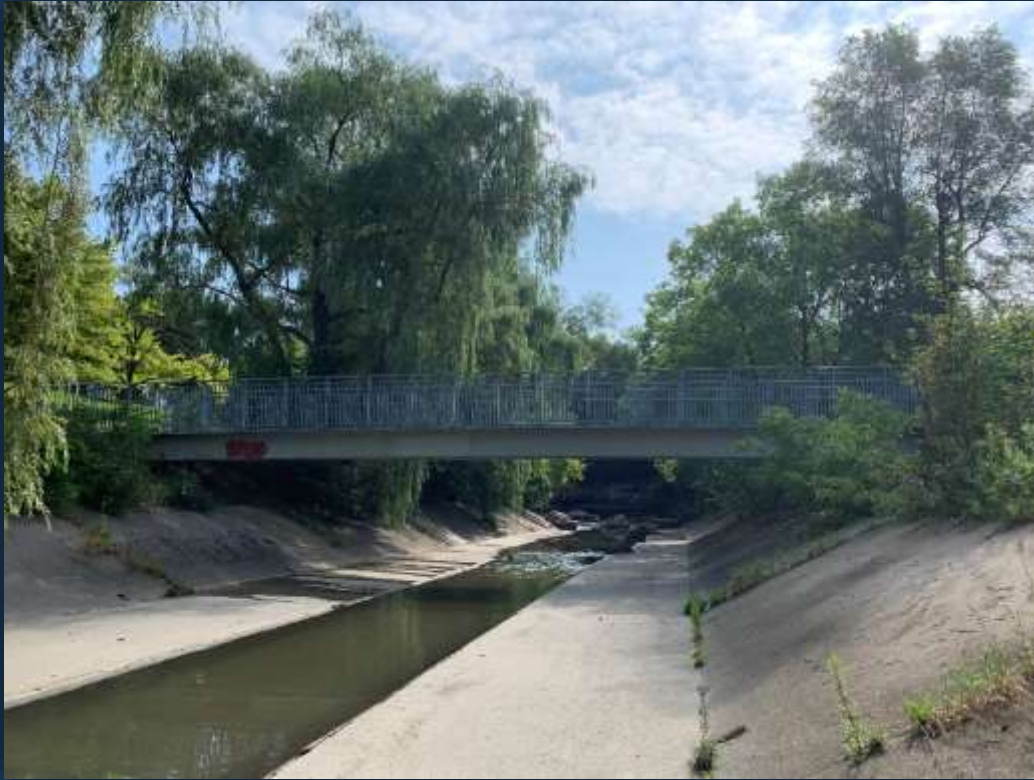
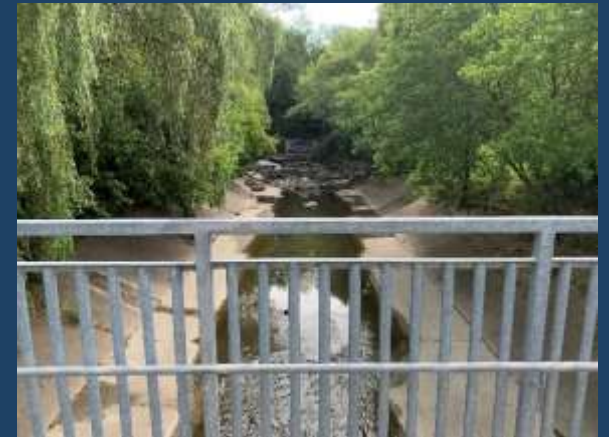
ID 308523

Type. BRIDGE: Pedestrian (T-Beams/Girder)
Construction Date. 1980
Location. Smythe Park over Black Creek
Cultural Heritage Evaluation
O-Reg 9/06 Summary.   Not Significant

- Precast concrete deck top;
- Steel post and panel railing system;
- Precast concrete girders (T-type);
- Cast-in-place concrete abutments and ballast walls;
- Cast-in-place reinforced concrete retaining walls;

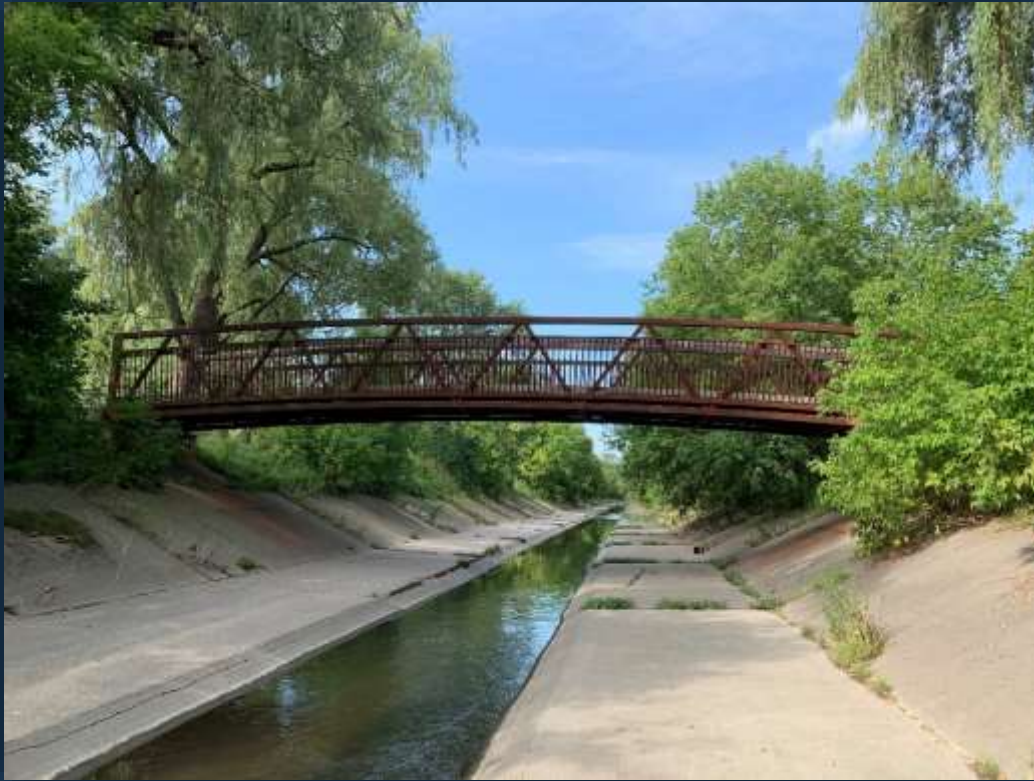
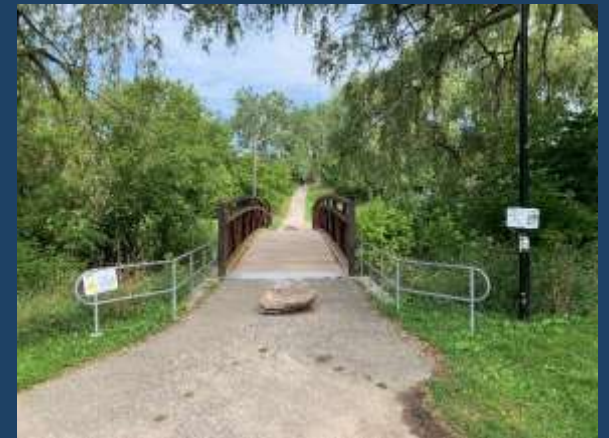
ID 308522

Type. BRIDGE: Pedestrian (Half-Through Truss)

Construction Date. 2005

- Steel joints (armoring/retaining devices)
- 2-Rail steel and wood railing system
- Steel box/trapezoidal floor beams
- Cast-in-place concrete abutment walls
- Cast-in-place reinforced concrete wingwalls

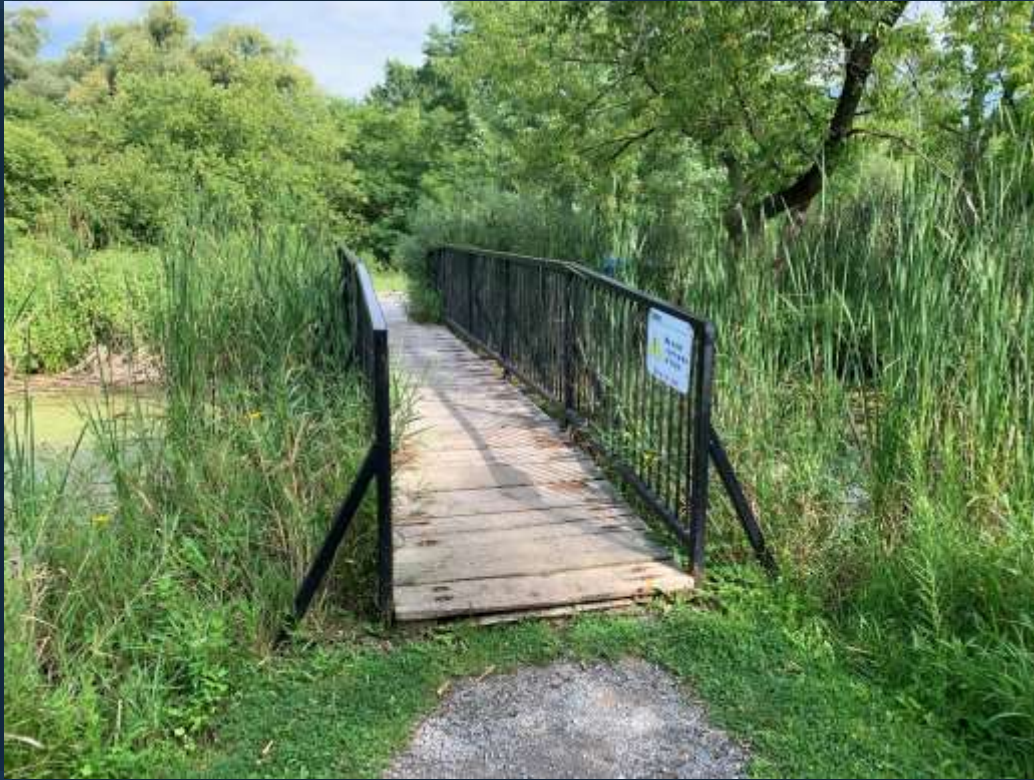
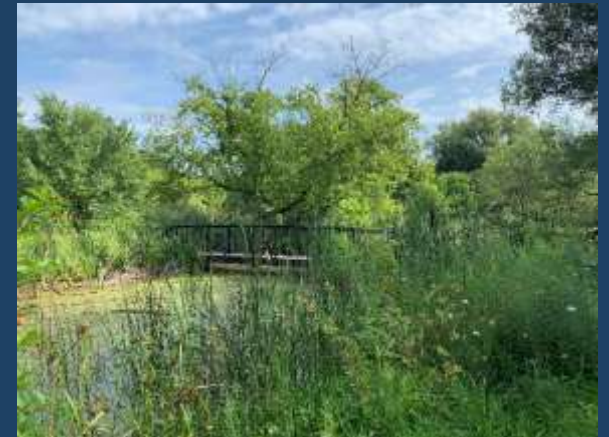
ID 308521

Type. BRIDGE: Pedestrian (I-Beams/Girder)
Construction Date. 2000
Location. Smythe Park
Cultural Heritage Evaluation
O-Reg 9/06 Summary.

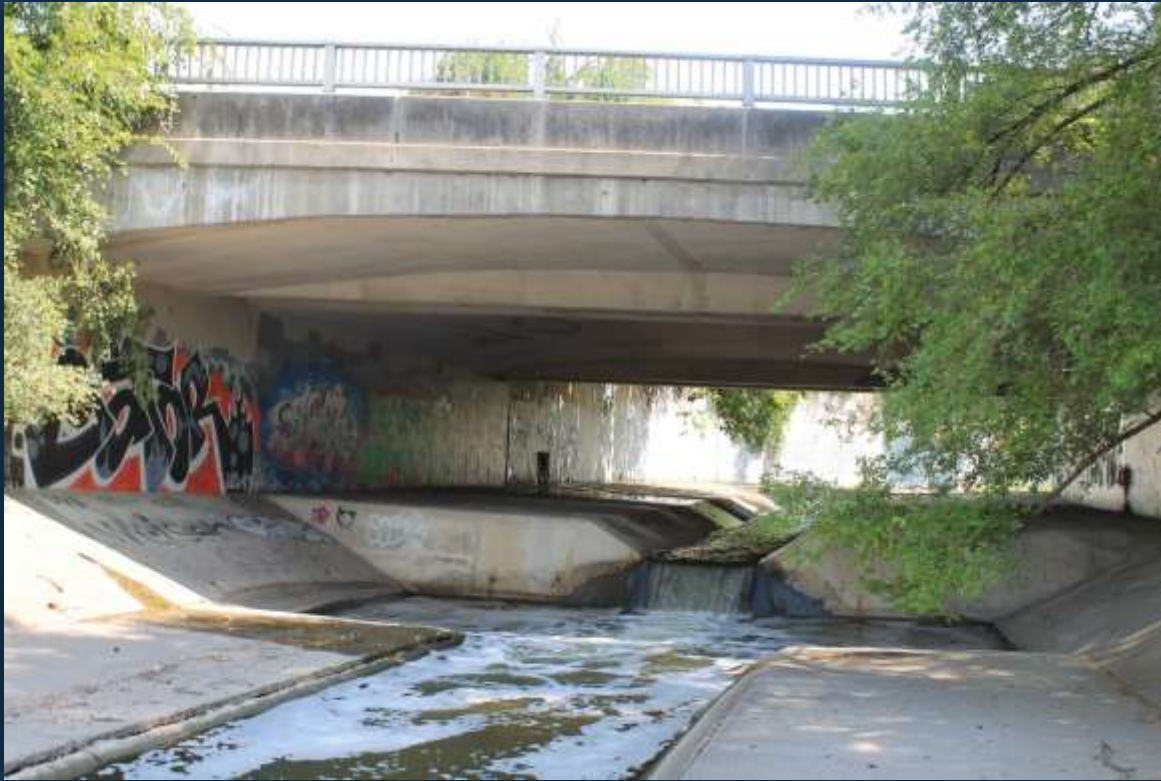
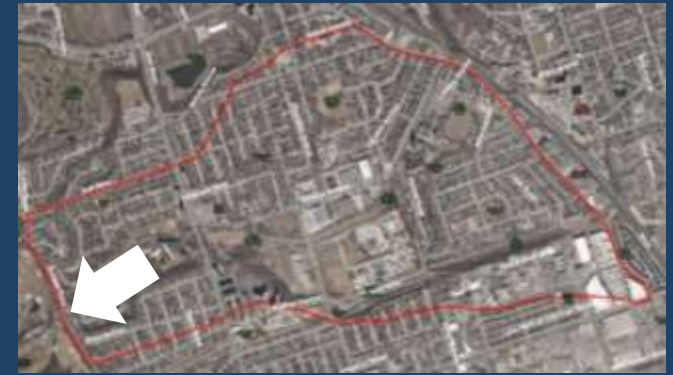
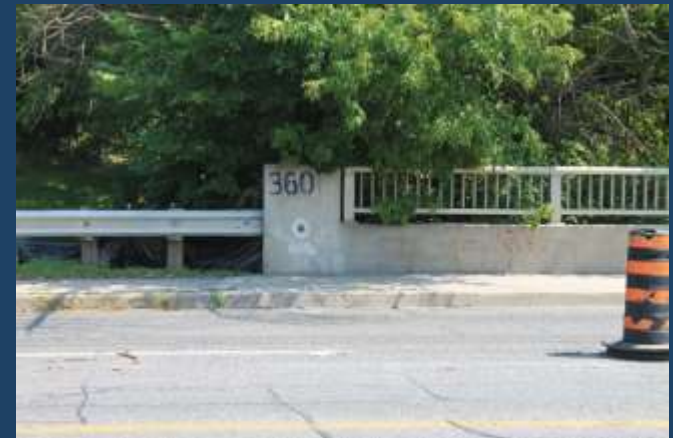
ID 360

Type. BRIDGE: Road/Vehicular (Rigid Frame, Vertical Legs)

Construction Date. 1983

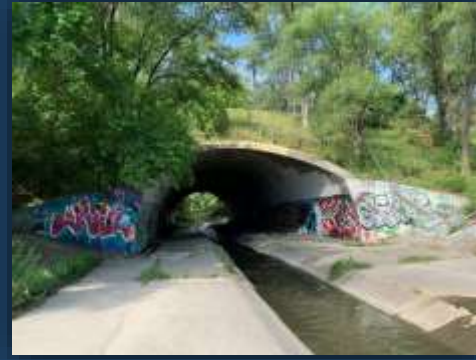
ID 091

No. The only portions of concrete which are visible from Jane Street includes its asphalt deck and aluminum barriers, which are typical of any road. The arch of the culvert is only visible to those walking along the base of the Channel, which is not part of the public realm.

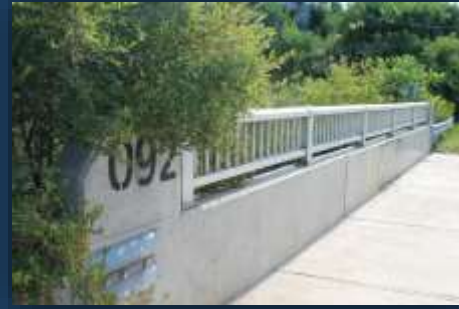
No. Cast-in-place concrete bridges are not considered rare, or unique in Ontario. ID 705 is not a prototype, or exemplary of its type. Does not display a high degree of technical merit or scientific achievement. Does not signify a progressive leap in bridge engineering standards. Many bridges of this type are located within the City of Toronto and Province of Ontario as per a review of the Government of Ontario List of Provincial Bridges (2017). The bridge underwent significant repairs in 2006 which removed most of the original (1980) components including both parapet walls/railings which were the most visible features. This bridge represents a modern standard of bridge design in Ontario.

No. The only portions of the bridge which is visible from the immediate context are its cast-in-place concrete parapet walls with aluminum railing. These portions of the bridge are the only ones located at grade (along Weston Road) are of standard design and are not distinguishable from other bridges within its context. The bridge does not include any unique or rare features which would distinguish it as a landmark. Further, Bridge ID 092 is dwarfed by the larger rail bridge (ID. 377) located east of Weston Road.

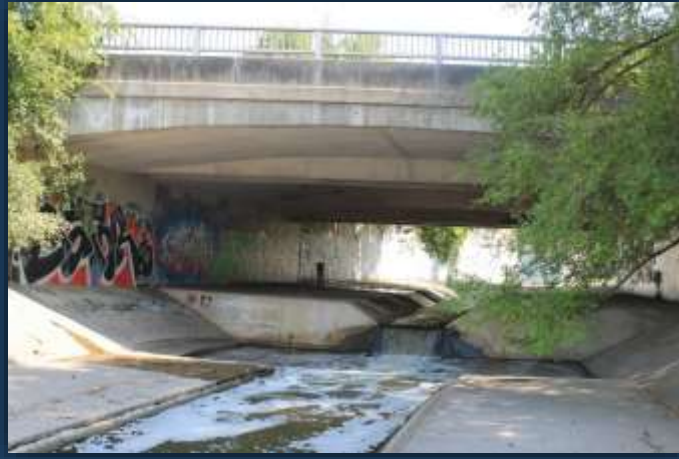
ID 360

No. Only the aluminum railing and concrete parapet of the bridge is visible while travelling along Jane Street over Black Creek Chanel. The existing railing and deck are of a standard design and is similar to Bridge IDs. 092, and 702.

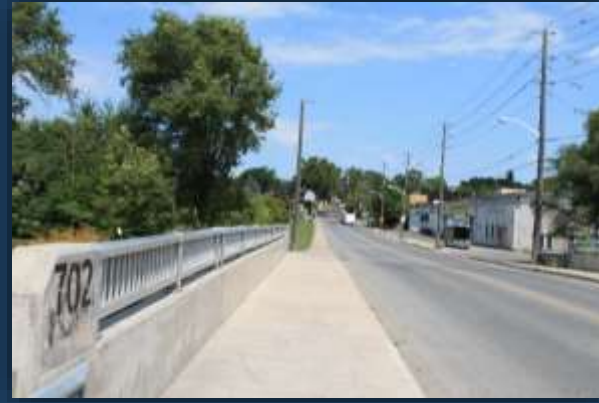
No. While Bridge ID No. 702 was originally constructed in 1963, the bridge has been widened, with repairs/alterations to abutments and wingwalls, and parapet walls replaced in 2007 which has essentially resulted in the existing early 21st century bridge design. The 2007 replacement of the parapet walls with a cast-in-place concrete parapet wall with aluminum post and panel railing system which is of a standard design and is indistinguishable from Bridge ID No. 092. Cast-in-place concrete bridges of this type are not rare or unique in Ontario. ID 702 is not a prototype, or exemplary of its type.

No. The only portions of the bridge which is visible from the immediate context are its cast-in-place concrete parapet with aluminum railing system, which is a standard and frequently used type of railing (i.e. Bridge ID No. 092). These are of standard design and are not readily distinguishable from other bridges within its context. The bridge does not include any unique or rare features which would distinguish it as a landmark.

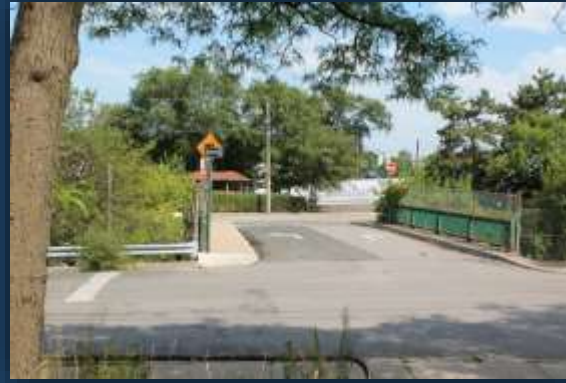
ID 703

No. The only portions of the bridge which is visible from the immediate context are its pre-fabricated steel post and panel railing, which is a standard and frequently used type of railing system. These are of standard design and are not readily distinguishable from other bridges within its context. The bridge does not include any unique or rare features which would distinguish it as a landmark.

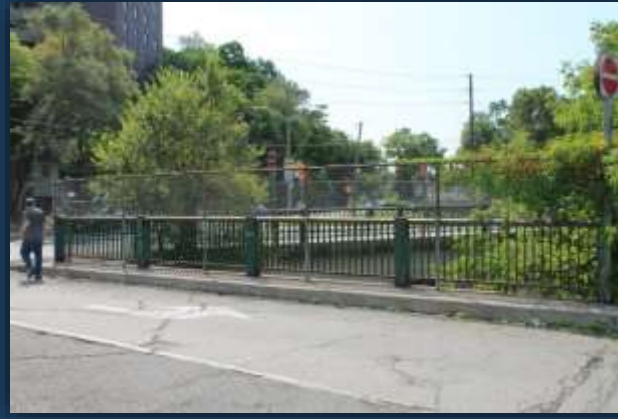
ID 704

No. The only portions of the bridge which is visible from the immediate context are its pre-fabricated steel post and panel railing, which is a standard and frequently used type of railing system. These are of standard design and are not readily distinguishable from other bridges within its context. The bridge does not include any unique or rare features which would distinguish it as a landmark.

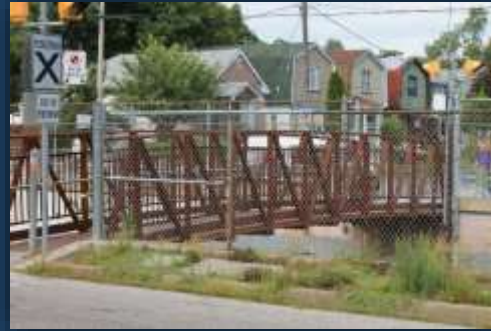
| i. Rare, unique, representative or early example of a style, type, expression, material or construction method | No. 21 st century half-through truss pedestrian bridges made of steel are not rare or unique in Ontario. ID 705 is not a prototype, or exemplary of its type. While half through truss bridges dating to the early 20 th century may have cultural heritage value, later examples do not. The previous bridge in this location was constructed in 1943, fully replaced in 1975 and again in 2015. |

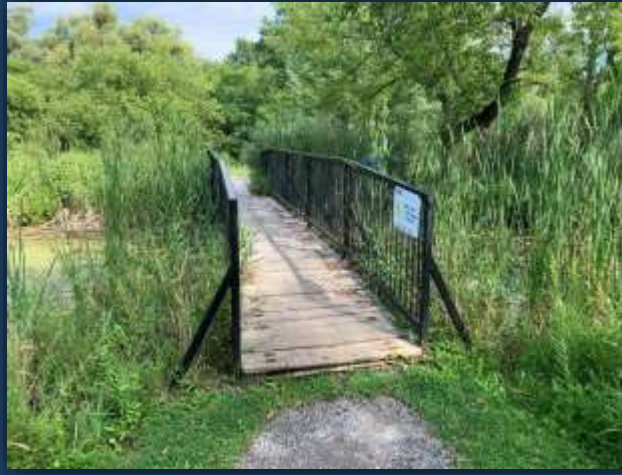
ID 308521

- i. Rare, unique, representative or early example of a style, type, expression, material or construction method
- No. Bridge ID. 308521 was constructed in 2000. Early 21st century wood and steel bridges with simple I-type girders and steel floor beams are not unique. The bridge is of a recent design and is therefore not early.
- ii. Displays high degree of craftsmanship or artistic merit
- No. The bridge does not display a high degree of craftsmanship or artistic merit.
- iii. Demonstrates high degree of technical or scientific achievement
- No. Bridge ID. 308521 does not demonstrate a high degree of technical or scientific achievement. It does not signify a progressive leap in bridge engineering standards as bridges constructed of steel girders with wood plank deck tops are not rare in Ontario.
