# **CLASS ENVIRONMENTAL ASSESSMENT FOR REMEDIAL FLOOD AND EROSION CONTROL PROJECTS**

Ajax Shoreline Erosion Mitigation Project  
Town of Ajax

**ENVIRONMENTAL STUDY REPORT**  
AUGUST 1, 2024

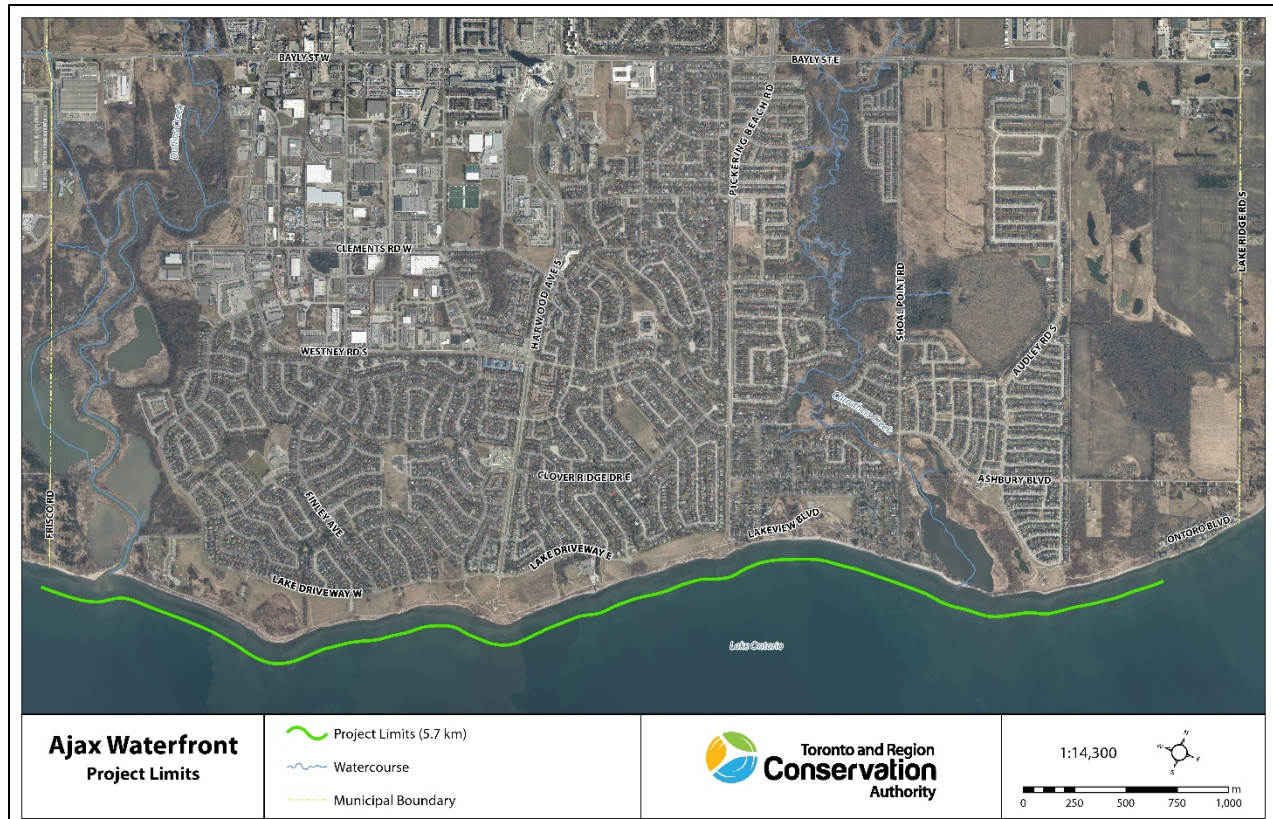
**Figure 1.** Ajax Waterfront Shoreline Erosion Mitigation Project limits along 5.7 kilometers of shoreline from Frisco Rd to Ontoro Blvd in Ajax, ON. *Source: TRCA, 2019.*

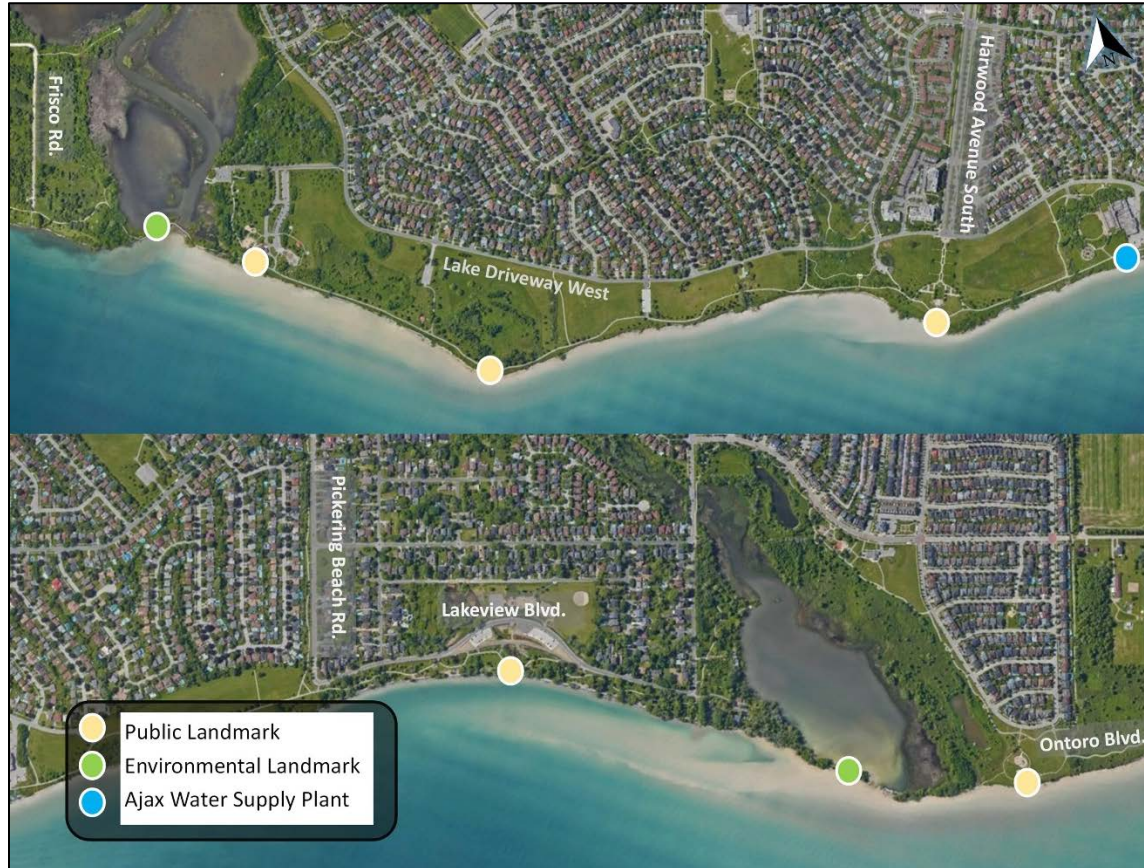
**Figure 3.** Location of project area and notable features along the Ajax waterfront. *Source: TRCA, 2024.*

There are a number of public and environmental landmarks at Ajax Waterfront Park; public landmarks refer to playgrounds, gardens, and recreation areas like Paradise Beach and Rotary Park Pavilion, while environmental landmarks refer to significant coastal wetlands. The location of these public and environmental landmarks is shown on **Figure 3**.

Along with the Public Landmarks identified in **Figure 3**, there are two major Environmental Landmarks within the project area: Duffins Creek Marsh and Carruthers Marsh (**Figure 7**). These marshes provide important habitat for local fauna and aquatic species. There is significant public interest in protecting these spaces which is reflected in design recommendations.

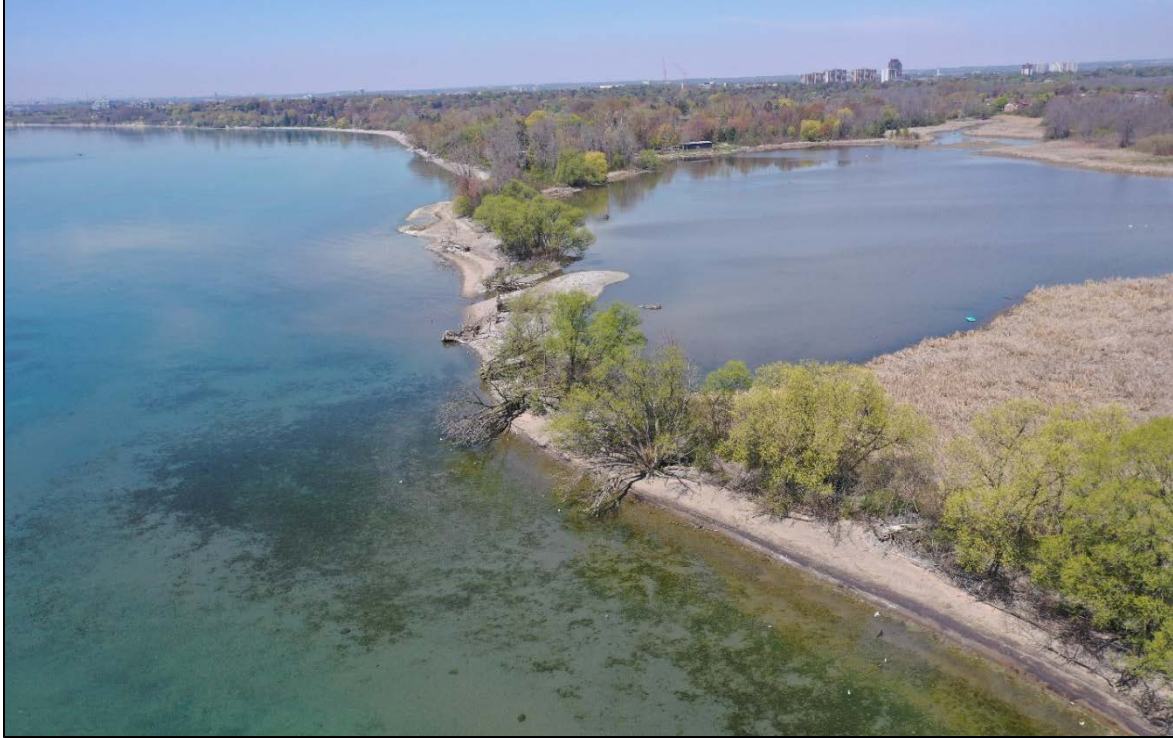
**Figure 7.** Aerial view of the shoreline at Carruthers March, one of the two Environmental Landmarks in the project area. *Source: TRCA, 2021.*

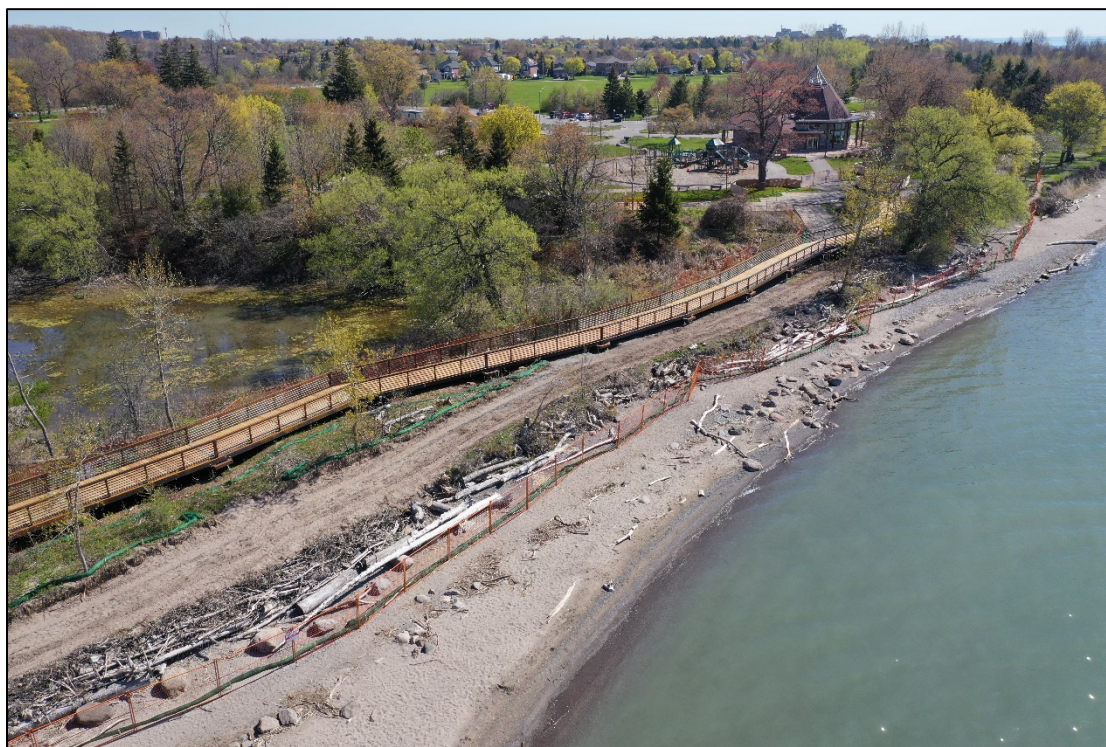
**Figure 9.** Part of the Duffins Creek Boardwalk. *Source: TRCA, 2022.*

TRCA has been involved in a number of restoration and infrastructure projects at Ajax Waterfront Park, including wetland creation, post and paddle fencing, outfall repairs and planting sites. Installation of erosion and flood control structures along the shoreline have included the Duffins Creek boardwalk in 2021 (**Figure 9**), and the Love Crescent Outfall in 2019 (**Figure 10**).

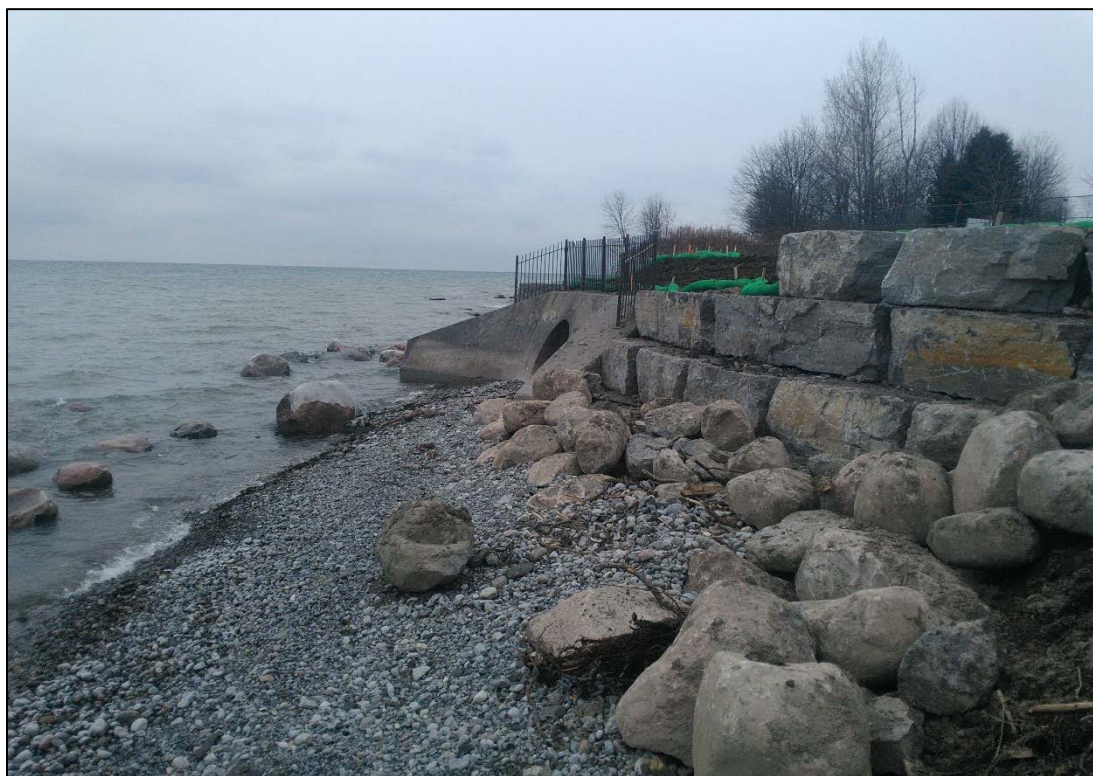
**Figure 10.** Love Crescent Outfall, completed by TRCA in 2019. *Source: TRCA, 2019.*

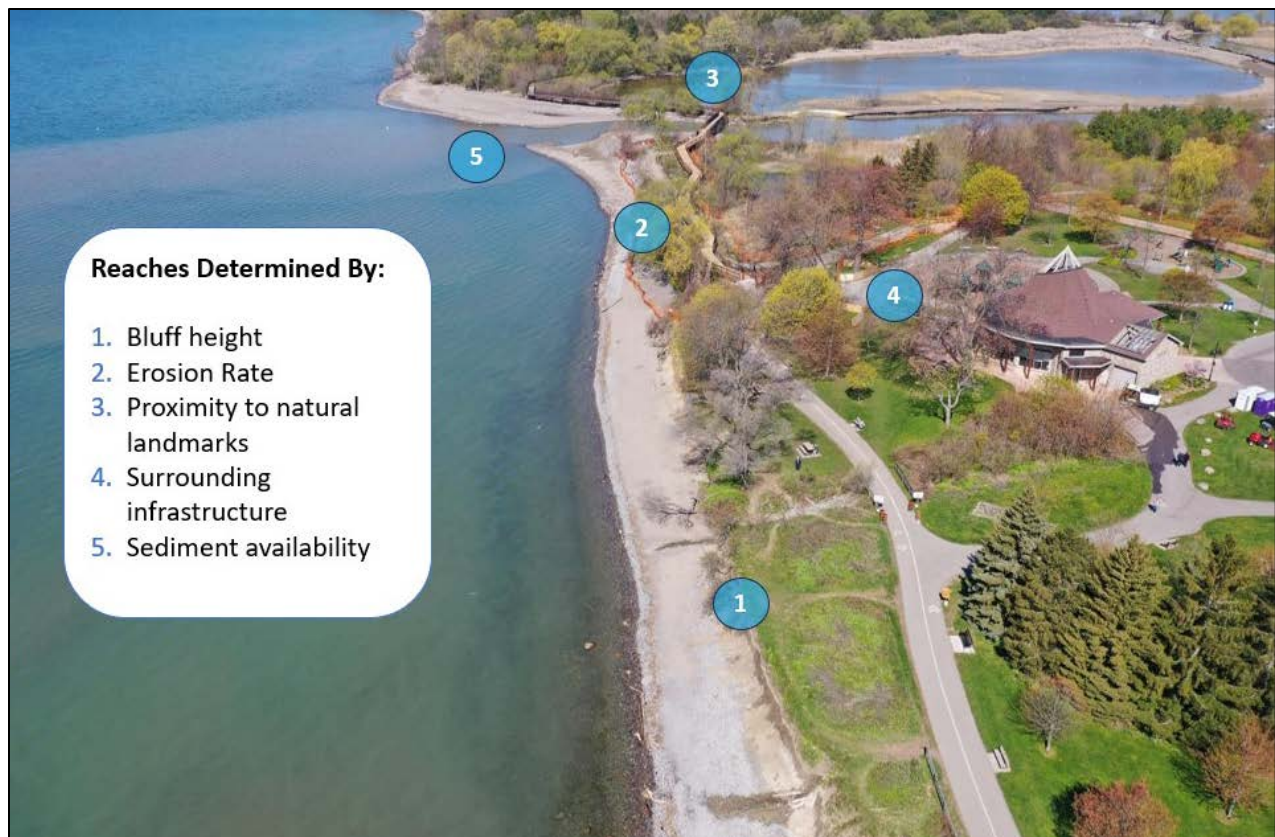
**Figure 11.** Reach Criteria. *Source: TRCA, 2023.*

In order to accurately and effectively prescribe alternatives, Baird divided the 5.7km shoreline area into 12 distinct areas called “reaches”. Reaches were determined during the coastal and gap analysis phase, and used criteria outlined in **Figure 11**.

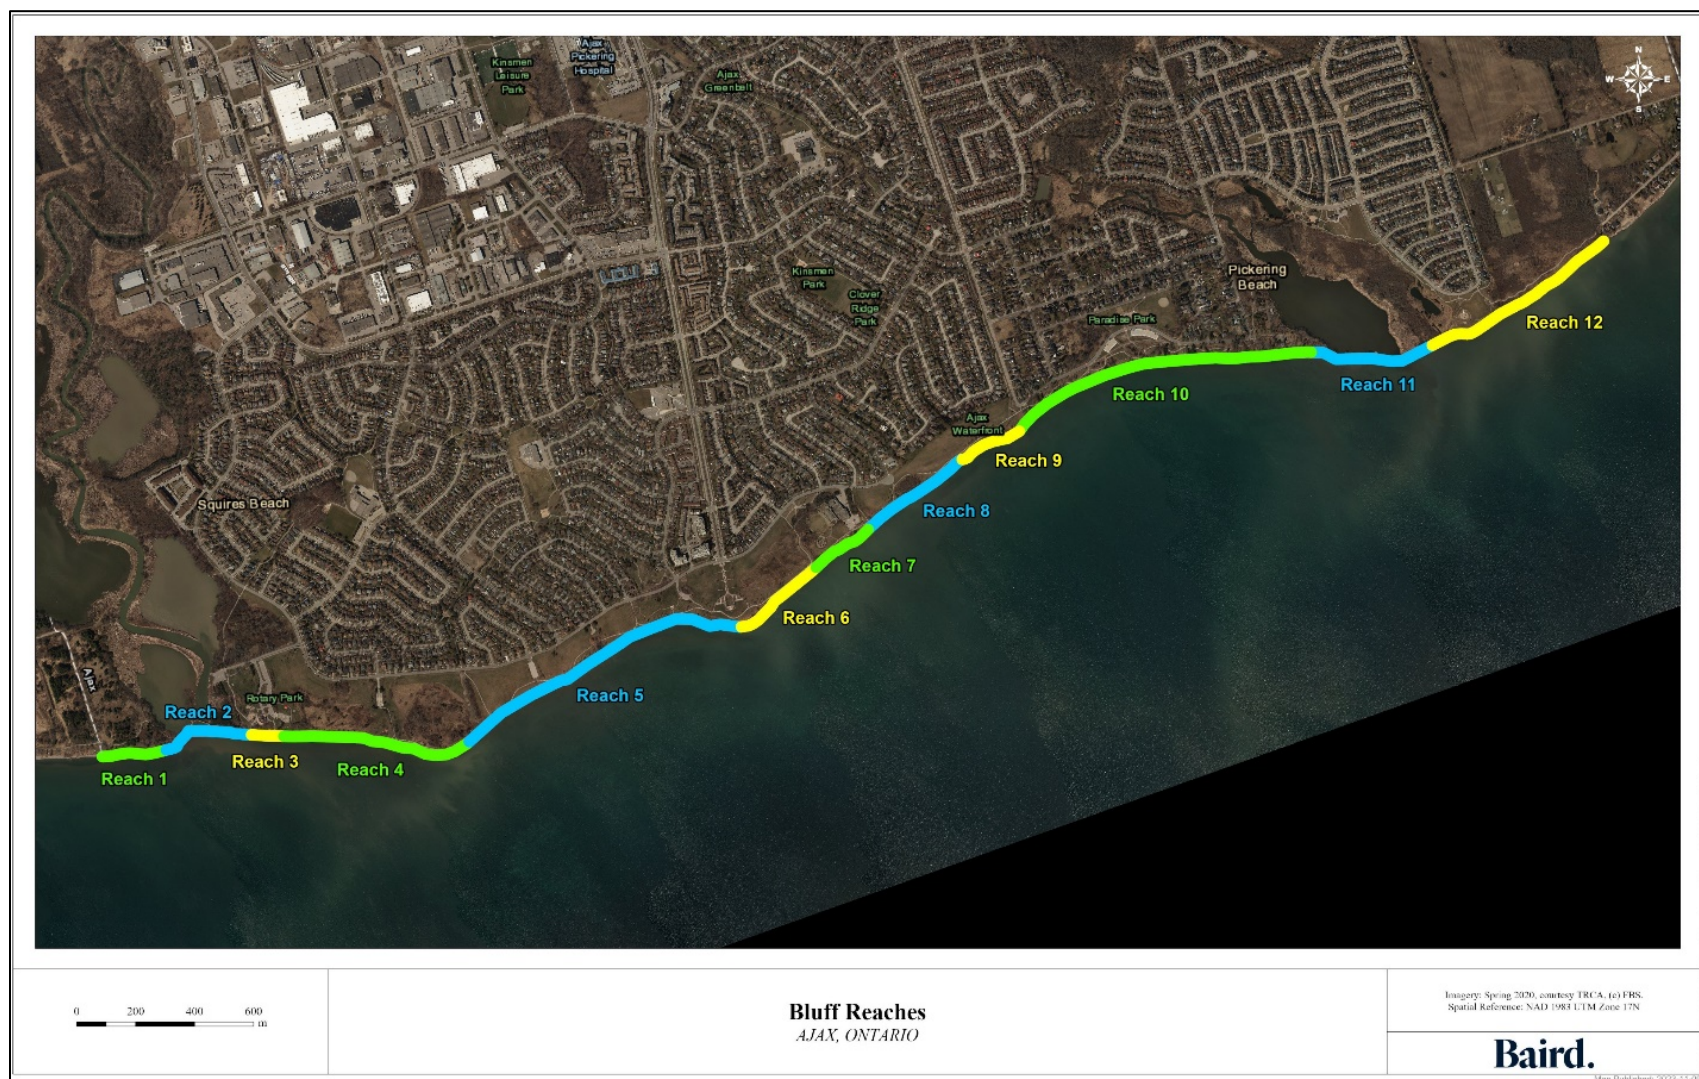
Figure 12. Ajax Waterfront Park shoreline reaches. Source: Baird, 2023.

Reaches vary in length from as little as 100 meters to over 1 kilometer depending on shoreline conditions. Once reaches were established, alternatives were developed to address concerns specific to each reach. Priority levels were assigned to each reach based on proximity to permanent infrastructure, erosion rates, and potential public hazards. **Figure 12** shows the location of each shoreline reach and its approximate length.

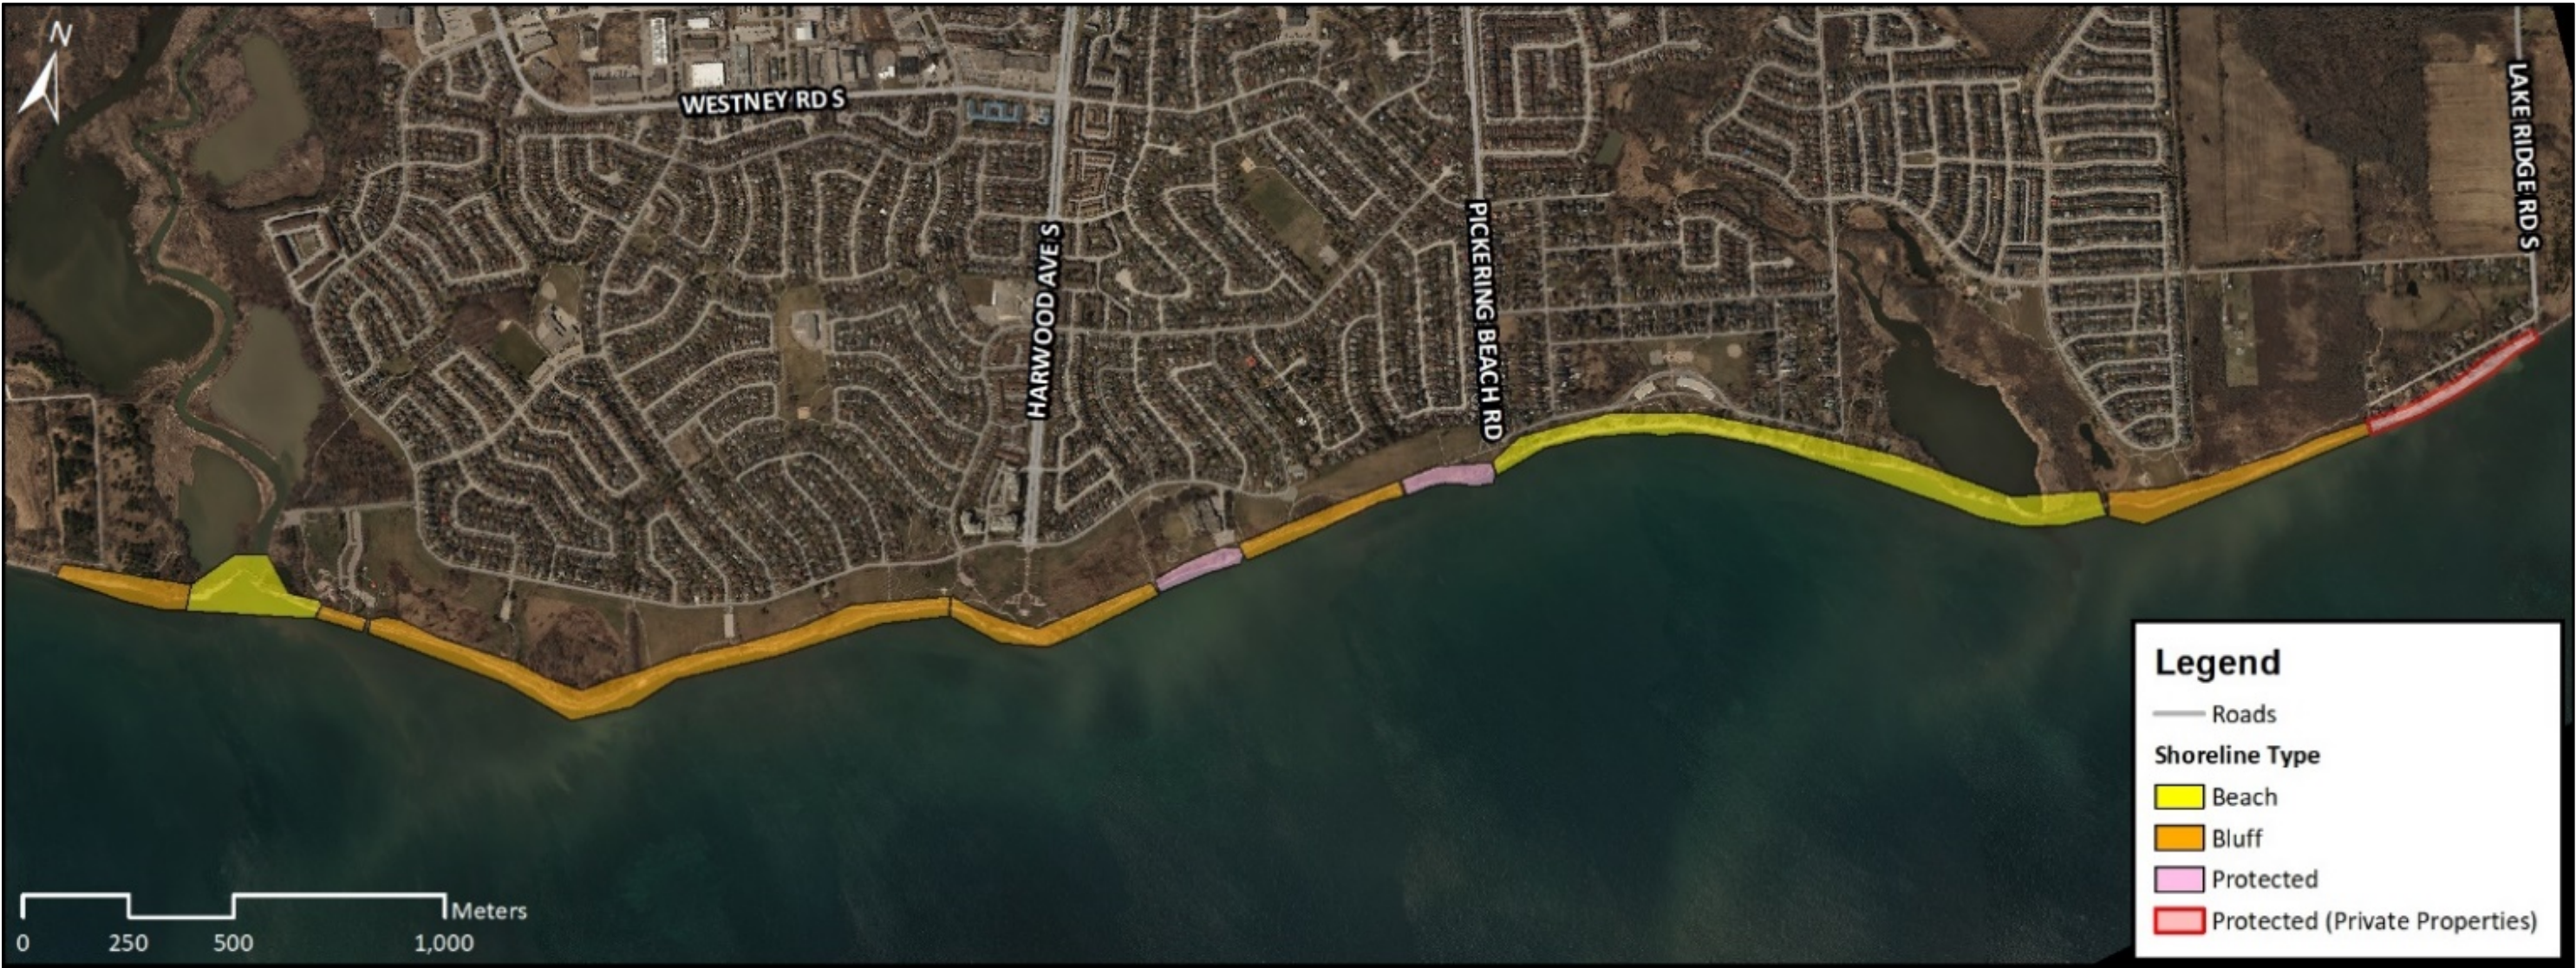
Figure 13. Shoreline types along the Ajax shoreline. Source: TRCA, 2021.

The small bluffs and sand and cobble beaches are the most significant natural features in the area. These bluffs and beaches are evident along the waterfront for 5.7 kilometers. **Figure 13** shows the approximate locations of bluffs and beaches along the shoreline. “Protected”, in the context of **Figure 13** refers to areas of the Ajax waterfront shoreline where erosion mitigation and protection structures are already in place.

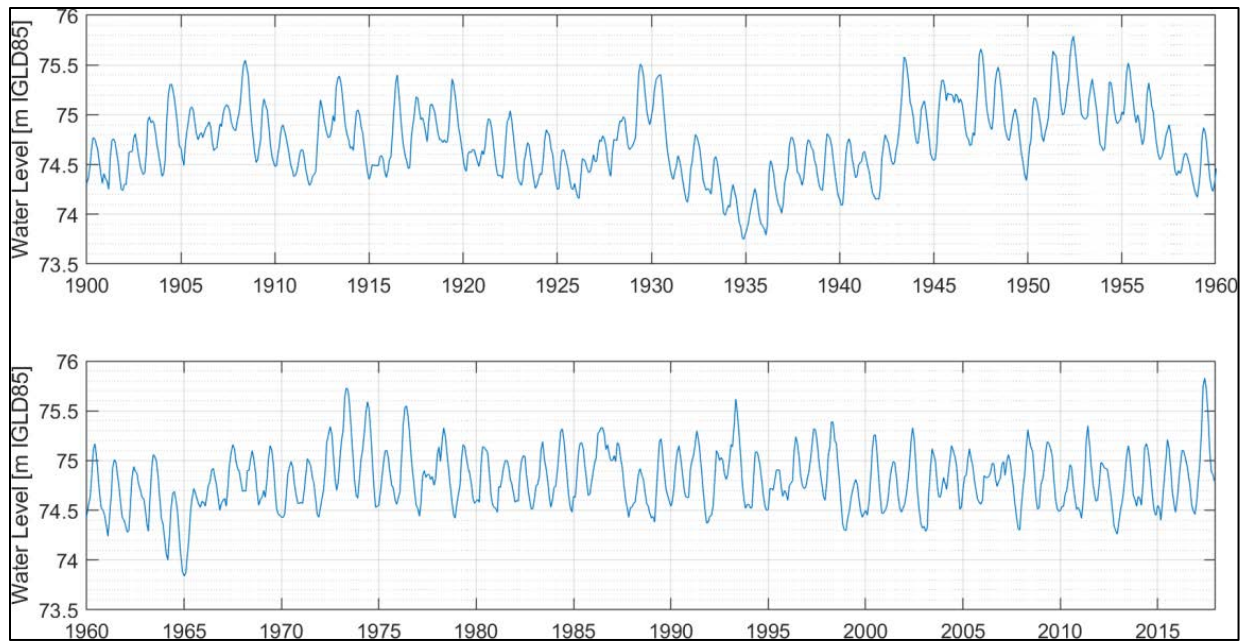
**Figure 14.** Water levels in Lake Ontario before regulation (top) and after regulation (bottom). *Source: Baird, 2021.*

Lake Ontario water levels are measured and recorded on an hourly basis in the Toronto Harbour by Fisheries and Oceans Canada (DFO). Water levels in Lake Ontario have been regulated since the 1960s, but lake levels still fluctuate based on the inputs and outputs. The graphs below in **Figure 14** shows the water level fluctuations before the regulation and after.

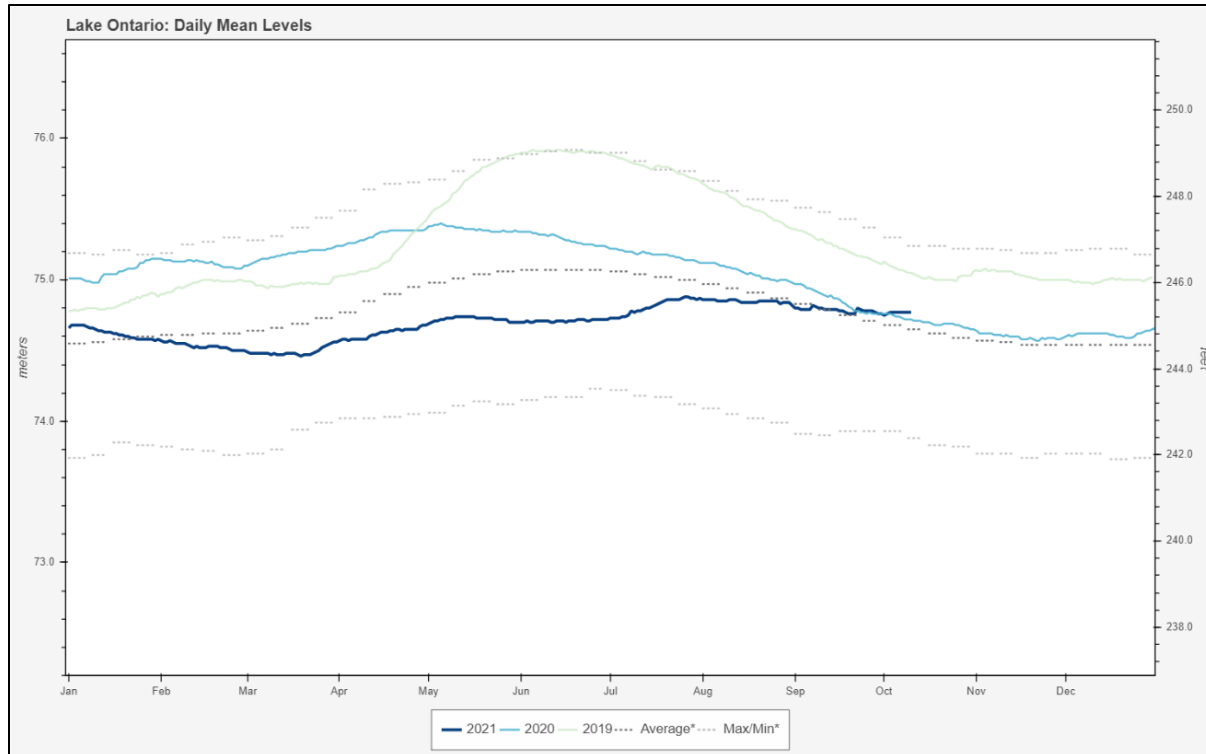
**Figure 15.** Daily water levels of Lake Ontario from 2019 to 2021 to demonstrate the high water levels in 2019. Source: International Joint Commission (IJC), 2021.

In 2017 and 2019, Lake Ontario experienced record high lake level events causing extensive flooding and erosion along the shoreline. **Figure 15** demonstrates the high water levels Lake Ontario experienced in 2019 compared to the water levels of Lake Ontario in 2020 and 2021.

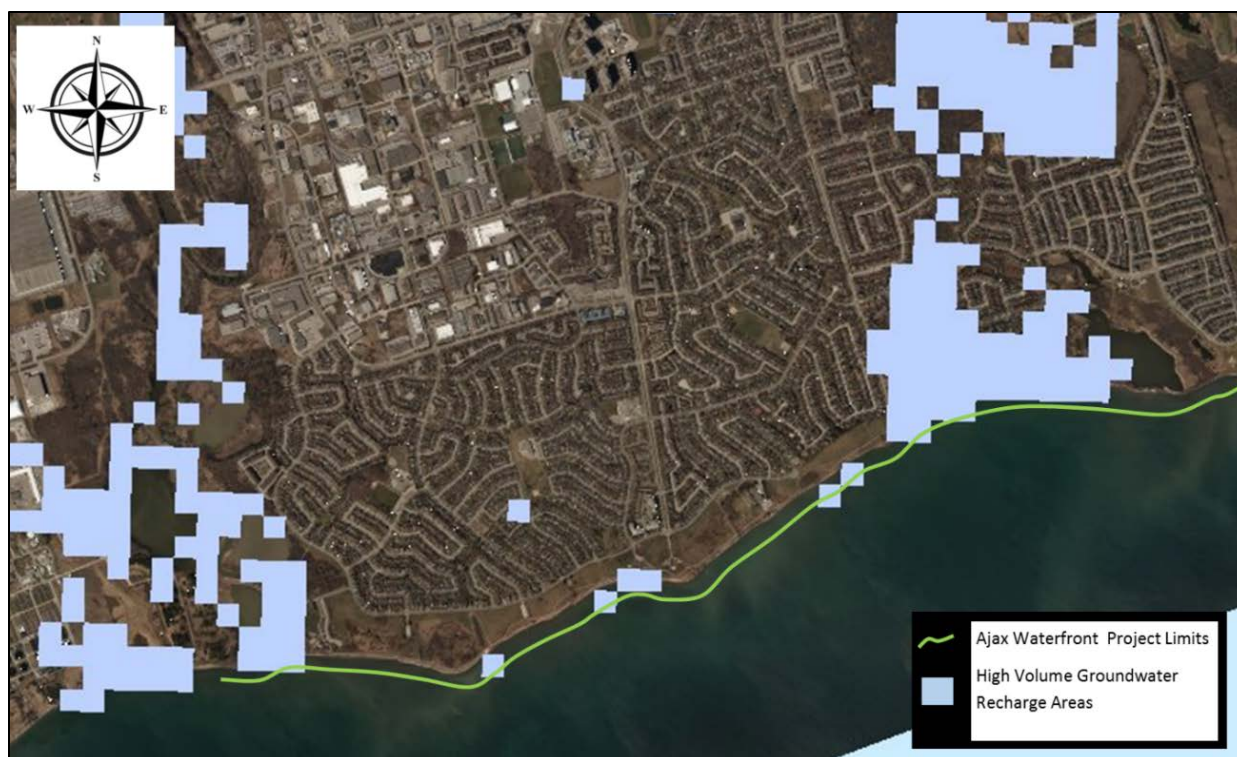
**Figure 16.** Groundwater recharge areas near and within the project area. *Source: TRCA, 2021.*

Duffins Creek and Paradise Park are the two major areas that contribute to the High Volume Groundwater Recharge Areas (HVGRA) located within the project limits (**Figure 16**). Two outfalls along the shoreline were also identified as HVGRAs.

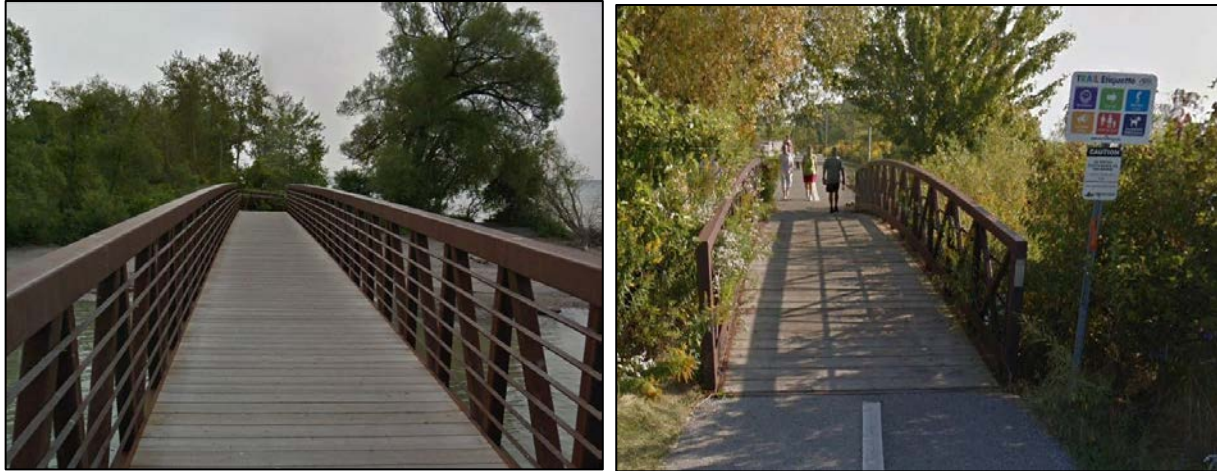
**Figure 17.** The boardwalk at Duffins Creek and the pedestrian crossing located west of the Ajax Water Supply Plant. *Source: Google Earth, 2021.*

There are pedestrian crossings along the project limit. The constructed crossing on the west end of the project area is the boardwalk from Rotary Park to Duffins Creek. There is also a small pedestrian bridge on the Waterfront Trail that is located to the west of the Ajax Water Supply Plant. It is important to note that these crossings are strictly for recreational purposes—no vehicle or rail crossings are present within the project area.

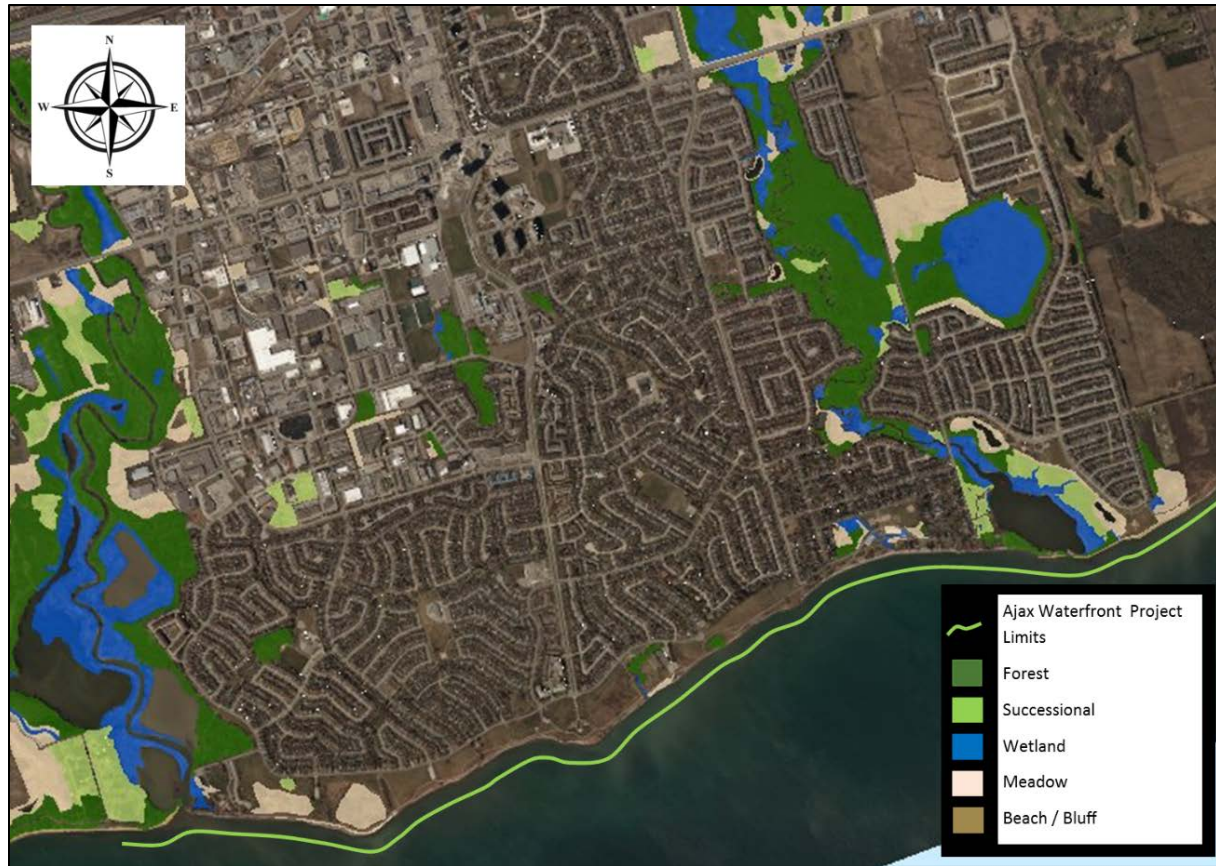
**Figure 18.** Location of Ecological Land Classification data that was collected in 2017. *Source: TRCA, 2021.*

The project area consists mainly of manicured lawn, parks and greenspace for public use. There are a few potential wildlife habitat areas that have been identified around the wetlands on either side of the project area, and in the meadow and forested areas along the Ajax waterfront shoreline (**Figure 18**). Along with manicured greenspaces, there are wetlands, small forested areas and meadows. The small forested areas may provide breeding and nesting habitat for birds and provide shelter for terrestrial fauna. Duffins Creek, Caruthers Marsh and Paradise Park provide wetland habitat for multiple terrestrial and aquatic species. Along with these identified areas, the shoreline itself can provide wildlife habitat for multiple bird species and other local fauna.

In 2022 TRCA conducted updated ELC, flora and fauna surveys to reflect current conditions and found that in addition to the 5 identified habitat types in **Figure 18**, plantation habitat was also present in areas where the Town of Ajax had introduced vegetation or trees. A full exploration of vegetation communities is included in the Ajax Waterfront Terrestrial Biological Inventory in **Appendix B**.

There are three wetlands located within the project area. From west to east, there is: Duffins Marsh, Paradise Park Wetlands and Carruthers Marsh. These wetlands are identified in **Figure 18** where the natural cover of the Ajax waterfront is outlined. These wetlands provide a diverse ecosystem for multiple terrestrial and aquatic species. Wetlands also contribute to promoting water quality by filtering the water and allowing sediment to deposit before entering Lake Ontario. The Lake Ontario SMP notes that preserving barrier beaches will help protect wetlands from wave action.

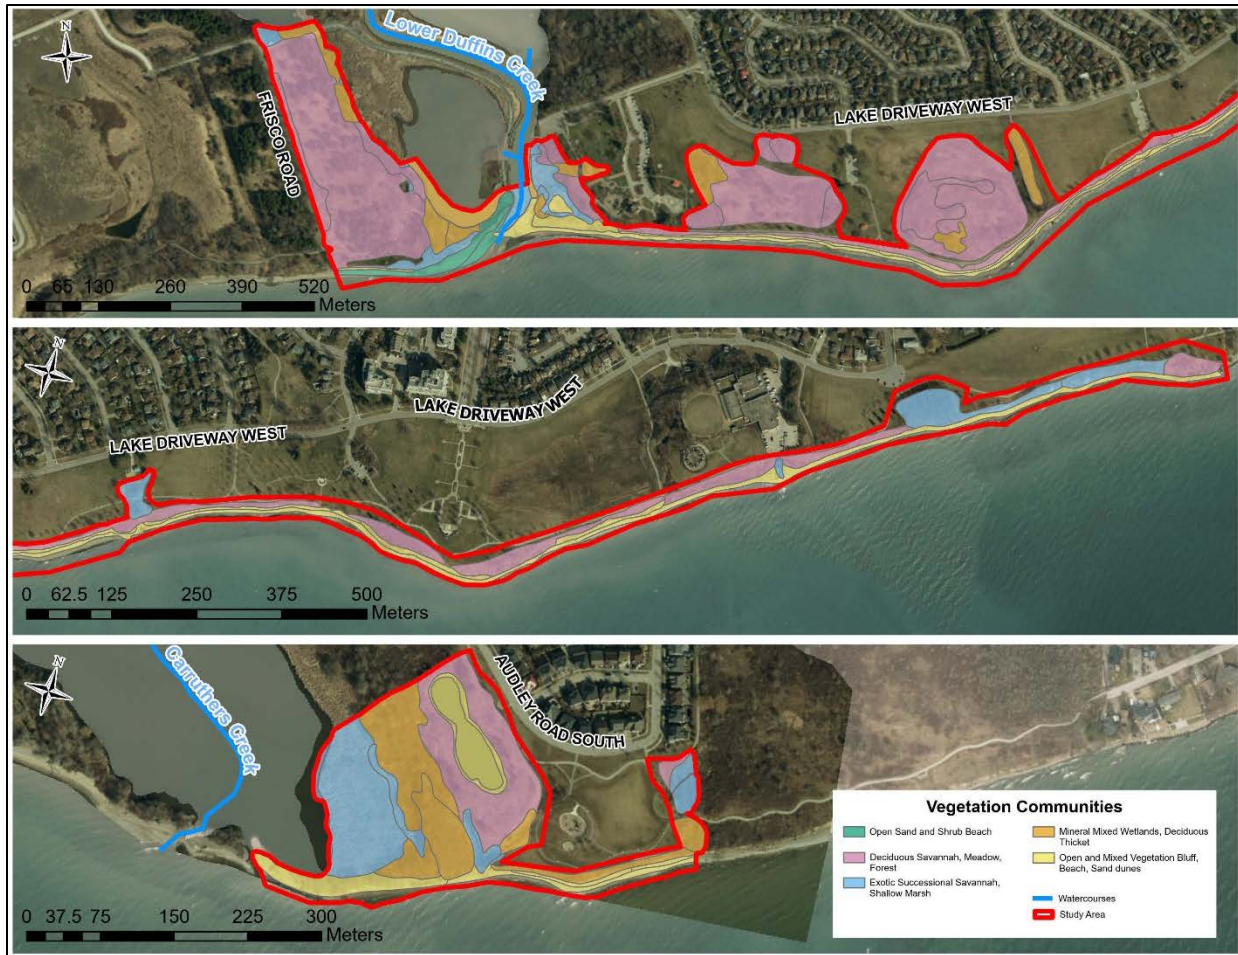
**Figure 19.** Ecological Land Classification Data. *Source: TRCA, 2024.*

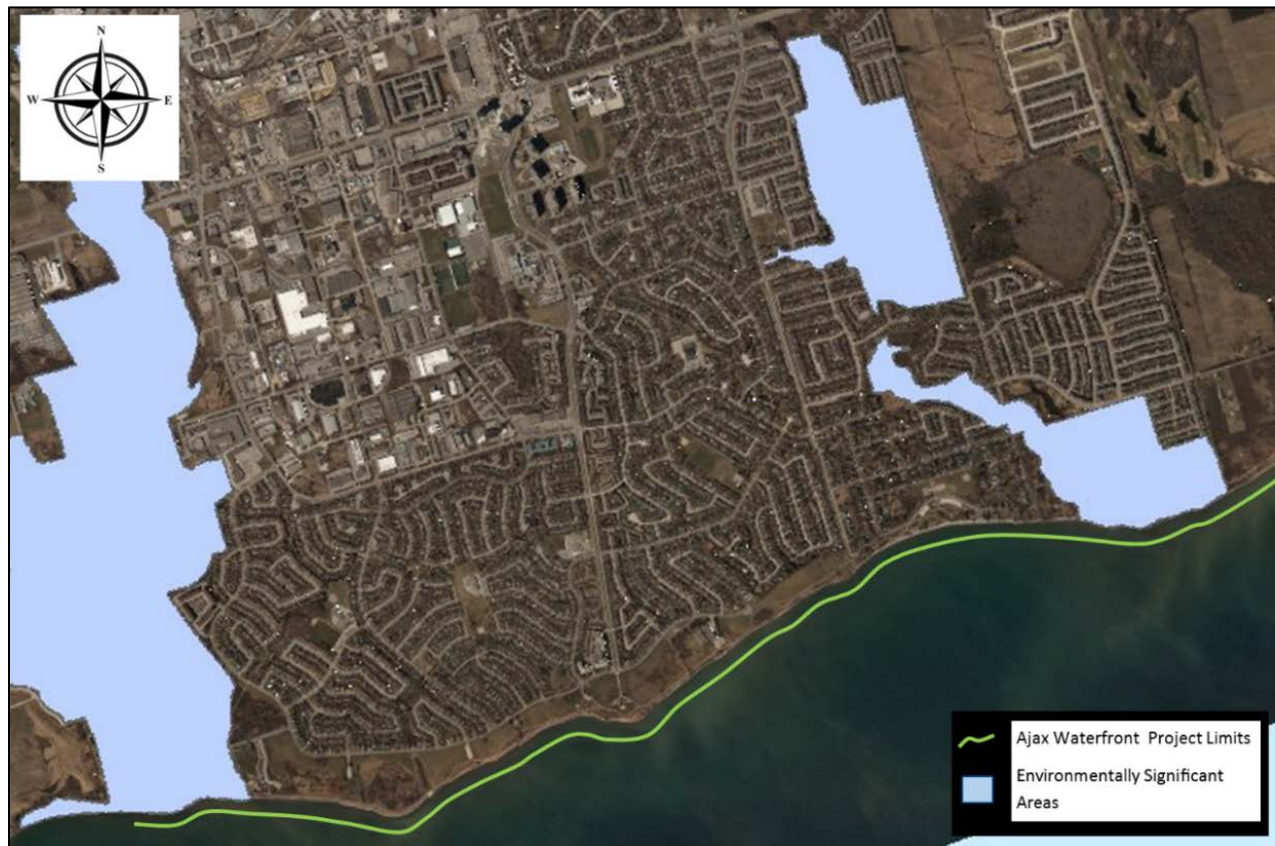
**Figure 20.** ESAs along the Ajax waterfront. *Source: TRCA, 2021.*

ESAs are defined as areas of land that meet one or more certain physical or biological criteria. Duffins Creek and Carruthers Marsh have been identified as ESAs (**Figure 20**). These ESAs have also been identified as Provincially Significant Wetlands and are shown in **Figure 21**.

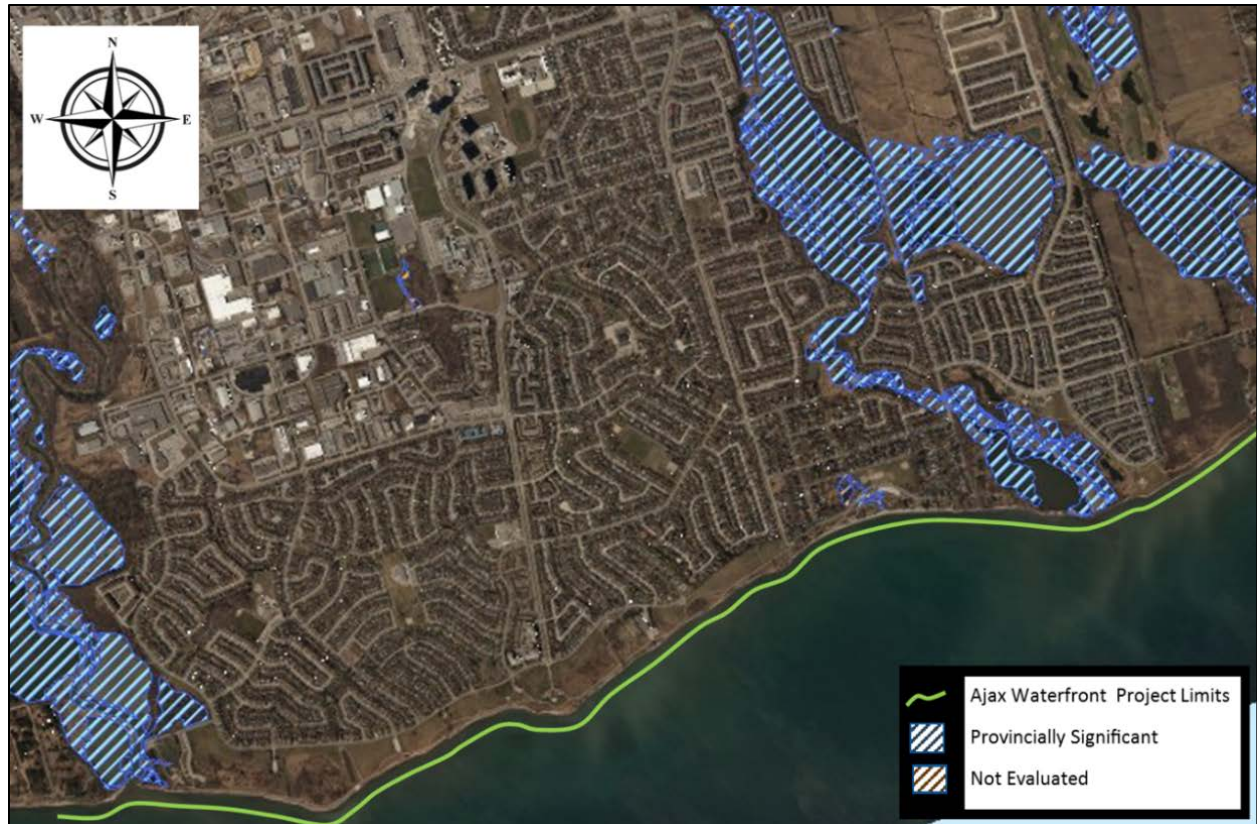
**Figure 21.** Provincial Significant Wetlands that have been identified within the project limits. *Source: TRCA, 2021.*

There are two Provincially Significant Wetlands (PSW) (**Figure 21**) that provide unique habitats to multiple species that are not common in other parts of the project area. The wetlands fall into Reach 2 and Reach 11, both of which would benefit from long-term monitoring. A monitoring program will ensure that changes in coastal processes that may jeopardize the integrity of the PSW could be monitored or potentially addressed. Any implementation of shoreline work adjacent to PSWs, like Reach 3 or Reach 12, will take stringent measures to limit any negative impacts or disturbances to those areas. A PSW is determined through the Ontario Wetland Evaluation System, which can designate a wetland as significant according to a scoring system. Wetlands scoring above a 600 across all scoring categories or above 200 in Biological criteria are designated PSWs.

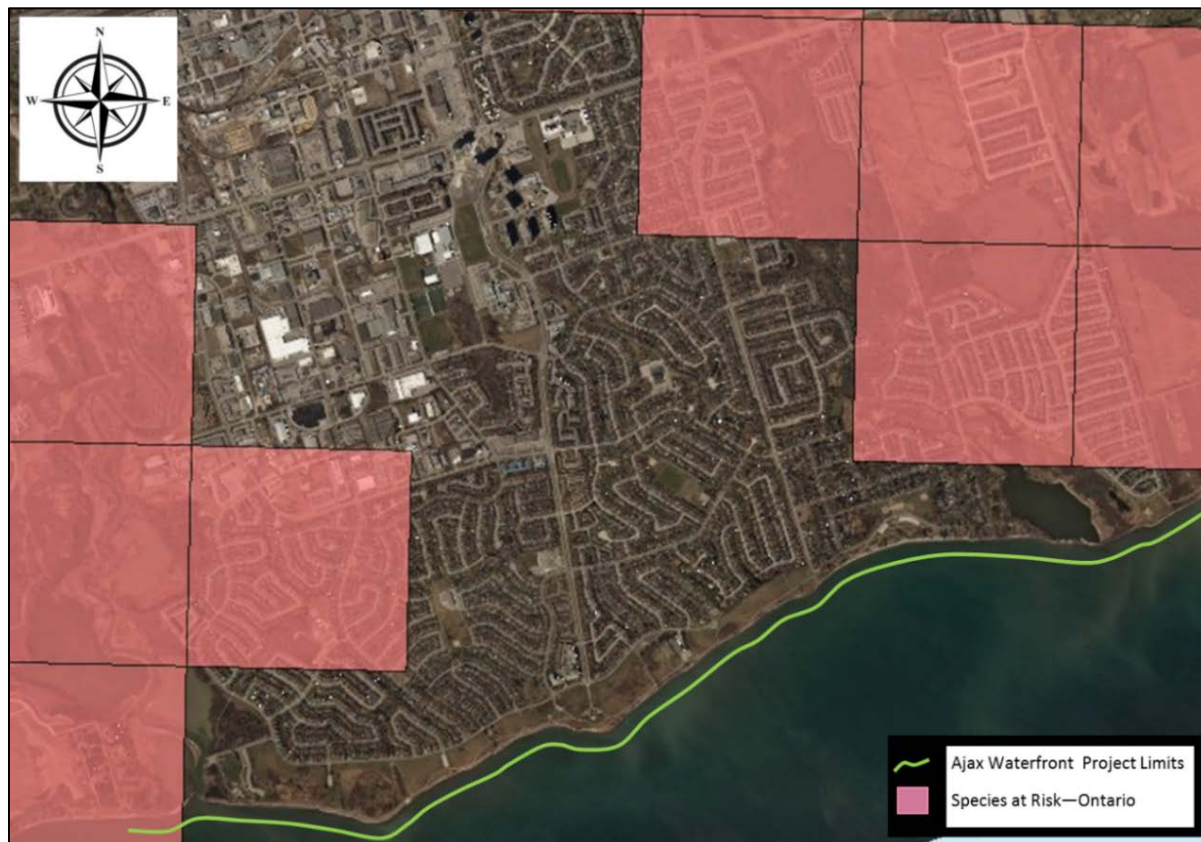
**Figure 22.** Species at Risk locations where species have been identified near the project area. *Source: TRCA, 2021.*

Species at Risk polygons are shown in light red in **Figure 22**. During 2022 flora and fauna inventory work, TRCA identified 63 flora species of regional and urban concern, 15 fauna species of concern, and 22 bird species concern. Impacts to these species should be considered during the detailed design phase and mitigative measures should be identified. Although not reflected in **Figure 19**, multiple Bank Swallow (*riparia riparia*) nesting sites have been identified along the Ajax Shoreline within the project area. Bank Swallows are identified as provincially Threatened; their habitat has protected status under Species at Risk legislation. Bank Swallows have been documented via iNaturalist and eBird mapping, as well as visual documentation taken by staff while on site. Any work that occurs in areas where Bank Swallows are nesting will undergo the necessary mitigation measures and permitting in order to complete work without negatively impacting any colony present.

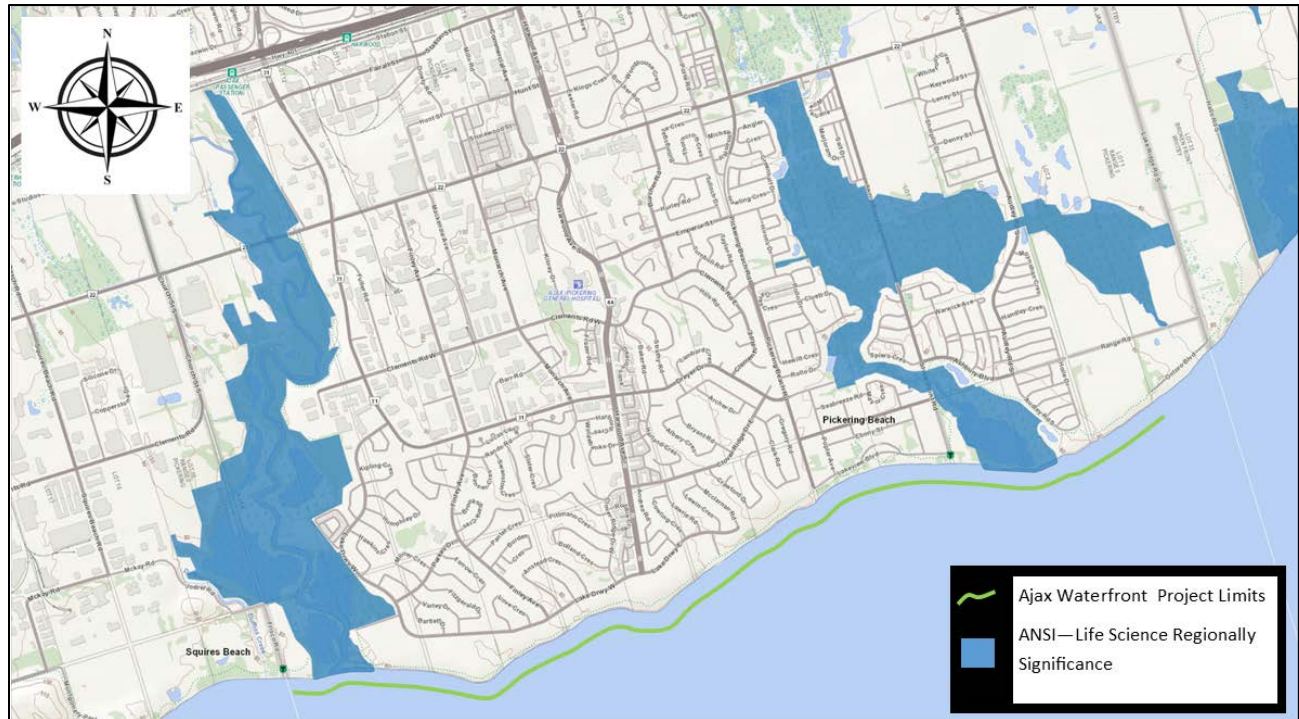
**Figure 23.** Life Science ANSI Identified at Carruthers Marsh and Duffins Creek. *Source: Ontario GeoHub, 2021.*

Two ANSI-LS have been identified within the project area and are shown on **Figure 23**. Duffins Creek Coastal Marsh is located on the western limit and has been identified as a candidate provincially significant ANSI-LS. Carruthers Marsh at the eastern limit of the project area has also been identified as a confirmed regionally significant ANSI-LS.
