# **CLASS ENVIRONMENTAL ASSESSMENT FOR REMEDIAL FLOOD AND EROSION CONTROL PROJECTS**

Ajax Shoreline Erosion Mitigation Project  
Town of Ajax

**ENVIRONMENTAL STUDY REPORT**  
AUGUST 1, 2024

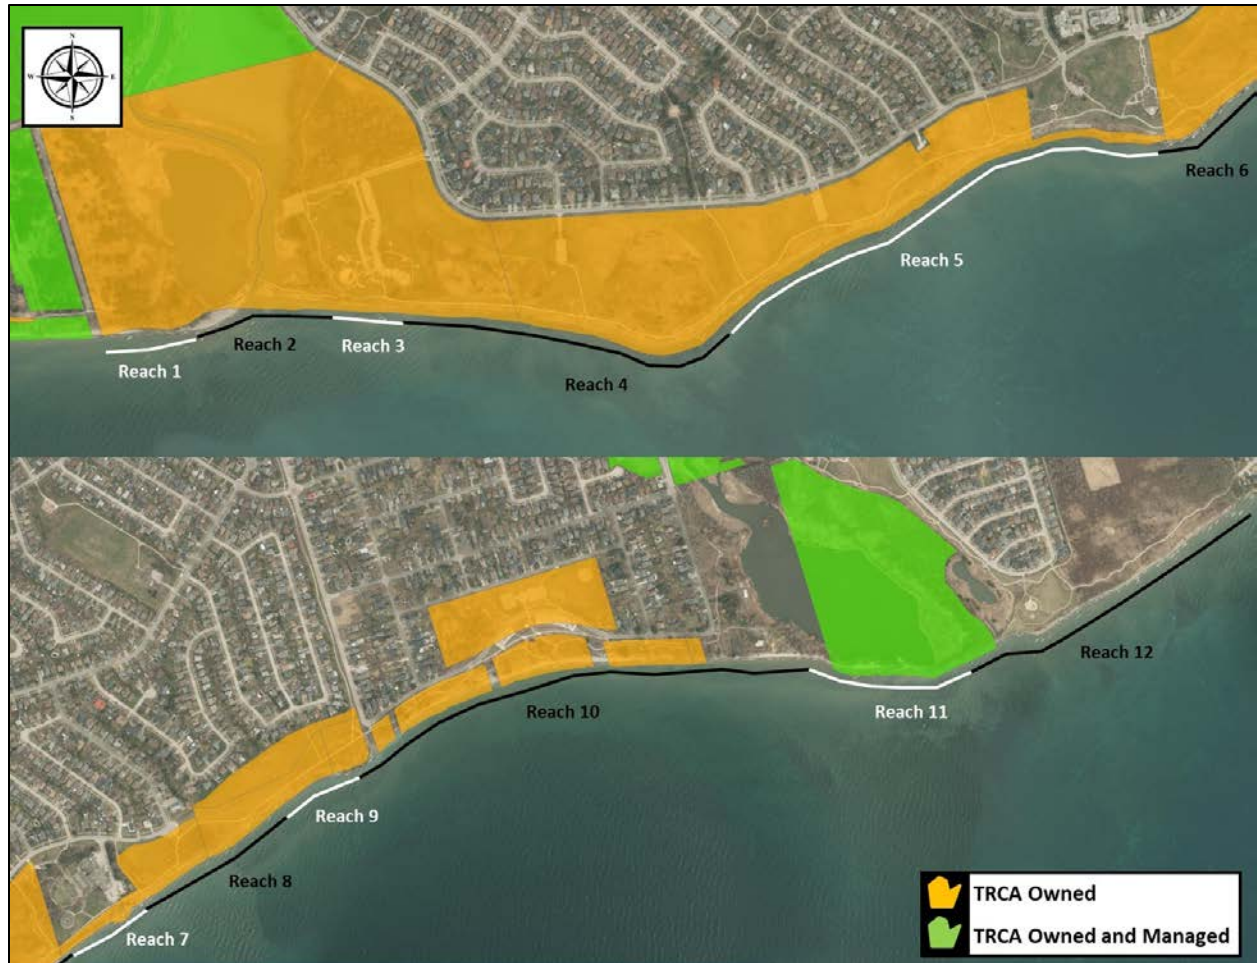
**Figure 24.** Ownership of property along the Ajax waterfront. TRCA owned refers to property that is owned by TRCA and managed by the Town of Ajax; TRCA owned and managed refers to property that is both owned and managed by TRCA. *Source: TRCA, 2024.*

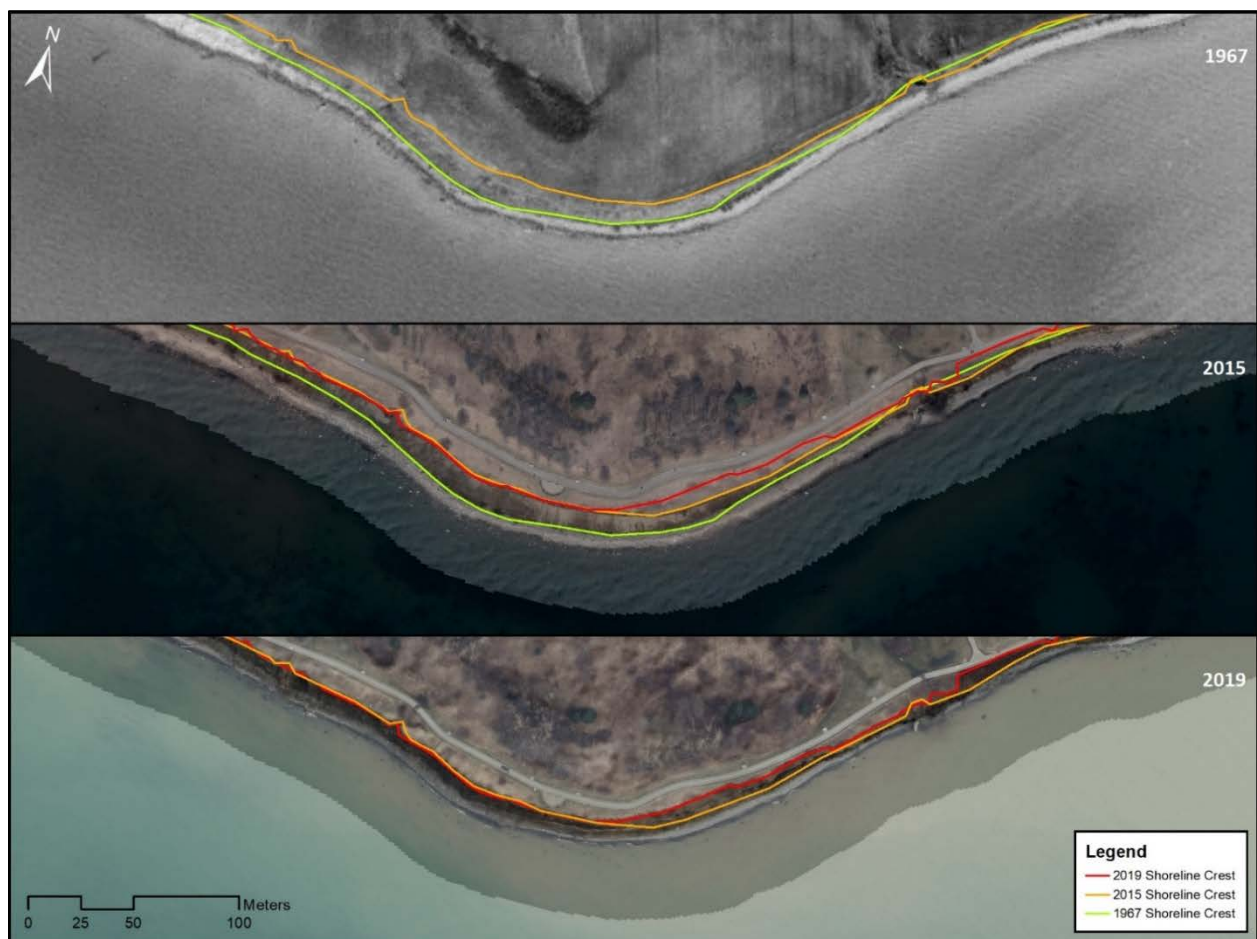
**Figure 25.** Shoreline crest delineation comparison between 1967-2015 and 2015-2019. *Source: TRCA, 2021.*

Transects were created for every metre across the shoreline. To reflect notable historic events like post-hurricane Hazel water levels in 1967, and Lake Ontario high water levels in 2017 and 2019, the shoreline delineation was separated into two groups: the long-term change rate between 1967 and 2015, and the short-term change rate between 2015 and 2019 as seen in **Figure 25**. The top image shows the long-term change, the bottom image shows the short-term change, and the middle image shows the shoreline recession across the three featured years.

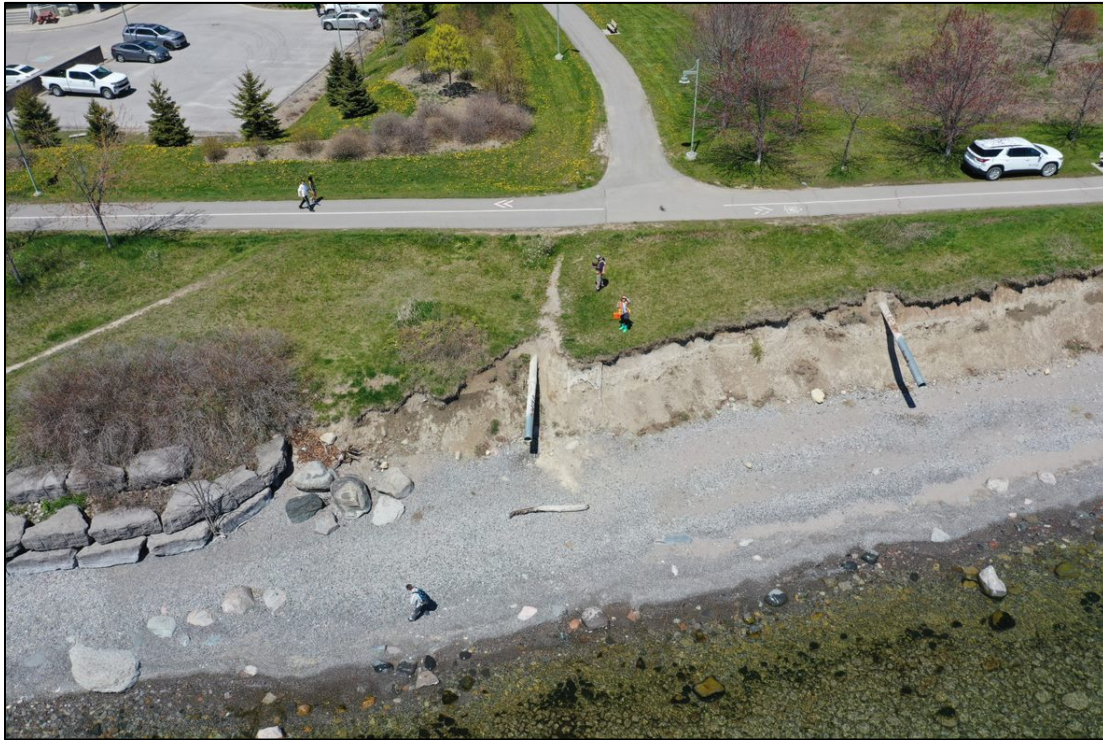
**Figure 26.** Infrastructure exposed along the Ajax waterfront. *Source: TRCA, 2021.*

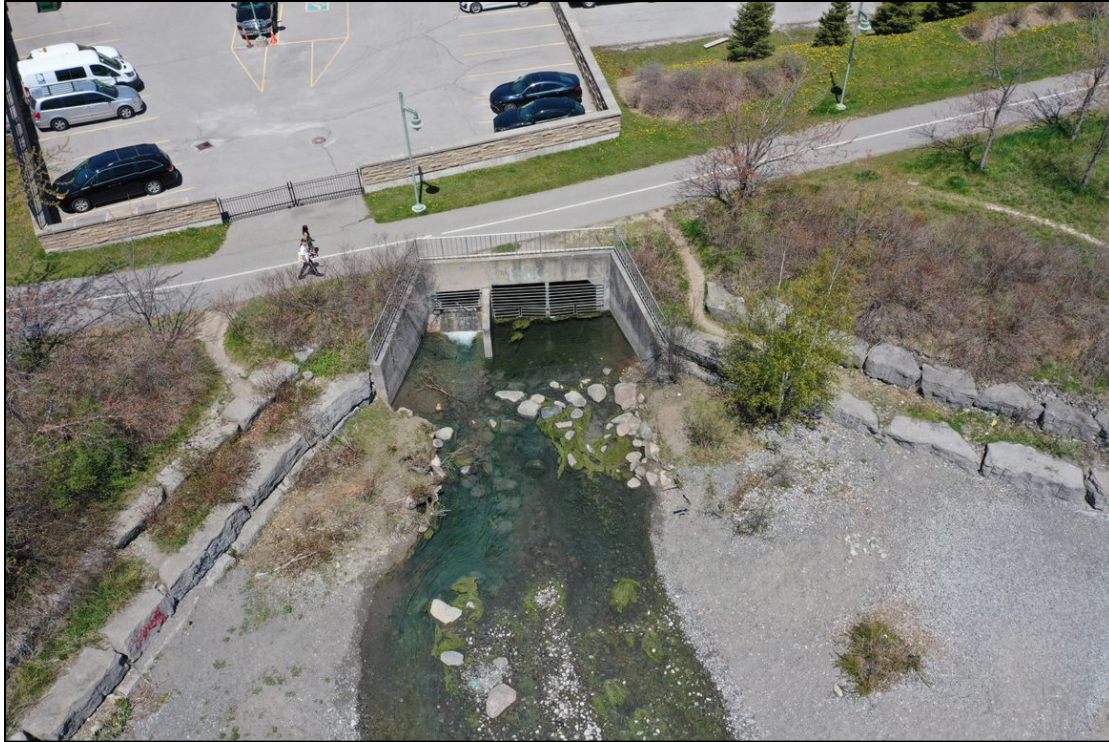
**Figure 27.** Stormwater outfall located near the Ajax Water Supply Plant. *Source: TRCA, 2021.*

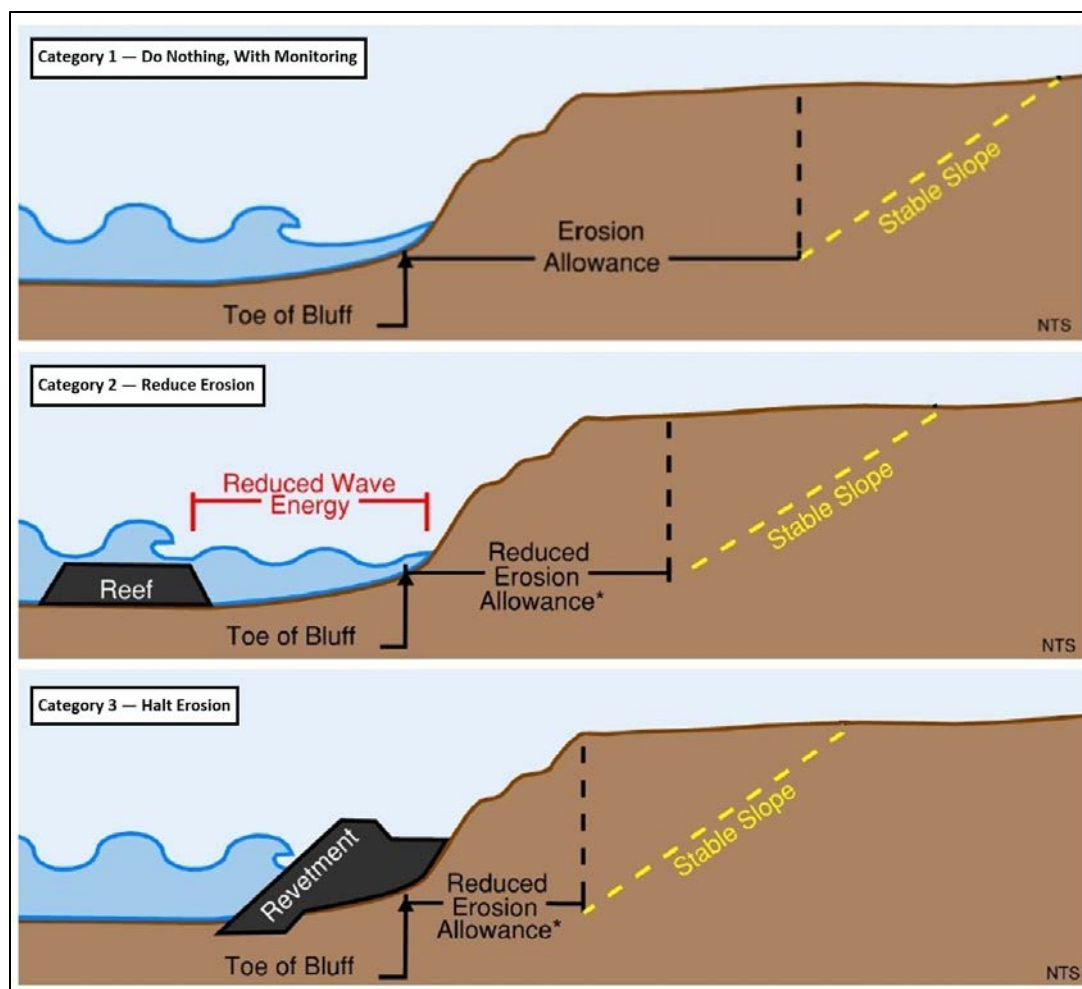
**Figure 28.** Three categories of designs for alternative development. The total amount of erosion and land loss decreases with Category 2 and 3 approaches. *Source: Baird, 2023.*

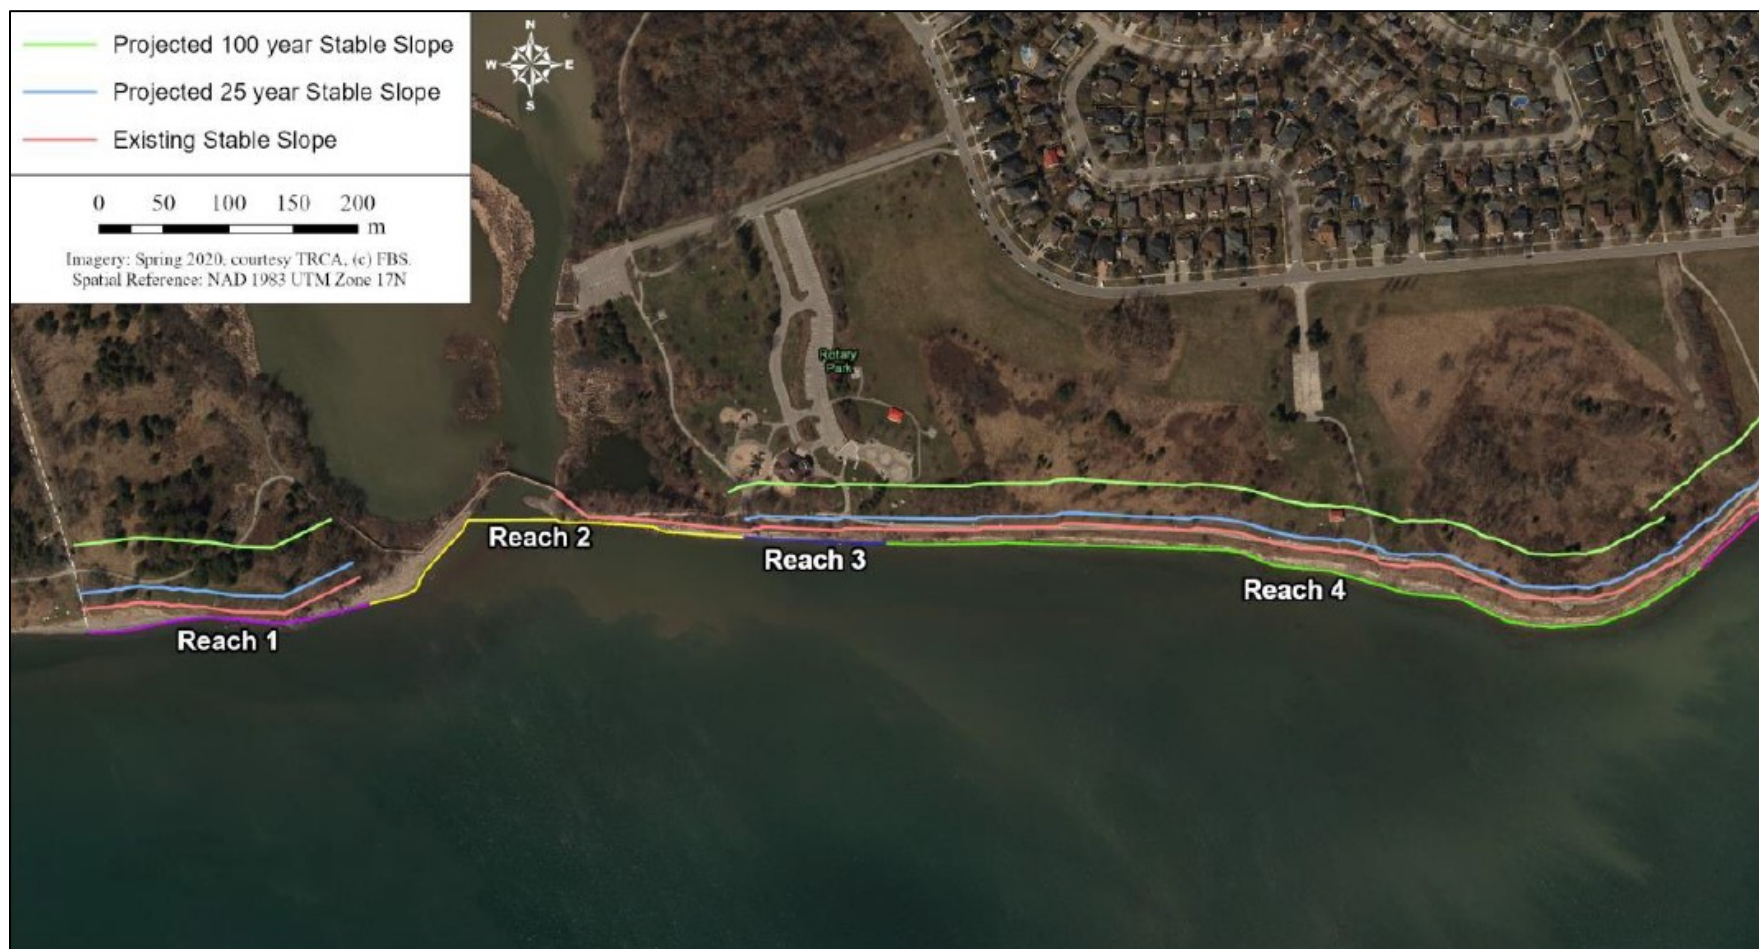
**Figure 29.** Long-term stable slope projections for Reaches 1-4. *Source: Baird, 2023*

**Figure 29** shows the expected top of slope for Reaches 1-4 based on historic and predicted changes to shoreline erosion rates. The top of slope for the remaining reaches can be found in Environmental Assessment and Conceptual Design Development report in Environmental Assessment and Conceptual Design Development report in **Appendix A**.

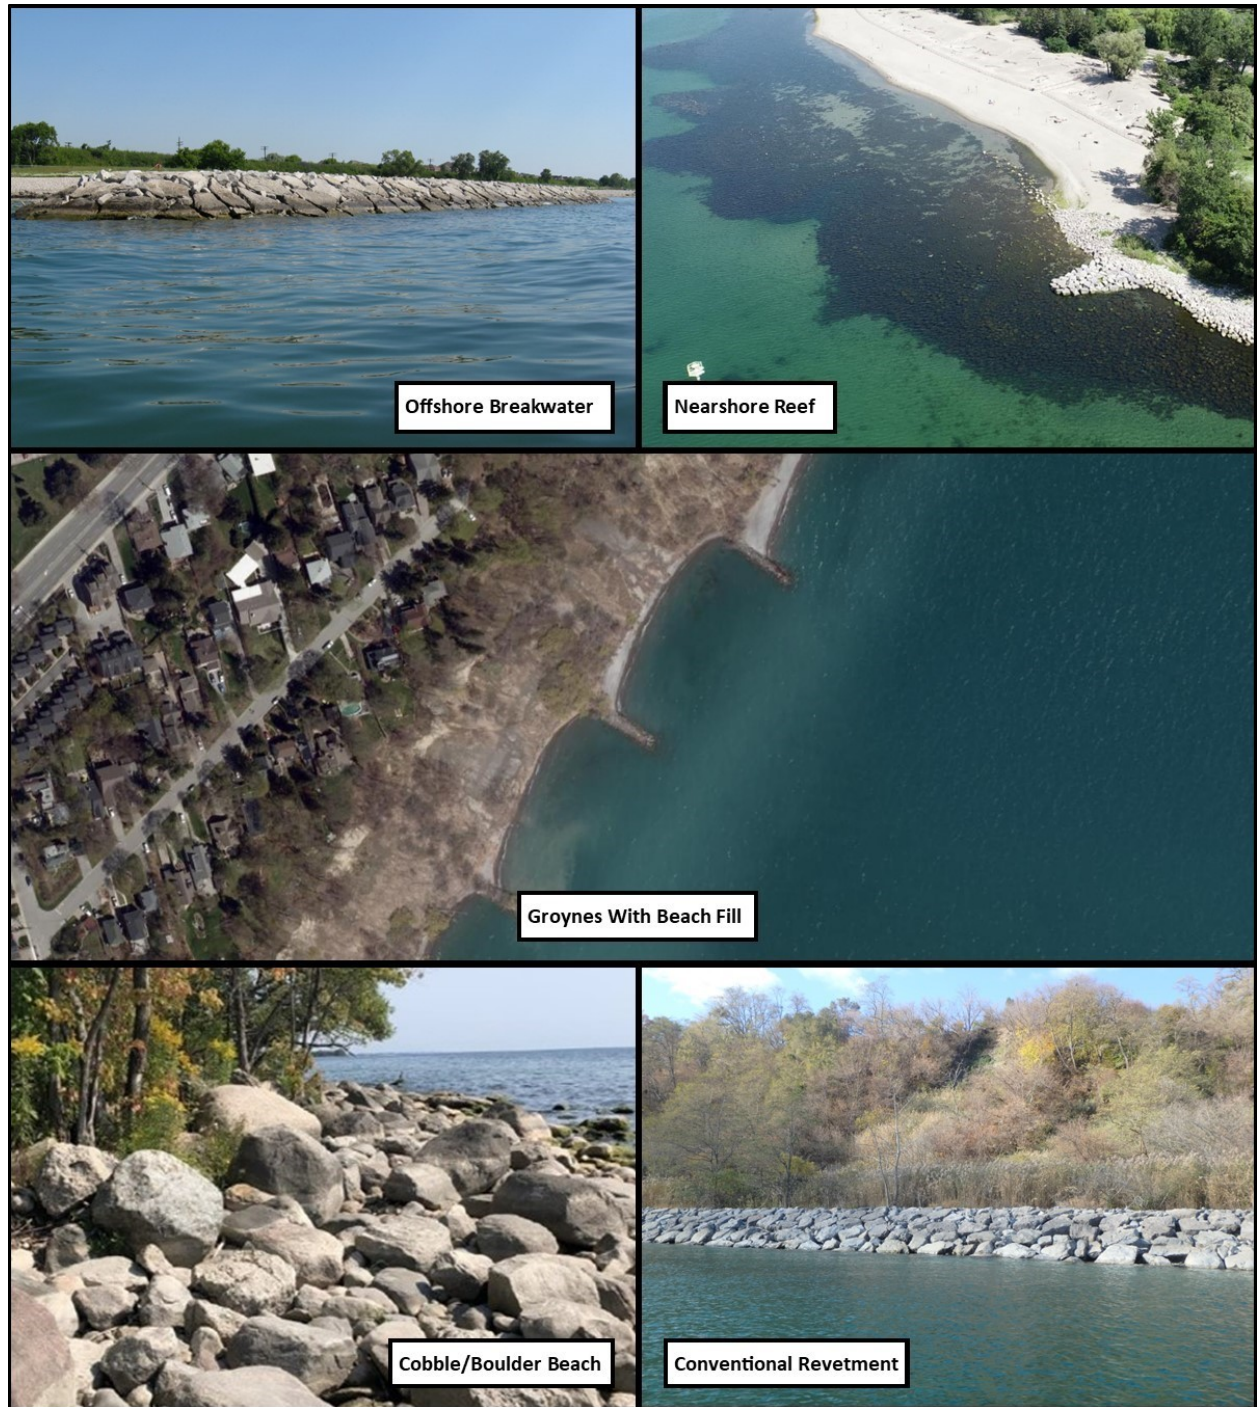
**Figure 30.** Examples of proposed preliminary alternatives from on-site and off-site examples. *Source: TRCA, various years.*

Example photos of what the structures may look like can be found in **Figure 30**.

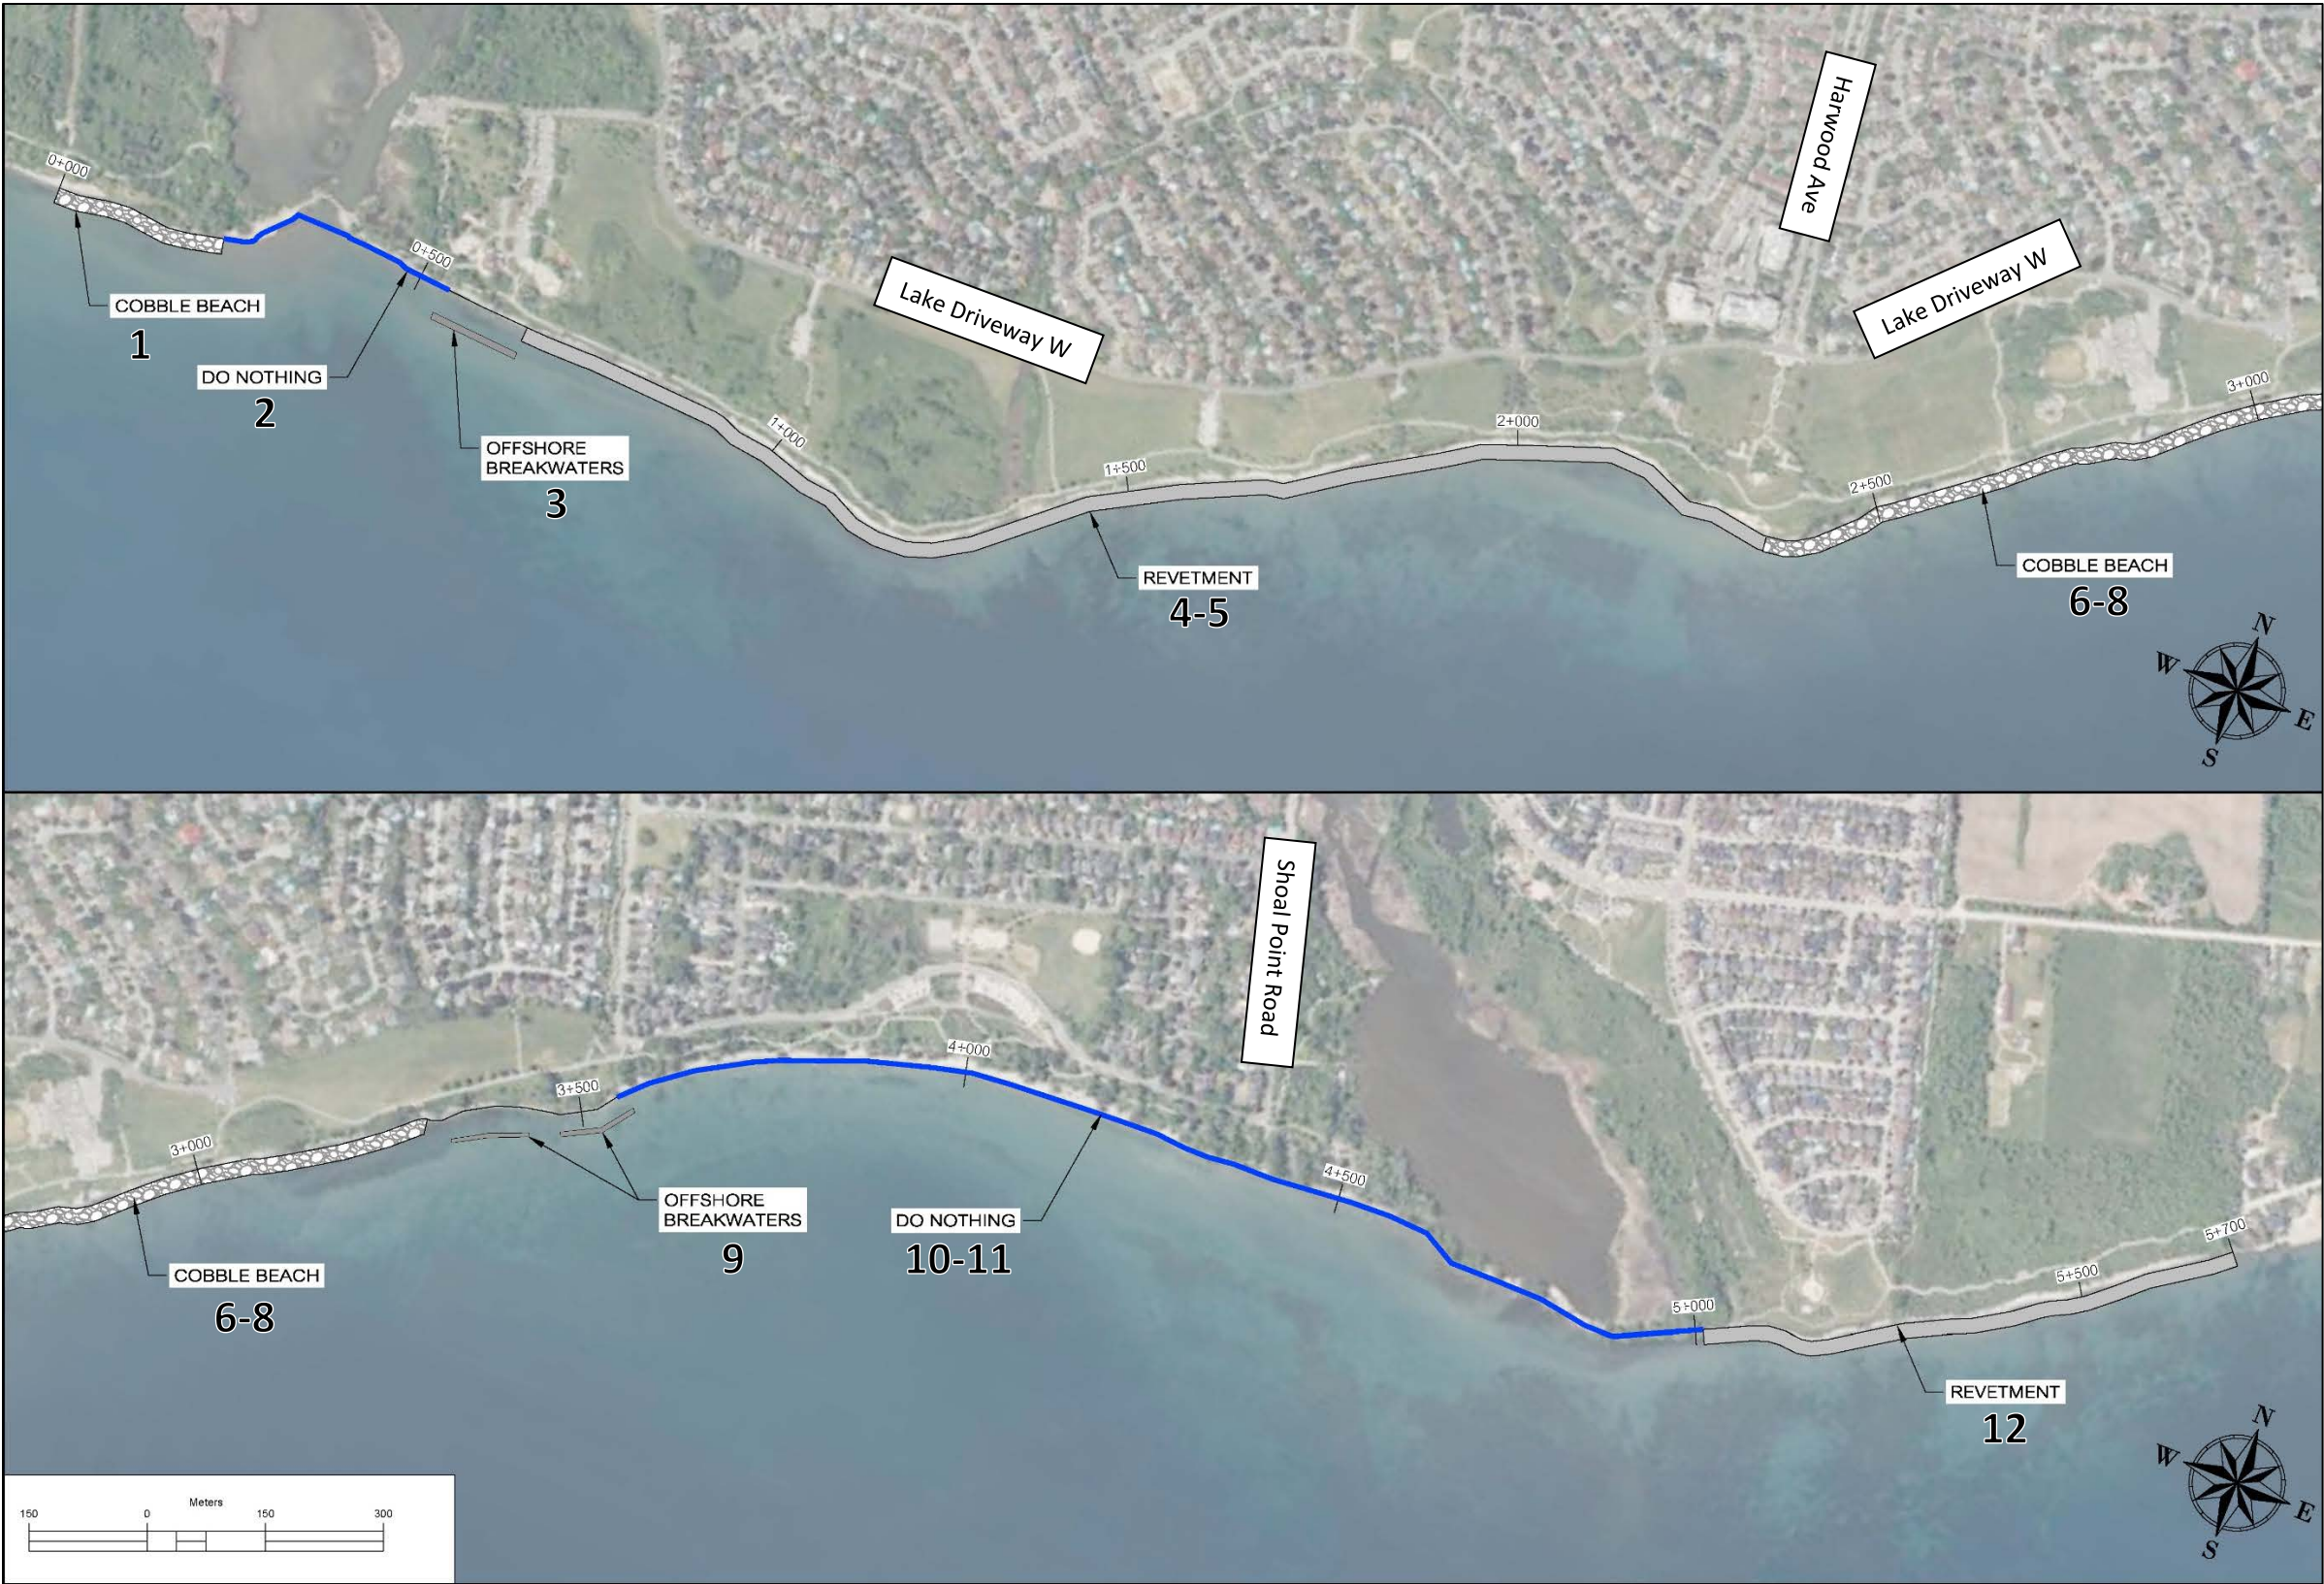
Figure 3131. Preliminary recommended alternatives for all reaches. Reach numbers are located below each alternative type. Source: Baird, 2023.

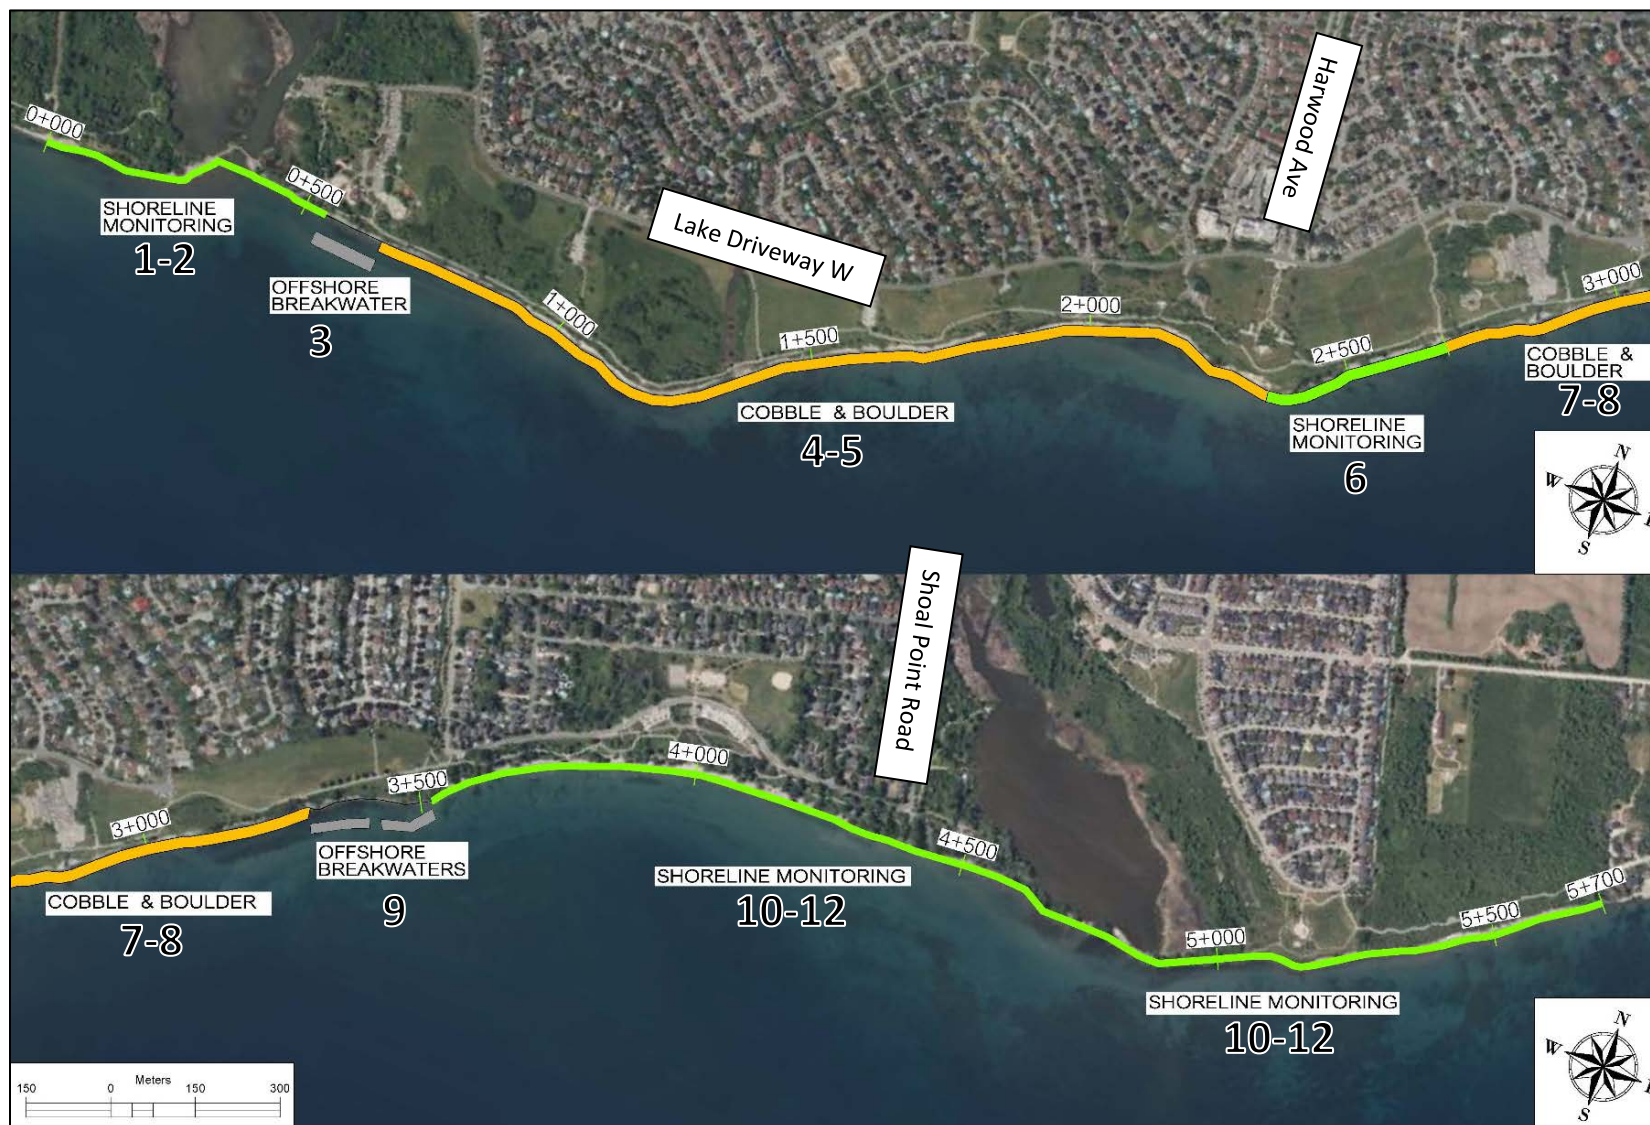
**Figure 3232.** Map of final recommended alternatives for Ajax shoreline. Reach numbers are included below alternative type. Source: Baird, 2024.
