**MARINE ARCHAEOLOGICAL ASSESSMENT
BACKGROUND RESEARCH AND
GEOTECHNICAL SURVEY
FOR THE
GIBRALTAR POINT EROSION CONTROL
PROJECT
LAKE ONTARIO SHORELINE ON THE LAKEWARD
SIDE OF THE TORONTO ISLANDS
ENVIRONMENTAL ASSESSMENT
CITY OF TORONTO**

**License # 2016-13
March 1, 2017**

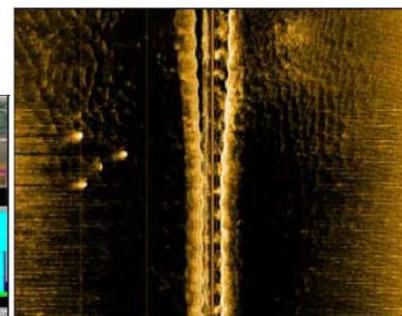
Group: Group 1
Description: S48 was located using side scan sonar, and could also be seen from the surface. S48 is made up of 3 pilings and a rock.
Latitude: 4336.7151,N
Longitude: 07923.3785,W
Depth: --- m
Created: 14/OCT/2016, 11:26:54
Position Set: 14/OCT/2016, 11:26:40
Dive Number: N/A
Diver/Operator Name: Boat
