Carruthers Creek Watershed Plan Fluvial Geomorphic Assessment

FLUVIAL GEOMORPHIC ASSESSMENT OF REGIONAL WATERSHED MONITORING PROGRAM DATA 2003-2016

Prepared by:
MATRIX SOLUTIONS INC.

REVISED
October 2019
Mississauga, Ontario

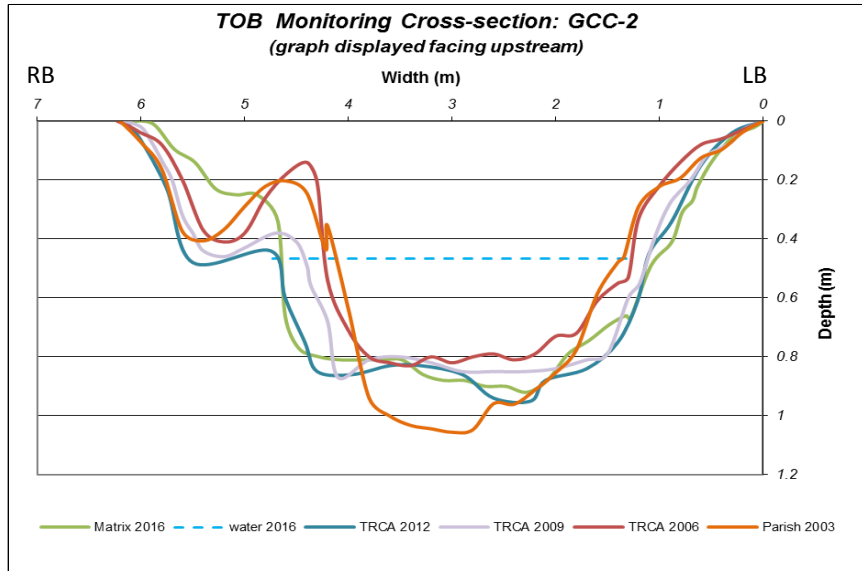
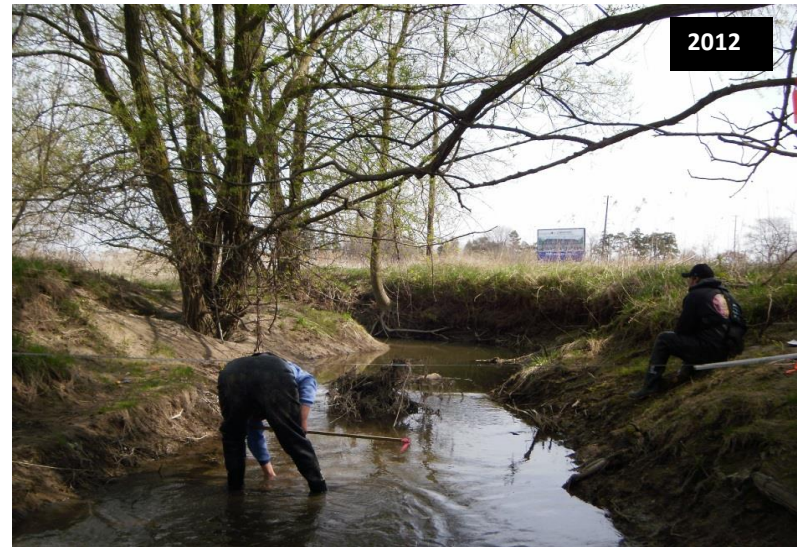
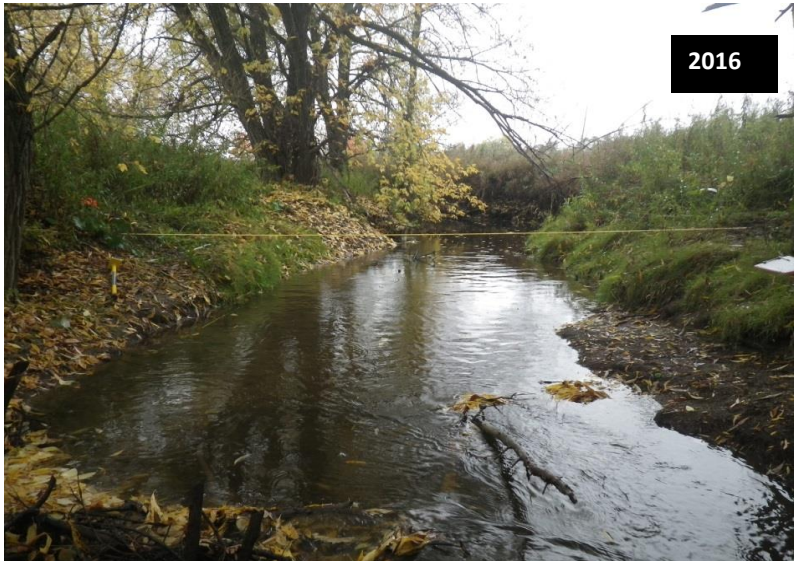
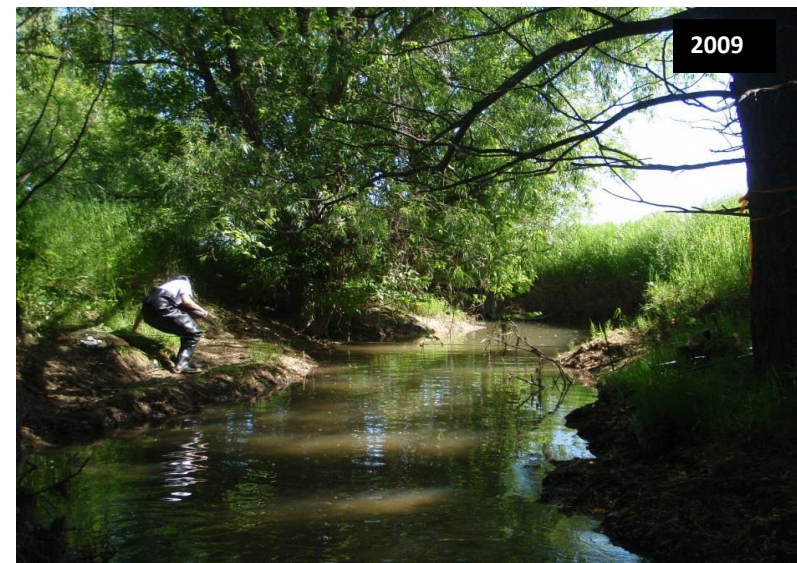
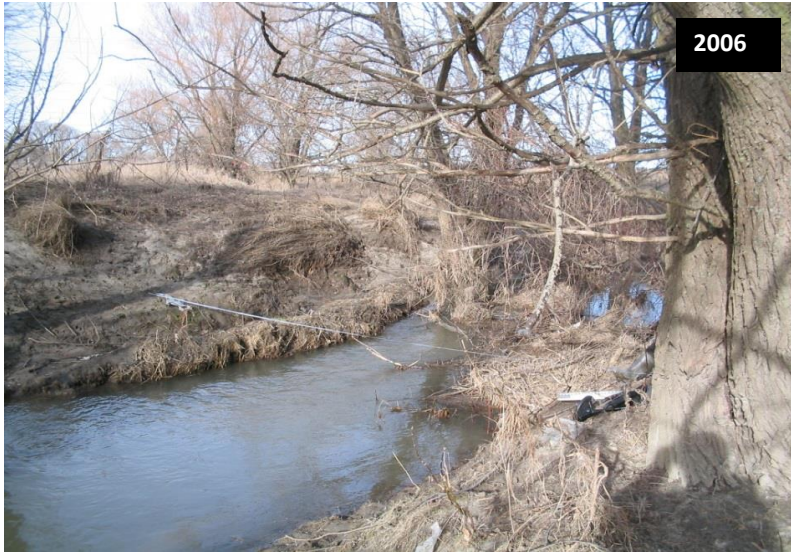
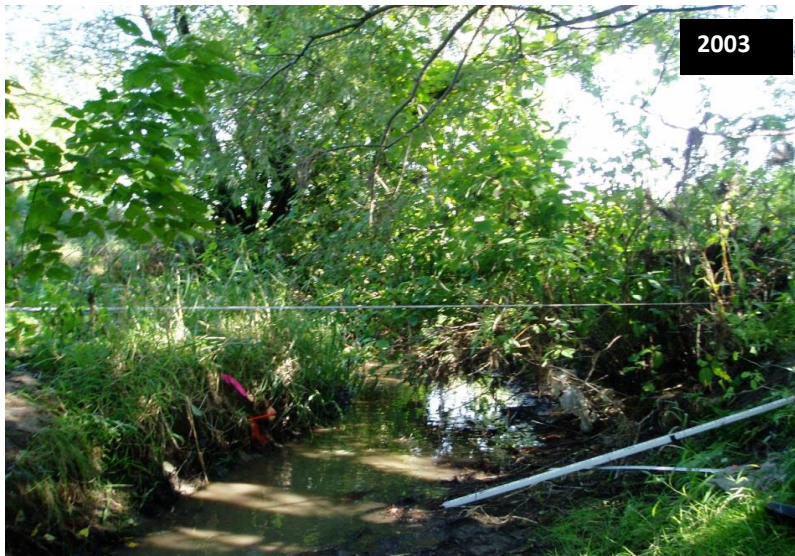
1. During the monitoring period, the grain size distribution remained consistent overall.
2. The distribution consists primarily of fine material. The distribution is particularly small given the size of the channel.
3. This is reflective of the active bank erosion.
4. The D_{50} typically consisted of pebbles, the coarsest material was coarse gravel.

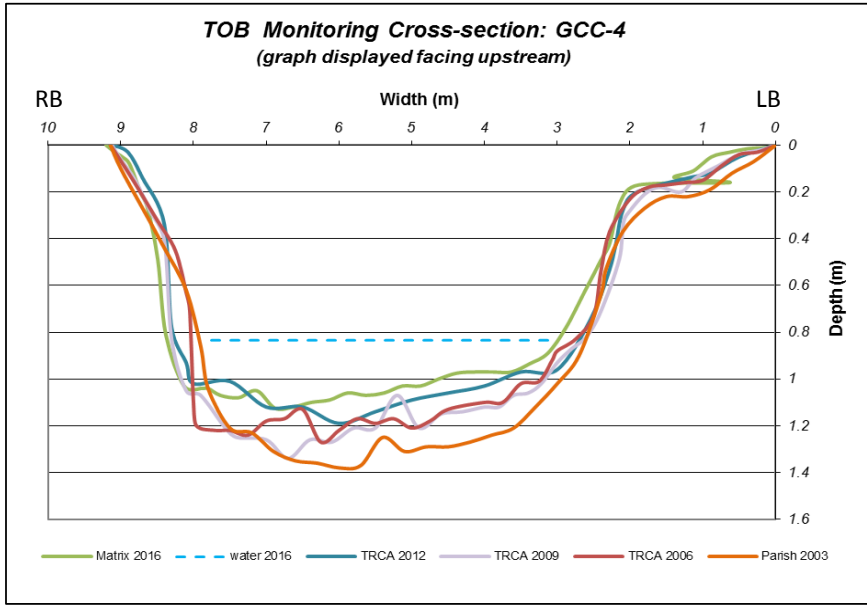
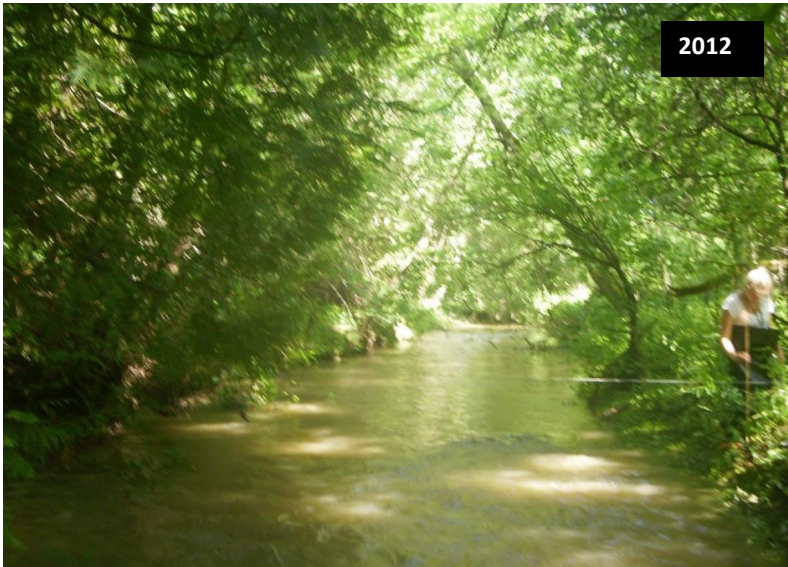
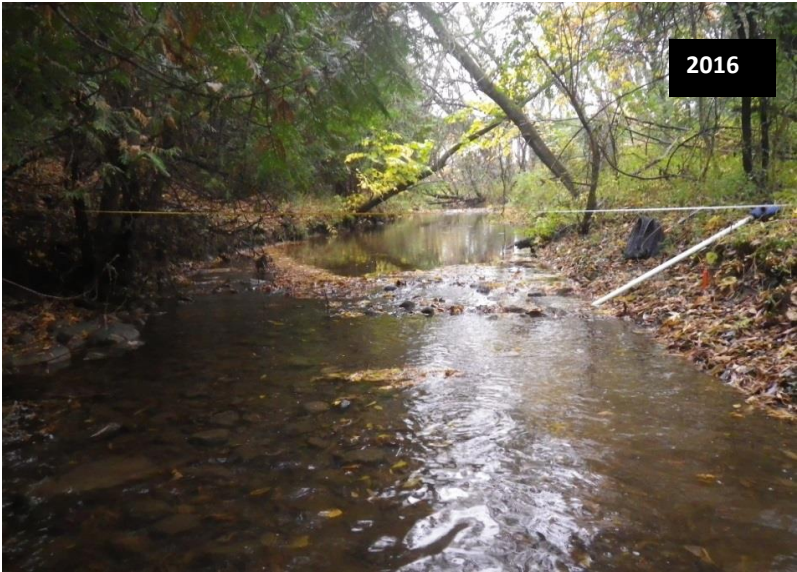
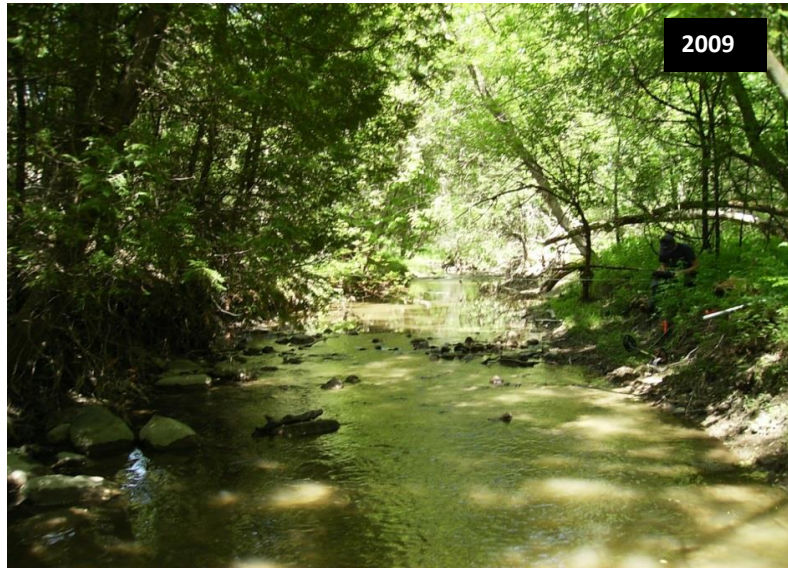
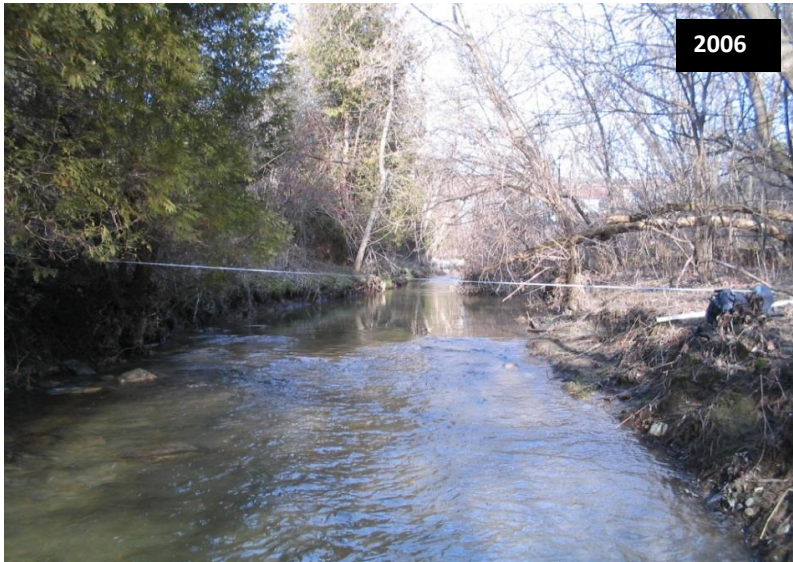
1. The substrate data shows a general coarsening trend.
2. The D_{50} has increased from coarse gravel to small cobbles.
3. The cross-section is located at a riffle which has accumulated increased coarse material.

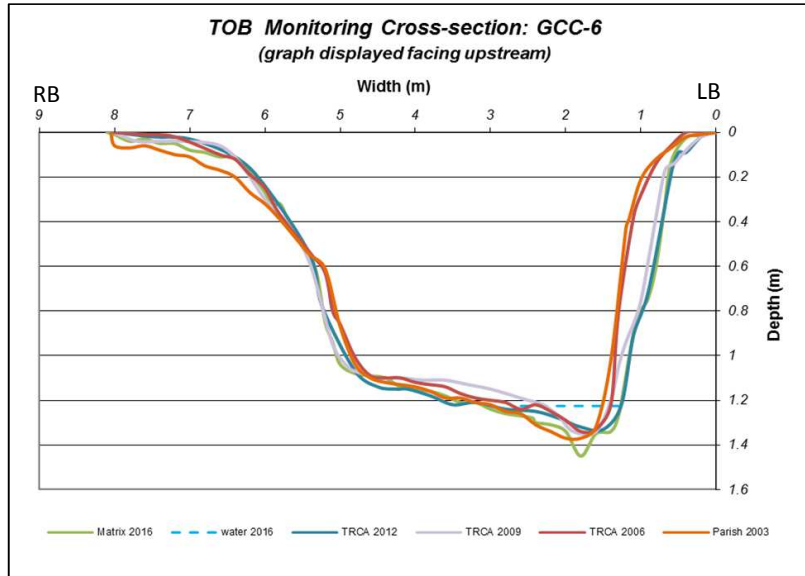
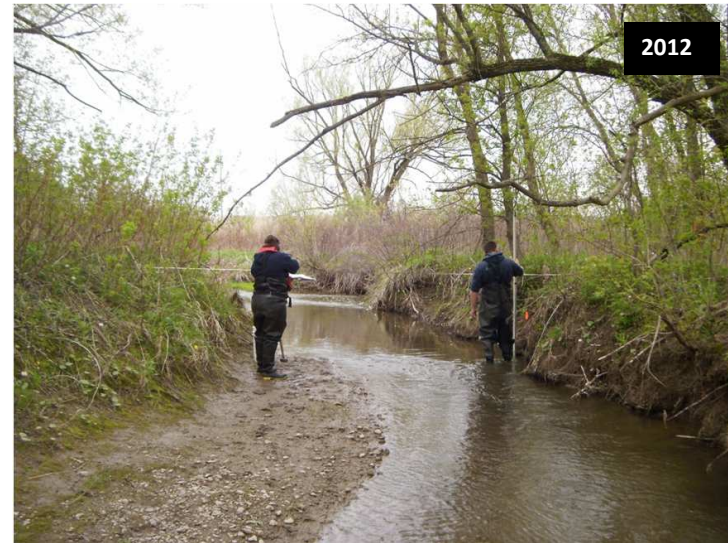
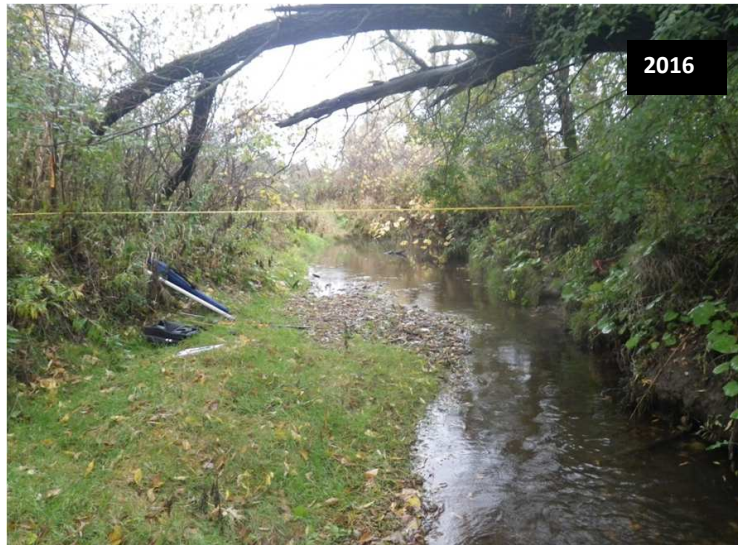
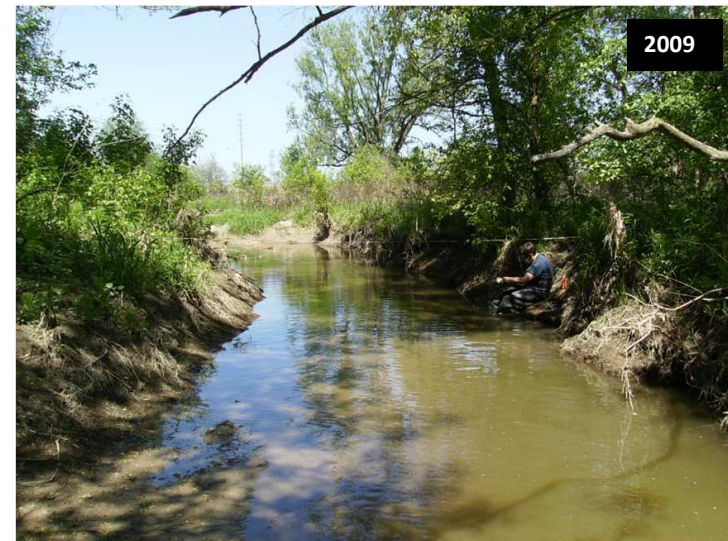
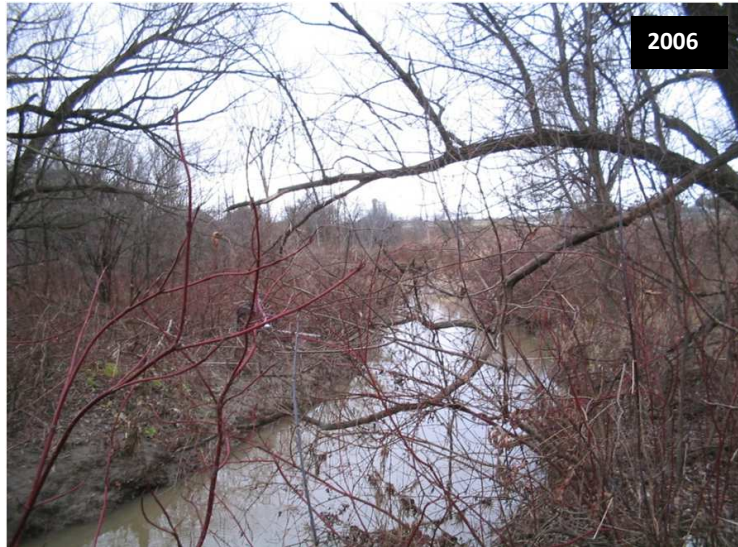
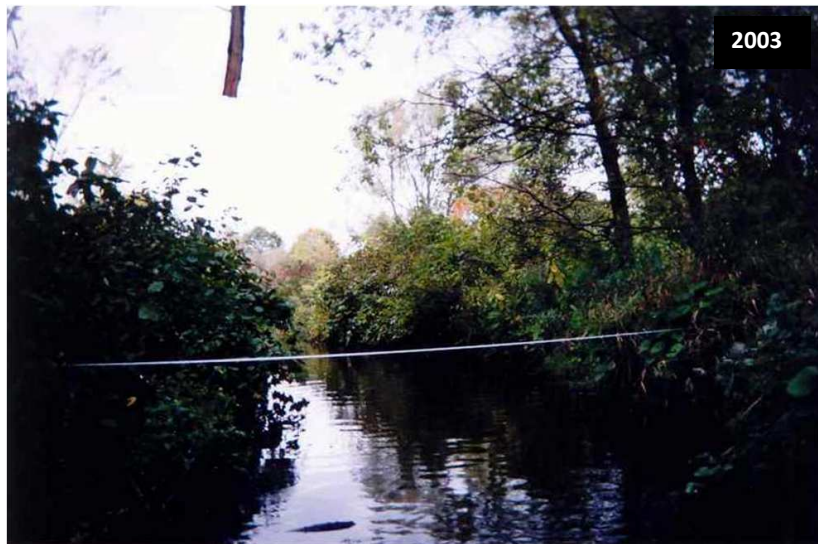
1. The grain size distributions have been generally similar over the length of the monitoring period.
2. The D50 has not varied substantially and was the same in 2006 and 2012. Generally the D50 was between pebbles and medium gravel.
3. More variability was seen in the D16 and D84 which is typical because the ends of the distribution are more sensitive to sampling bias. It is not necessarily indicative of changes in the overall distribution.

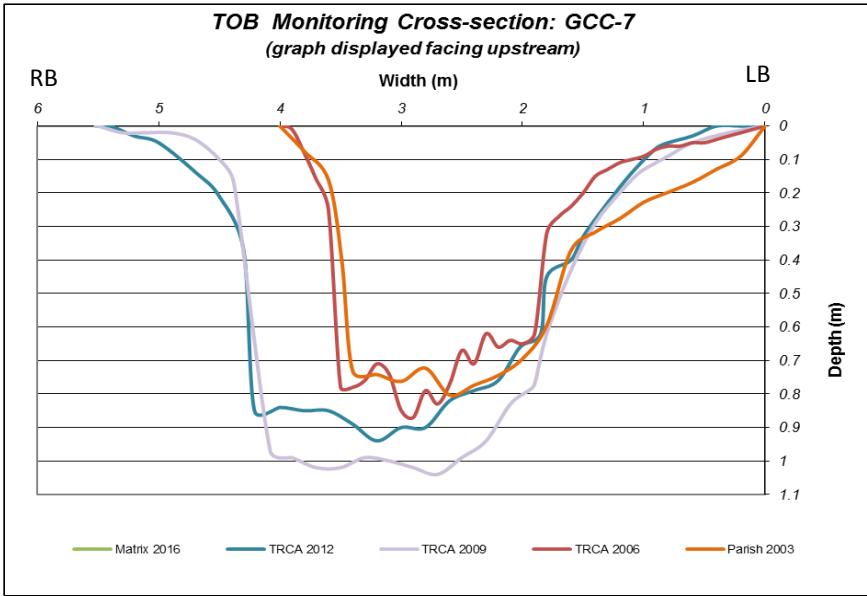
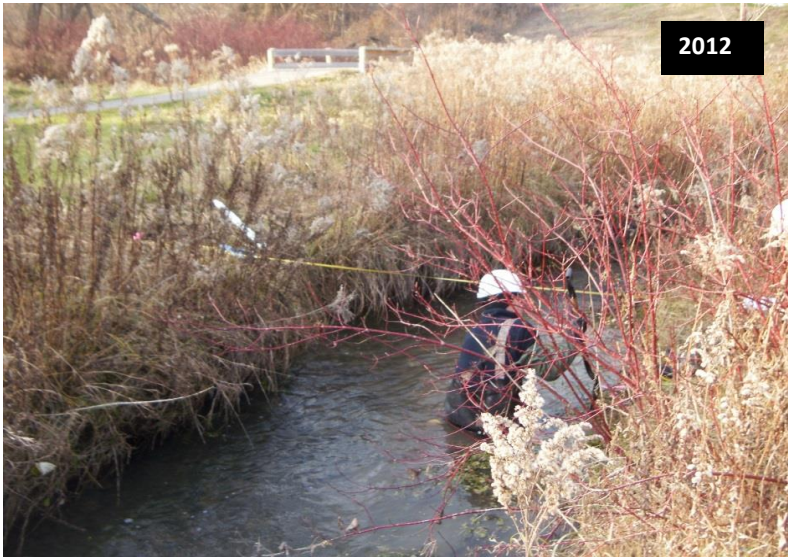
2016

**Cross-section bank pins could not be located;
cross-section was not reinstated**

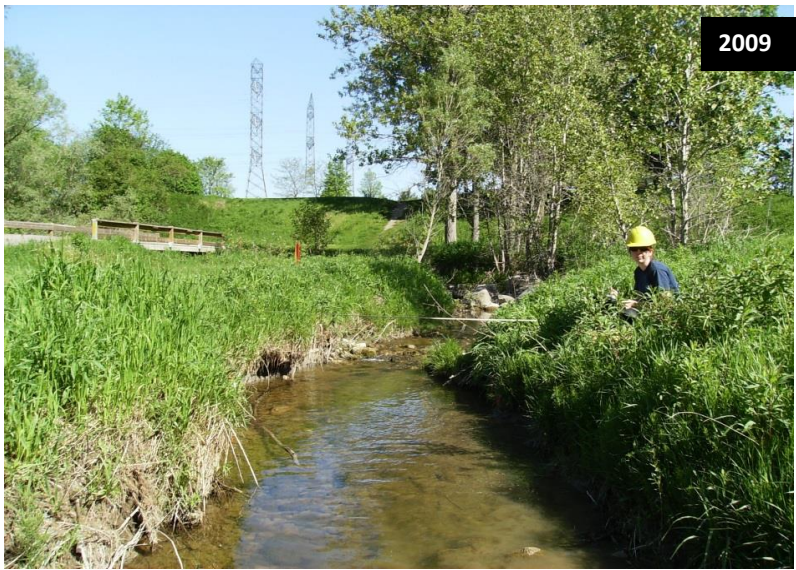
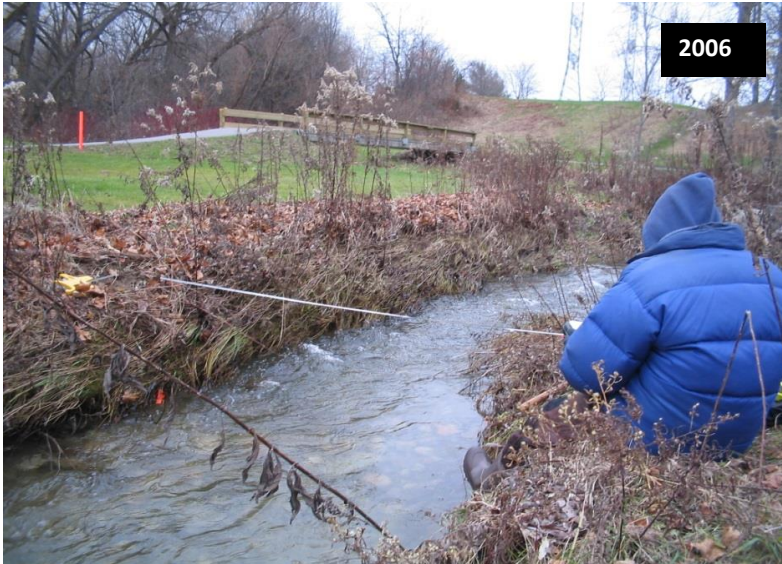
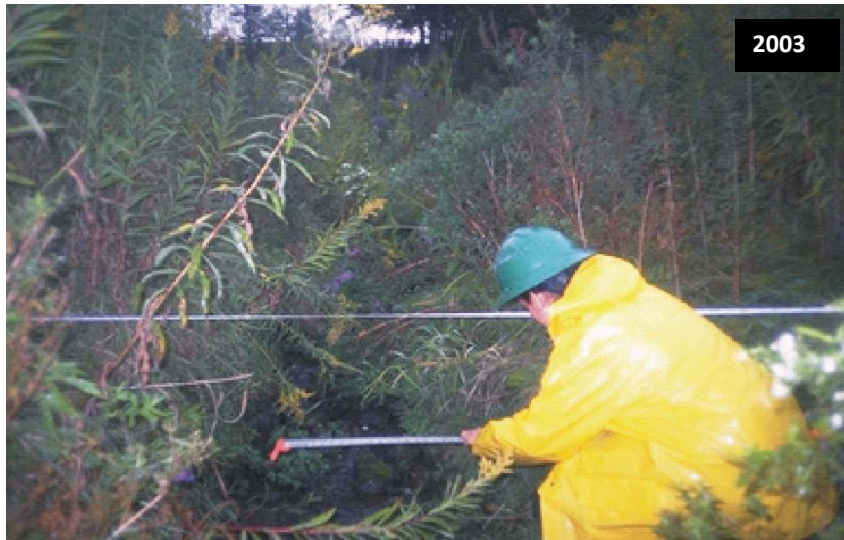
1. Grain size distributions were consistent through the various monitoring periods with minimal variation
2. The majority of the material at the cross-section consists of medium gravel to coarse gravel.
3. The largest material is classified as small cobbles.
4. The coarse nature of the material is expected due to the location within the golf course and high potential for modification and erosion protection

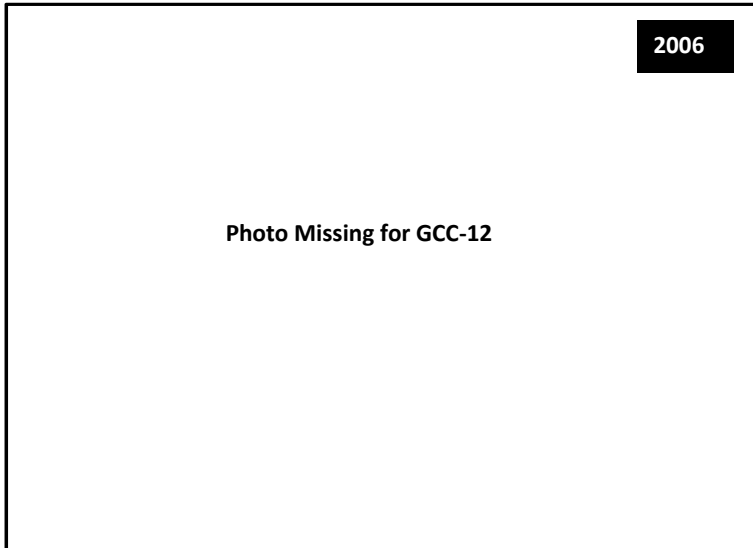
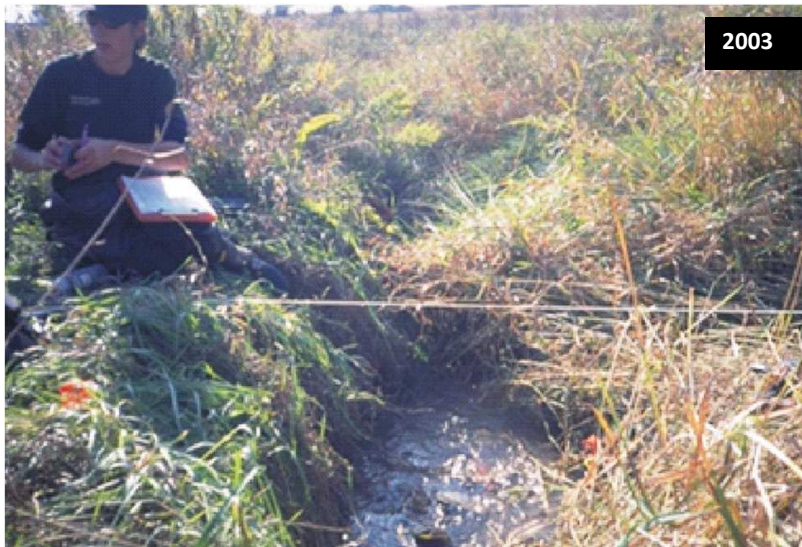
1. Two erosion pins were located at the monitoring cross-section: EP3 (LB) and EP4 (RB).
2. EP4 (RB) was eroded out/lost twice during the monitoring period in 2006 and in 2016. In 2016, partially buried on the bed by slumped material indicating failure of the right bank.
3. EP3 (LB) was eroded out/lost twice during the monitoring period, in 2012 and 2016. In 2006, 34.5cm of the pin was covered by material. This corresponds with the change in the left bank profile between 2003 and 2006. In 2016, EP3 could not be located, attempts to locate it using a pin finder suggest it was buried by material on the bed.
4. EP2 and EP1, located downstream of the cross-section in a bend, exhibited large increases in exposure between 2003 and 2006. The bend is actively eroding.
5. Based on the change in exposure of EP4 between 2006 and 2012 the migration rate is approximately 8.33cm/yr.

1. Grain size distributions are generally at the site are primarily composed of medium to coarse gravels.
2. There appears to be a coarsening of the distribution in 2012 and 2016. The D_{16} value for both years is similar to the D_{50} values from previous monitoring years. The D_{50} and D_{84} from 2012 and 2016 also suggest a shift to coarser material.
3. The coarsening of the distribution could be attributed to the deepening of the cross-section. As the channel continually erodes the bed over time, fines are removed and coarser material that the channel can not transport is left behind.

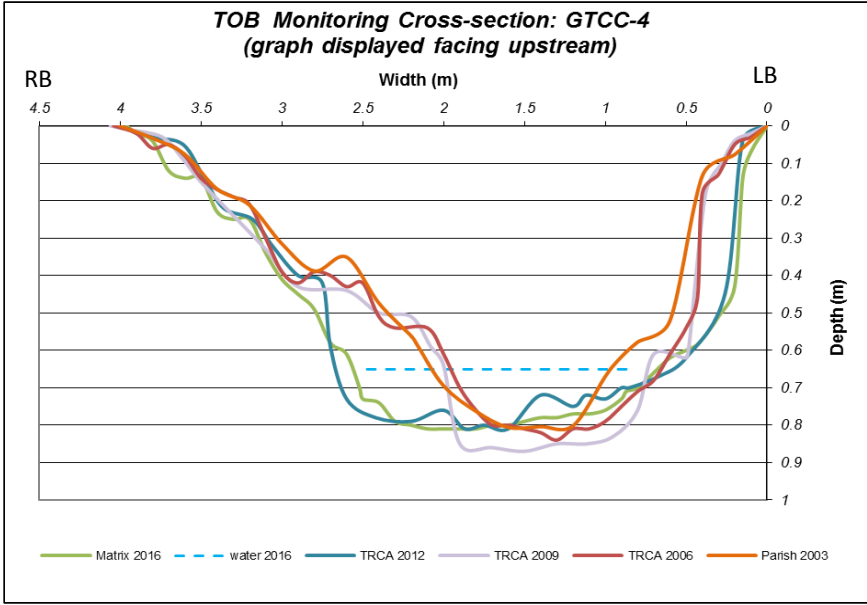
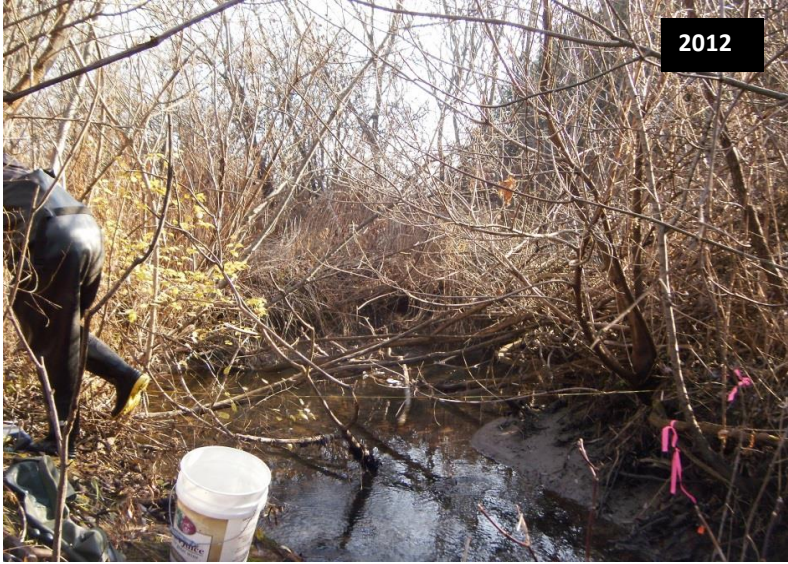
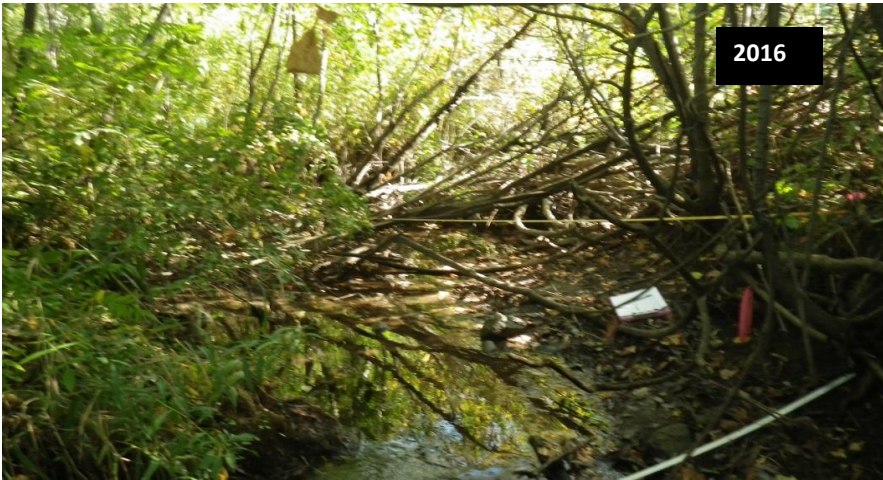
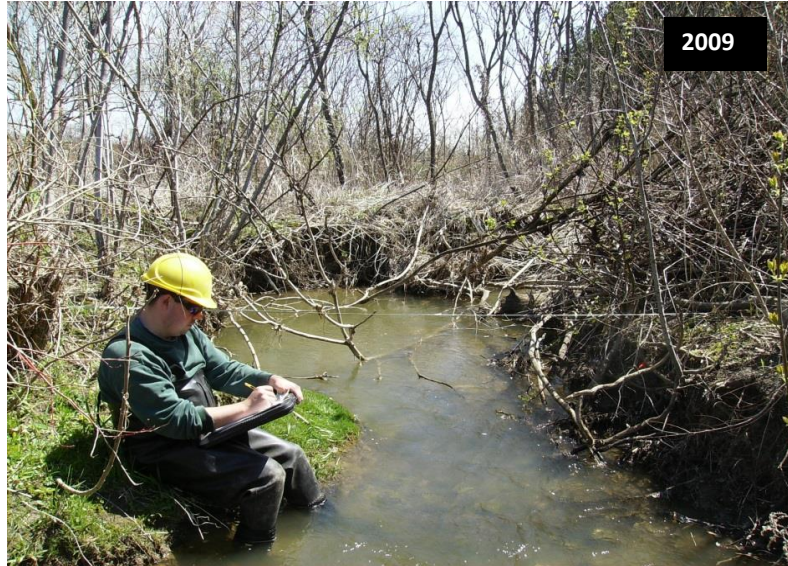
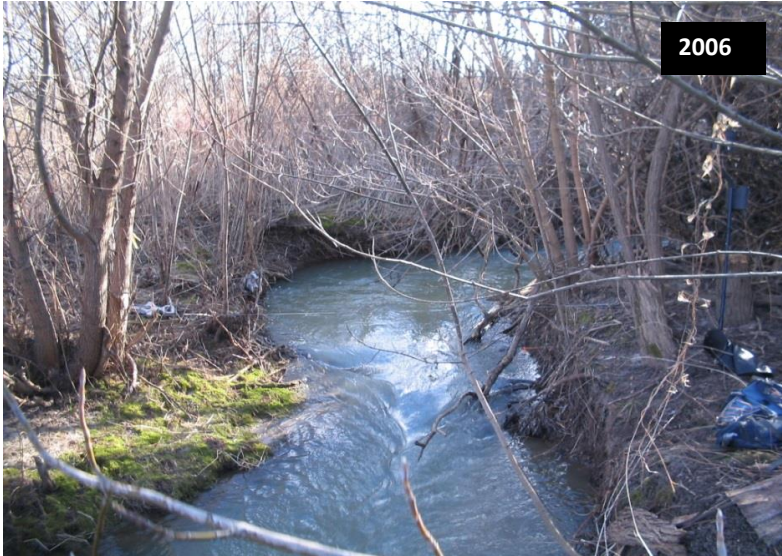
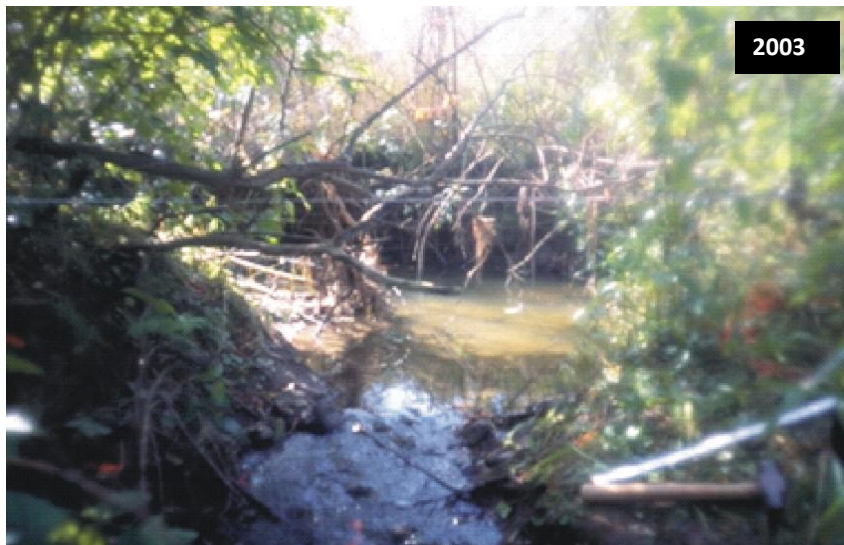
4. Another difference with the 2012/2016 cross-sections is the retreat of the lower portion of the right bank. Whereas the previous cross-sections show very little change in the right bank, in the 2012 cross-section it appears to have eroded approximately 0.70m and established a vertical bank profile. It's unclear from the photos what could have caused this change.

1. One erosion pin was located at the cross-section, EP2 (LB).
2. EP2 exhibited increased exposure ranging from 6-15.5cm and was lost in 2009.
3. The other erosion pins exhibited large changes in exposure during the various monitoring years. Overall the average migration rate based on the erosion pin data is 5.03cm/year.

1. The grain size distributions were consistent throughout the monitoring period with minimal change.
2. The D_{50} varied between 1.0-2.5cm which corresponds to medium and coarse gravel.
3. The D_{90} was indicative of coarse to very coarse gravels (3.0-4.8cm)
4. The material is relatively coarse for the size of the channel and could be why most of the cross-sectional change was lateral (bank erosion).

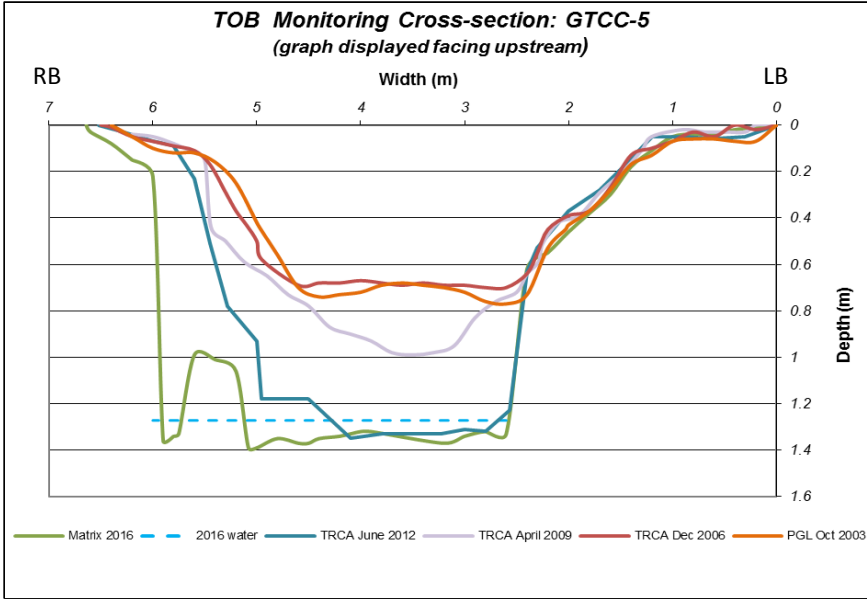
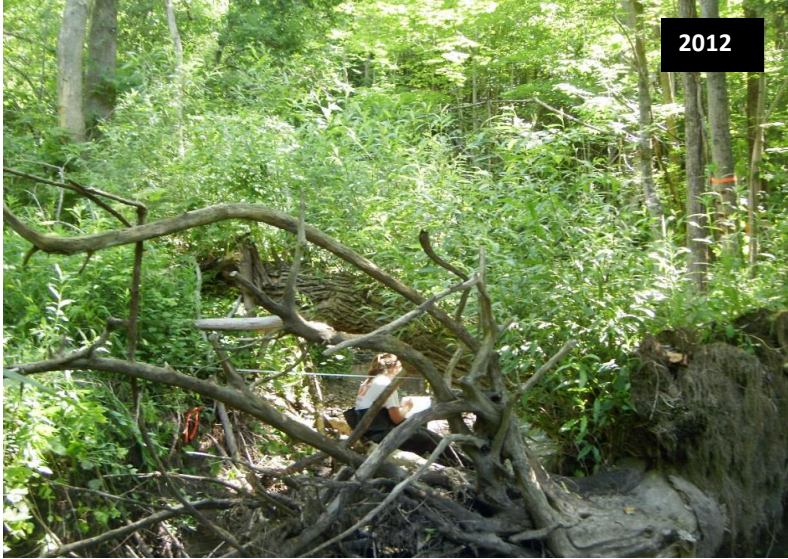
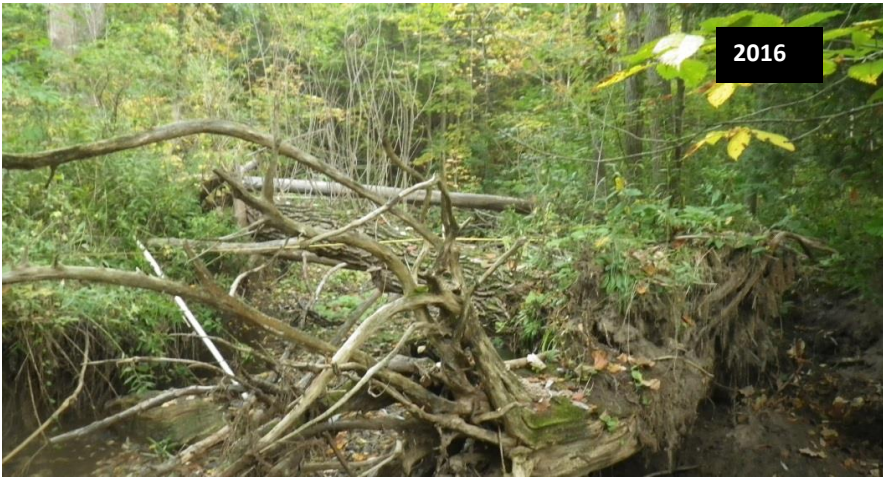
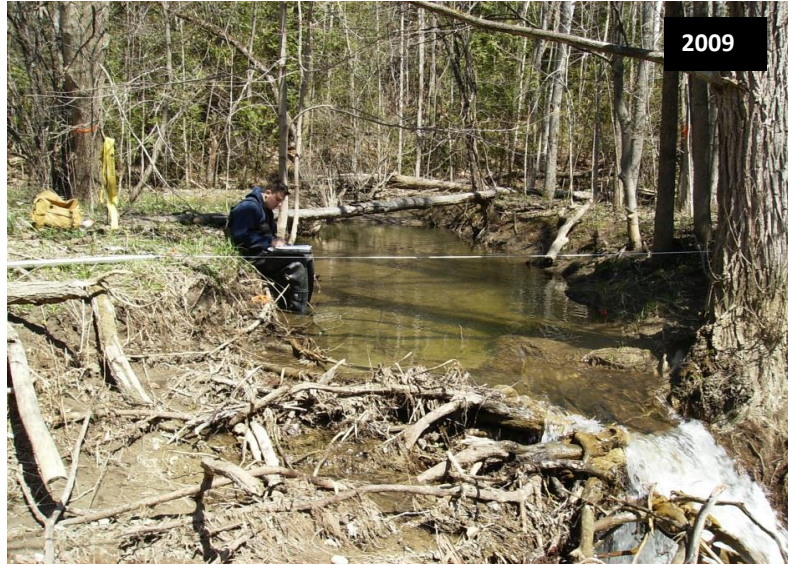
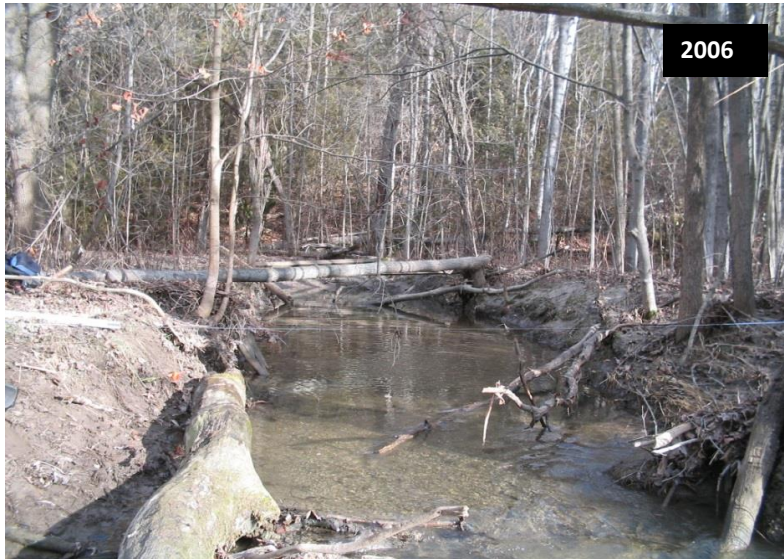
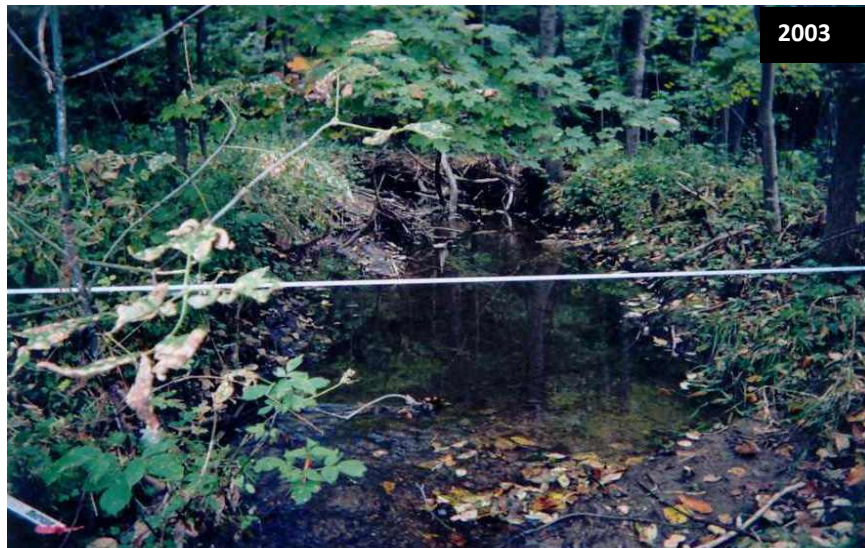
3. A review of the 2003 long profile indicates that there was a 0.53m drop in elevation associated with the debris jam.
4. Between 2006 and 2009 the debris jam appears to have destabilized based on the 2009 cross-section photo. As a result, the 2009 cross-section is deeper and widening with erosion noted along the right bank. The max depth increased from 0.7m (2006) to 0.99m (2009).

1. In general, there is a lack of erosion pin data from GTCC-5 due to frequent loss of pins.
2. It can be assumed that the pins were lost due to ongoing erosion which was noted not just at the monitoring cross-section but throughout the reach.
3. EP2 (LB) and EP3(RB) were located at the monitoring cross-section.
4. Similar to the cross-section, EP2 exhibited minimal change in exposure over the monitoring period.
5. Based on the data collected for EP3 the average migration rate for the right bank is 5cm/year. The pin was found eroded out and lying on the bed in 2016.

1. Grain size distributions are similar between 2003/2006/2009. Fine material (coarse sand, pebbles, silt) is a large part of the distribution. Medium and coarse gravels represented the coarse fraction.
2. The distribution coarsened in 2012 and 2016. When the debris jam no longer created a backwater, fine sediment was more efficiently transported downstream, leaving coarser material behind. As the channel incised more, more fine material was removed.
3. Coarsening of the bed is an indication that incision is slowing as the accumulation of coarse material acts to reduce bed erosion.

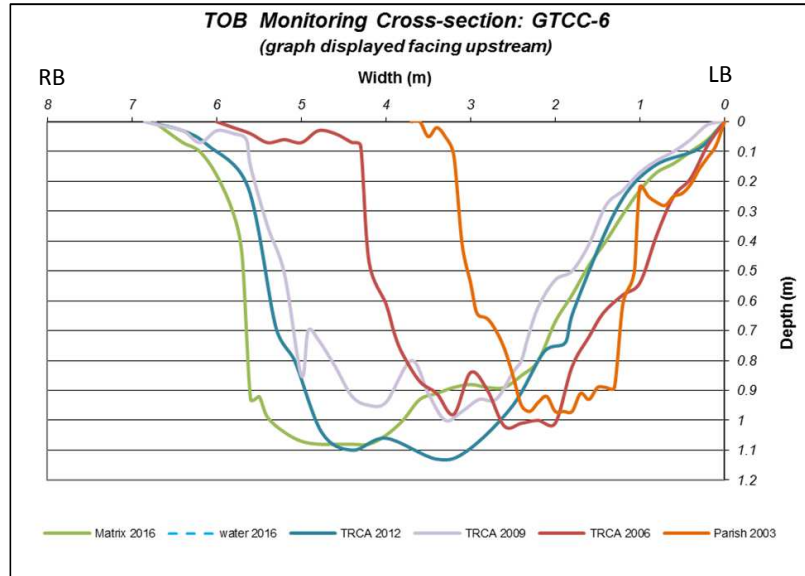
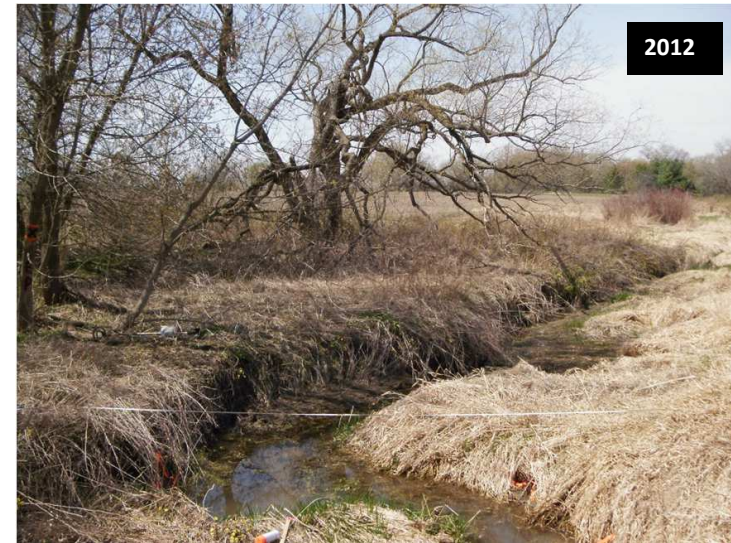
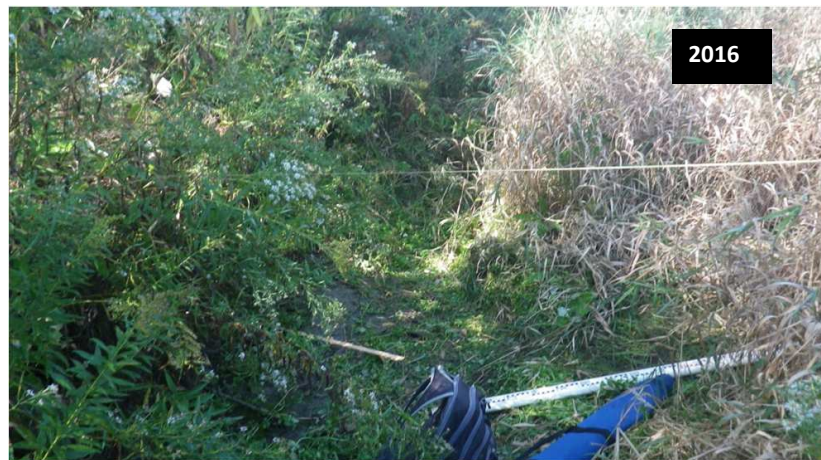
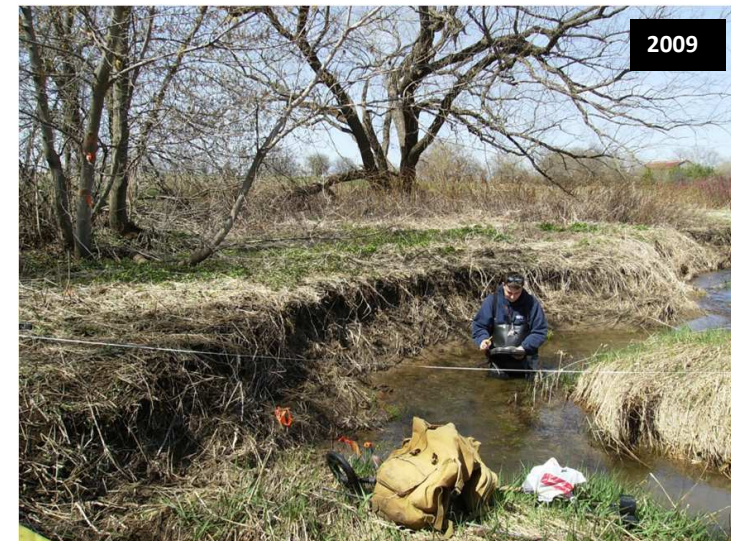
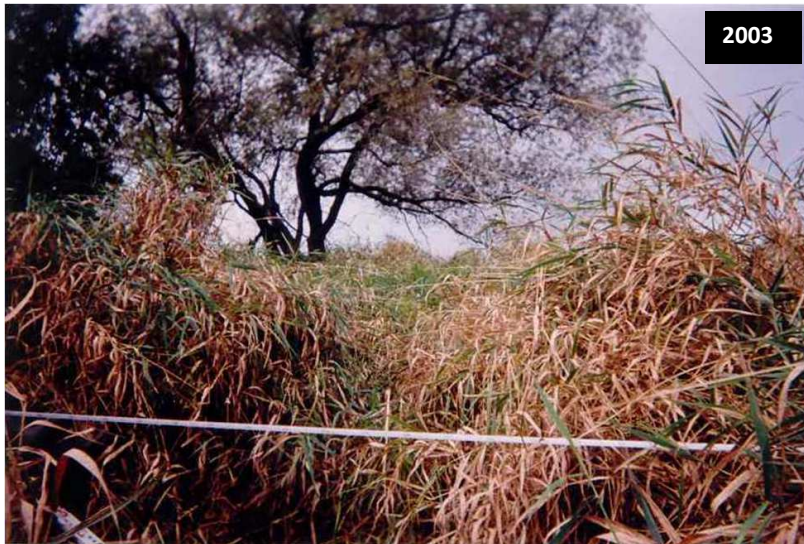
1. Two erosion pins were located at the monitoring cross-section EP4 (RB) and EP5 (LB).
2. EP4 indicated that the right bank is retreating relatively quickly, as is seen in the cross-section and field photos. The average migration rate based on the exposure data is approximately 13.3cm/year
3. Data for EP5 is variable suggesting periodic erosion followed by slumping of the material.

4. EP2 and EP3 are both located in an actively eroding bend and exhibit evidence of this. EP3 was documented as eroded out and lying on the channel bed during at least two monitoring visits. EP2 was also documented as eroded out and found on the bed during two of the monitoring visits.

1. Bed material is primarily composed of fine material (silt/sand/pebbles) and therefore minimal variation is noted between years.
2. The coarsest material consists of medium and coarse gravel (1-3cm).

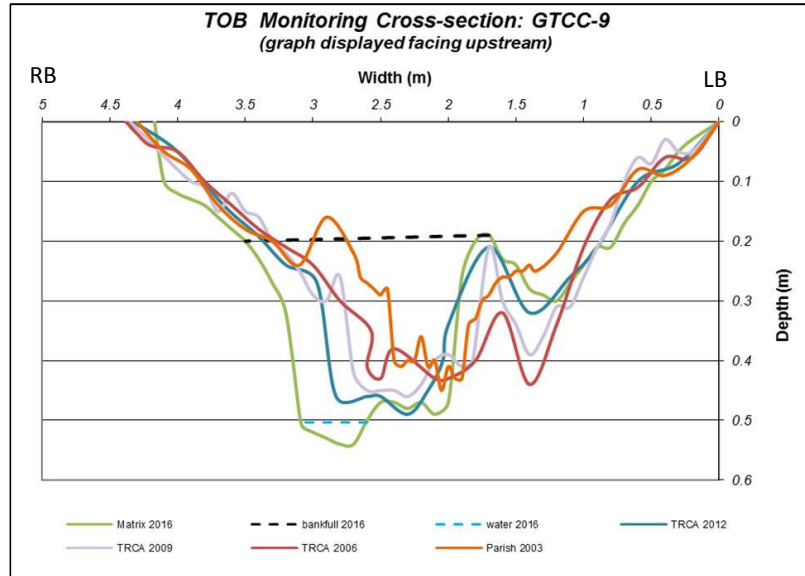
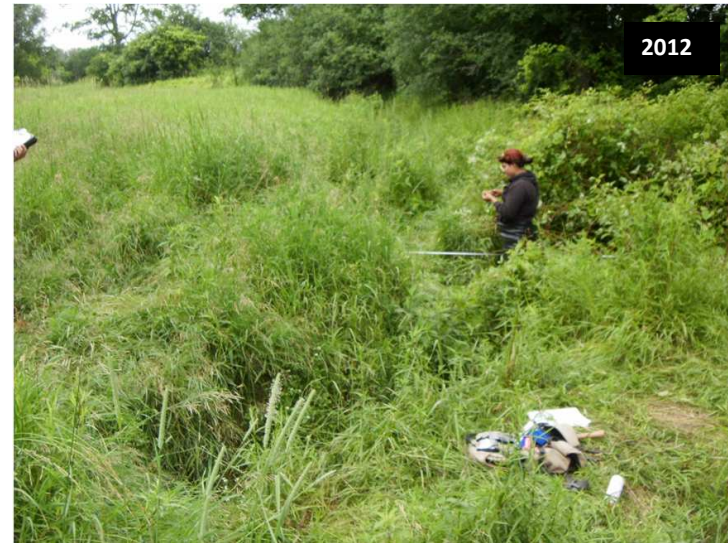
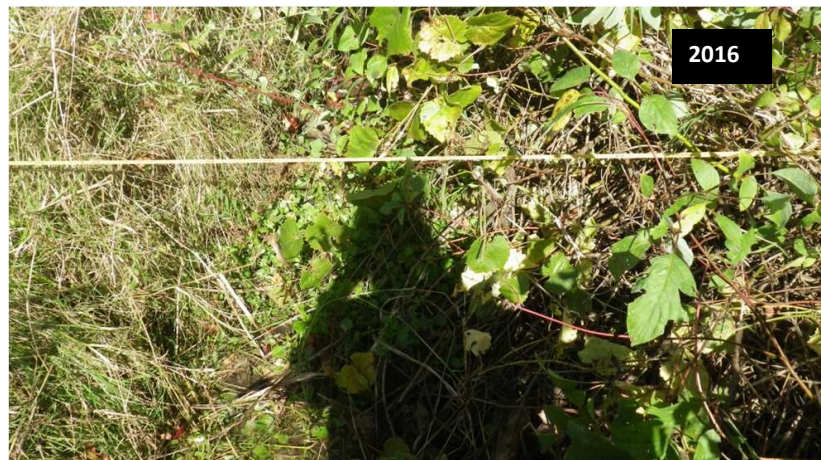
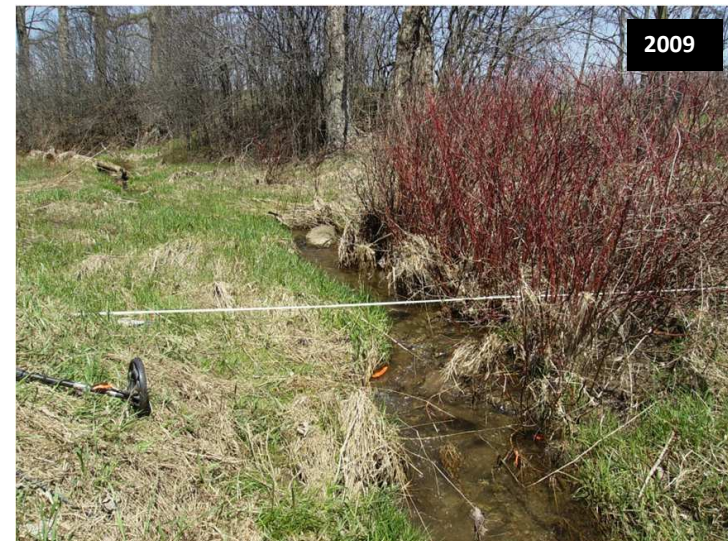
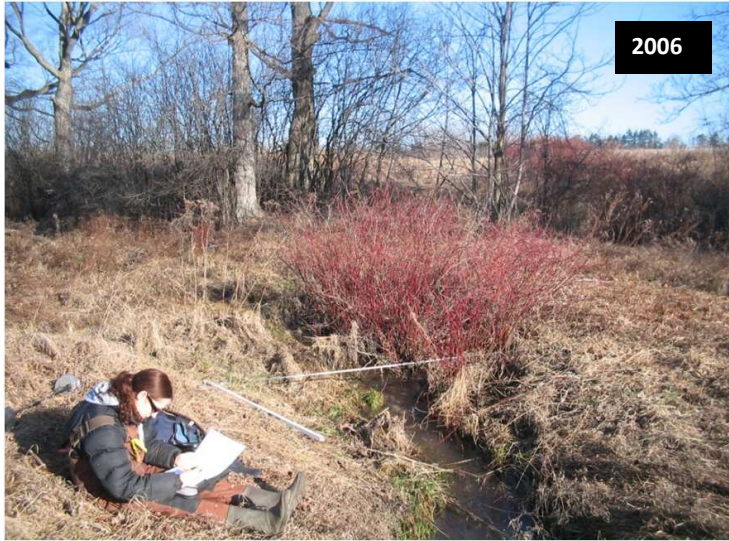
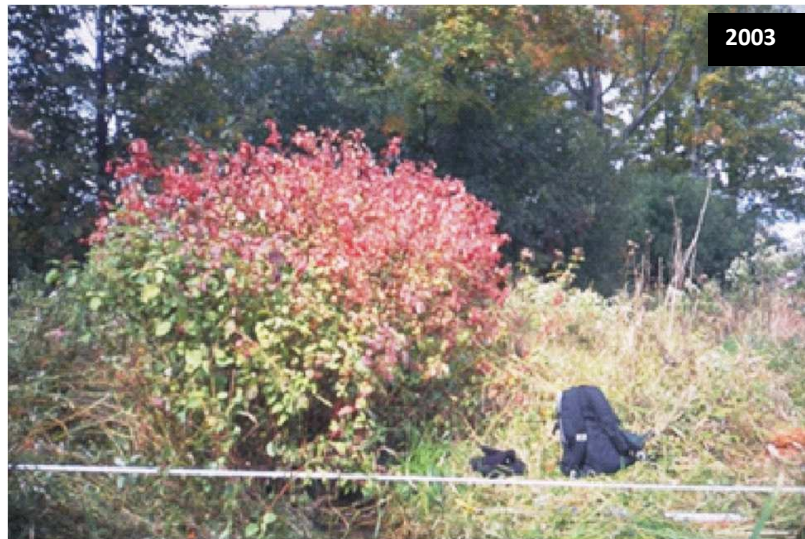
5. Between 2012 and 2016 the cross-section area increased primarily through erosion along the right bank. Which has widened the low flow area and deepened the cross-section

6. Overall, the bankfull cross-section within the monitoring cross-section has become larger through deepening and widening. The cross-section has also shifted further towards the right bank and filled in along the left bank. This shift could be related to the ongoing growth of the red-osier dogwood stabilizing the left bank.

1. Erosion pins located at monitoring cross-section, EP3 (LB) and EP4 (RB), show changes in exposure that are in agreement with cross-section changes.
2. EP3 exhibited a small increase in exposure between 2003 and 2006 when the overall bankfull cross-section widened. Pin exposure was then reduced for both the 2006-2009 period and the 2009-2012 period as the cross-section shifted towards the right bank and infilled along the left bank where EP3 is located.
3. EP4 exhibited large increases in exposure during the 2003-2006 period and then 2006-2009 period, 16cm and 16.5cm respectively. This corresponds with the shift towards the right
4. No erosion pins were located during the 2016 monitoring visit.
5. EP1 and EP5 also exhibited large increases in exposure throughout the monitoring period.

1. Substrate is primarily fine grained material with gravels.
2. Grain size distribution relatively consistent between monitoring periods.
3. Finer fraction consists of silt and sands while coarsest material is typically medium to coarse gravel.
