Carruthers Creek Watershed Plan Fluvial Geomorphic Assessment

FLUVIAL GEOMORPHIC ASSESSMENT OF REGIONAL WATERSHED MONITORING PROGRAM DATA 2003-2016

Prepared by:
MATRIX SOLUTIONS INC.

REVISED
October 2019
Mississauga, Ontario

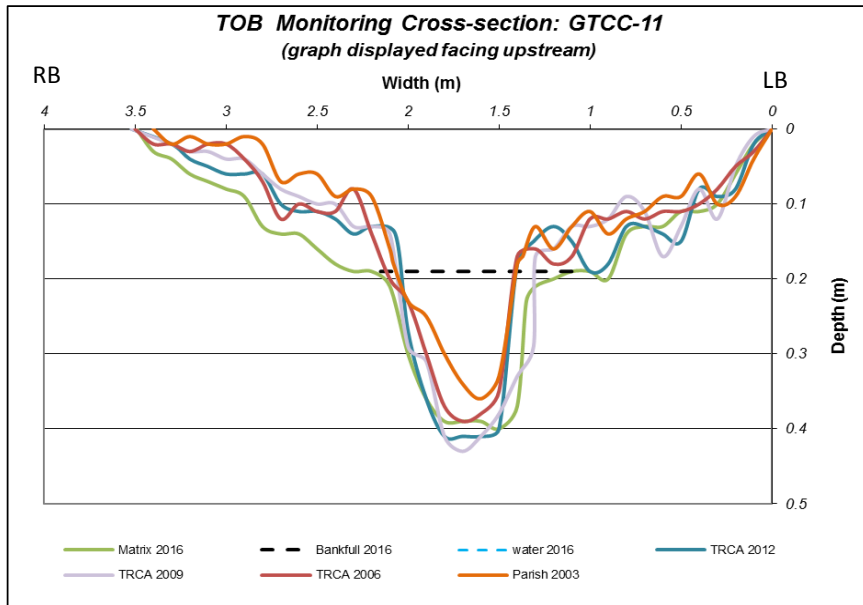
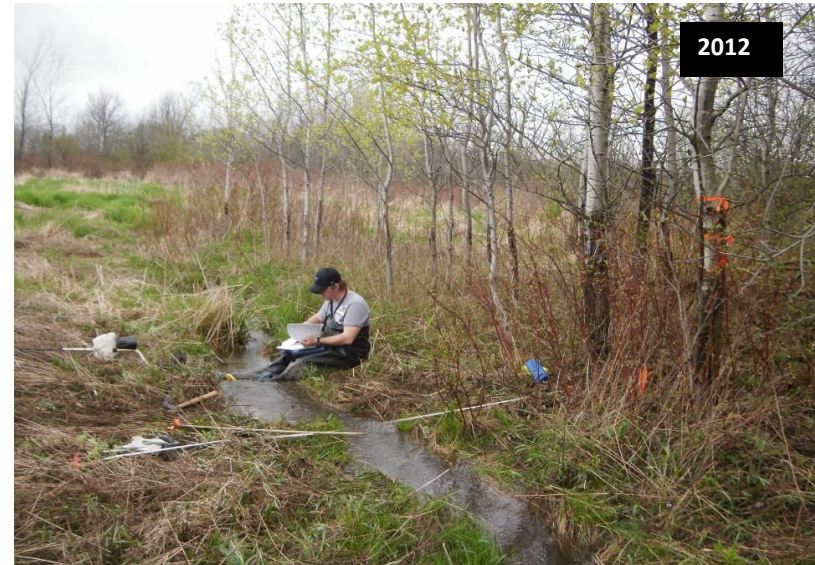
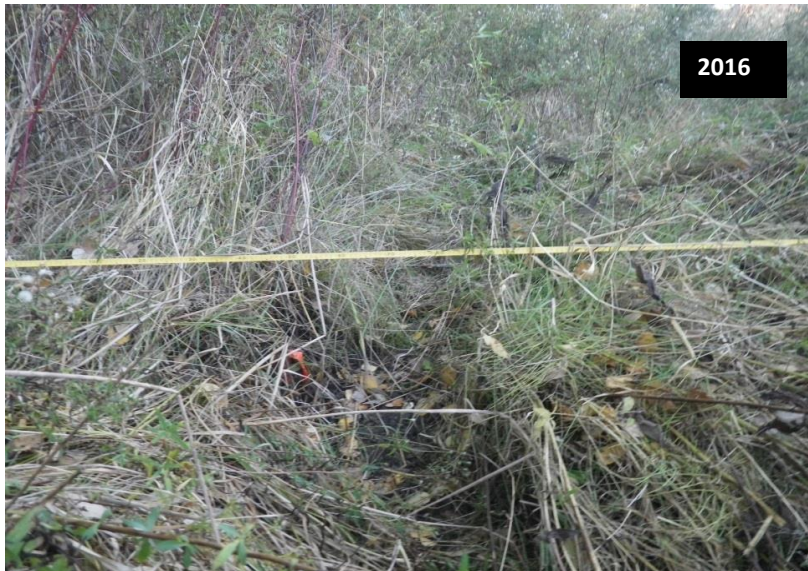
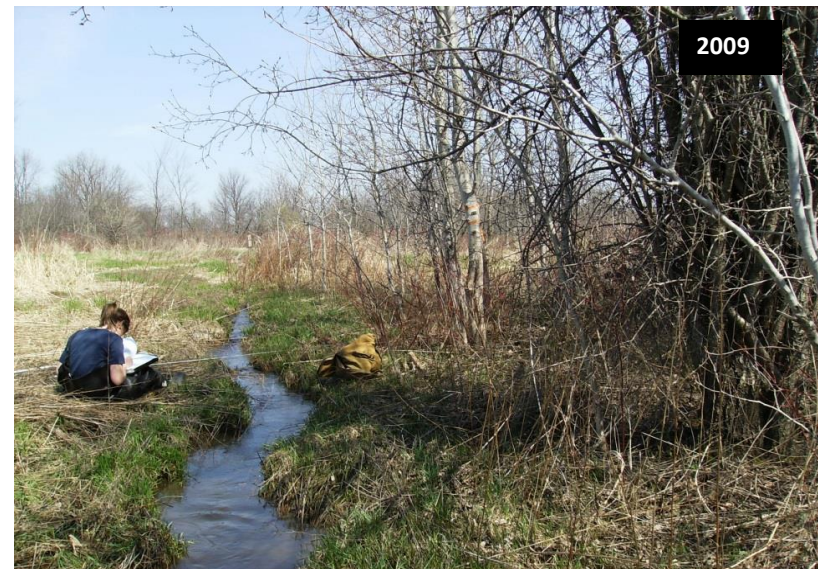
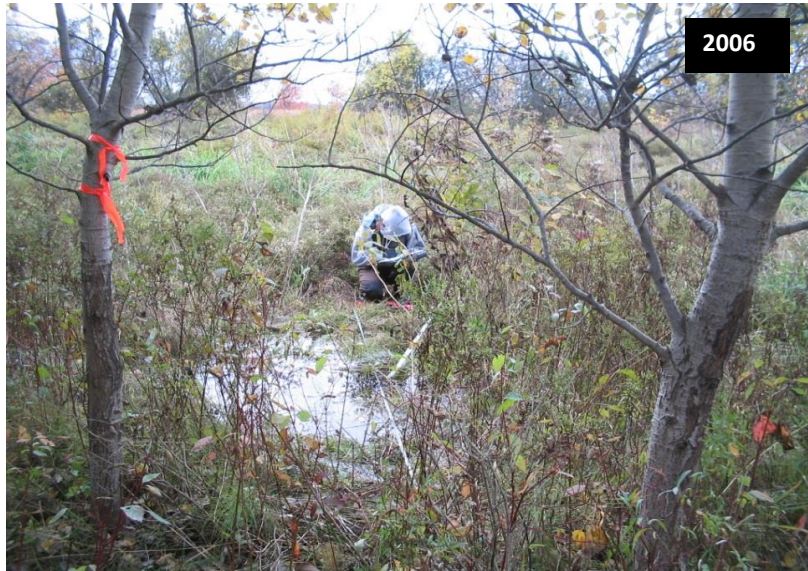
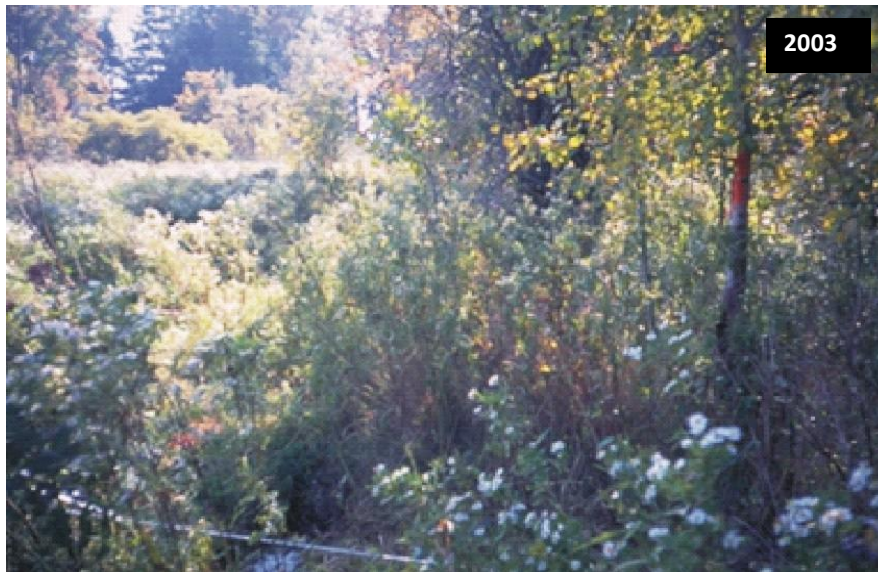
1. Bed material is composed of fine grained material, silt, sand and small pebbles. It is difficult to determine any variation over time when the dominant material is fine grained.
