Geomorphology Technical Memo (Palmer 2020)

Date: January 15, 2020

Project #: 1903601

Re: Fluvial Geomorphology Baseline Assessment – West Duffins Creek and Duffins Creek
Pickering and Ajax Flood Control Dykes Rehabilitation Class Environmental Assessment

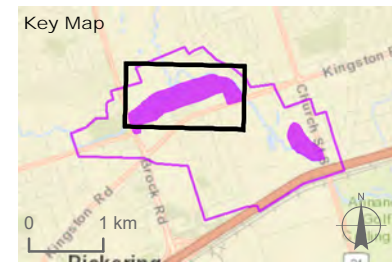
Pickering Dyke
 Figure 2

Rates of channel migration were documented at 14 meanders (**Figure 2**) near the Pickering Dyke. Time-averaged rates and the associated time period in which the meander displayed systematic channel migration are detailed in **Table 1**. Migration rates for individual time periods (e.g. 2002 to 2009) are documented in **Appendix B**. Four existing meanders do not display systematic channel migration due to confinement by the Pickering dyke itself (M1, M3, M5) or by a valley wall (M14). High migrations rates were observed at M2 and M4 in Reach 1a and M13 in Reach 2. Both M2 and M4 are downstream of two prominent riffles that steepen the channel as it enters the meanders. Review of aerial imagery and field reconnaissance indicate the riffles have migrated, which has led to the subsequent down-valley migration at M2 and M4.

Three high risk areas were delineated at M1, M3, and M5 (**Figure 2**). These are consistent with erosion areas documented in the previous geomorphic assessment (Geomorphic Solutions – Sernas Group, 2009). The previous assessment noted failing erosion control blankets, localized soil loss and scour at these three sites. Review of aerial photography and site photographs from the previous assessment reveal growth of riparian vegetation on or near the dyke at all three encroachment sites. Riparian vegetation and associated root networks could increase the shear resistance of the bank to erosion. However, the vegetation could also locally displace the stone comprising the erosion protection. Although active erosion was not observed during field reconnaissance, erosion is expected at or near these locations in the future based on reach-scale planform adjustments. As well, toe erosion of the valley wall is likely to occur at M14 at a rate that could be estimated based on detailed site assessment.

The rapid down-valley migration at M2 and M4, and associated reduction in radius of curvature (i.e. ‘tighter’ bends), could induce a channel avulsion near M3 and M5, respectively (**Figure 2**). In particular, a channel avulsion at M4/M5 could occur along the persistent topographic depression of the 1946 channel alignment. Avulsions and/or continued rapid channel migration could result in the channel abutting the bank/dyke downstream of existing erosion protection.

The large oxbow east of M6 is unlikely to be readopted in the short term because of the existing position of the Duffins Creek-West Duffins Creek confluence. If the oxbow is reoccupied, however, erosion protection will likely be required where the oxbow is within 10 m of the dyke (i.e. location of the 50” flap valve). Downstream of the oxbow, Duffins Creek is sufficiently far from the dyke that erosion risk remains low. At M11, continued outer bank migration could undermine or outflank the south bank abutment of a pedestrian bridge (**Figure 2, Photo 8**). At M13, the channel is rapidly migrating and the dyke is within 35 m of the channel. However, based on the down-valley migration trajectory, the channel is unlikely to migrate closer to the dyke.

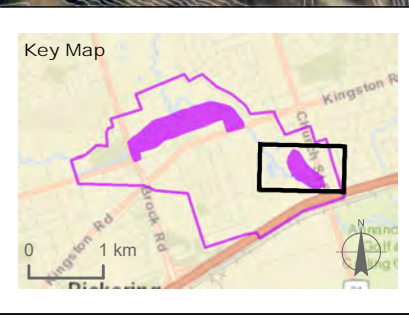
Figure 3

Rates of channel migration were documented at eight meanders (**Figure 3**) near the Ajax Dyke. Time averaged rates and the associated time period in which the meander displayed systematic channel migration are detailed in **Table 2**. Migration rates for individual time periods (e.g. 2002 to 2009) are documented in **Appendix B**. Two meanders did not display systematic channel migration since 1988 (i.e. shortly after the dykes were constructed). M20 is confined by localized channel hardening downstream of the WSC structure. Lateral migration of M22 is hindered by the downstream Church Street South bridge. The other six meanders are migrating both laterally and longitudinally as Reach 3 readopts a more sinuous planform following channel straightening in the mid 20th century.

Based on historic and existing morphological conditions, the Ajax Dyke was divided into erosion risk categories (**Figure 3**). Most of the dyke is considered low risk because the dyke is greater than 50 m from the channel and there are no signs of migration toward the dyke. The dyke is locally within 40 m of the channel, however, the bank protection at M20 will hinder channel migration towards the dyke. M15 is migrating towards the stormwater ponds in the western floodplain. Migration of the channel into the ponds and the potential avulsion that could result would drastically alter channel dynamics and sediment supply downstream in the vicinity of the dyke. Migration of M15 should be monitored. The Church Street South crossing controls the channel location near M22 and, thus, channel migration is not expected at M22 unless the crossing is modified/replaced.
