West Don River at E.T. Seton Park – Detailed Fluvial Geomorphic Analysis and Erosion Risk Assessment

Contract # 10009019

Toronto and Region Conservation Authority

October 2, 2019

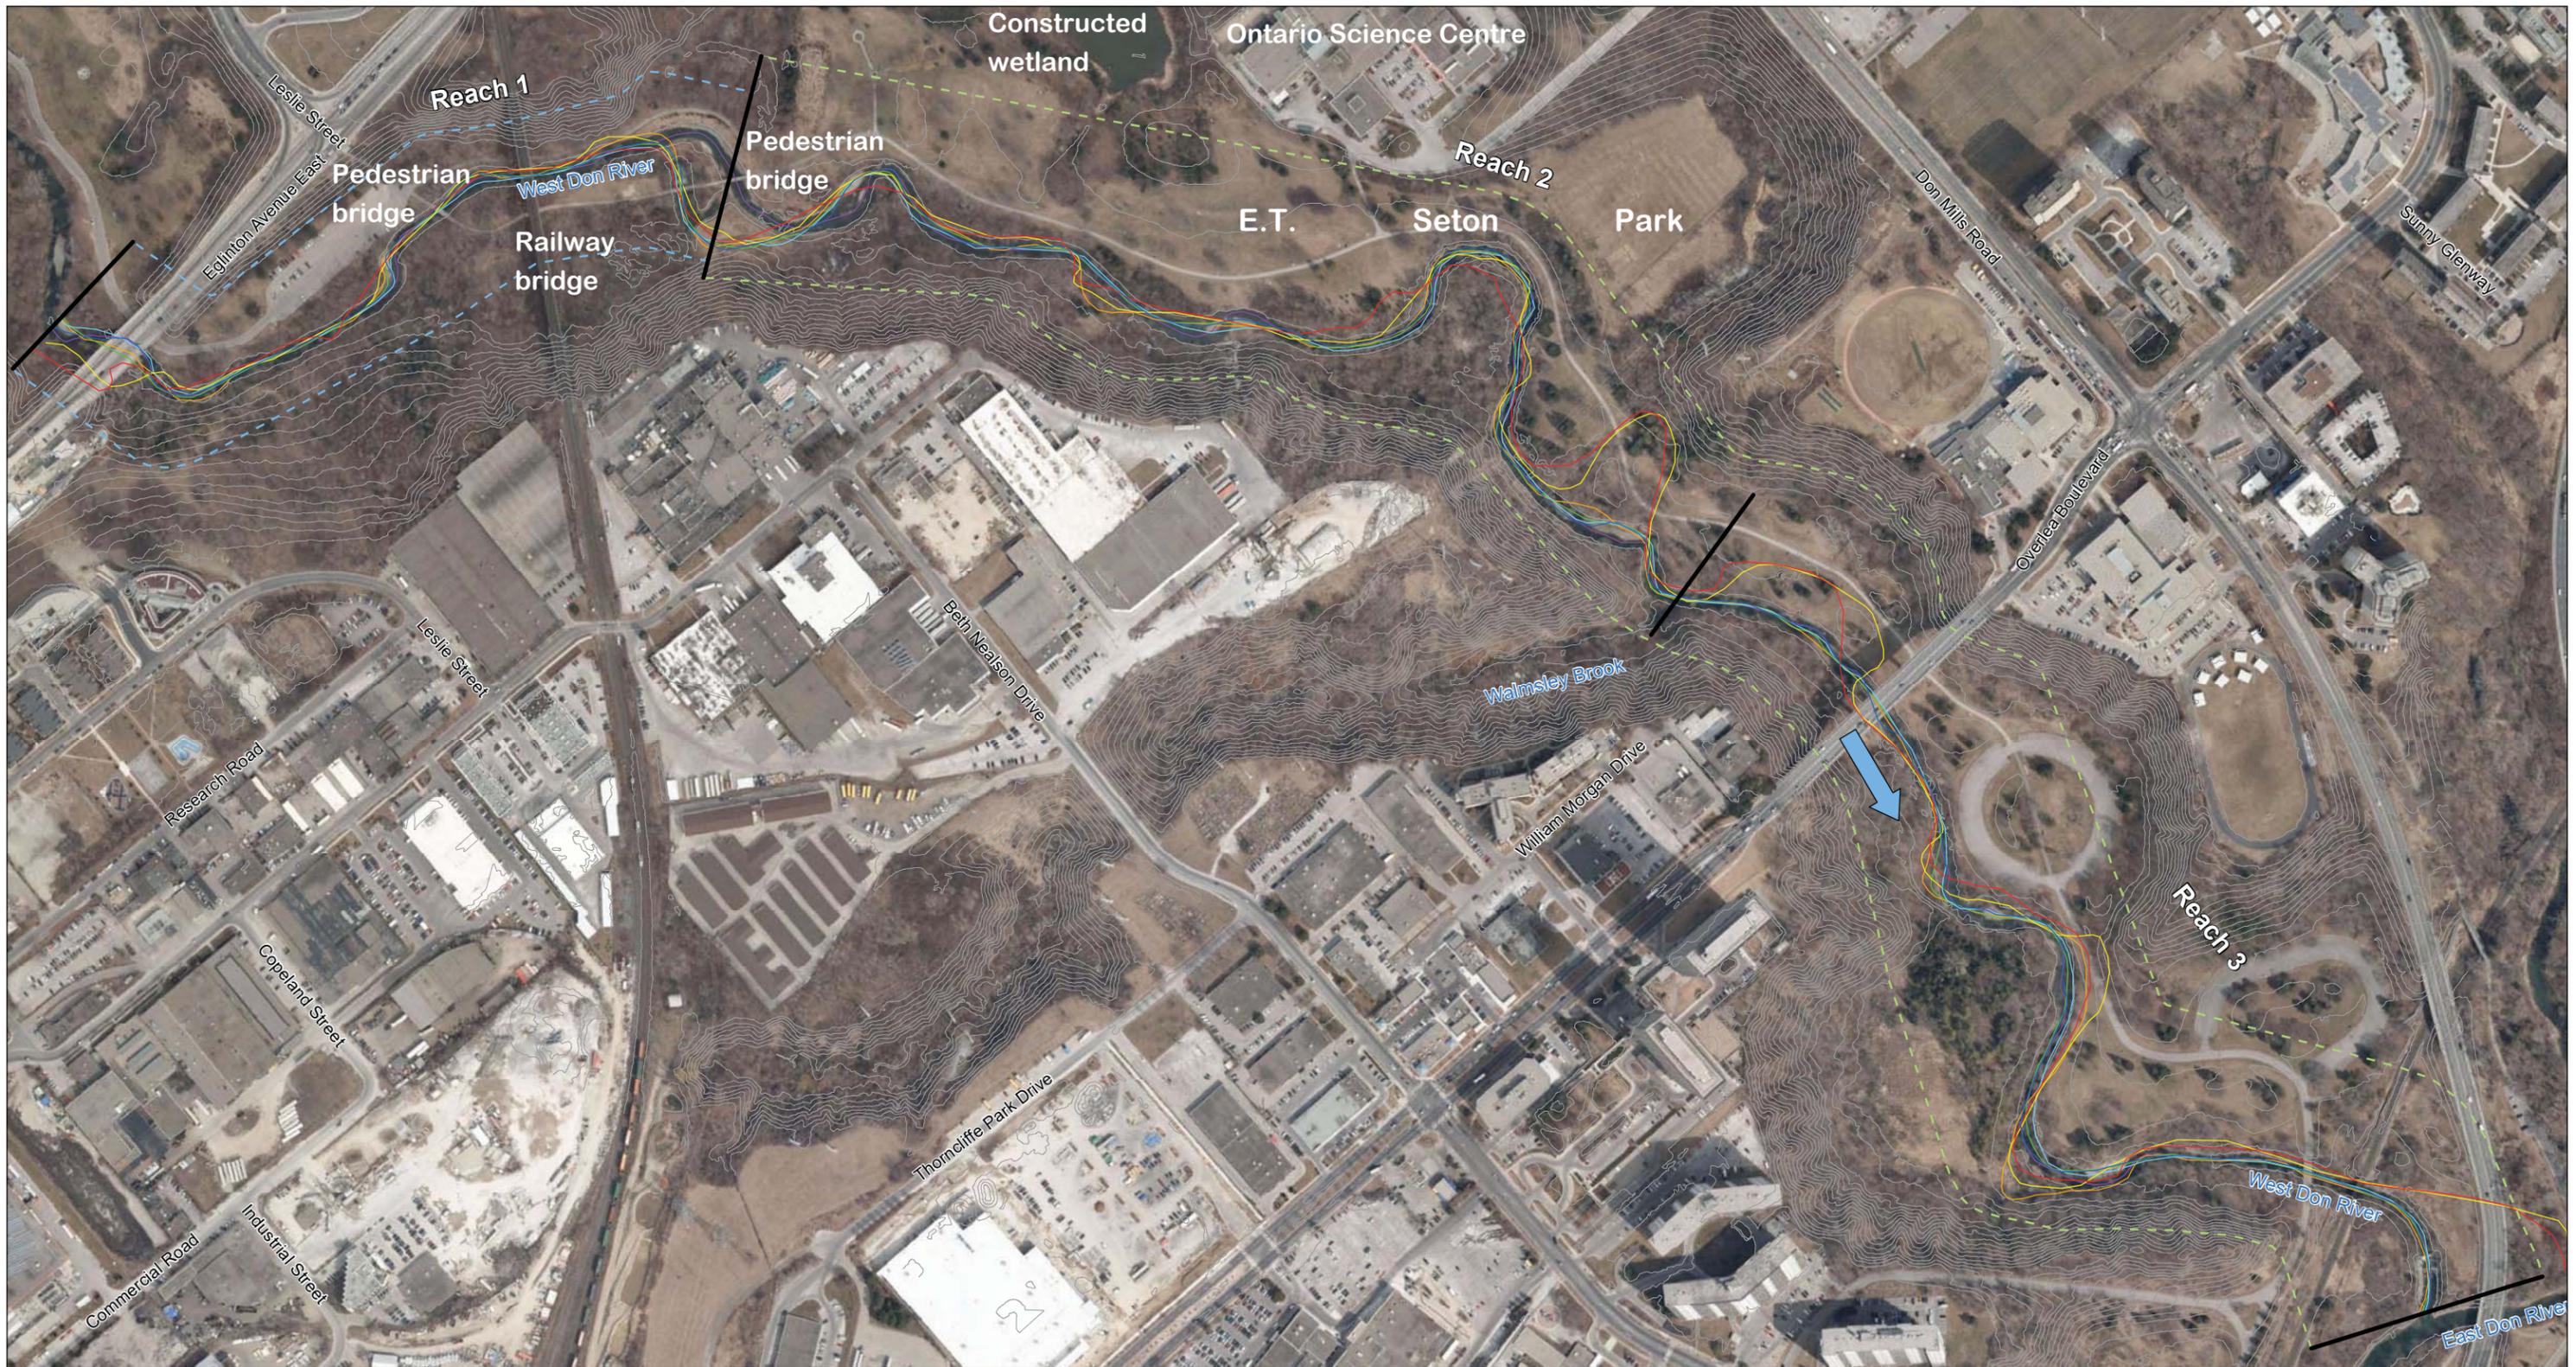
FIGURE 1

West Don River exhibits a history of channel realignment, most of which occurred between 1965 and 1978. West Don River has been progressively realigned along the toe of the western valley wall (**Figure 1**) through a series of anthropogenic meander cut-offs. A series of meander scars and oxbows in an anomalously wide section of valley bottom behind the Ontario Science Centre reveal the former, natural channel planform (**Figure 2**).

The study area encompasses three distinct reaches of West Don River (**Figure 1**). Reach 1 has remained largely unchanged despite the channel being realigned near its downstream end in 2005. Over the period of record, the channel has been shortened slightly from 677 m in 1939 to 663 m in 2018. A large meander was cut-off between 1965 and 1978 immediately upstream of the defined study area. Reach 2 has been straightened and realigned in a few locations to protect to toe of the valley wall, including a large meander cut-off beneath the hydro corridor between 1954 and 1965. Channel length has decreased only 95 m between 1939 (1,226 m) and 2018 (1,131 m). Sometime prior to 1910 (based on historical mapping), approximately 1 km of channel was cut off based on oxbows clearly visible in the vicinity of what is now a constructed wetland on the valley bottom behind the Ontario Science Centre (**Figures 1 and 2**). Evidence of channel realignment is most pronounced along Reach 3, where channel length decreased by approximately 270 m between 1939 (1,319 m) and 2018 (1,051 m). Straightening and realignment of the channel to protect the toe of the valley wall and Don Valley Parkway has increased channel gradient compared to that along reaches 1 and 2.

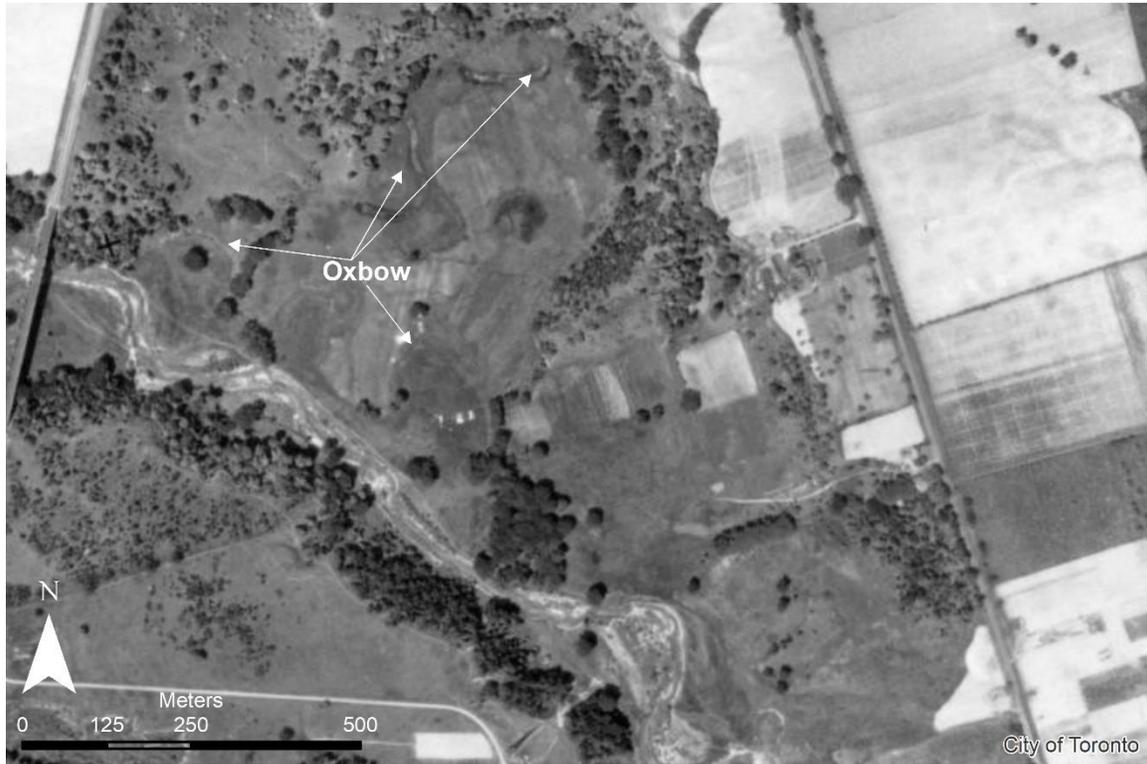
Figure 2. Relic Meander Features in Valley Bottom alongside the Upper Portion of Contemporary, Straightened Reach 2 (1939 Aerial Photograph Base)

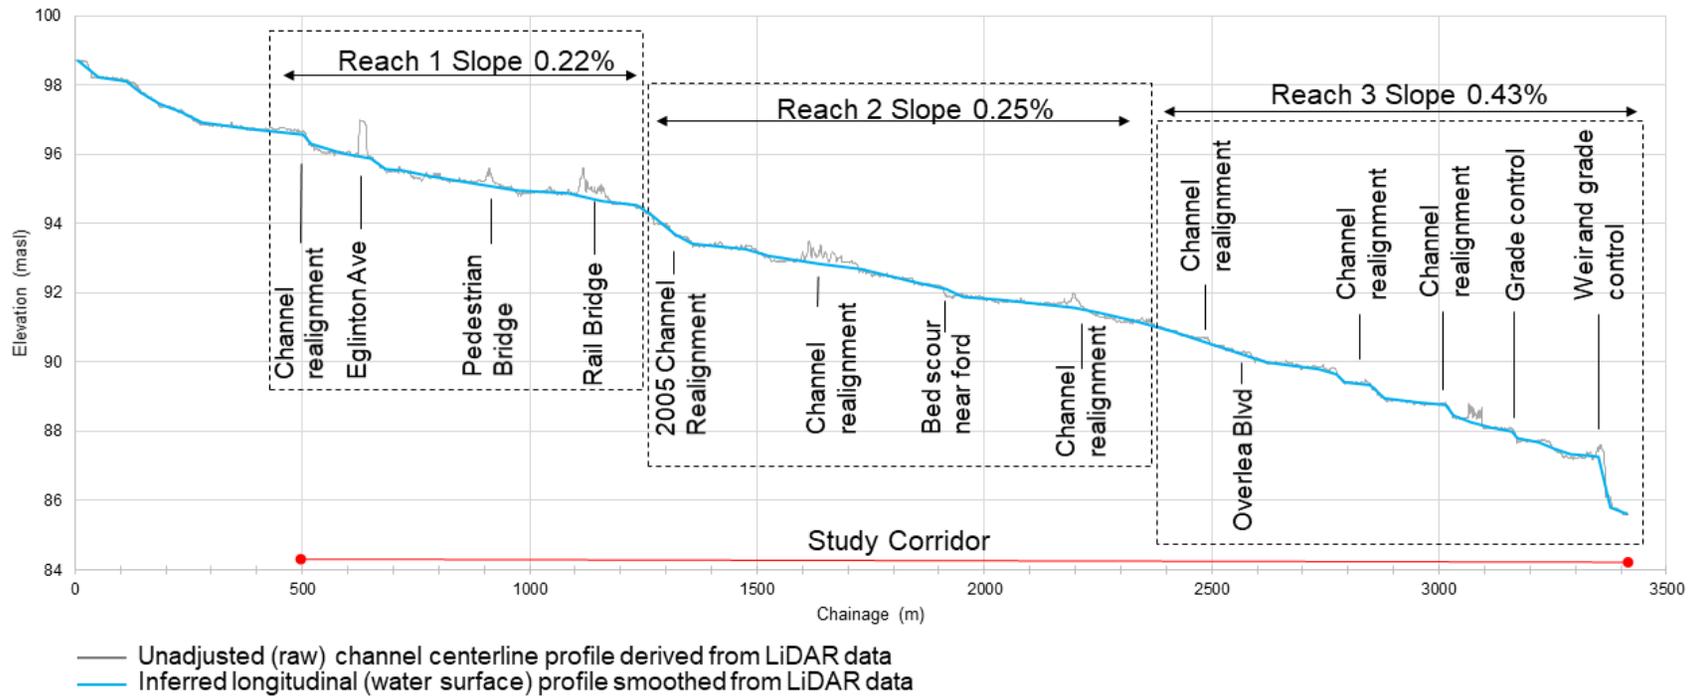
Figure 3. West Don River longitudinal profile derived from LiDAR data provided by TRCA

Pool-riffle morphology is generally well developed along the study corridor. Average bed gradient is 0.22% (**Figure 3**). The longitudinal profile exhibits local convexities and knickpoints that reflect past realignment (shortening and steepening) near Eglington Avenue East. The channel exhibits a roughly trapezoidal to rectangular cross-section along its riffles. Pool cross-sections are generally asymmetric, deepest along the base of the outer banks of meanders. Riffles tend to have the coarsest material based on field observations. Sand veneers overlie the bed in pools and runs. Sand and gravel point bars are located along the inner banks of most meanders. Mid-channel bars occur at anomalously wide sections of channel (**Photo 2**).

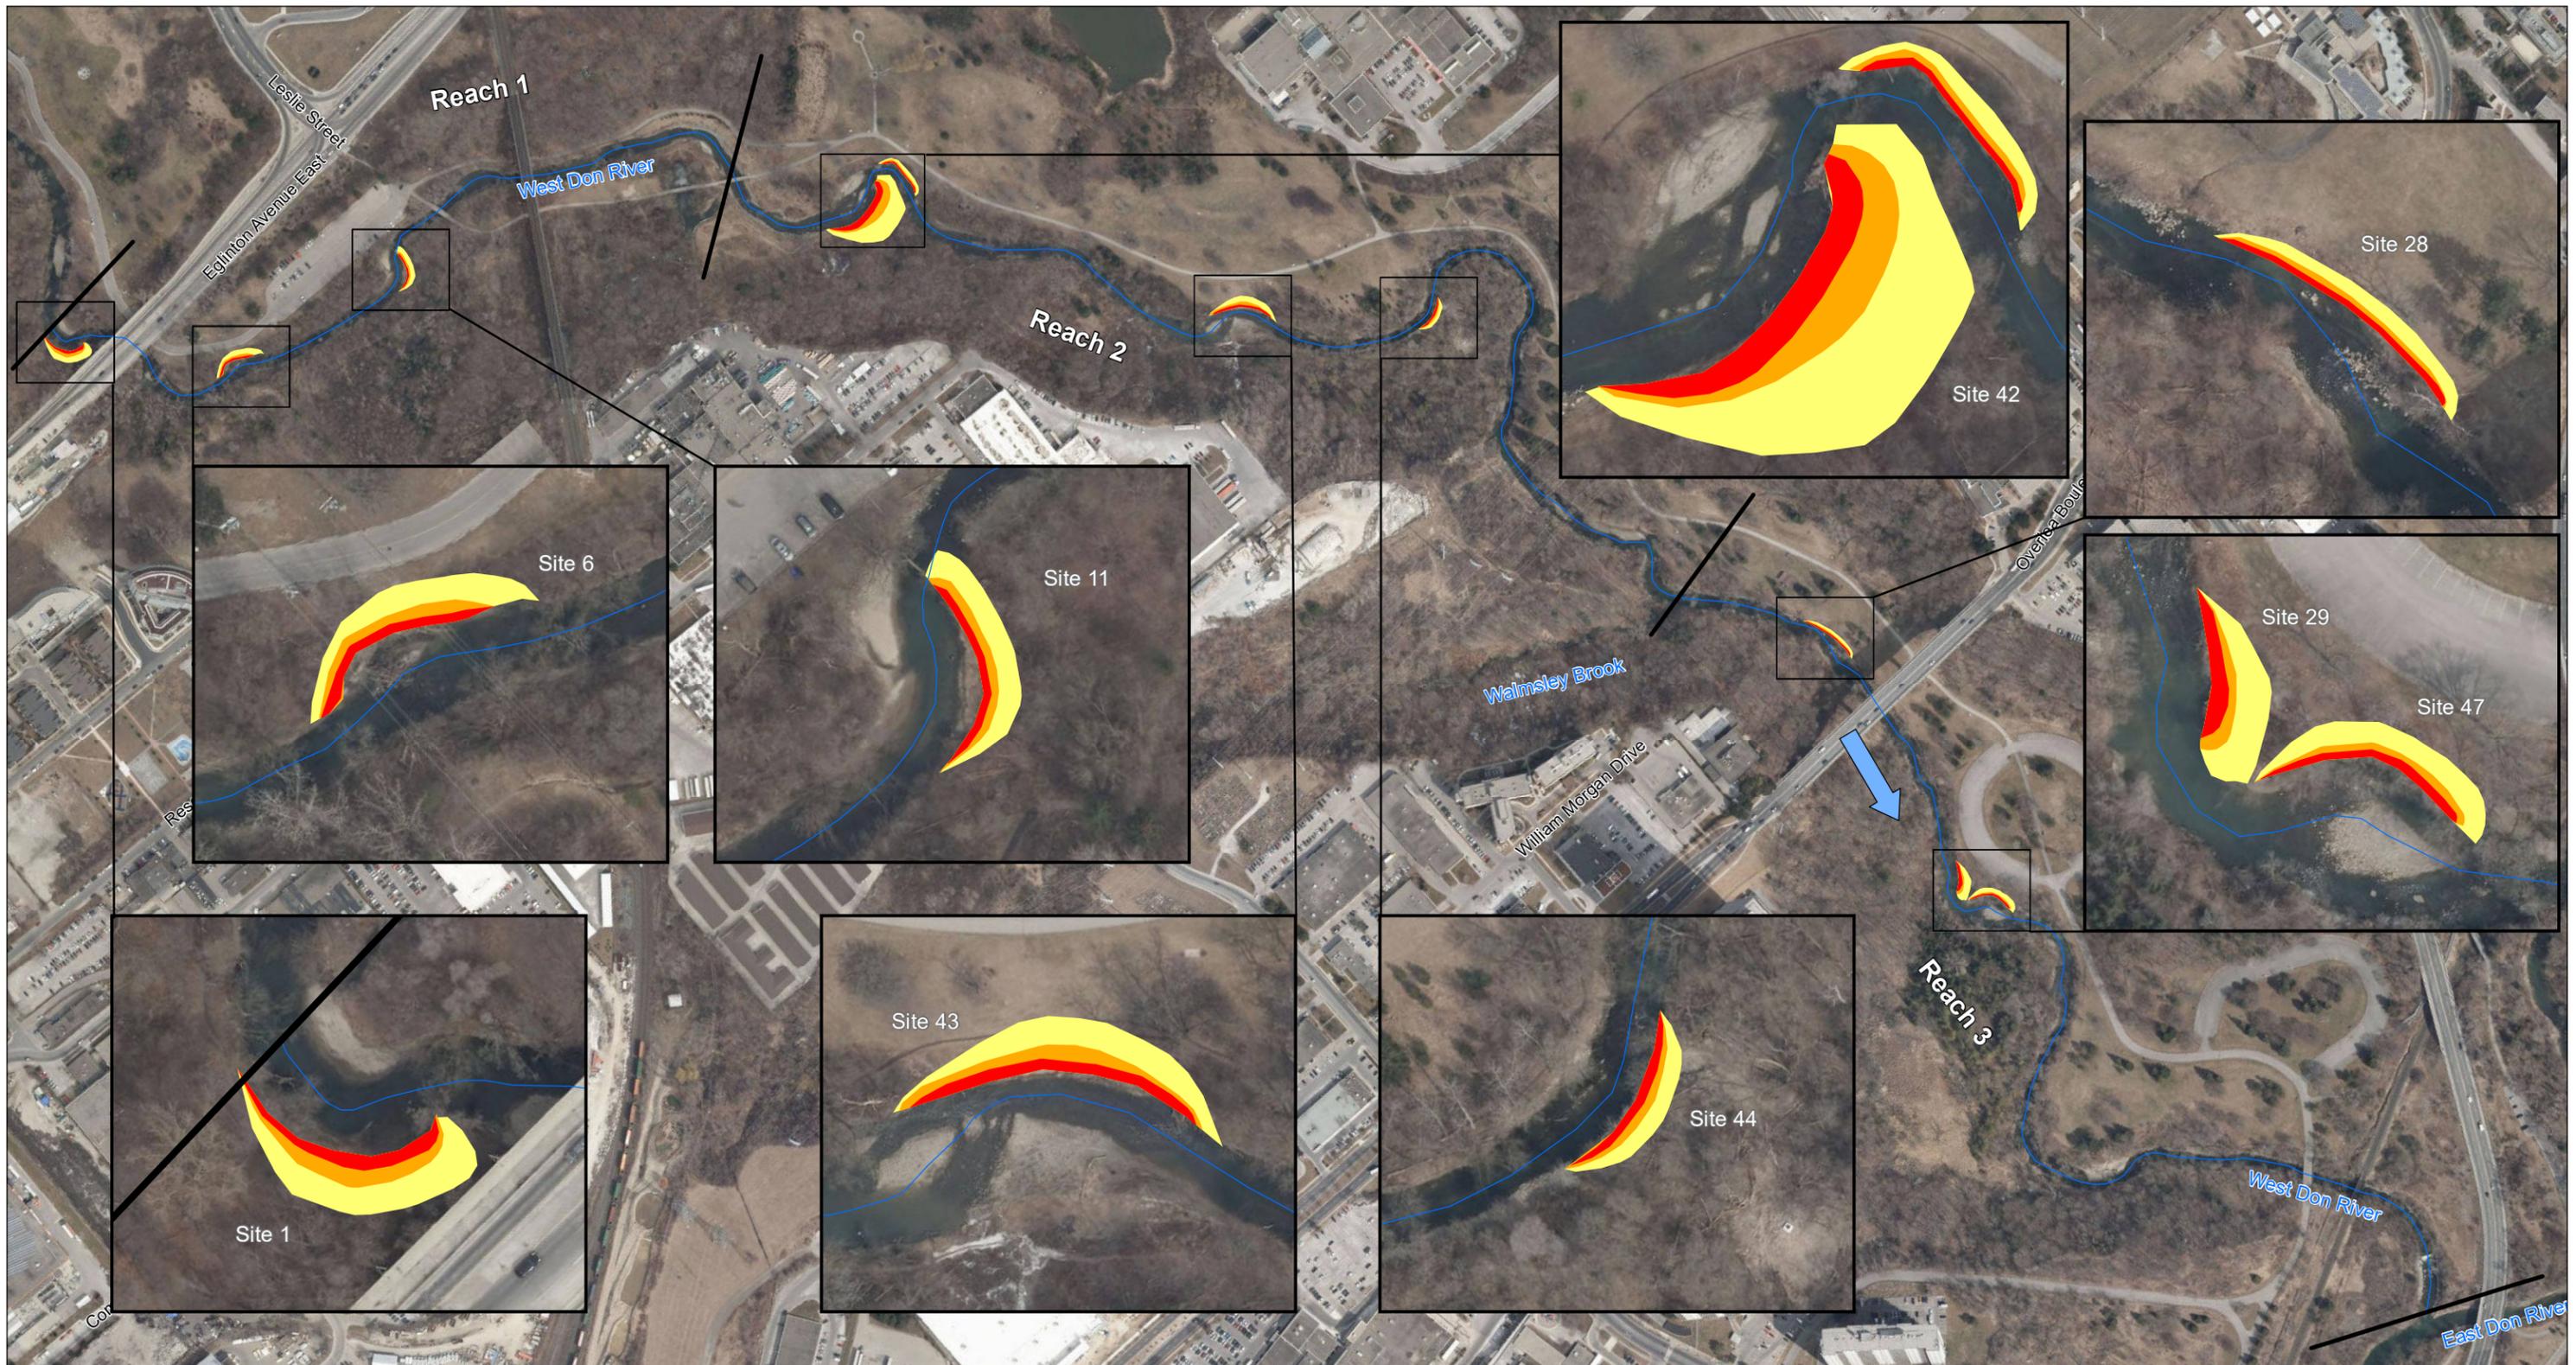
FIGURE 4

Erosion hazard areas are shown in **Figure 4**. Thalweg position and the most conspicuous erosion hollows are delineated in **Figure 5**. Natural meander adjustment within the study area has been limited due to the abundance and extent of erosion control structures along the banks. In addition, areas once migrating laterally have since been straightened and realigned (**Figure 1**). Systematic lateral erosion is limited to areas without bank stabilization measures. In addition, rapid outer bank erosion and erosional hollows have developed immediately downstream of erosion control structures or where structures have failed. The recent development of erosional hollows has typically occurred over the past 13 years (2005 to 2018) in responses to changes in thalweg configuration.

Areas of systematic bank erosion, which allow establishment of erosion hazard zones, are evenly distributed along each reach. Reach 1 has three mappable erosion hazard zones (**Figure 4**), which have the potential to impact infrastructure and are currently outflanking existing erosion control structures. Migration rates range from 0.20 to 0.25 m/year along Reach 1 where banks are unprotected (**Table 7**). The migration rate at Site 1 appears to have recently accelerated, resulting in the exposure of a pipe (now elevated above the water surface) and outflanking of a gabion basket retaining wall. Migration rates along reaches 2 and 3 highlight a similar trend of accelerated lateral erosion between 2005 and 2018. A changing hydrologic regime (watershed urbanization), increased flood peaks and continued deterioration of existing erosion control structures are contributing to an increase erosion risk within the study area. Most existing erosion control structures are still reasonably effective, despite nearing or exceeding their expected lifespan. Continued deterioration of gabion baskets, in particular, may result in rapid erosion once they fail (e.g. Site 6).

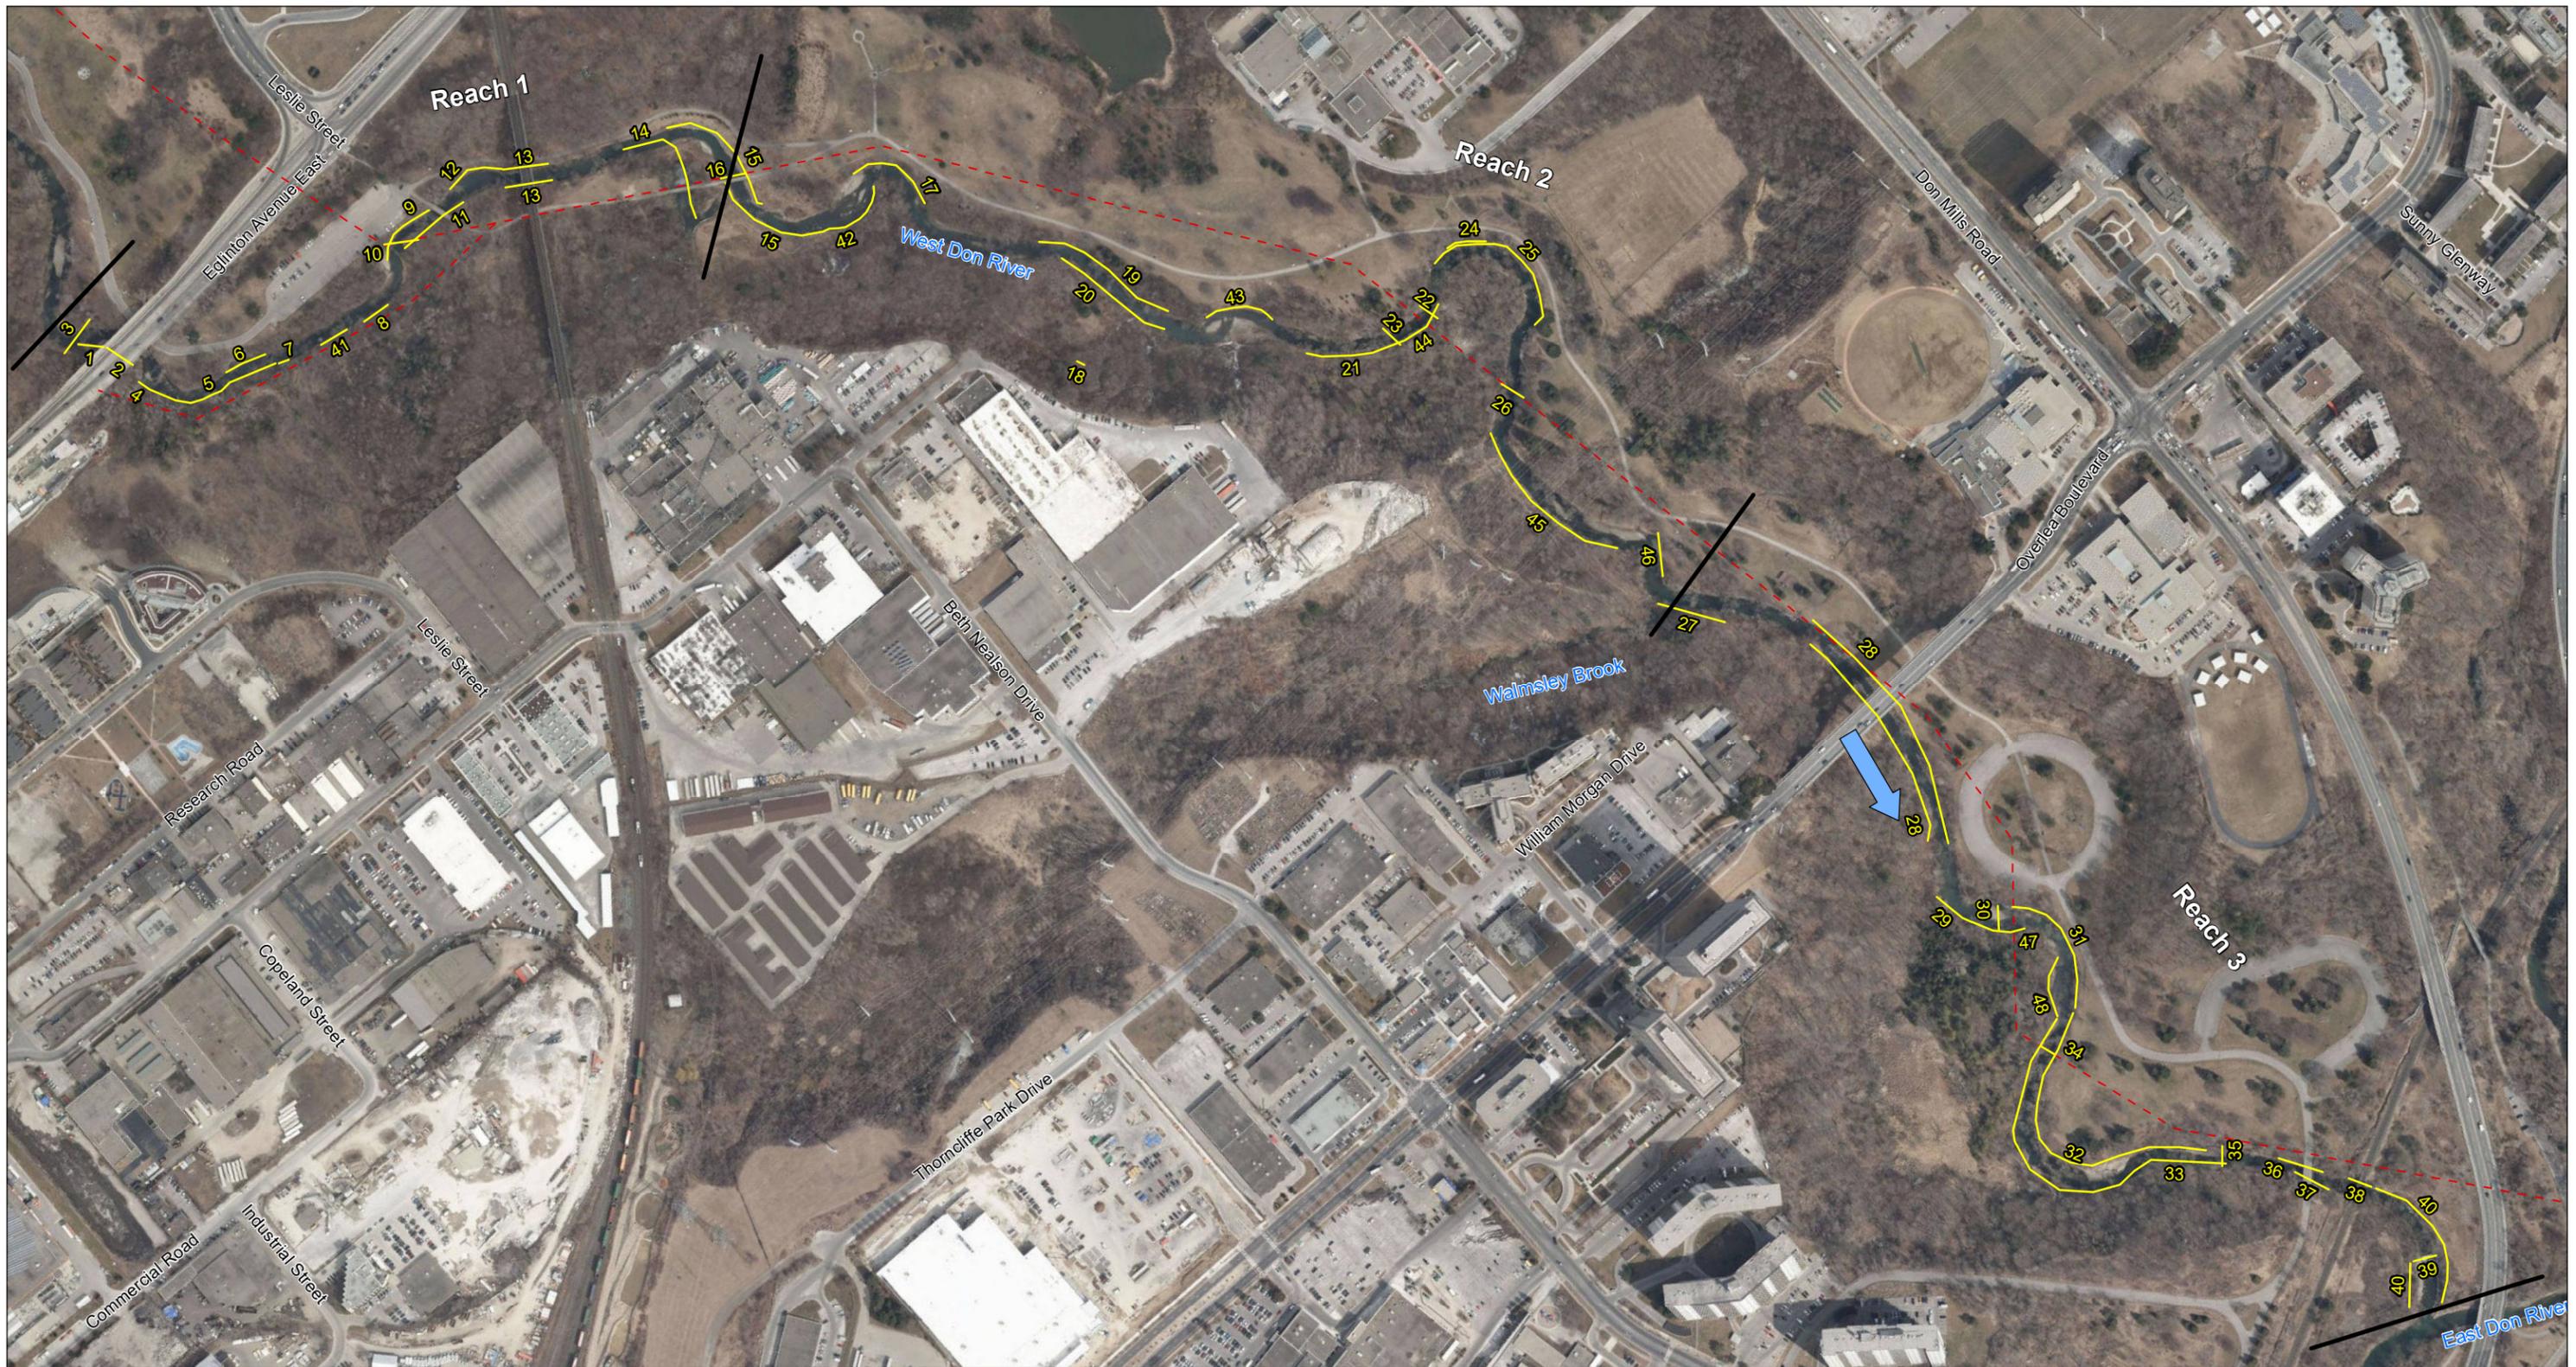
FIGURE 6

A total of 48 erosion hazard sites were identified and inventoried (**Figure 6**) through desktop review and field reconnaissance. Standardized characterizations of each erosion hazard site, including a field photograph and descriptive paragraph of site conditions and erosional processes, are provided in **Appendix B**. Of the 48 sites, 17 have retaining walls (e.g. gabion baskets), 15 have bank revetments (e.g. rip-rap), five have grade controls (e.g. constructed riffle) and 11 are unprotected (i.e. no erosion control structure). At-risk infrastructure includes bridges, a sanitary sewer (including maintenance holes), a gas line, stormwater outfalls, and recreational trails. The characteristics of all existing erosion control structures, including their type, purpose, condition and effectiveness, are tabulated in **Appendix C**.

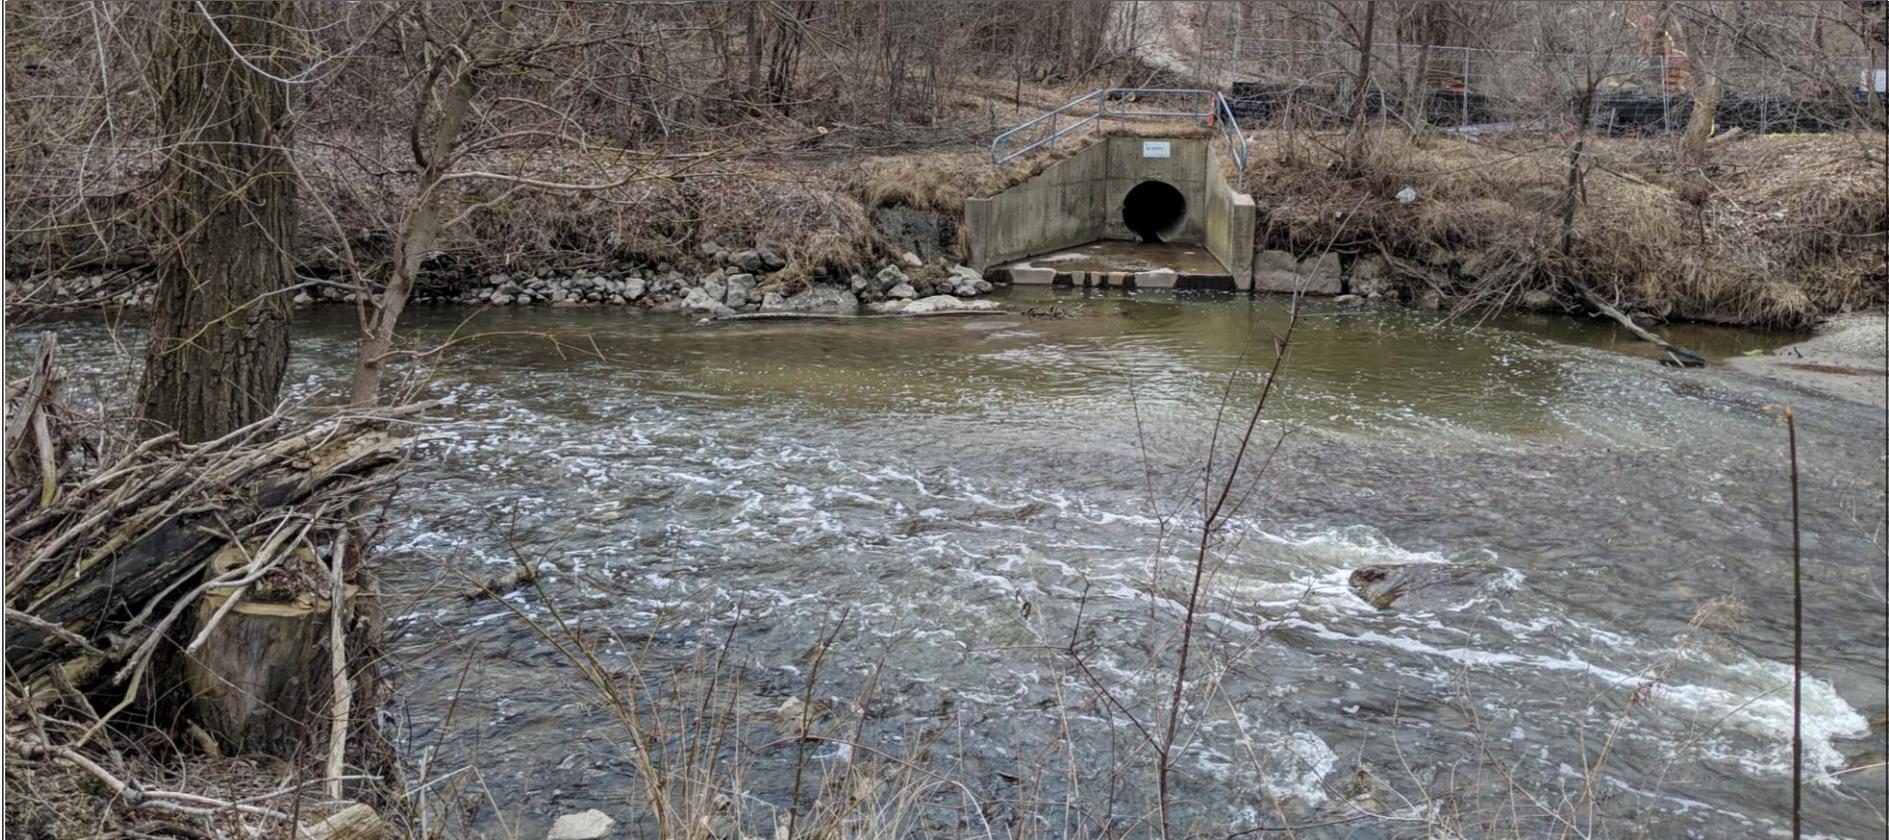
A stormwater outfall discharges perpendicular to flow along the outer bank of a meander. An anomalously wide cross-section moderates erosive energy at the recessed outfall. Thalweg position is along the opposite (inner) bank, and the meander apex is positioned further downstream. The widened cross-sectional width is a result of past channel realignment in association with Eglington Avenue. Rip-rap and armourstone protect the outfall from being outflanked with only minor displacement of stone observed. Minor scour was observed along the bed. Flow: right to left.

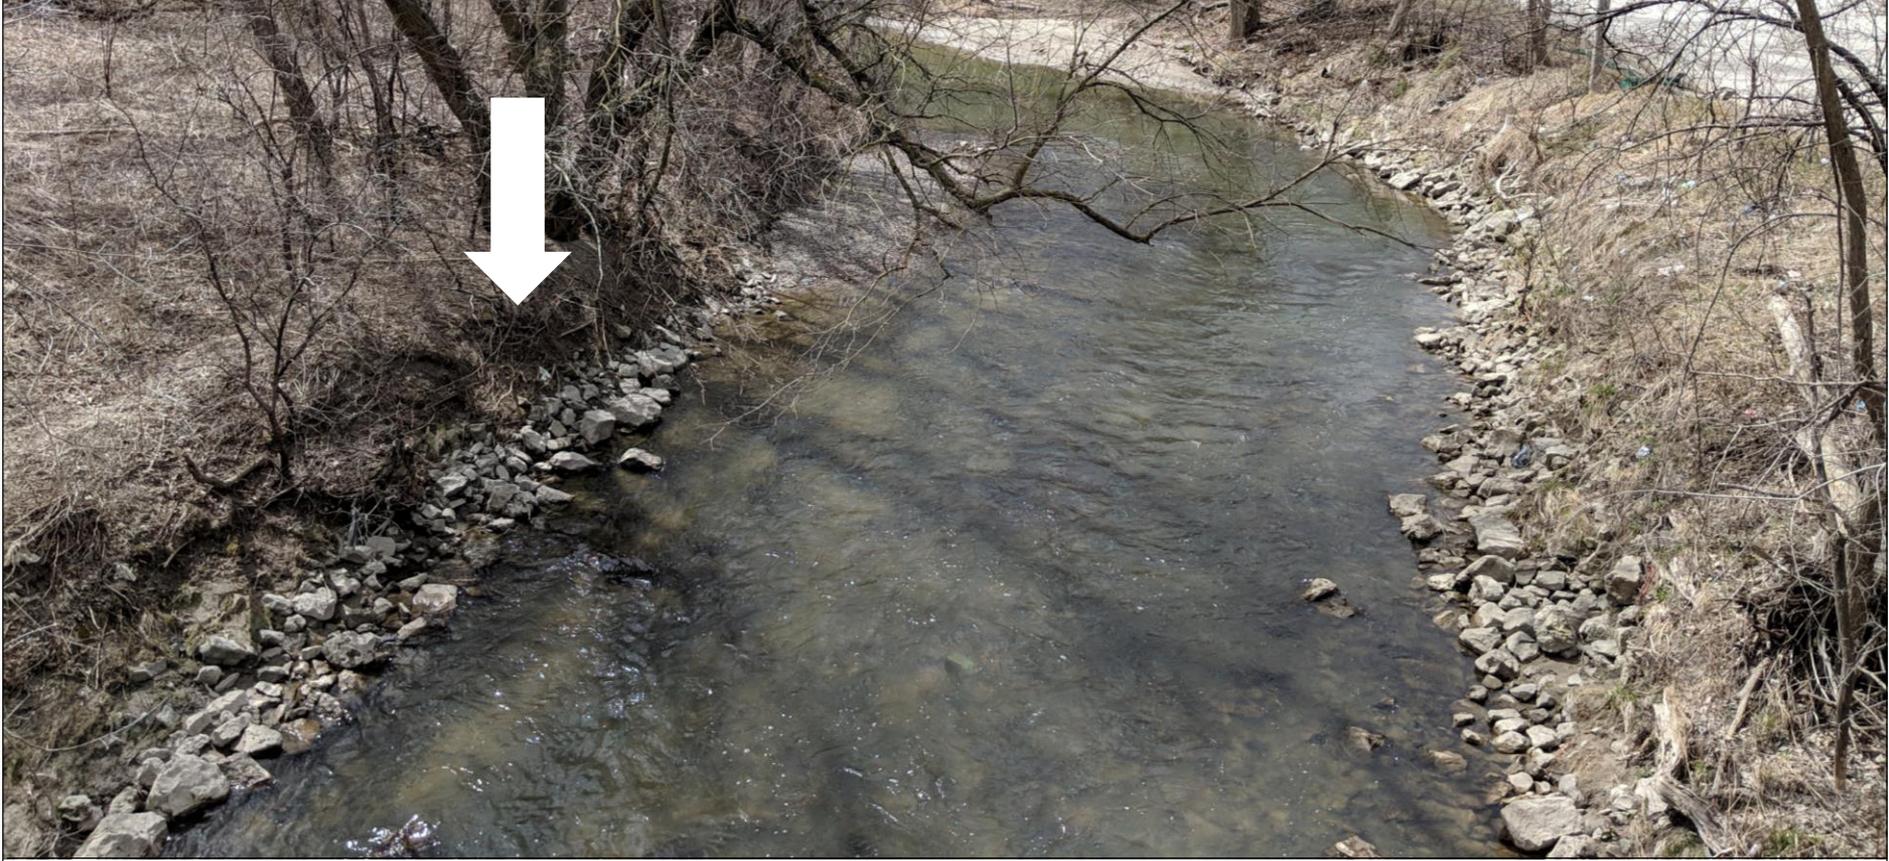
A cobble and boulder rip-rap revetment protects a pedestrian bridge abutment and sanitary maintenance hole along the inner bank of a meander. The crest of the revetment is below bankfull elevation. Upper-bank scour along its entire length has displaced some stone. Systematic, down-valley migration of an upstream meander has the potential to outflank the revetment at its upstream end. Flow: background to foreground.

Do Nothing – Continue to monitor planform adjustment upstream.

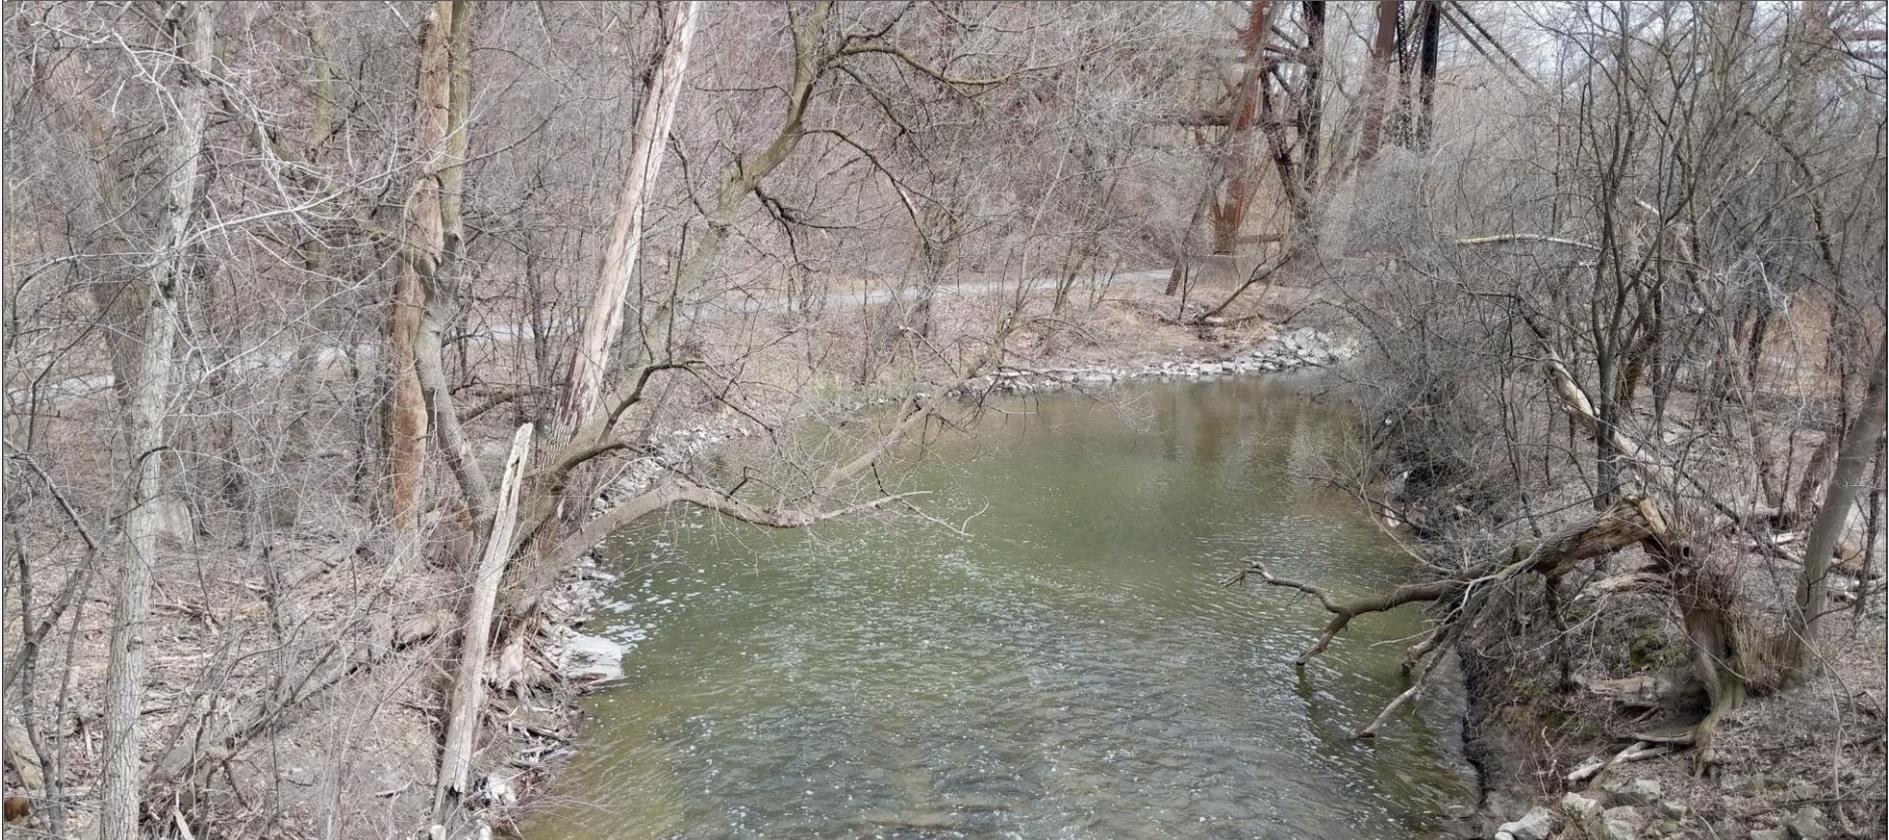
A cobble and boulder rip-rap revetment protects West Don River Trail along the outer bank of a meander. The top of the revetment is roughly coincident with or slightly below bankfull elevation. The outer (left) bank is well vegetated above bankfull depth with no scour observed above the revetment. Erosional energy is concentrated along the bed, with a large and deep pool formed along the toe of the revetment, where minor displacement of stone has occurred. Flow: foreground to background.

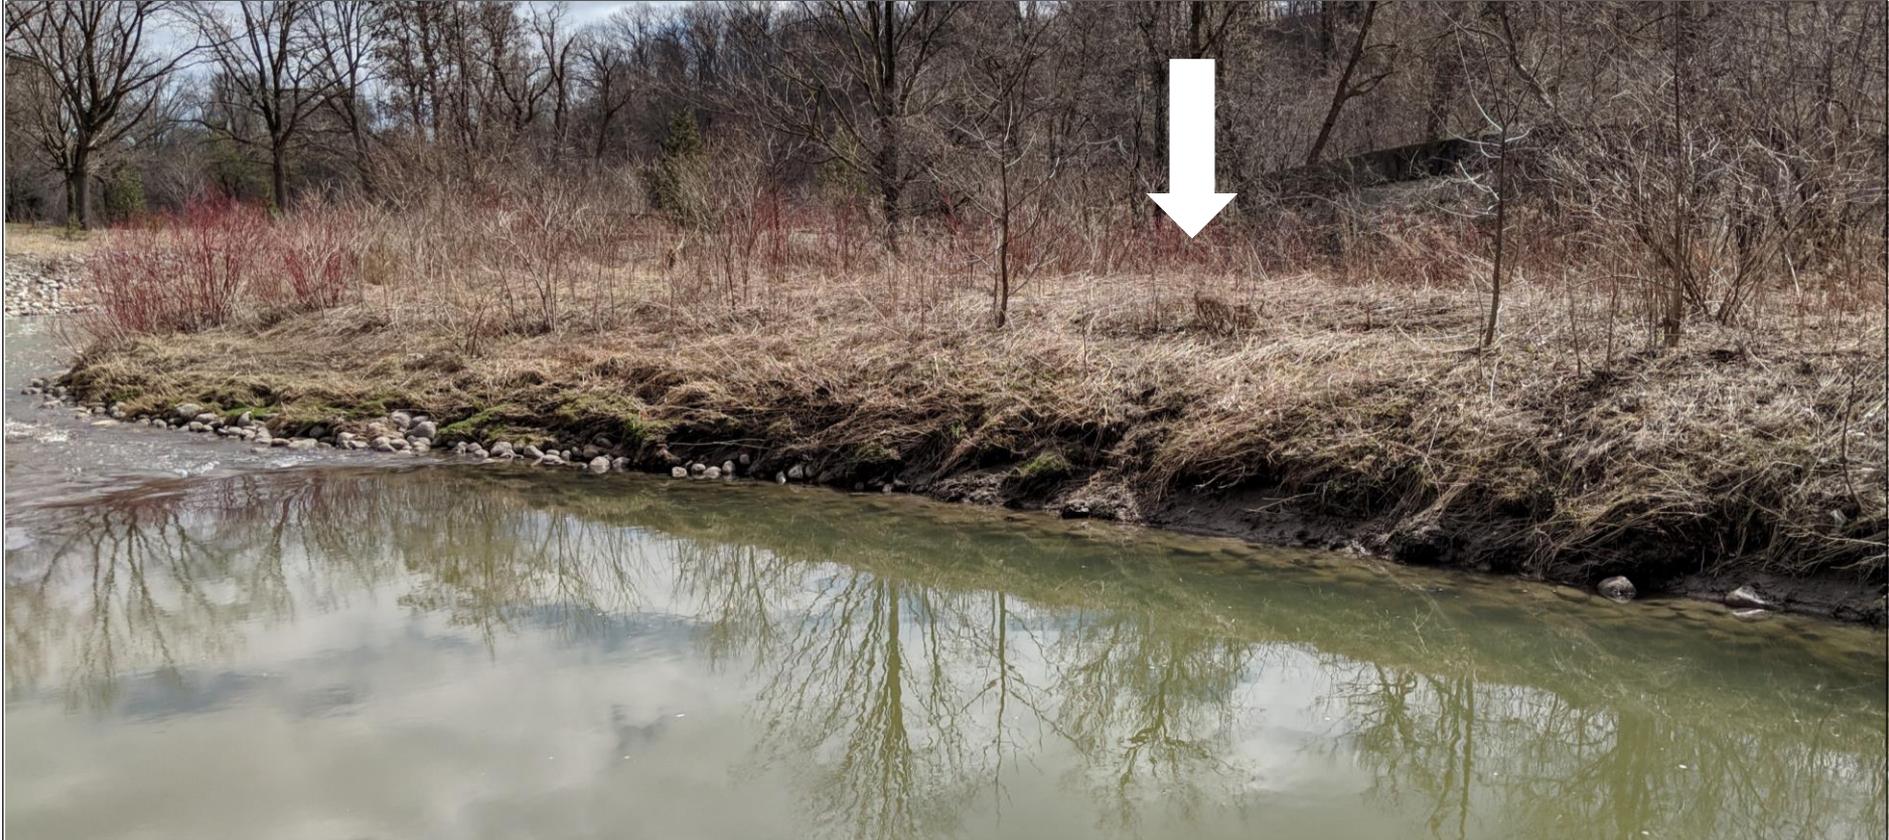
Channel realignment in 2005 resulted in the abandonment of the gabion basket retaining wall along the right bank of a relic meander (white arrow). The gabion wall used to protect the channel from outflanking an old concrete pedestrian bridge. The retaining wall is set back from the new channel bank and no longer needed for erosion protection. Flow: right to left

Abandon Existing Structure.

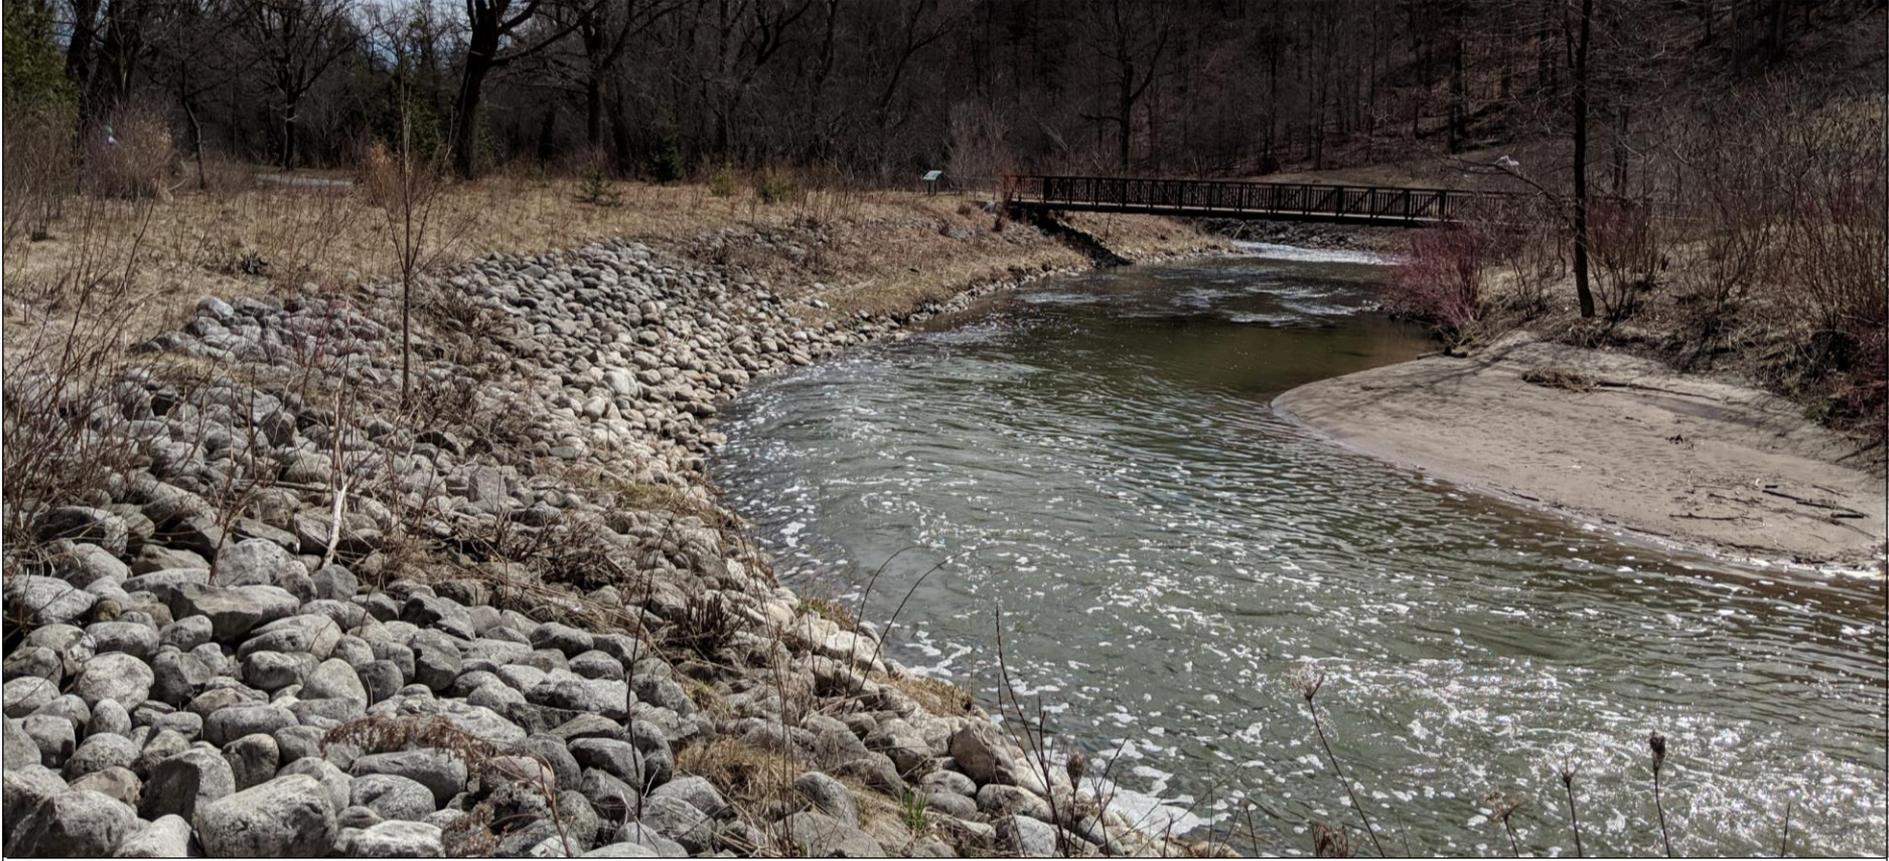
A vegetated cobble revetment along the outer banks of a realigned meander protects against lateral migration of the channel toward the West Don River Trail and toes of the valley walls. Minor settling of stone has occurred near the downstream extent of the realignment. Flow: foreground to background.

Do Nothing – Continue to monitor integrity of revetment.
