West Don River at E.T. Seton Park – Detailed Fluvial Geomorphic Analysis and Erosion Risk Assessment

Contract # 10009019

Toronto and Region Conservation Authority

October 2, 2019

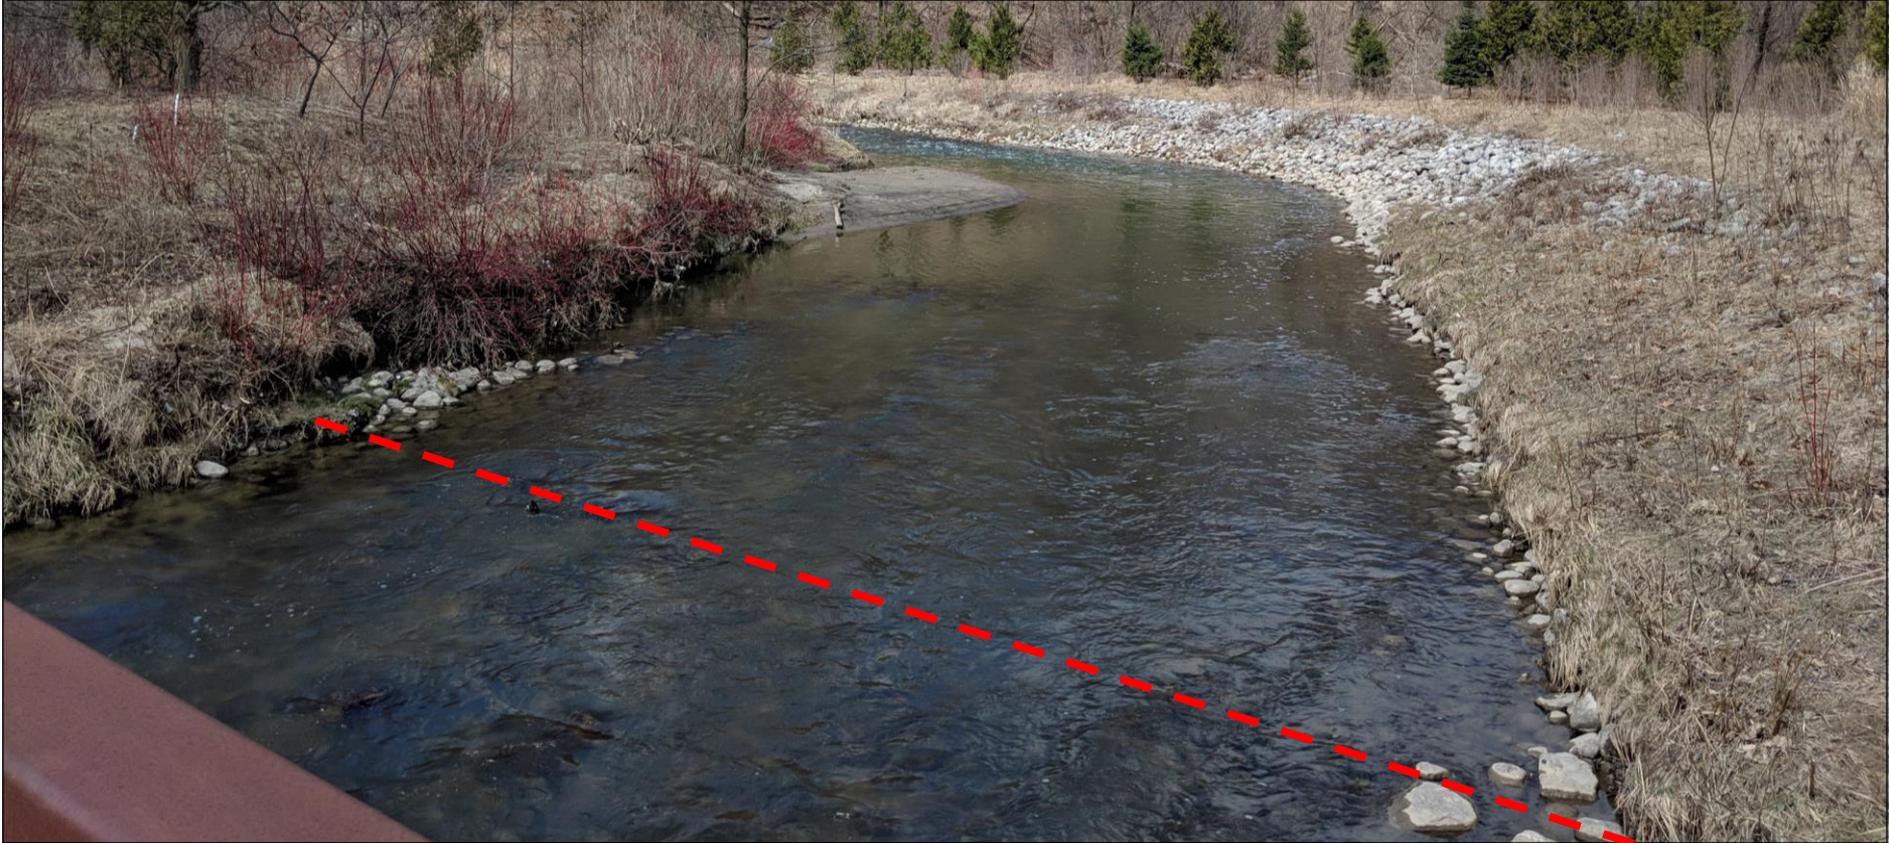
A cobble and boulder riffle constructed mid-way along a realigned meander protects a sanitary main that crosses beneath the channel. Minor erosion along the inner (right) bank was observed. No displacement of riffle stone or degradation over the pipe was identified. The depth of cover is approximately 1.1 m (2005). Flow: background to foreground.

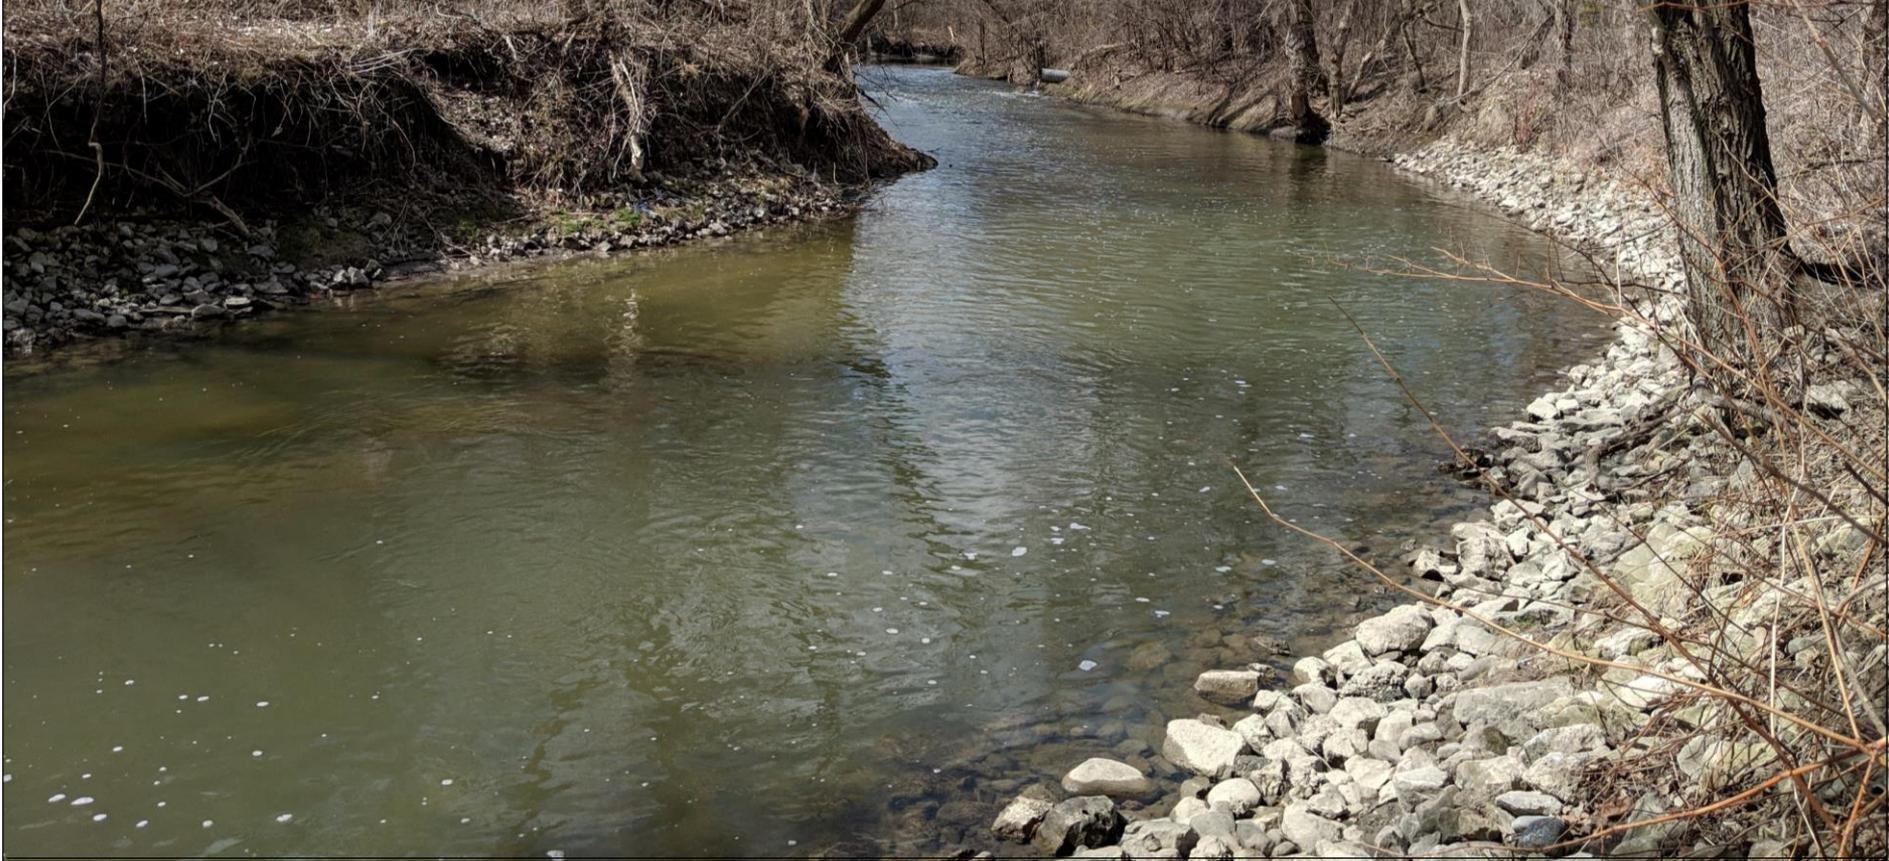
A cobble revetment along the outer bank of a broad meander protects West Don River Trail. The top of the revetment is approximately coincident with bankfull elevation and exhibits minor displacement of stone along its length. Tree roots exposed along the bank slope indicate winnowing of rip-rap and fill material. The bank is well vegetated above bankfull elevation helps resist erosion and maintain stability. Minor undermining of the revetment toe was observed as erosion is concentrated along the bed. Flow: background to foreground.

Likelihood: Low **Consequence:** Moderate **Risk:** Low

Recommended Action(s):
Do Nothing – Continue to monitor.

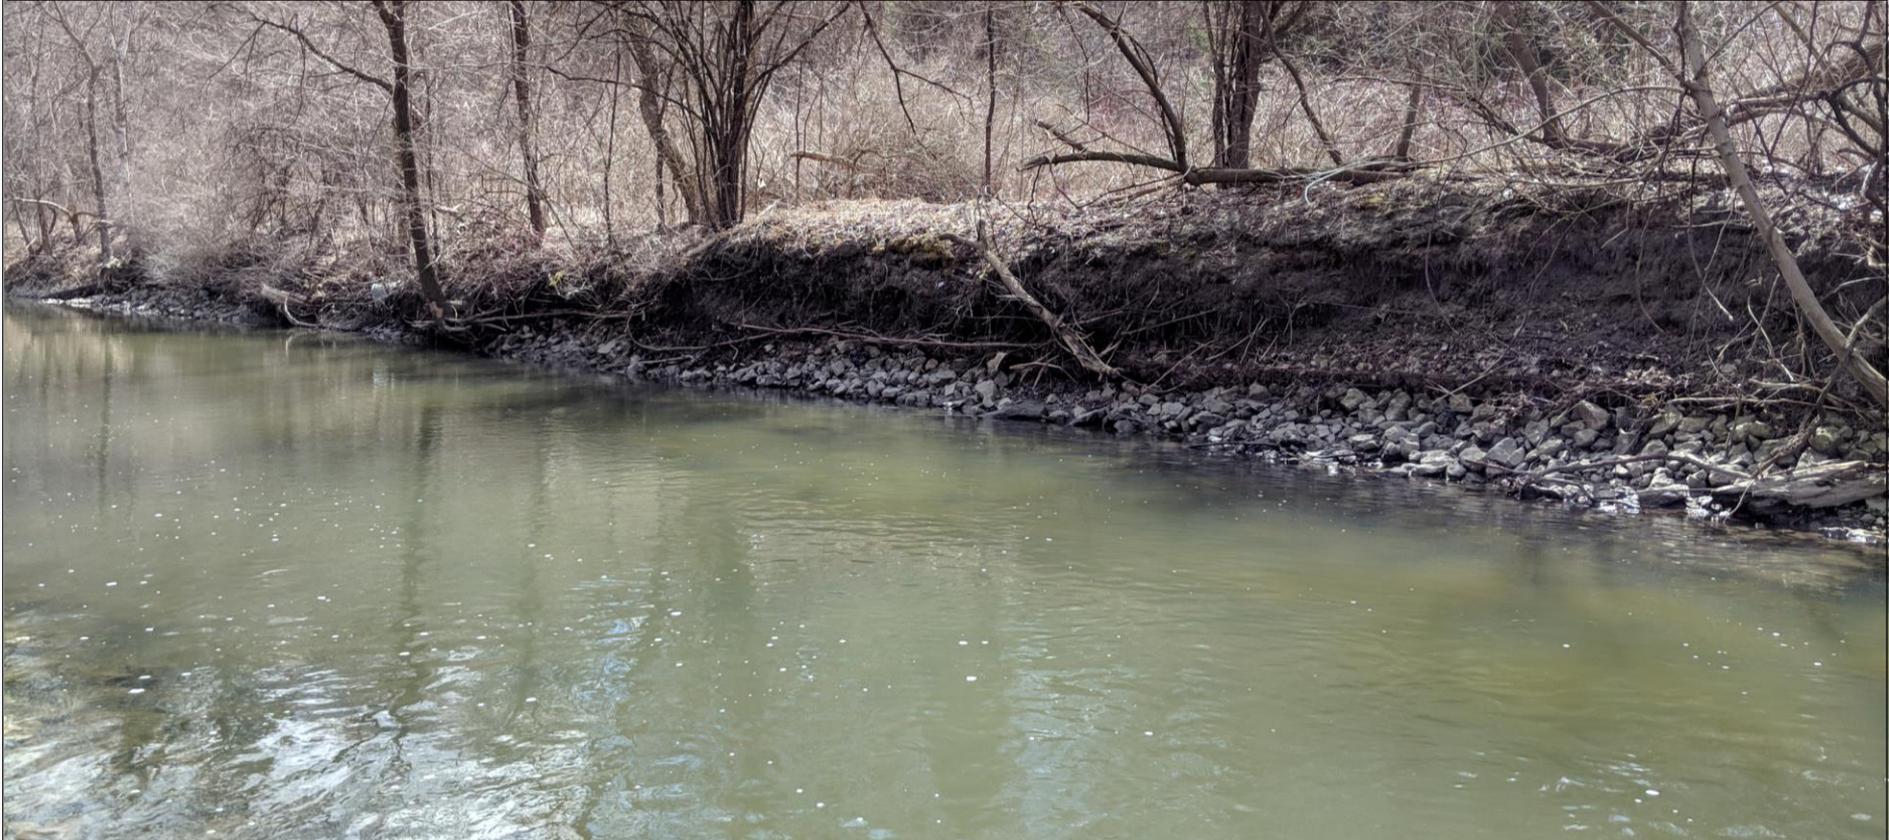
A gabion basket retaining wall along the outer (right) bank of a broad meander is protecting the toe of the western valley wall. The channel was realigned away from the valley wall between 1965 and 1978 to mitigate channel encroachment. The channel cross-section is slightly narrowed, increasing flow depth and shear stress, resulting in bed degradation and undermining of the retaining wall. The bottom tier of gabion baskets has deteriorated and released its stone along nearly its entire length. Deterioration of the bottom tier has caused the upper two tiers to ‘slip’ down the bank toward the channel. The existing erosion control structure only appears to protect an informal mountain bike trail. Flow: right to left.

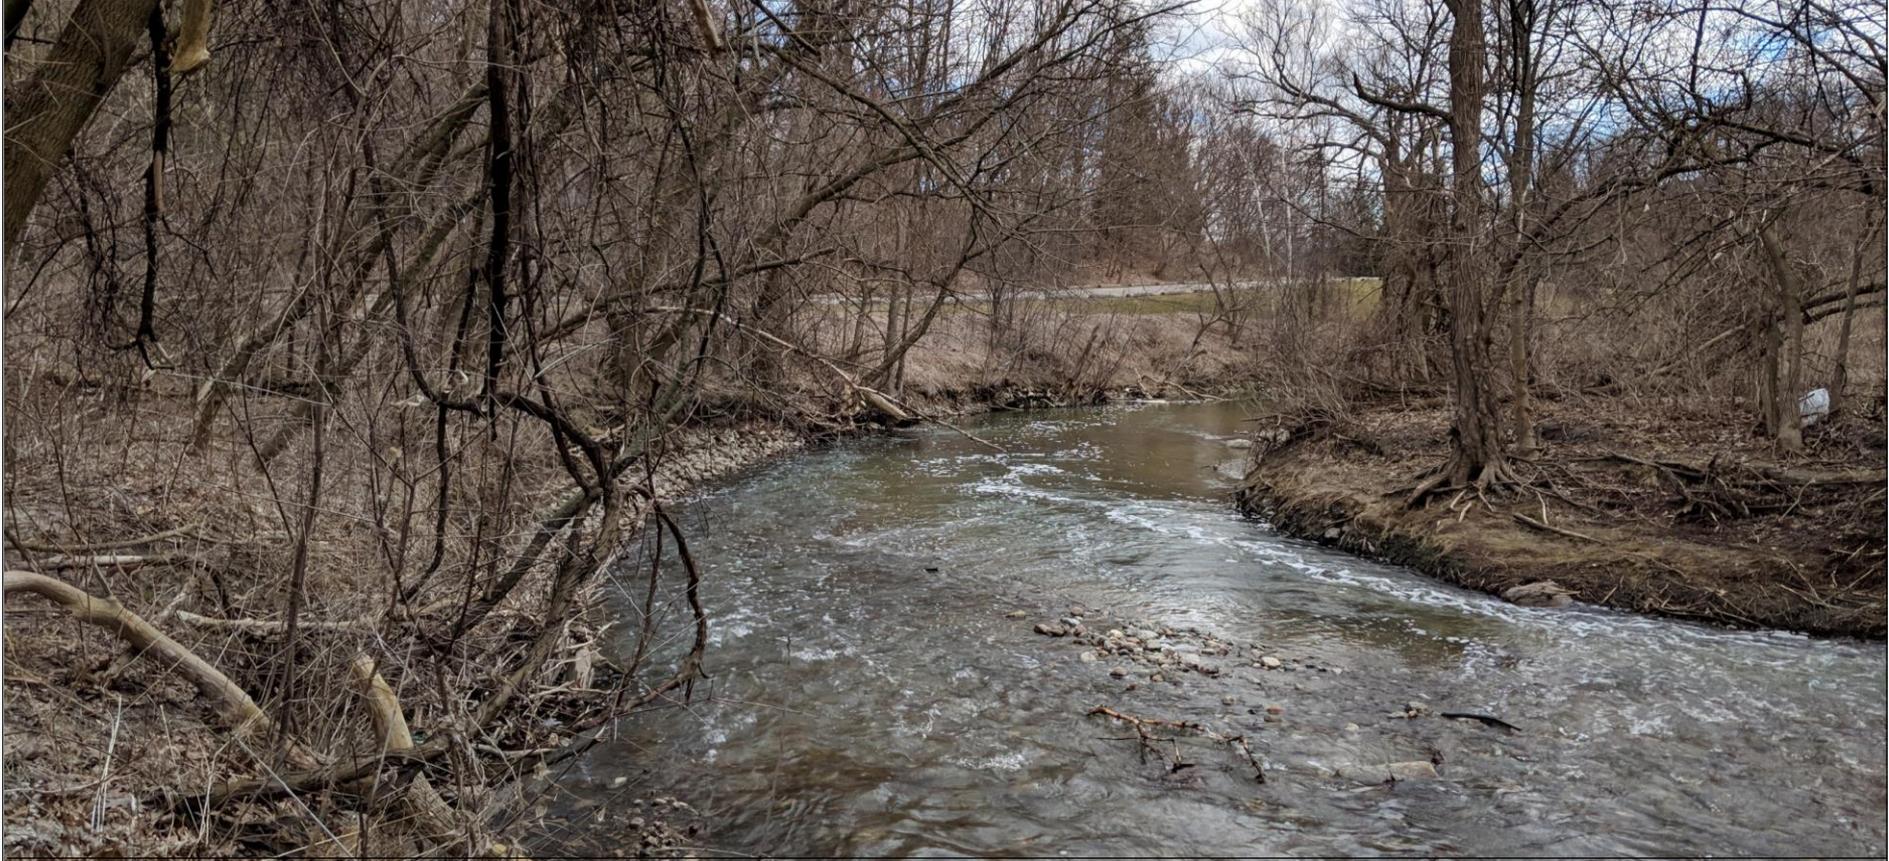
A gabion basket retaining wall along the outer (left) bank of a meander protects a gated access road to a parking lot along the West Don River Trail. The retaining wall extends to the top of the bank at an engineered angle, with fill placed ovetop to naturalize its appearance. Deterioration of the bottom tier and scour along the toe has released stone along the upstream extent. Vegetation along the upper bank (above bankfull elevation) resists erosion and improves stability. The structure is still functioning effectively with only minor deterioration. Flow: foreground to background.

Do Nothing – Continue to monitor for structure deterioration.

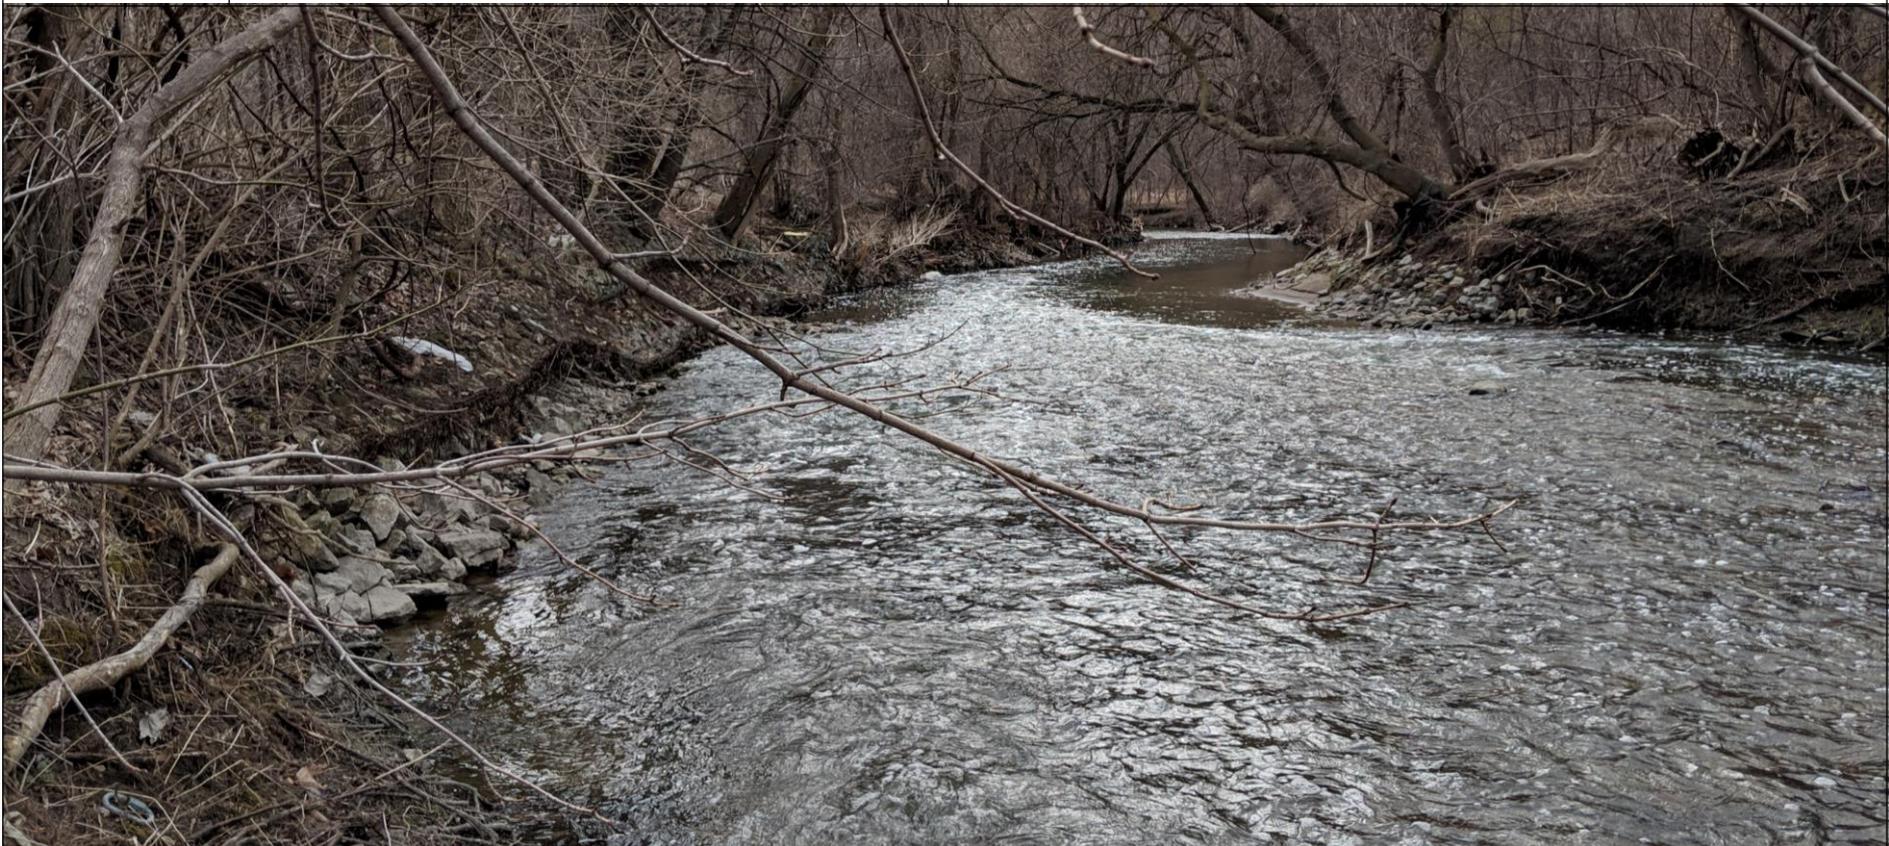
A long gabion basket retaining wall along the outer (right) bank of a meander inhibits down-valley migration and maintains existing meander geometry. The original purpose of the retaining wall is unclear, but the structure has prevented the straight section of channel from outflanking the grade control riffle at its downstream extent. The top of the retaining wall is coincident with bankfull elevation and well vegetated above. The bottom tier of gabion baskets has deteriorated and released stone along its entire length. Although exhibiting signs of deterioration, the retaining wall still provides effective erosion control. Flow: foreground to background.

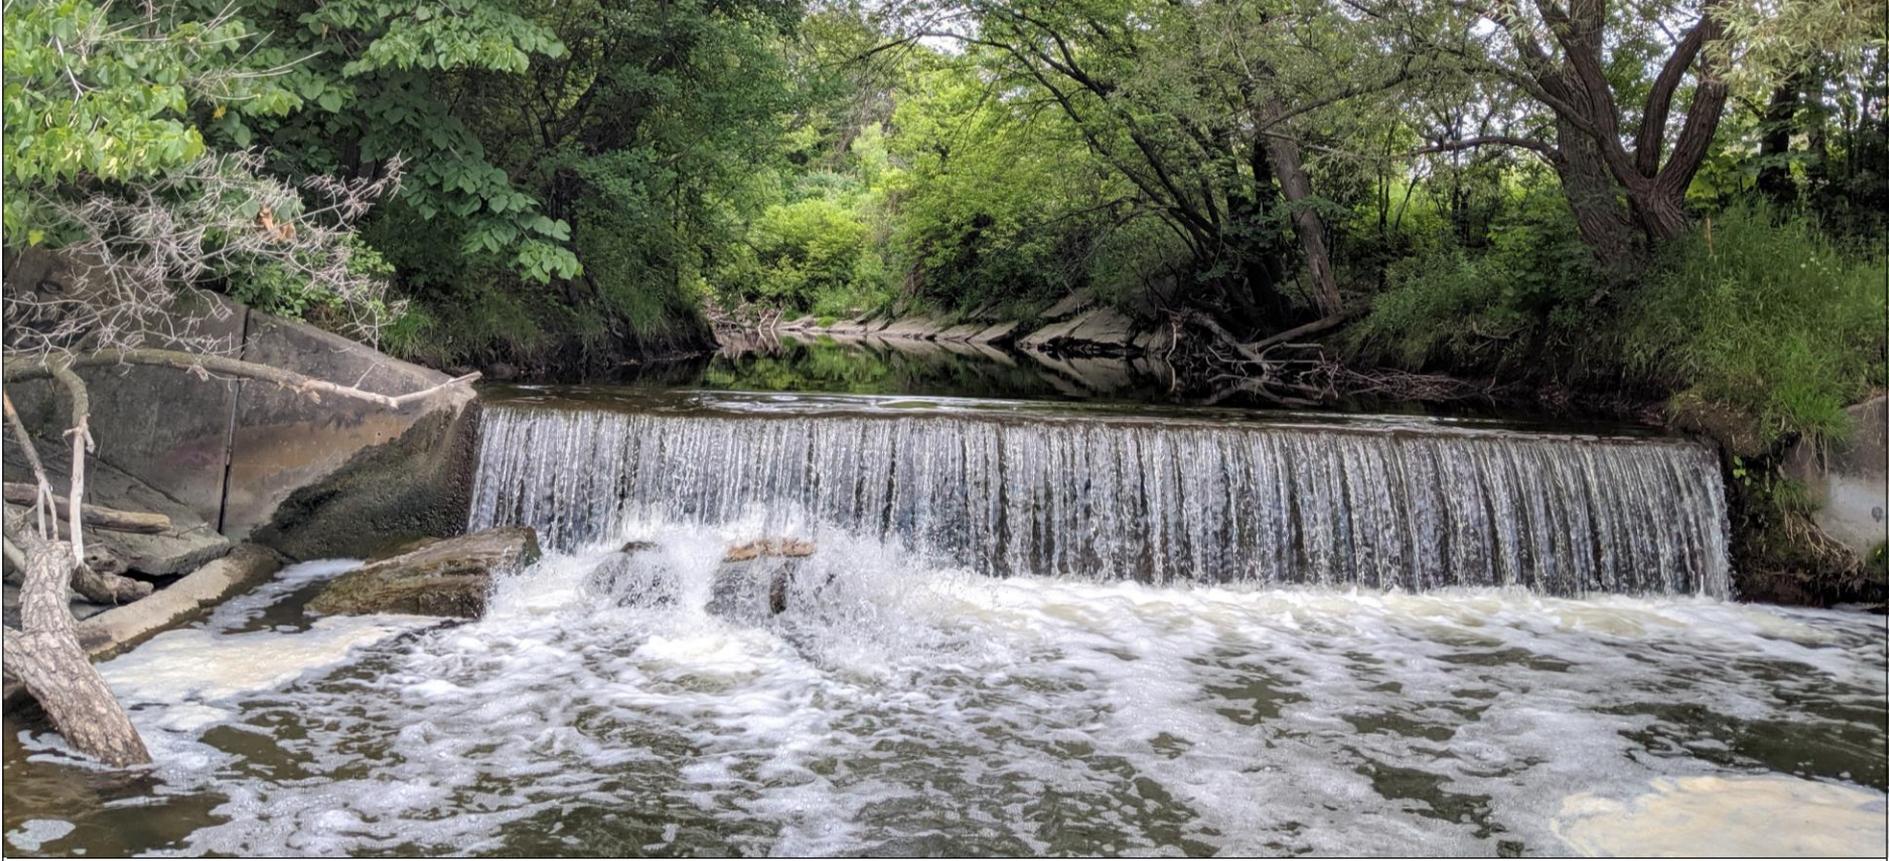
The construction of a concrete weir inhibits bed degradation (down-cutting) by acting as a grade control and controlling river base level downstream of the rail crossing. The channel was significantly realigned and shortened by approximately 90 m, creating a long and gradual meander to its confluence with Don River. Grade control was required due to the local increase in bed gradient along the realigned section, to prevent the upstream migration of a knickpoint. Sediment has deposited to the crest of the weir allowing for bed material transport over the structure. A plunge pool has developed immediately downstream, with bed-protecting armourstone slabs displaced slightly downstream. Flow: background to foreground.

<p>Site 39</p>	<p>TRCA ID: n/a</p>	<p>Likelihood: Low</p> <p>Recommended Action(s): Do Nothing – Continue to monitor for bed degradation within plunge pool.</p>	<p>Consequence: Moderate</p>	<p>Risk: Low</p>
-----------------------	----------------------------	---	-------------------------------------	-------------------------

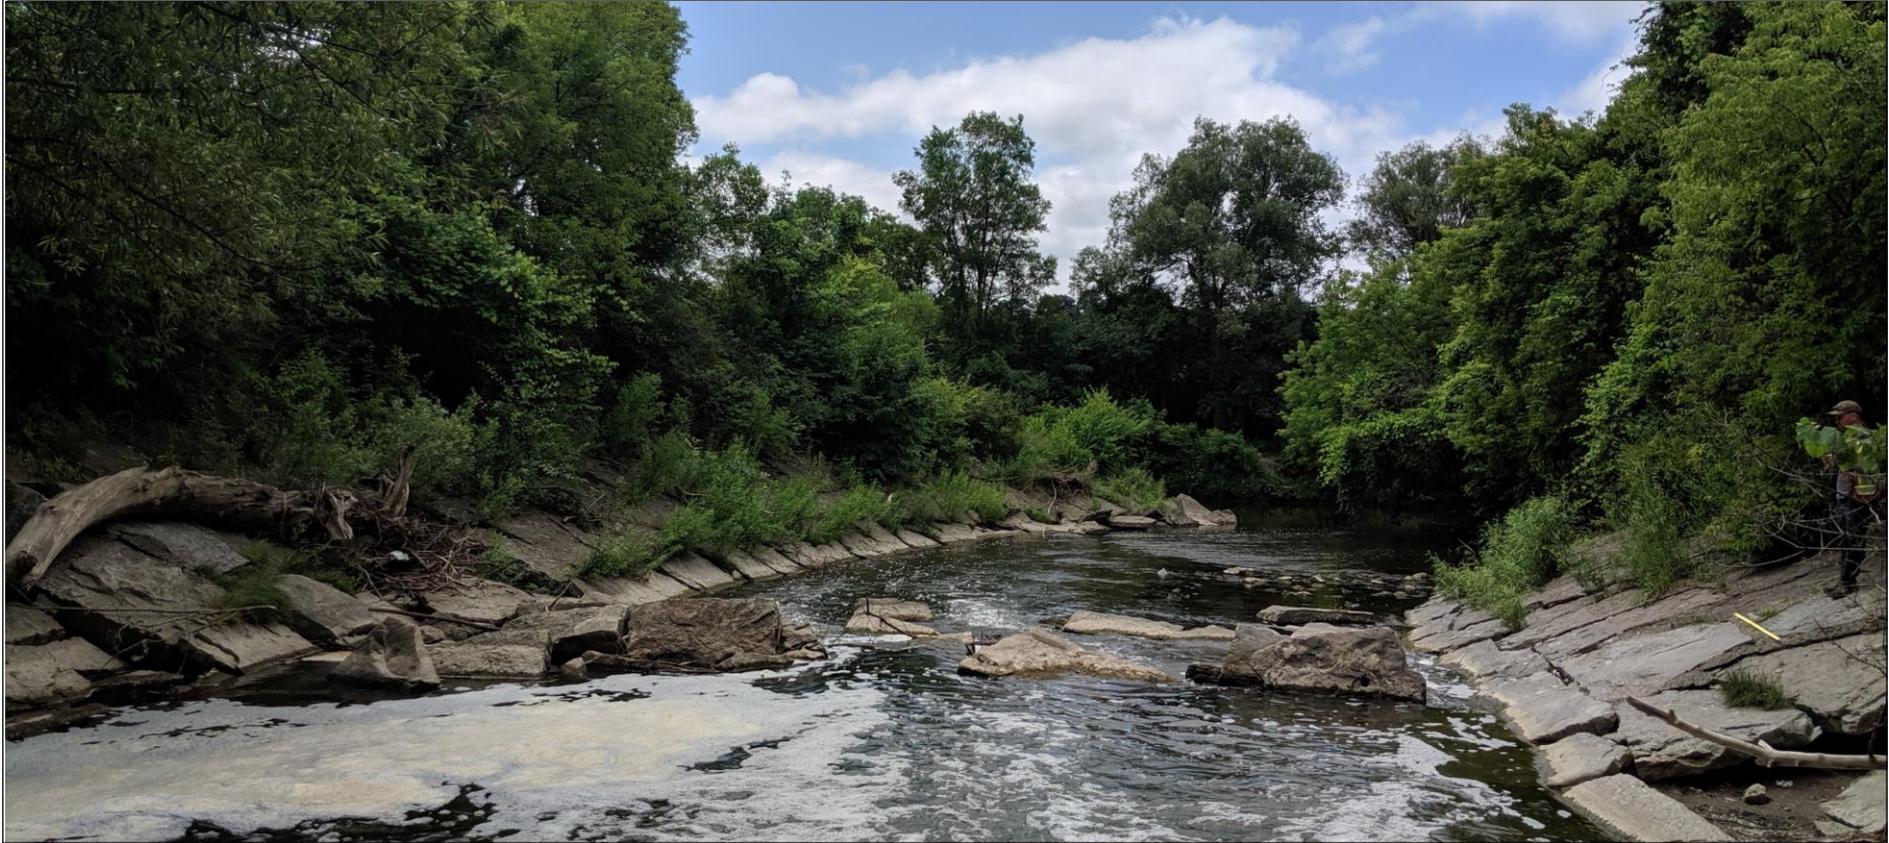
An armourstone slab revetment along the outer (left) bank of a broad meander extends the entire length of the realigned channel from the railway crossing to the confluence with Don River. Downstream of the weir, an armourstone slab revetment also protects the inner bank. Along the outer bank, the armourstone revetment ties in with TRCA's concrete slab revetment (DR05.01). The revetment inhibits lateral adjustment, maintains existing meander geometry and prevents outflanking of the concrete weir. Grouting between the armourstone slabs has deteriorated along its entire length, allowing water to undermine the slabs and winnow fine sediments. Discrete sections of armourstone slabs are missing. Although deterioration was observed, the revetment still provides effective erosion control and prevents outflanking of the weir. Flow: foreground to background.

<p>Site 40</p>	<p>TRCA ID: DR05.1</p>	<p>Likelihood: High</p> <p>Recommended Action(s): Do Nothing – Continue to monitor for outflanking and scour around armourstone slabs.</p>	<p>Consequence: Moderate</p>	<p>Risk: High</p>
-----------------------	-------------------------------	--	-------------------------------------	--------------------------

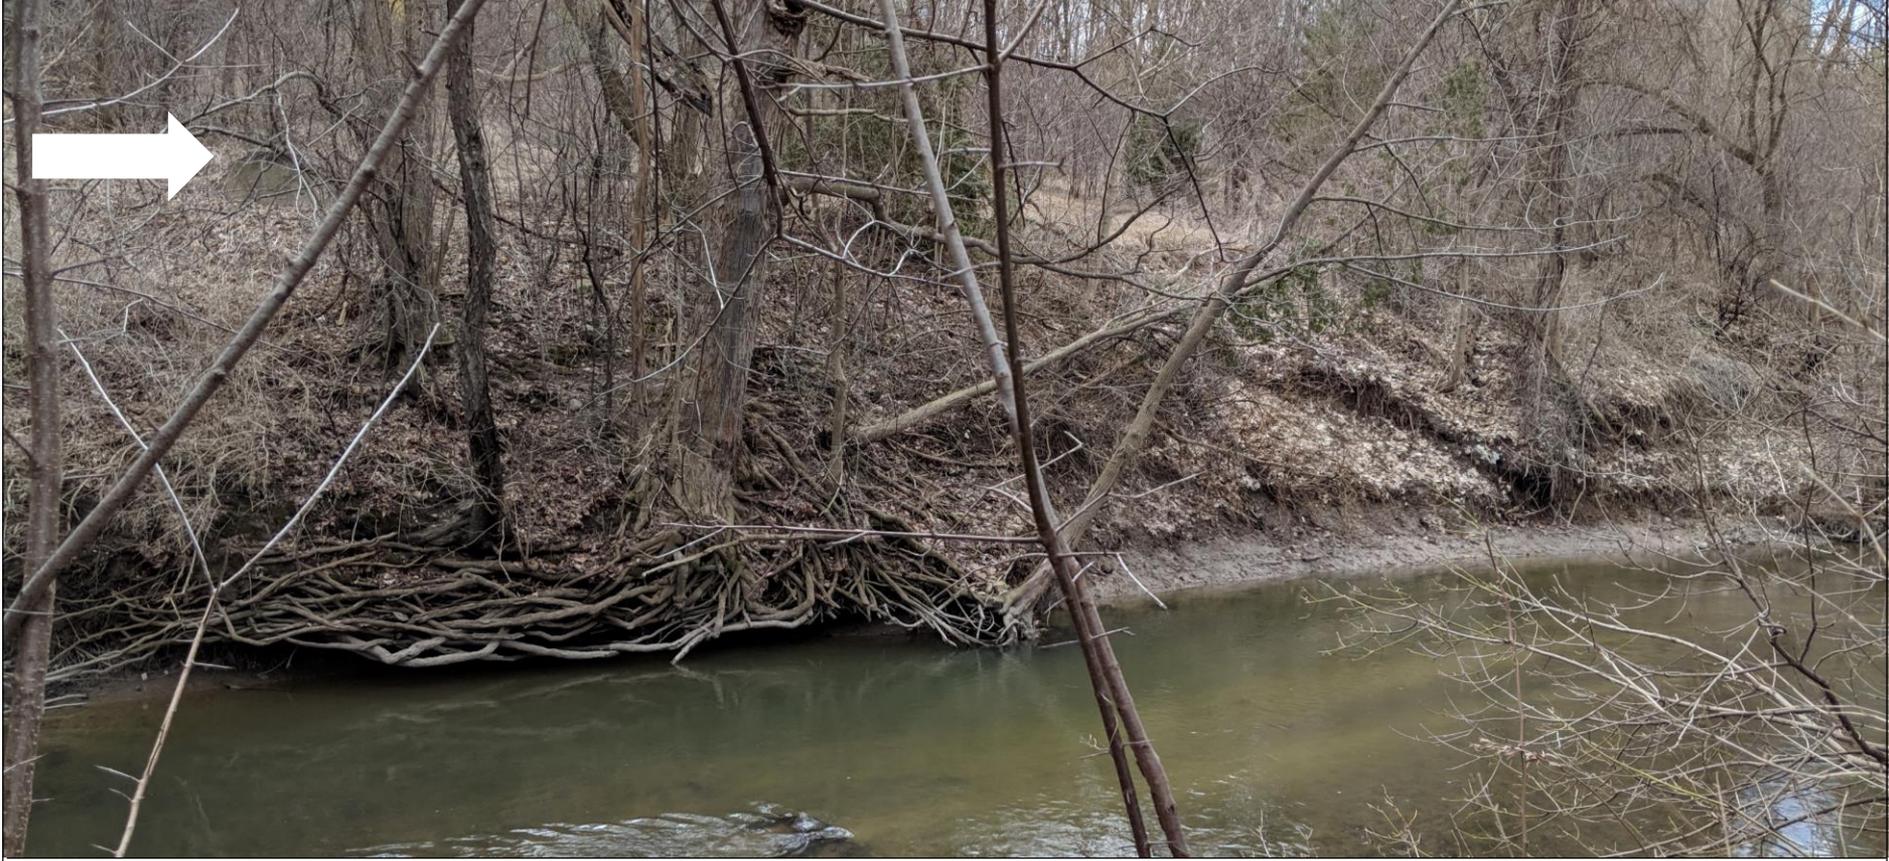
Downstream of DR05.20, scour along the toe of the right bank has undermined a large network of tree roots and formed a scallop-shaped failure. The sanitary sewer and maintenance hole are set back approximately 5 m from the active erosion scar. An armour layer exposed in the bank documents bed degradation (down-cutting) along this straight and slightly entrenched section. Energy transfer along the armoured outer bank immediately upstream has also contributed to erosion. Flow: right to left.

<p>Site 41</p>	<p>TRCA ID: n/a</p>	<p>Likelihood: Moderate</p>	<p>Consequence: High</p>	<p>Risk: High</p>
<p>Recommended Action(s): Construct New Structure – Vegetated boulder revetment in association with Site 5. Coordinate with Sites 5, 6, 7 and 8.</p>

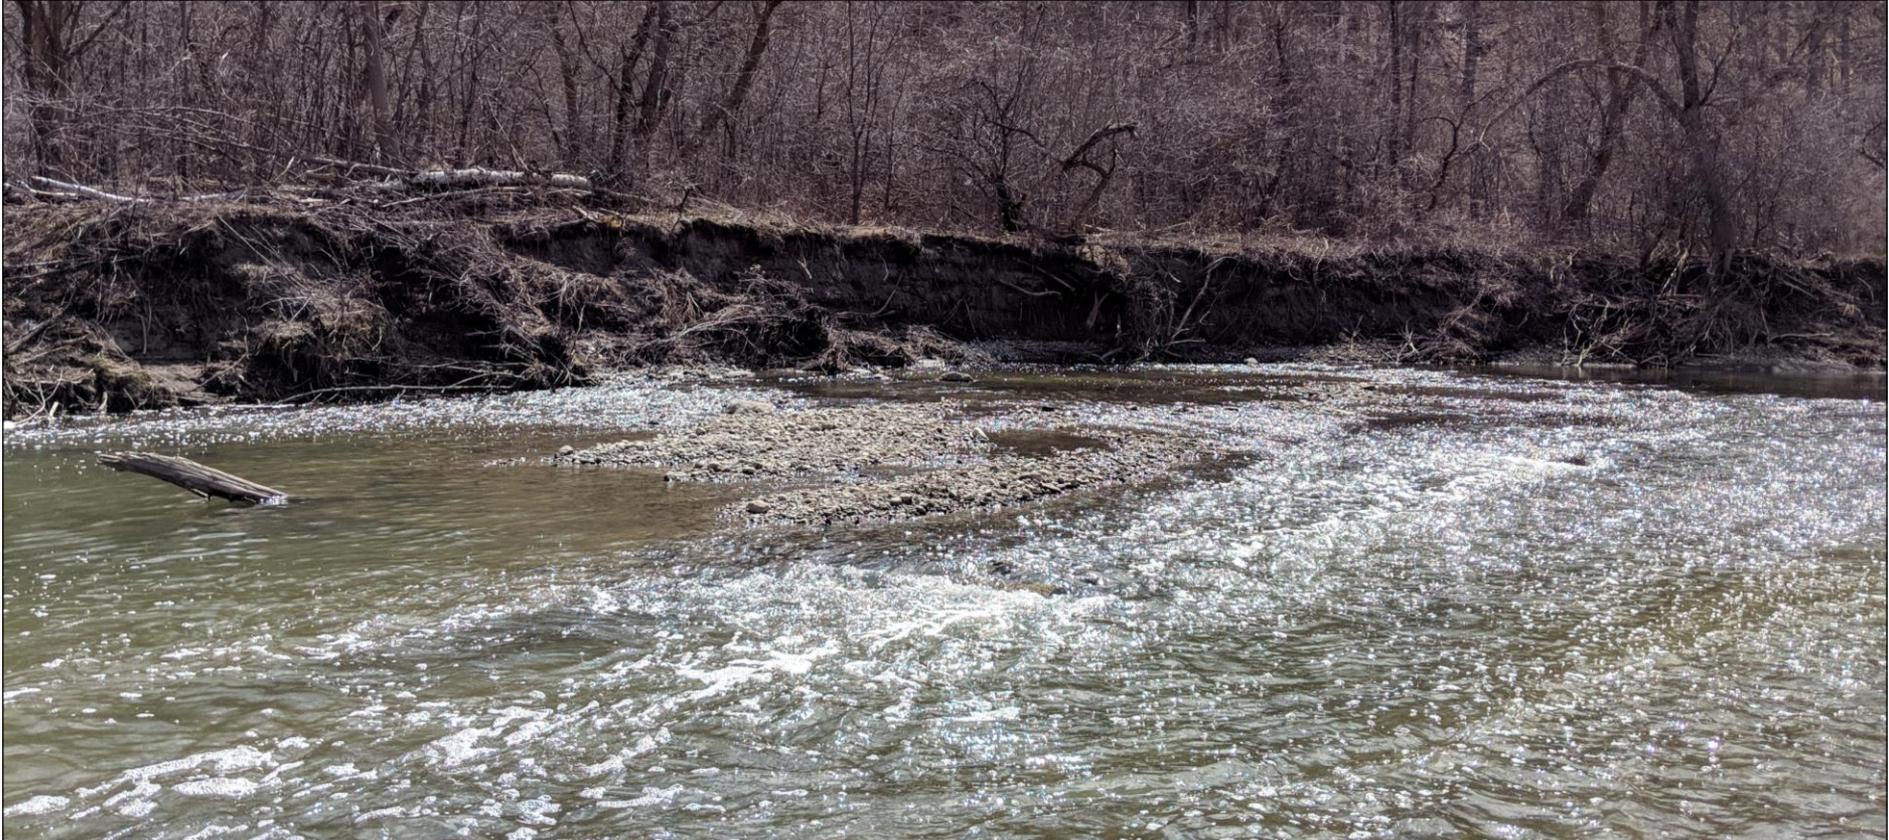
Severe erosion immediately downstream of the recently (2005) realigned channel (Site 15) has resulted in rapid and systematic lateral migration along the outer (right) bank of the meander. Downstream energy transfer from the armoured outer bank immediately upstream has exacerbated the erosion of loose alluvial material. Erosion has started to outflank the downstream extent of Site 15 as the length of erosion extends upstream. Rapid planform adjustment and the presence of loose alluvial material indicate that continued erosion is likely going to affect conditions immediately downstream at Site 17 (DR05.13). Flow: right to left.

<p>Site 42</p>	<p>TRCA ID: n/a</p>	<p>Likelihood: High</p>	<p>Consequence: Moderate</p>	<p>Risk: High</p>
<p>Recommended Action(s): Do Nothing – Continue to monitor planform geometry and its implications for erosion control works immediately downstream at Site 17.</p>

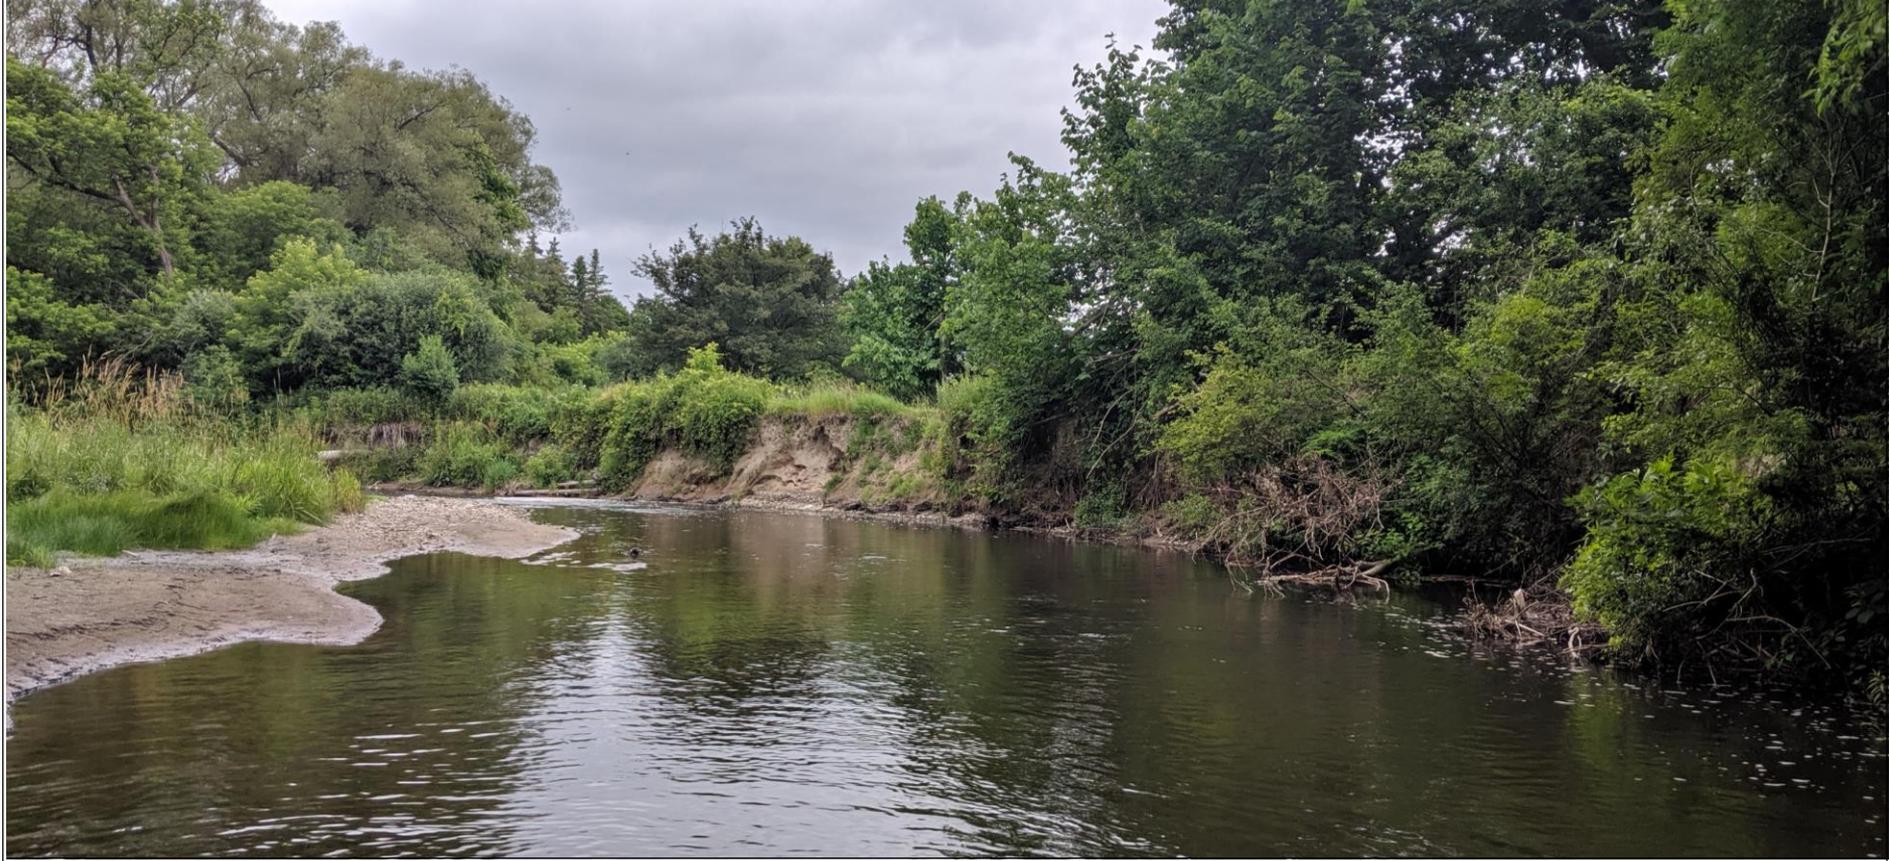
Debris from gullyng and mass movements on the steep valley wall has accumulated at the slope toe such that it projects slightly into the river, deflecting flow toward the opposite bank. This deflection has formed a small, new meander. The channel is slightly entrenched, which contributes to the erosion of loose alluvial material. A mountain bike trail along the top of bank is at risk of being undermined, with corresponding risk to park users. The West Don River Trail is setback approximately 25 m with the sanitary further behind the trail. Flow: Background to foreground.

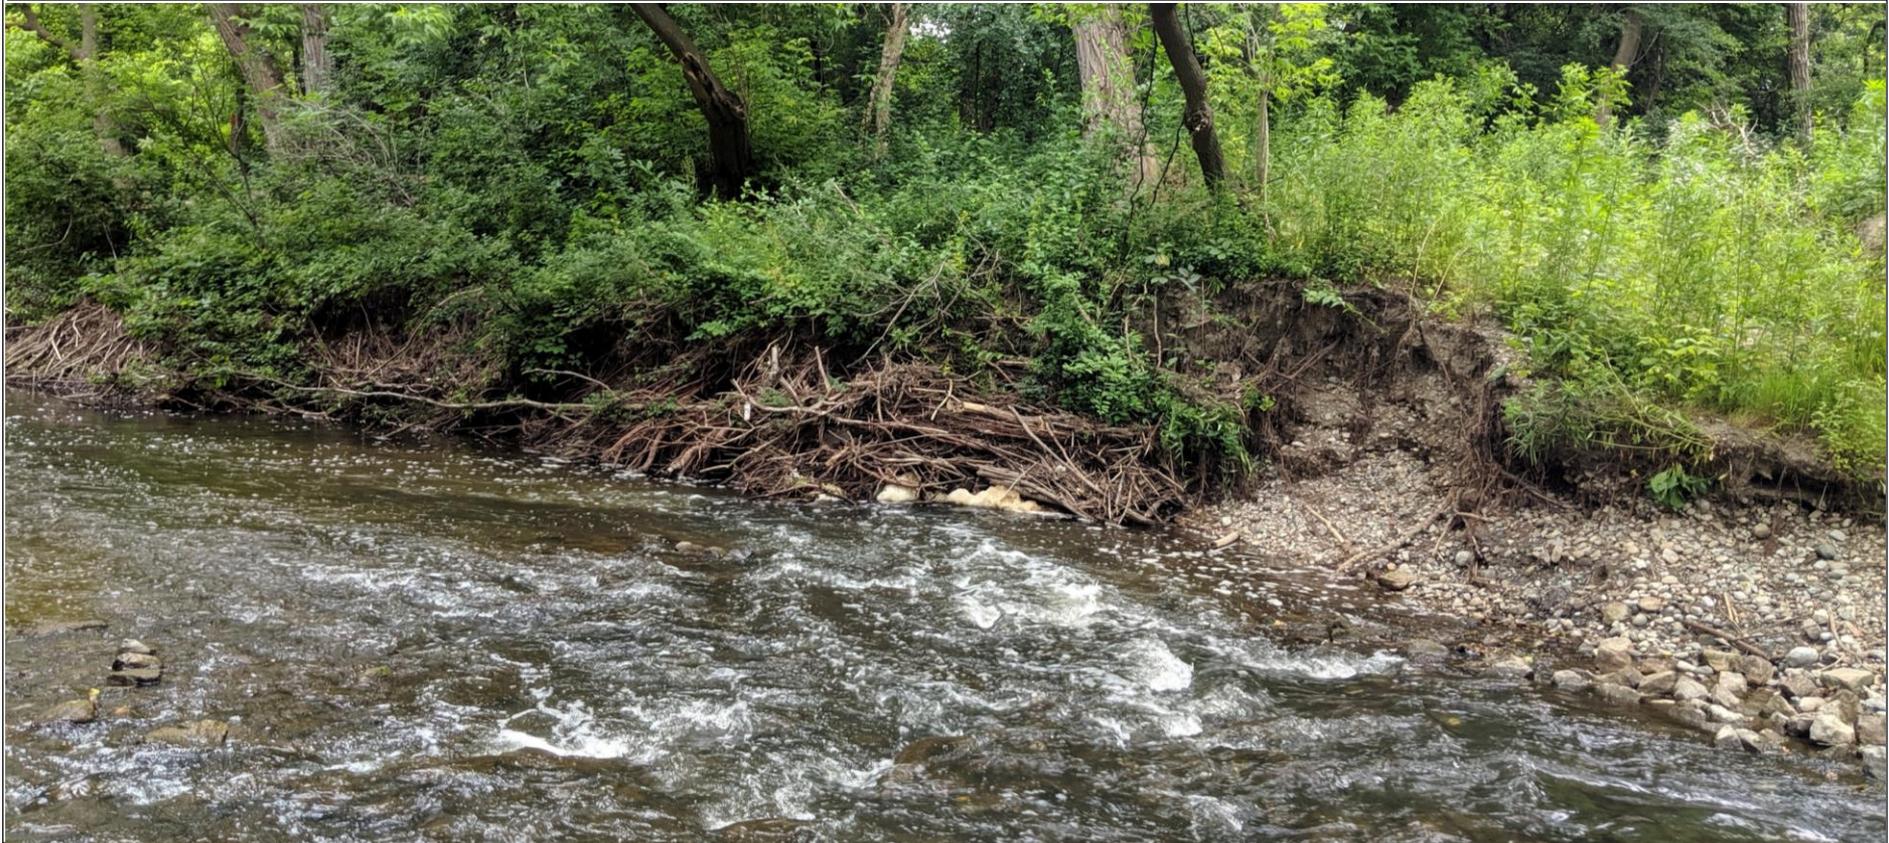
Downstream of Site 21, scour along the bed and toe of the right bank has formed a scallop-shaped erosional hollow. Bed scour and outer bank erosion is directly over a sanitary crossing (DRR221.01), increasing the risk of outflanking and exposure of the sanitary pipe. The depth of the sanitary pipe is unknown. Downstream energy transfer from the armoured outer bank (Site 21) immediately upstream has also contributed to erosion. Flow: right to left.

<p>Site 44</p>	<p>TRCA ID: n/a</p>	<p>Likelihood: Moderate</p> <p>Recommended Action(s): Construct New Structure – Grade control riffle and vegetated boulder revetment. Coordinate with Sites 21, 22, 24, 25 and 26.</p>	<p>Consequence: High</p>	<p>Risk: High</p>
-----------------------	----------------------------	--	---------------------------------	--------------------------

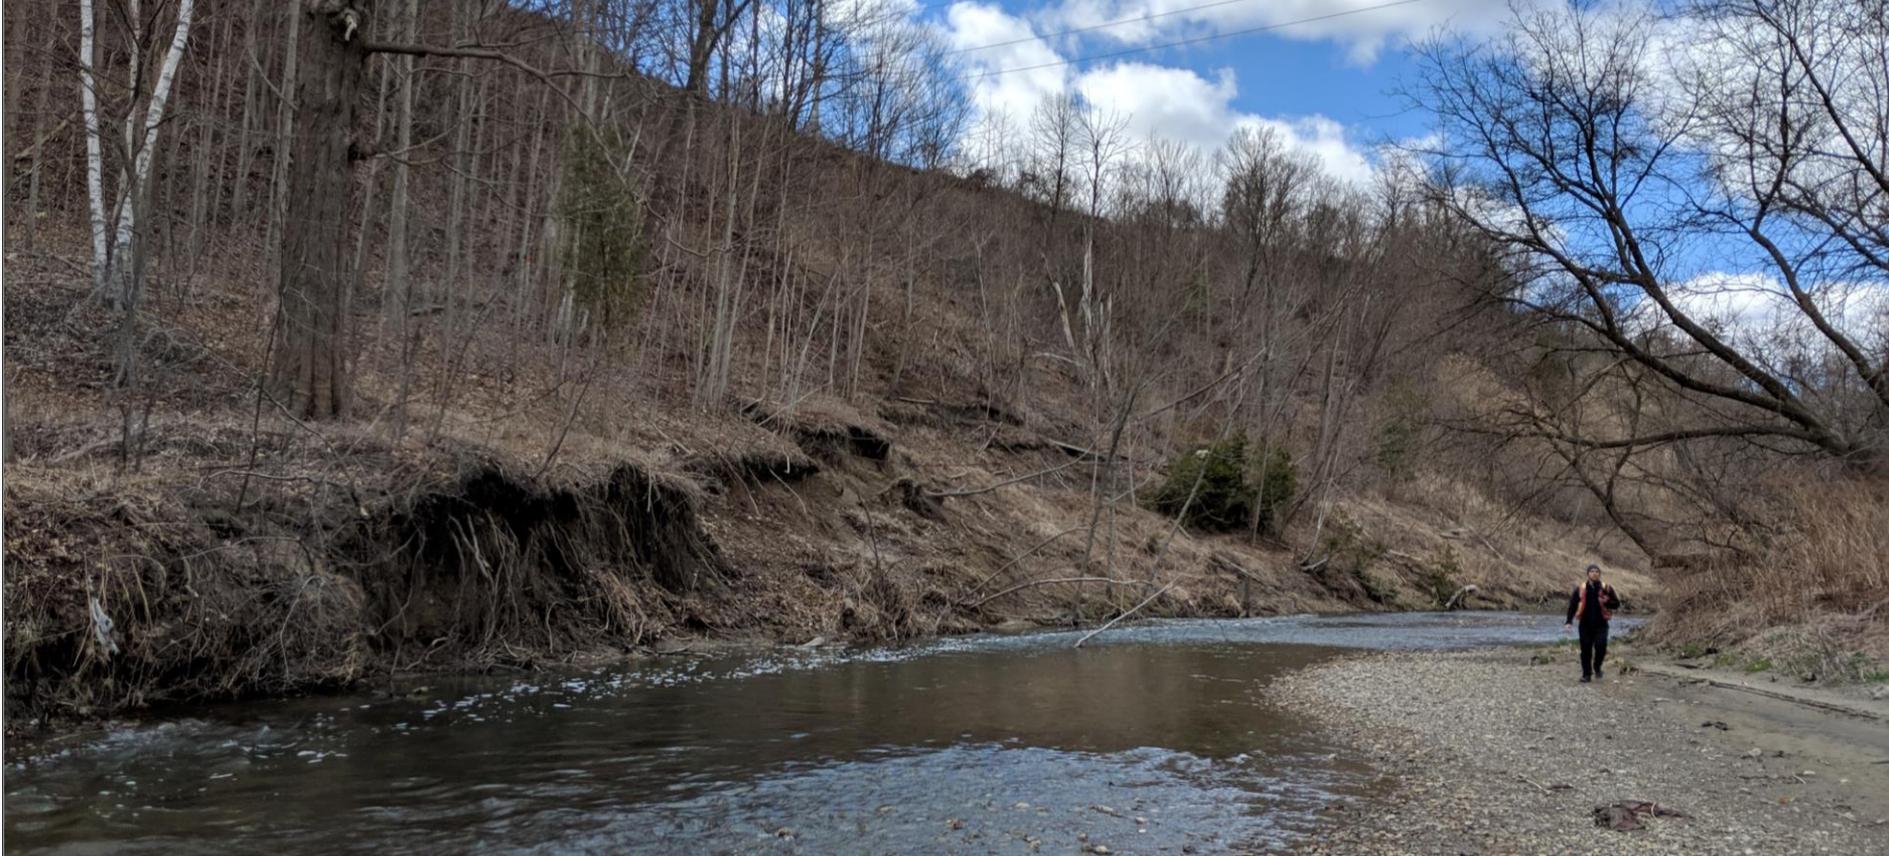
Fluvial scour along the toe of the valley wall has resulted in undercut banks and contributed to slumping failures on the valley wall beneath the hydro corridor. Hydro towers are located in close proximity (approximately 6 m) to the crest of the valley wall, which exhibits active and recurrent mass movements. Recent failures have deposited material in the channel. Flow: background to foreground.

<p>Site 45</p>	<p>TRCA ID: n/a</p>	<p>Likelihood: Moderate</p>	<p>Consequence: High</p>	<p>Risk: High</p>
<p>Recommended Action(s): Do Nothing – Continue to monitor planform adjustment and consider conducting a geotechnical/slope stability investigation to evaluate risk to the hydro towers.</p>
