West Don River at E.T. Seton Park – Detailed Fluvial Geomorphic Analysis and Erosion Risk Assessment

Contract # 10009019

Toronto and Region Conservation Authority

October 2, 2019

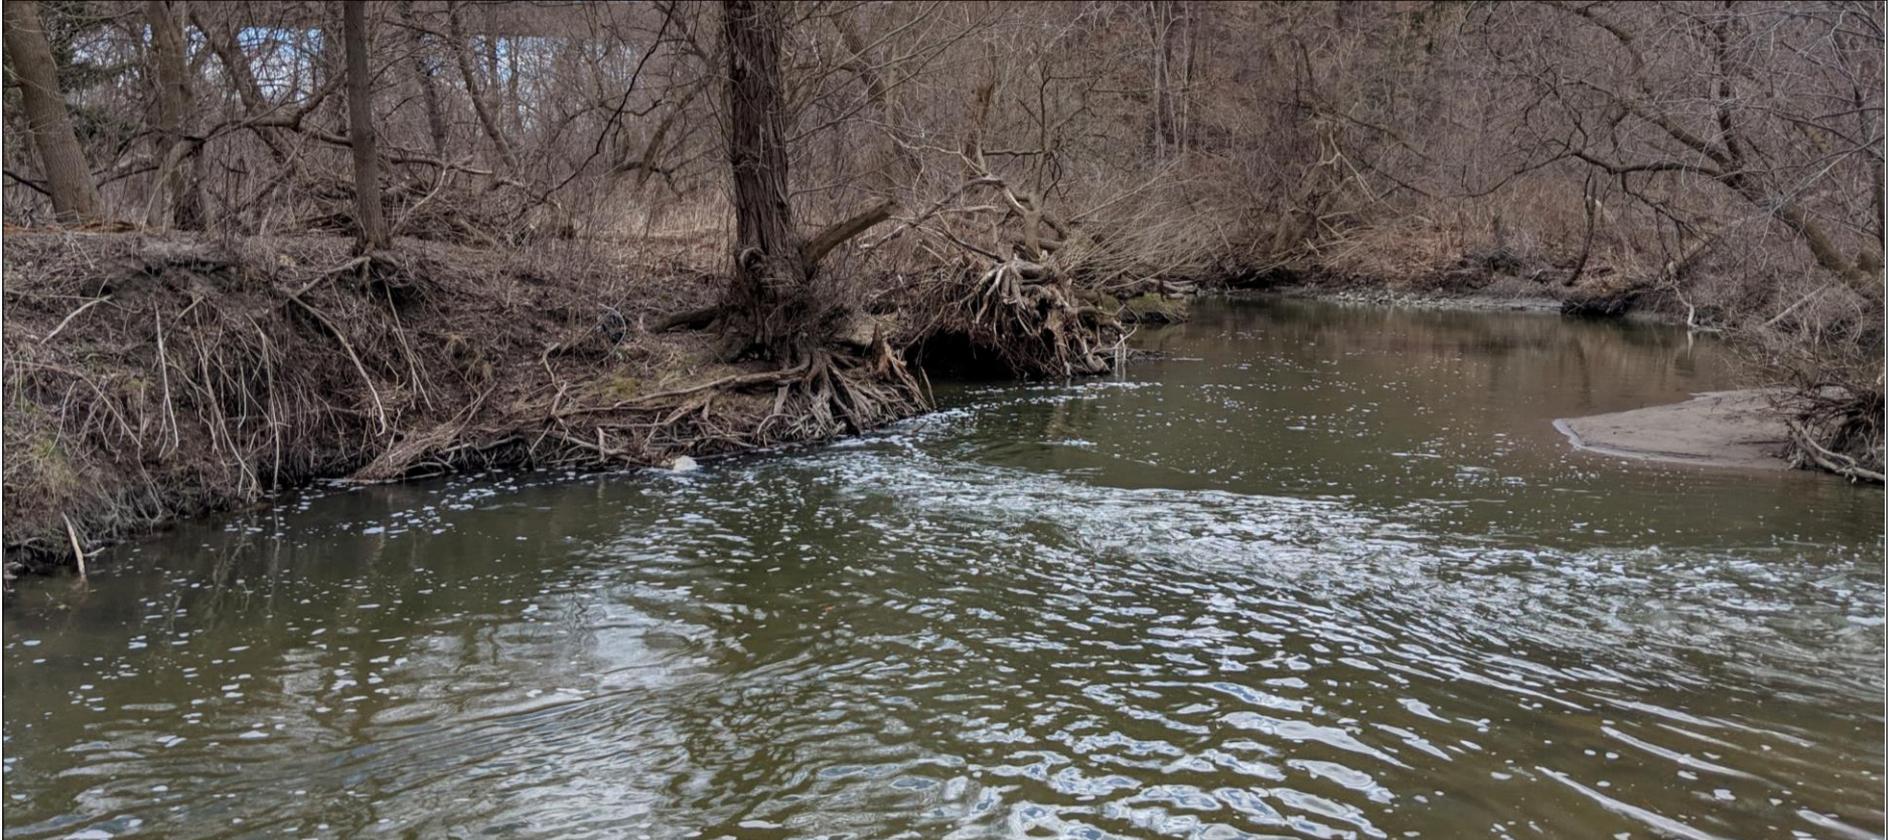
Scour and undermining along the outer (left) bank of a sharp meander has resulted in the exposure of tree roots and toppling of trees. The outer bank has become a point of erosion concentration downstream of a channel realignment and meander cut-off immediately upstream. A well vegetated bank has limited the down-valley migration of the meander; however, continued undermining, outflanking and toppling of trees will allow for lateral migration toward the sanitary sewer and West Don River Trail, both of which are more than 25 m away. Flow: foreground to background.

<p>Site 46</p>	<p>TRCA ID: n/a</p>	<p>Likelihood: Moderate</p>	<p>Consequence: High</p>	<p>Risk: High</p>
<p>Recommended Action(s): Do Nothing – Continue to monitor planform adjustment.</p>

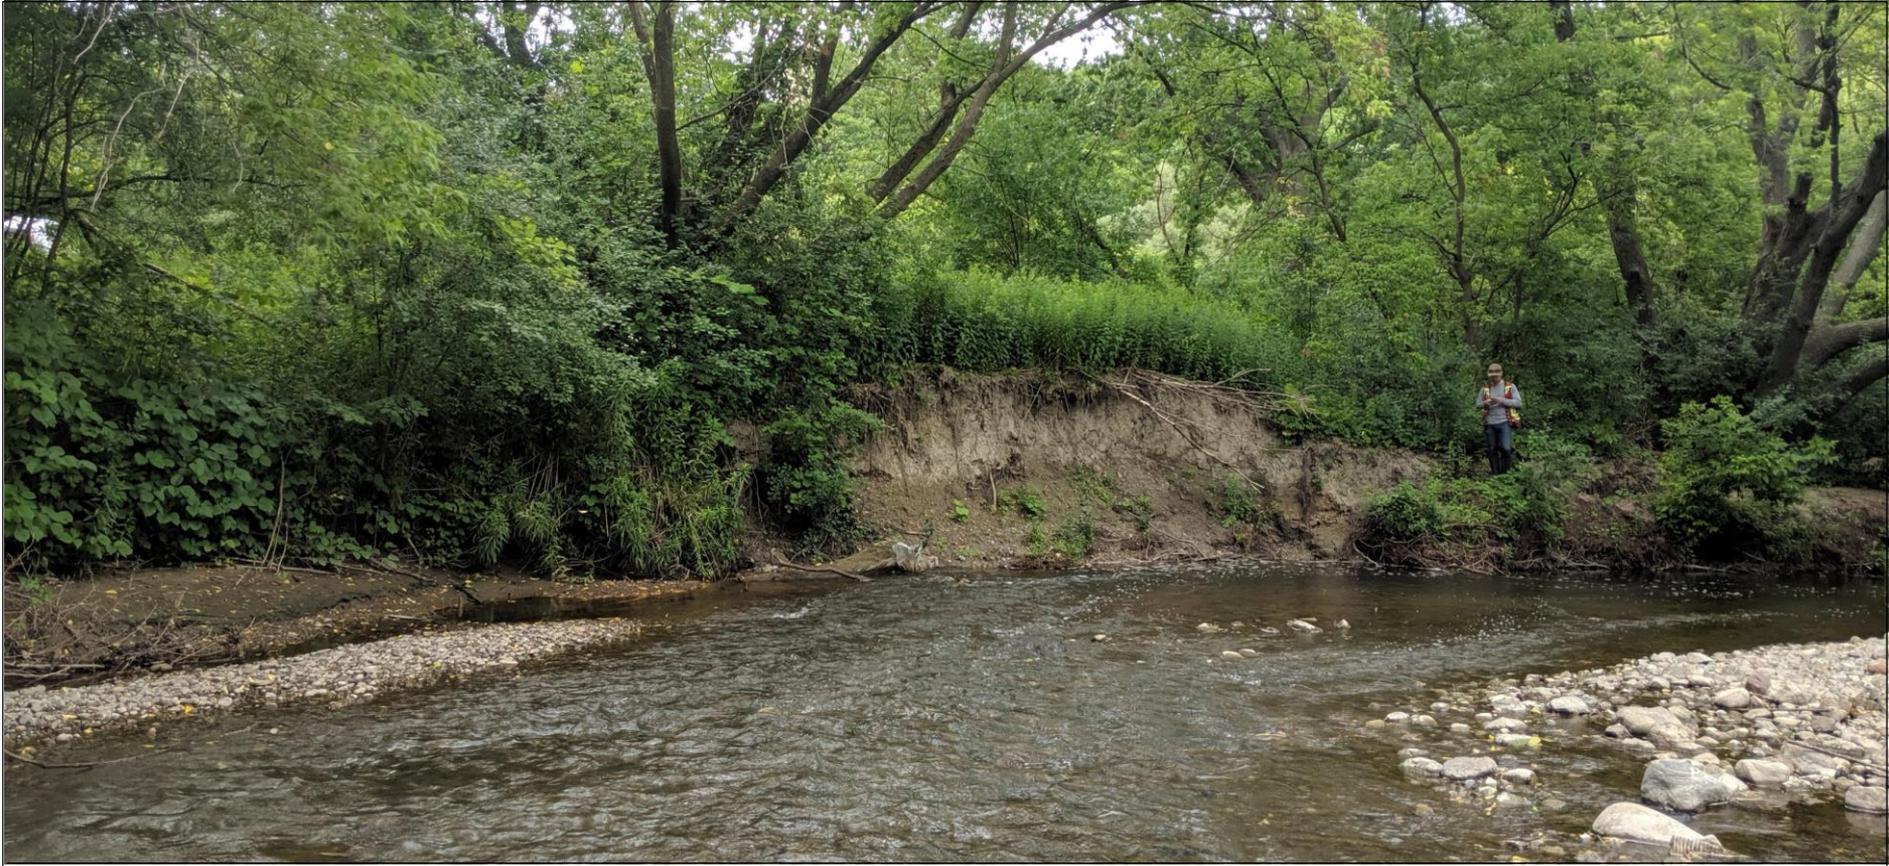
Severe erosion along both the outer and inner bank of a sharp meander has resulted in rapid and systematic lateral migration at a sanitary sewer crossing. The channel has an anomalously wide 'blow-out' where flow splits around a large cobble-boulder, mid-channel bar. Erosion along the outer bank has resulted in the failure of an erosion control structure (Site 29). Erosion along the inner bank is migrating toward a circular parking lot. A sanitary sewer crossing beneath the channel (Site 30) is at risk of being outflanked on one or both sides. The depth of sewer is unknown. Flow: background to foreground.

<p>Site 47</p>	<p>TRCA ID: n/a</p>	<p>Likelihood: High</p> <p>Recommended Action(s): Construct New Structure – Vegetated boulder revetment and determine current depth of cover over sanitary sewer.</p>	<p>Consequence: High</p>	<p>Risk: Very High</p>
-----------------------	----------------------------	---	---------------------------------	-------------------------------

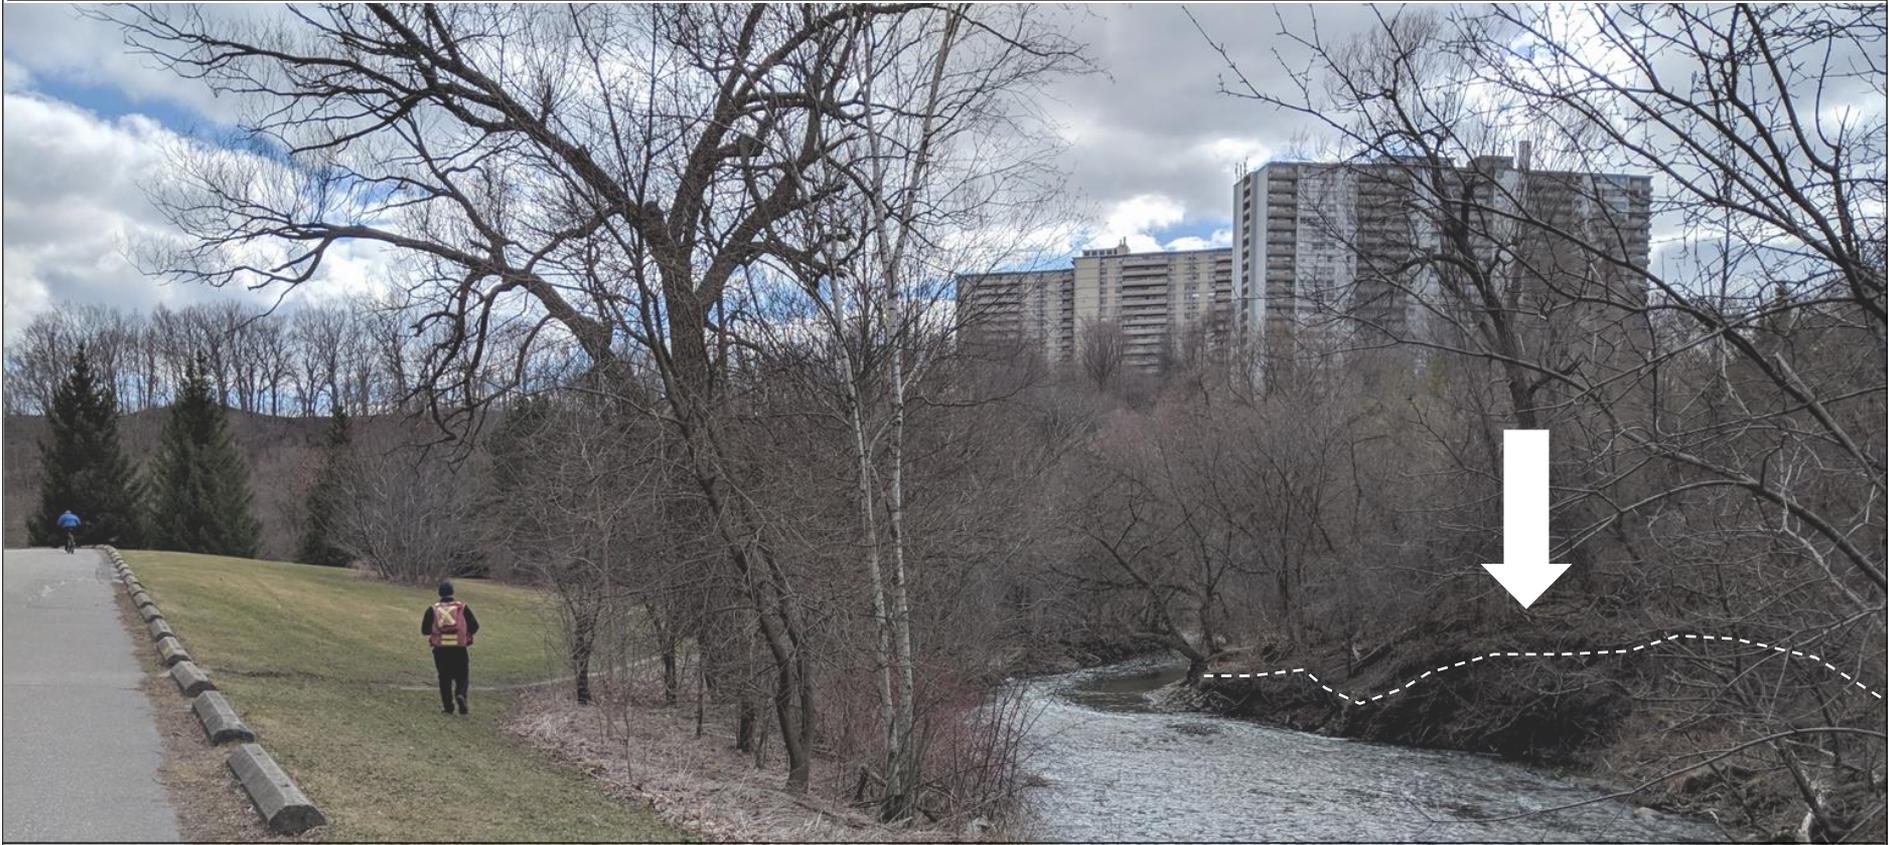
A scallop-shaped erosional hollow along the inner bank of a meander is coincident with thalweg contact. An anomalously wide 'blow-out' along the channel has formed where the thalweg is out of phase with meander geometry. A previous large woody debris accumulation could have deflected flow toward the inner bank and initiated anomalous scour. A bare slope is prone to further instability as a result of fluvial interaction. The sanitary sewer is set back approximately 25 m from the top of the erosional hollow. Flow: foreground to background.

<p>Site 48</p>	<p>TRCA ID: n/a</p>	<p>Likelihood: Low</p> <p>Recommended Action(s): Do Nothing – Continue to monitor planform adjustment.</p>	<p>Consequence: High</p>	<p>Risk: Moderate</p>
-----------------------	----------------------------	--	---------------------------------	------------------------------
