Flood Characterization and Preliminary Remediation Investigations Pickering / Ajax SPA's

Toronto and Region Conservation Authority
City of Toronto

March 2018 (FINAL)

**TORONTO AND REGION CONSERVATION
PICKERING-AJAX DYKE ASSESSMENT AND FLOOD REMEDIATION STUDY**

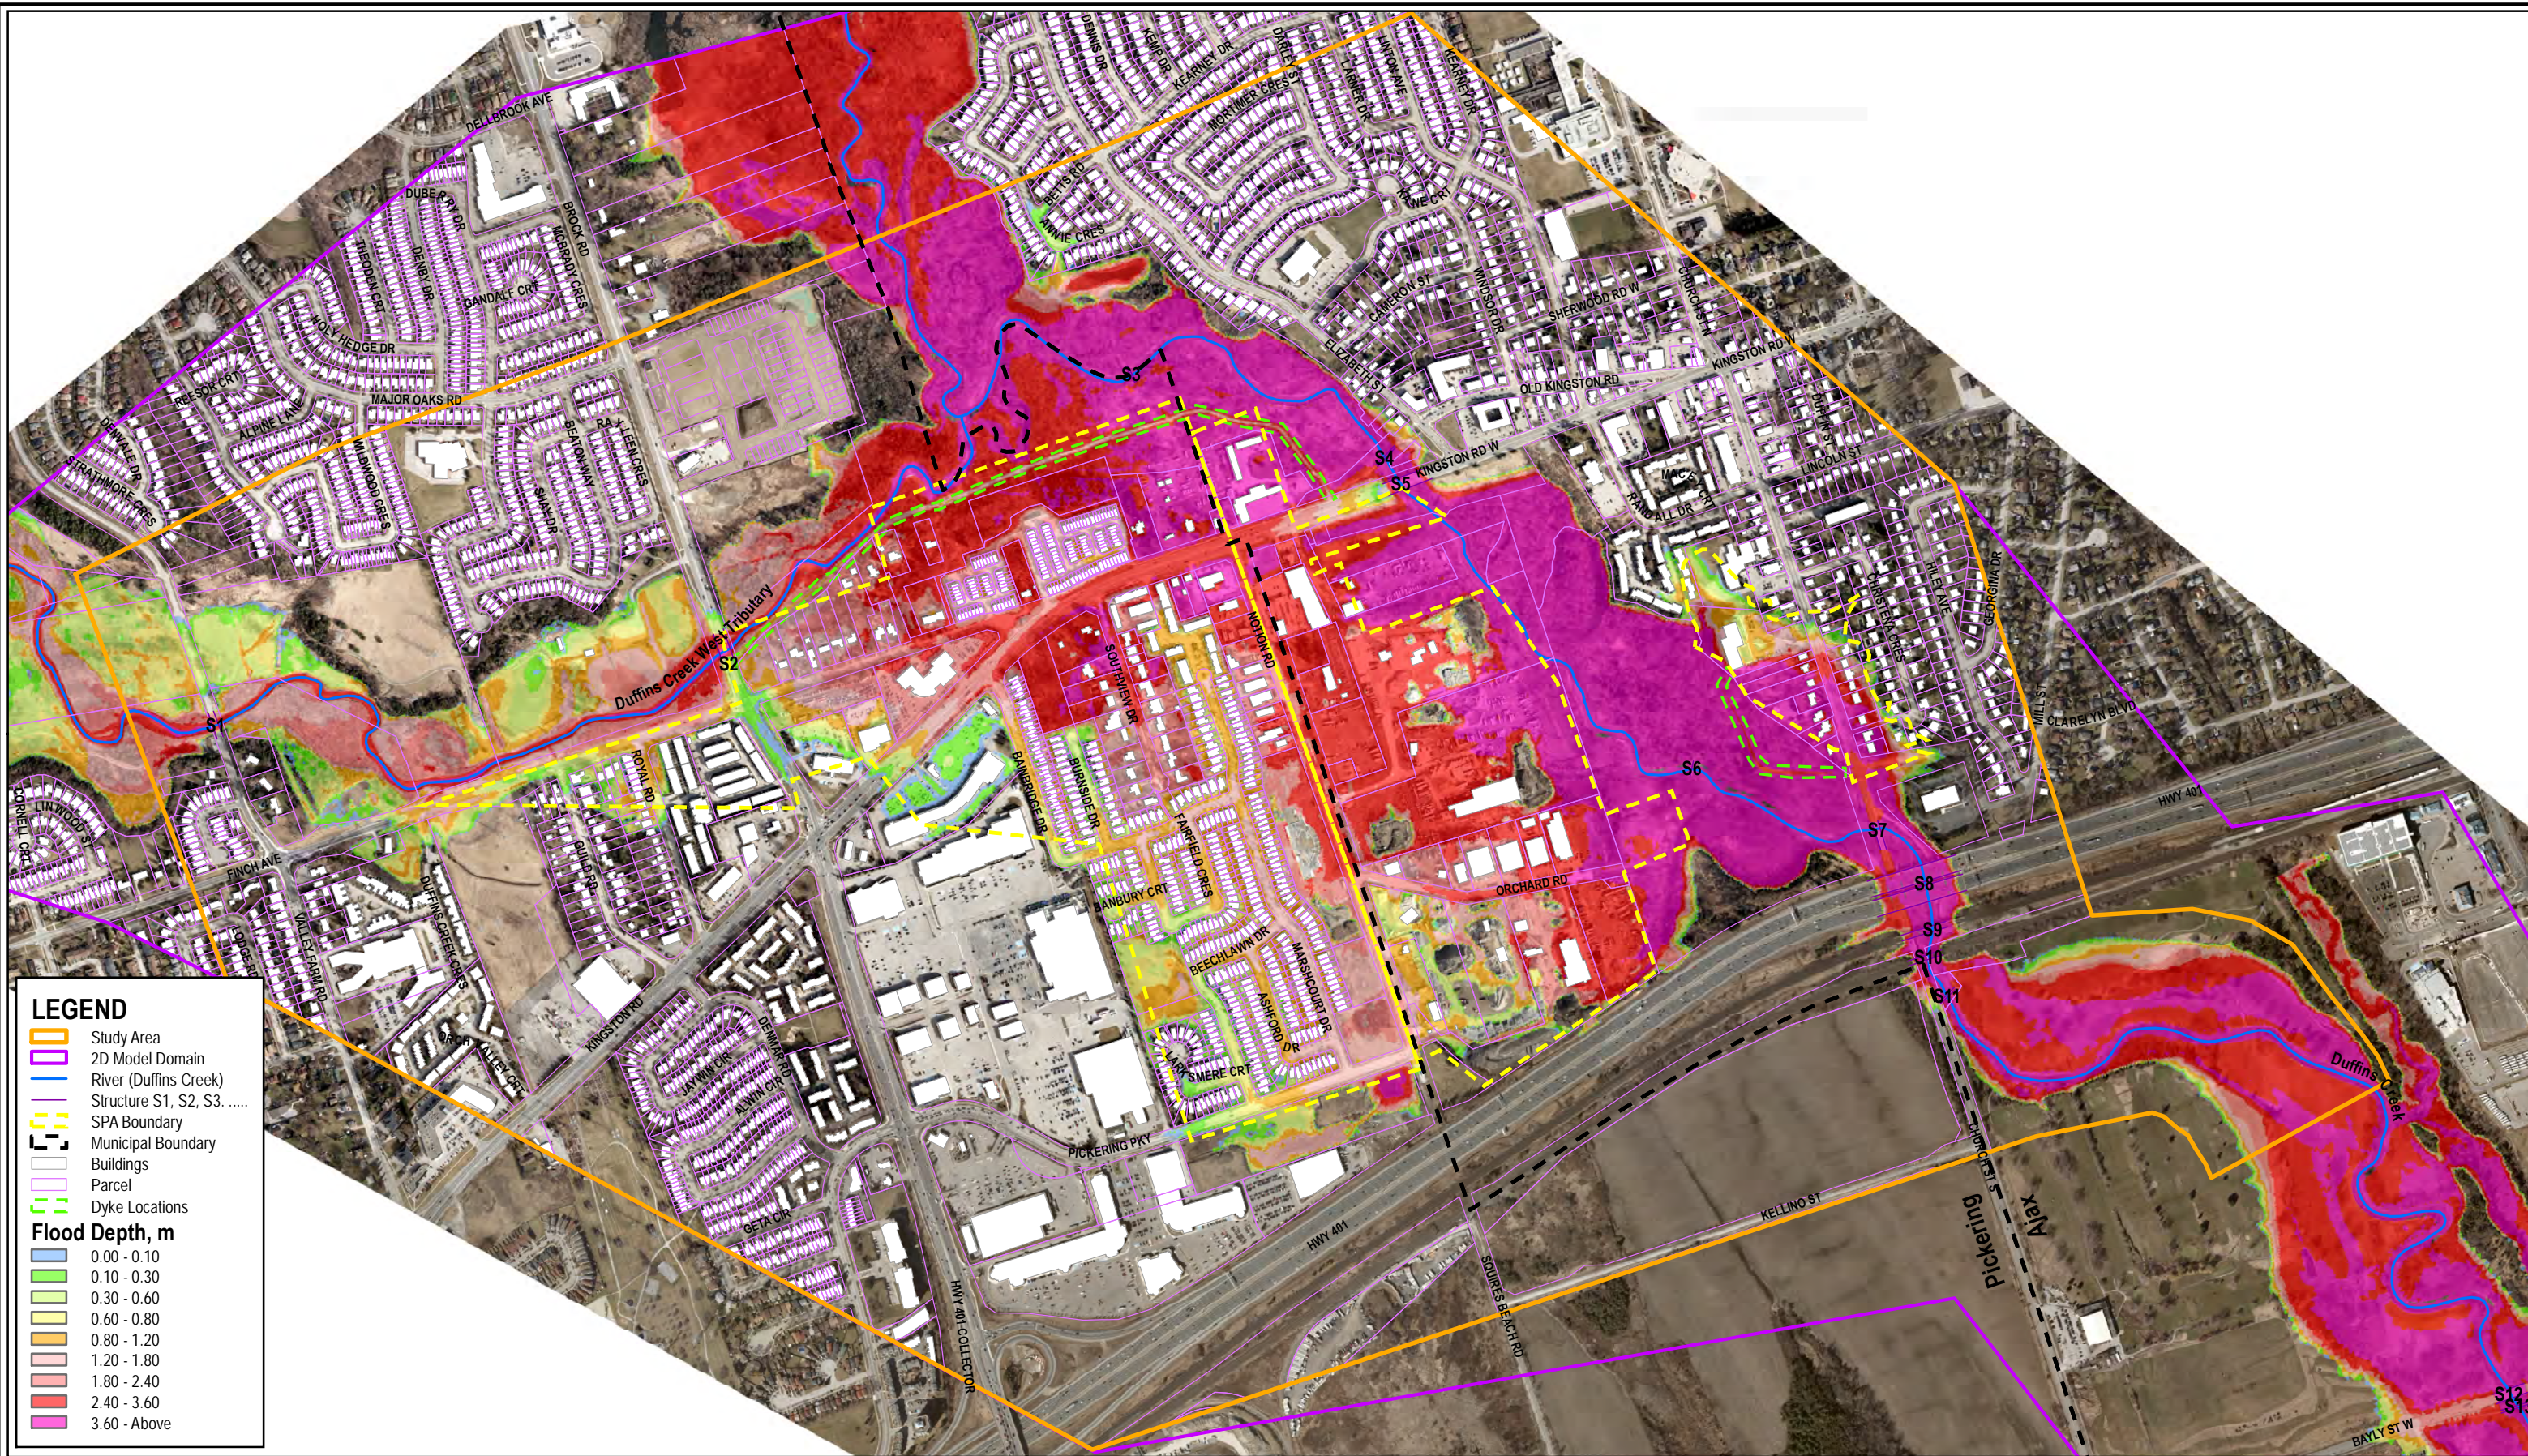
FIGURE 1.3
REGIONAL FLOOD DEPTH MAP
 (EXISTING CONDITION)

STEADY INFLOW HYDROGRAPH (HURRICANE HAZEL)

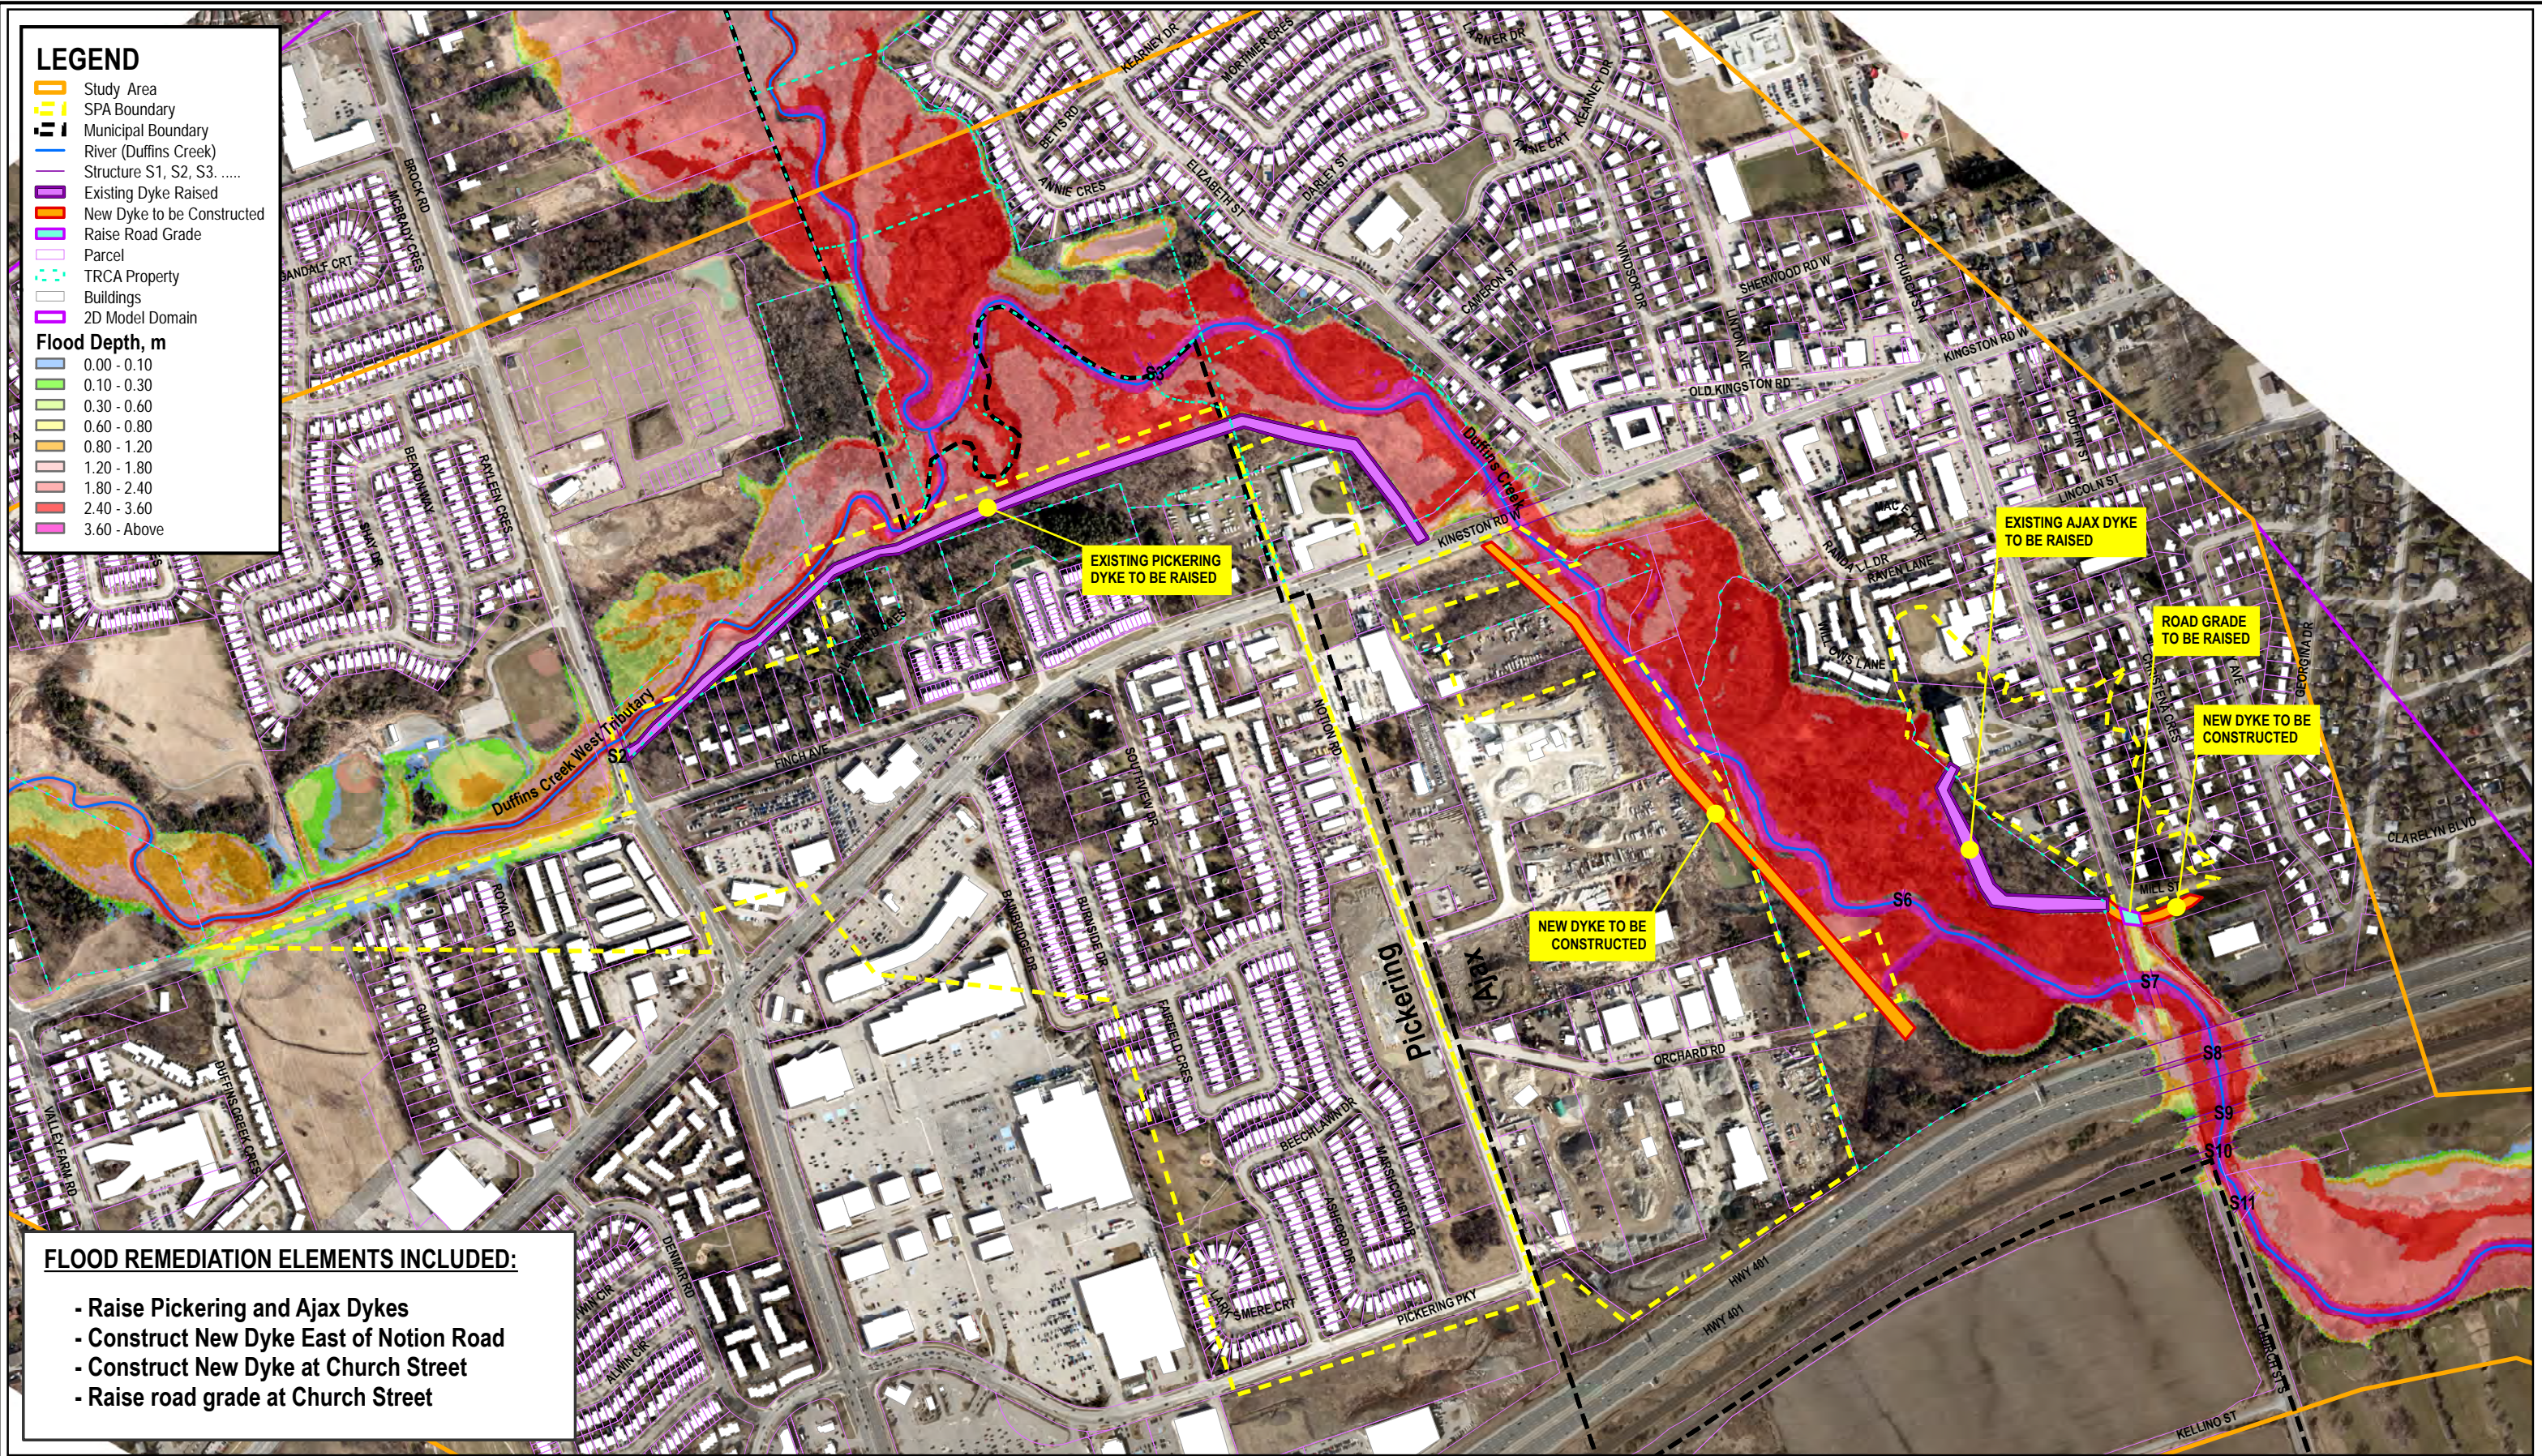
FLOOD REMEDIATION ELEMENTS INCLUDED:

- Raise Pickering and Ajax Dykes
- Construct New Dyke East of Notion Road
- Construct New Dyke at Church Street
- Raise road grade at Church Street

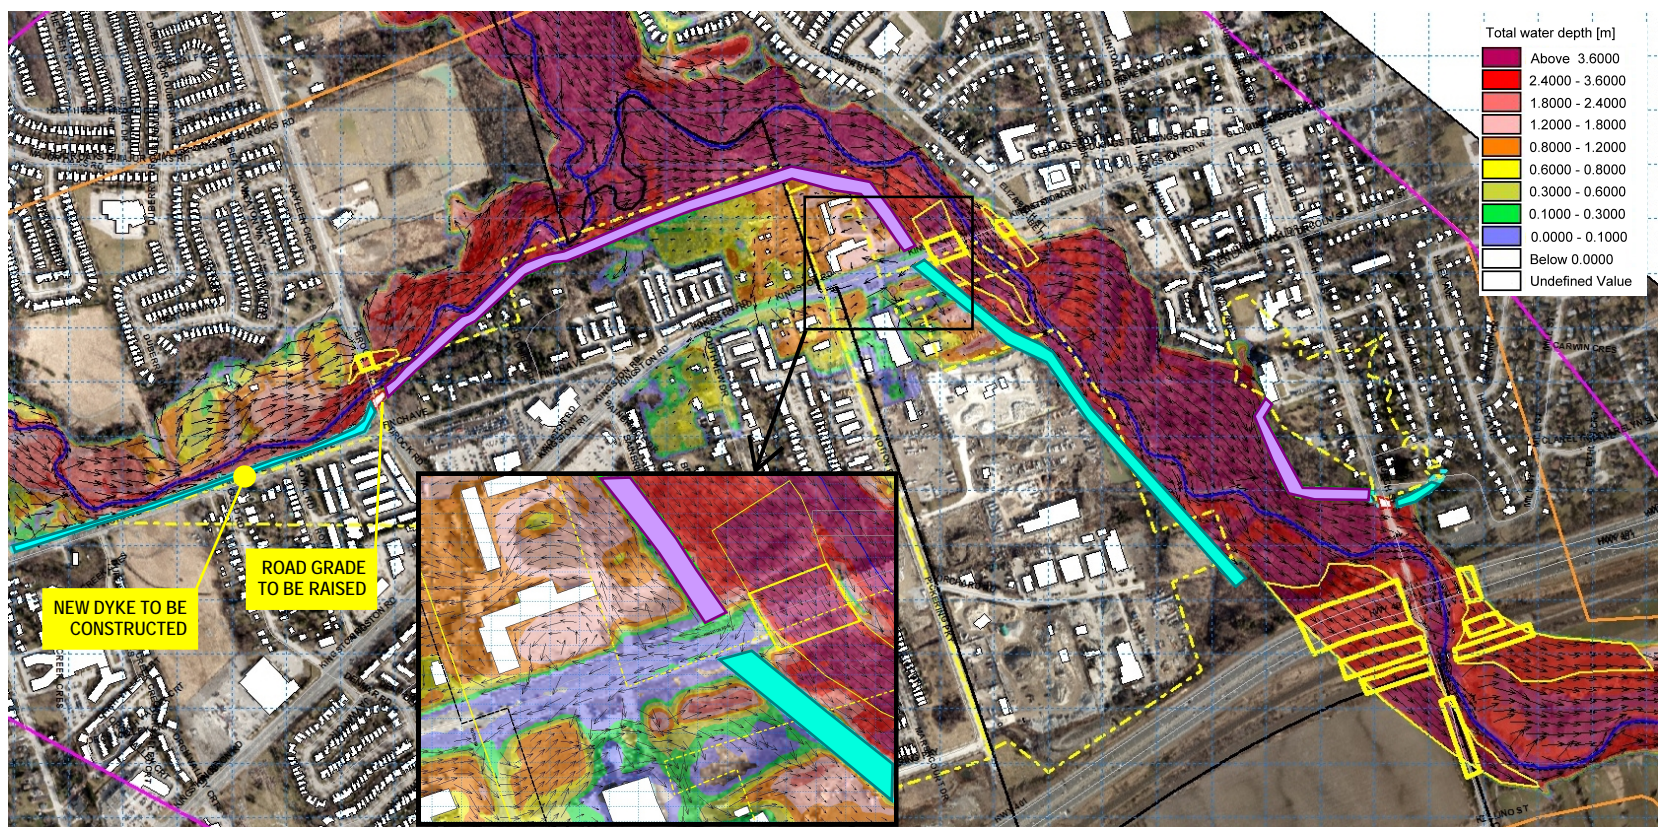
Fig 4.5a Widening Bridges and Channel, Raise Existing Dykes, Construct Two Dykes, Grade raise at Church

Fig 4.5b Widening Bridges and Channel, Raise Existing Dykes, Construct Three New Dykes, Grade raise at Church and Brock

Fig 4.5c Widening Bridges and Channel, Raise Existing Dykes, Construct Three New Dykes, Grade raise at Church, Brock and Kingston Road

FIGURE 4.5
INTERMEDIATE DEVELOPMENT STEPS FOR
OPTION 3 FULL FLOOD REMEDIATION (REGIONAL)
STEADY INFLOW HYDROGRAPH (HURRICANE HAZEL STORM)

flood remediation elements included in the initial step. As shown in **Figure 4.5 (b)**, flooding within the Pickering SPA continues to occur due to flow spilling across the low area on Kingston Road west of Duffins Creek.

The third flood remediation step consisted of raising Kingston Road at the low area west of Duffins Creek. As shown in **Figure 4.5 (c)** and **Figure 4.6**, the implementation of the noted set of flood remediation elements provides flood protection for virtually the entire Pickering and Ajax SPA's during the Regional storm. In addition, it was determined that the impacts of the proposed flood remediation elements would not raise upstream water levels significantly and would not flood additional buildings not currently residing within the floodplain.

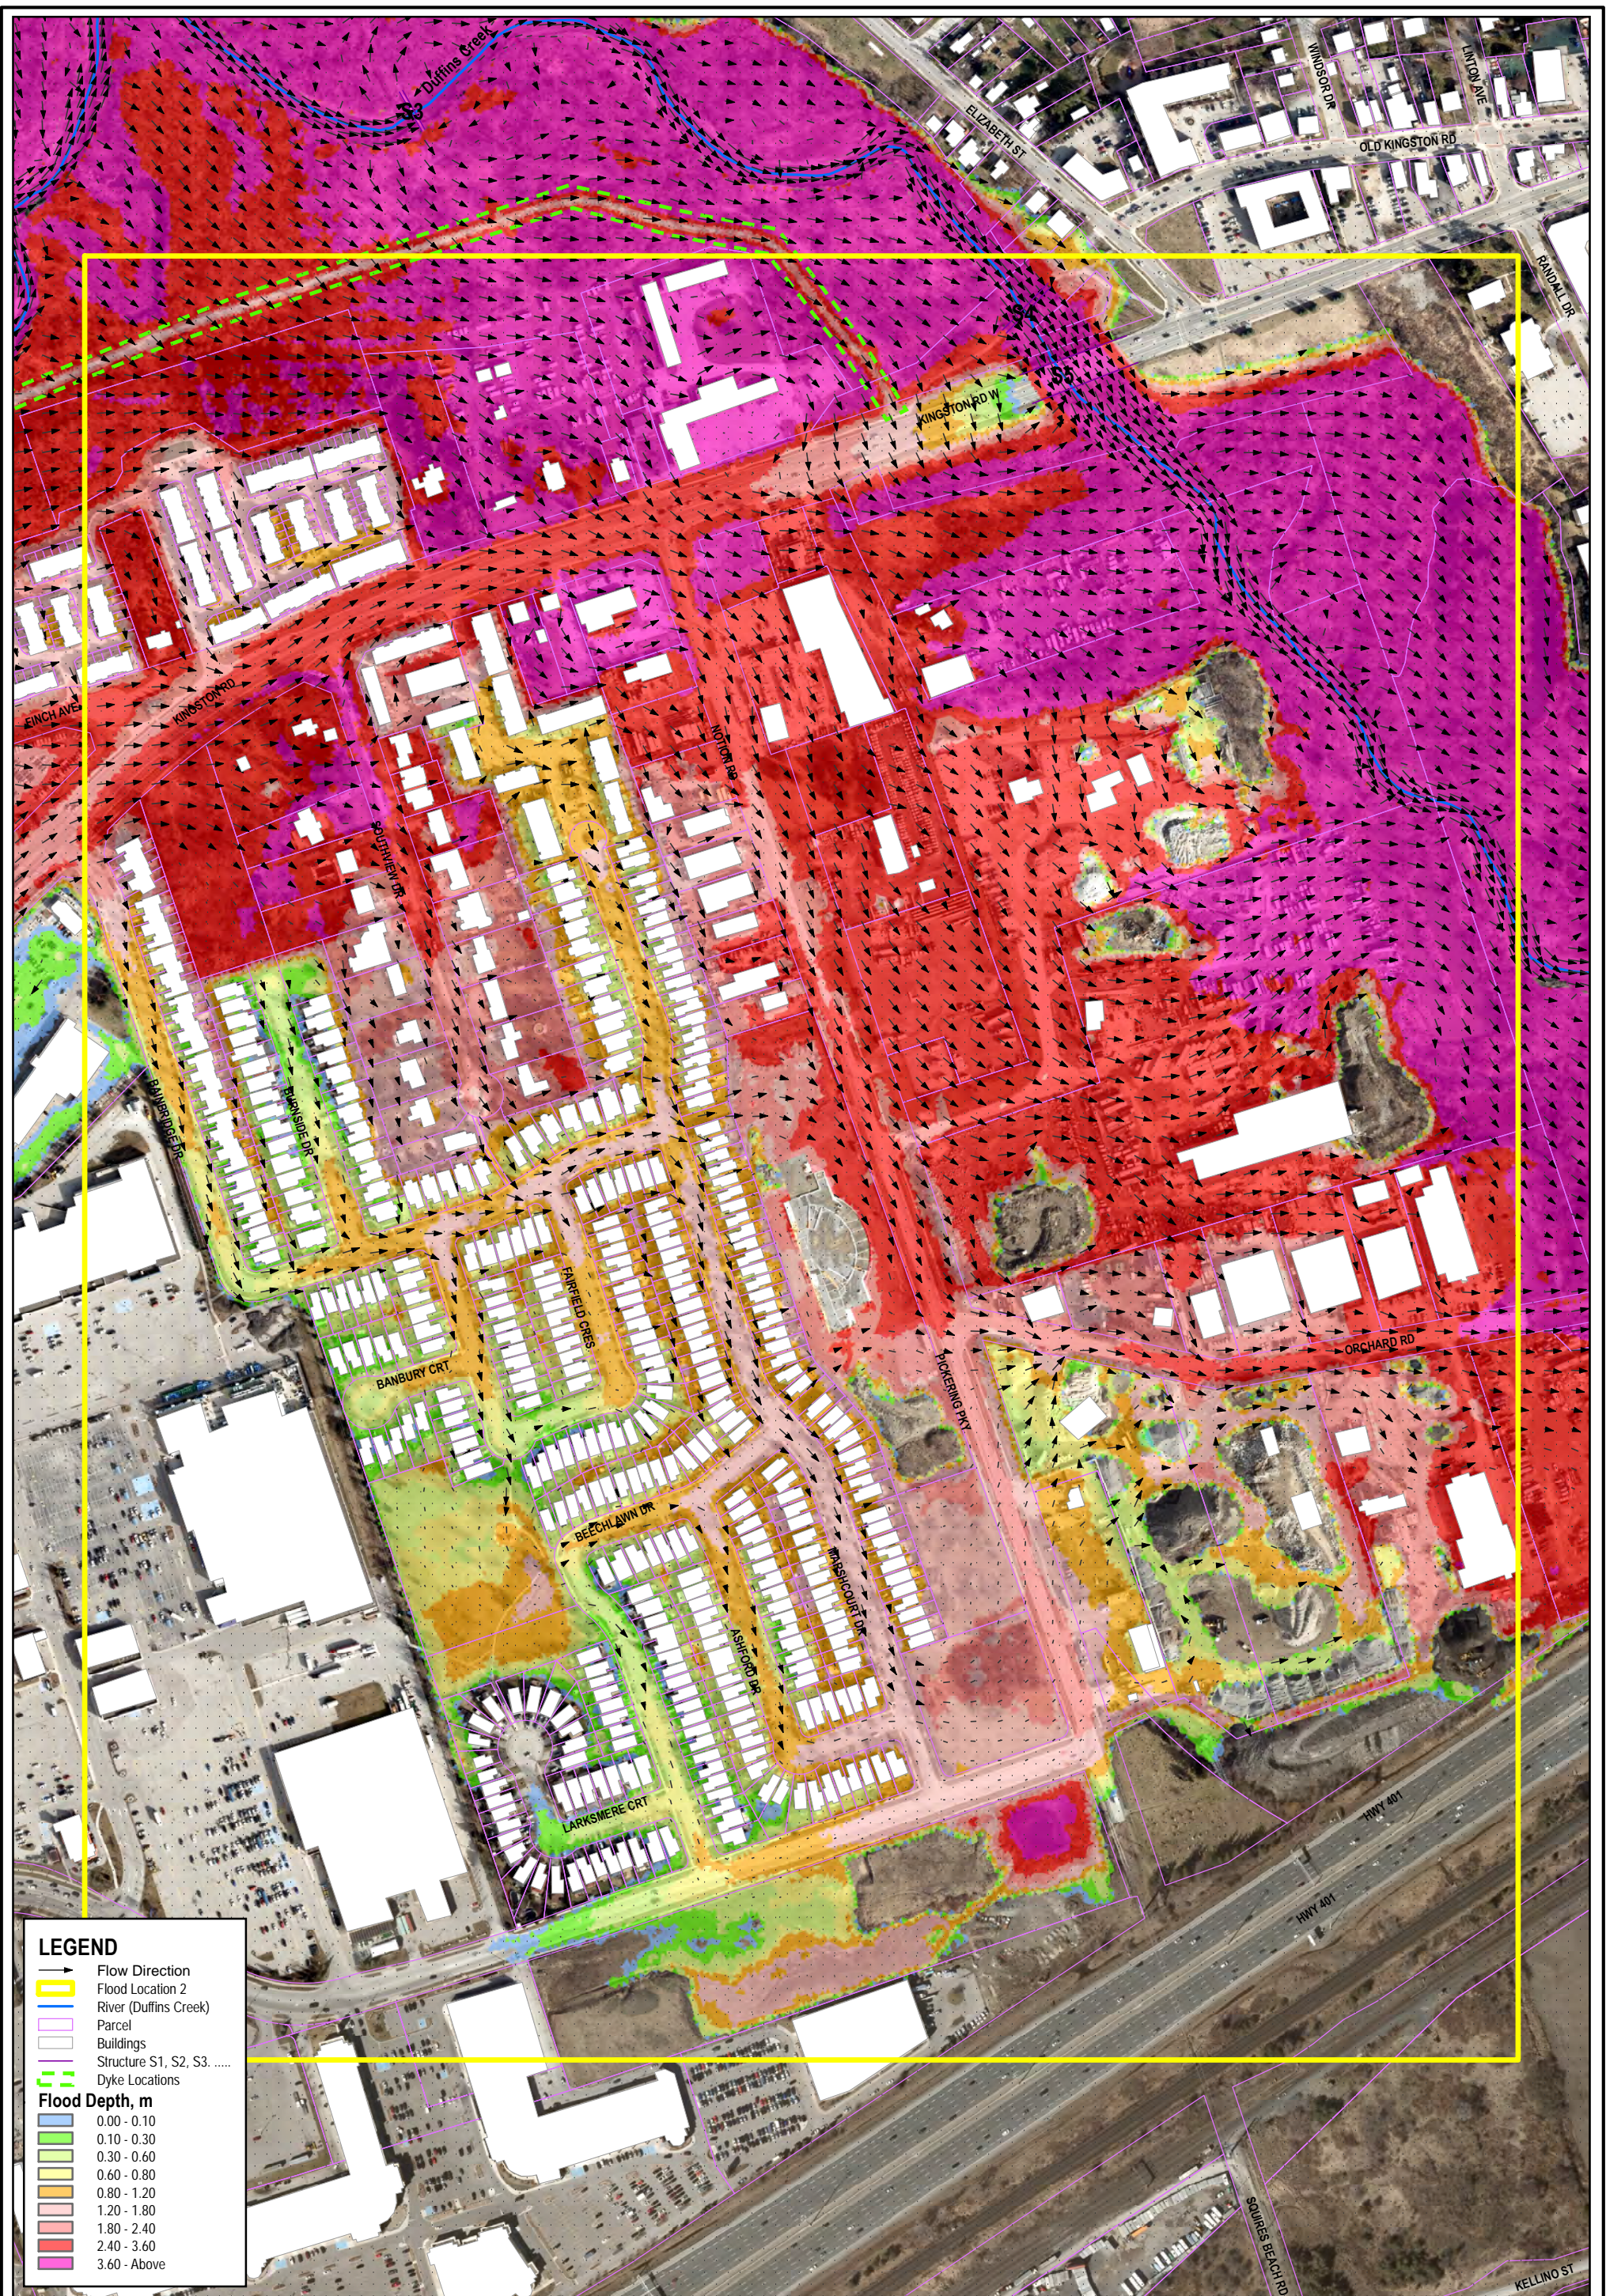
Figure A.5

REGIONAL FLOOD FLOW
(Location 2 - Ref. Figure A.3)

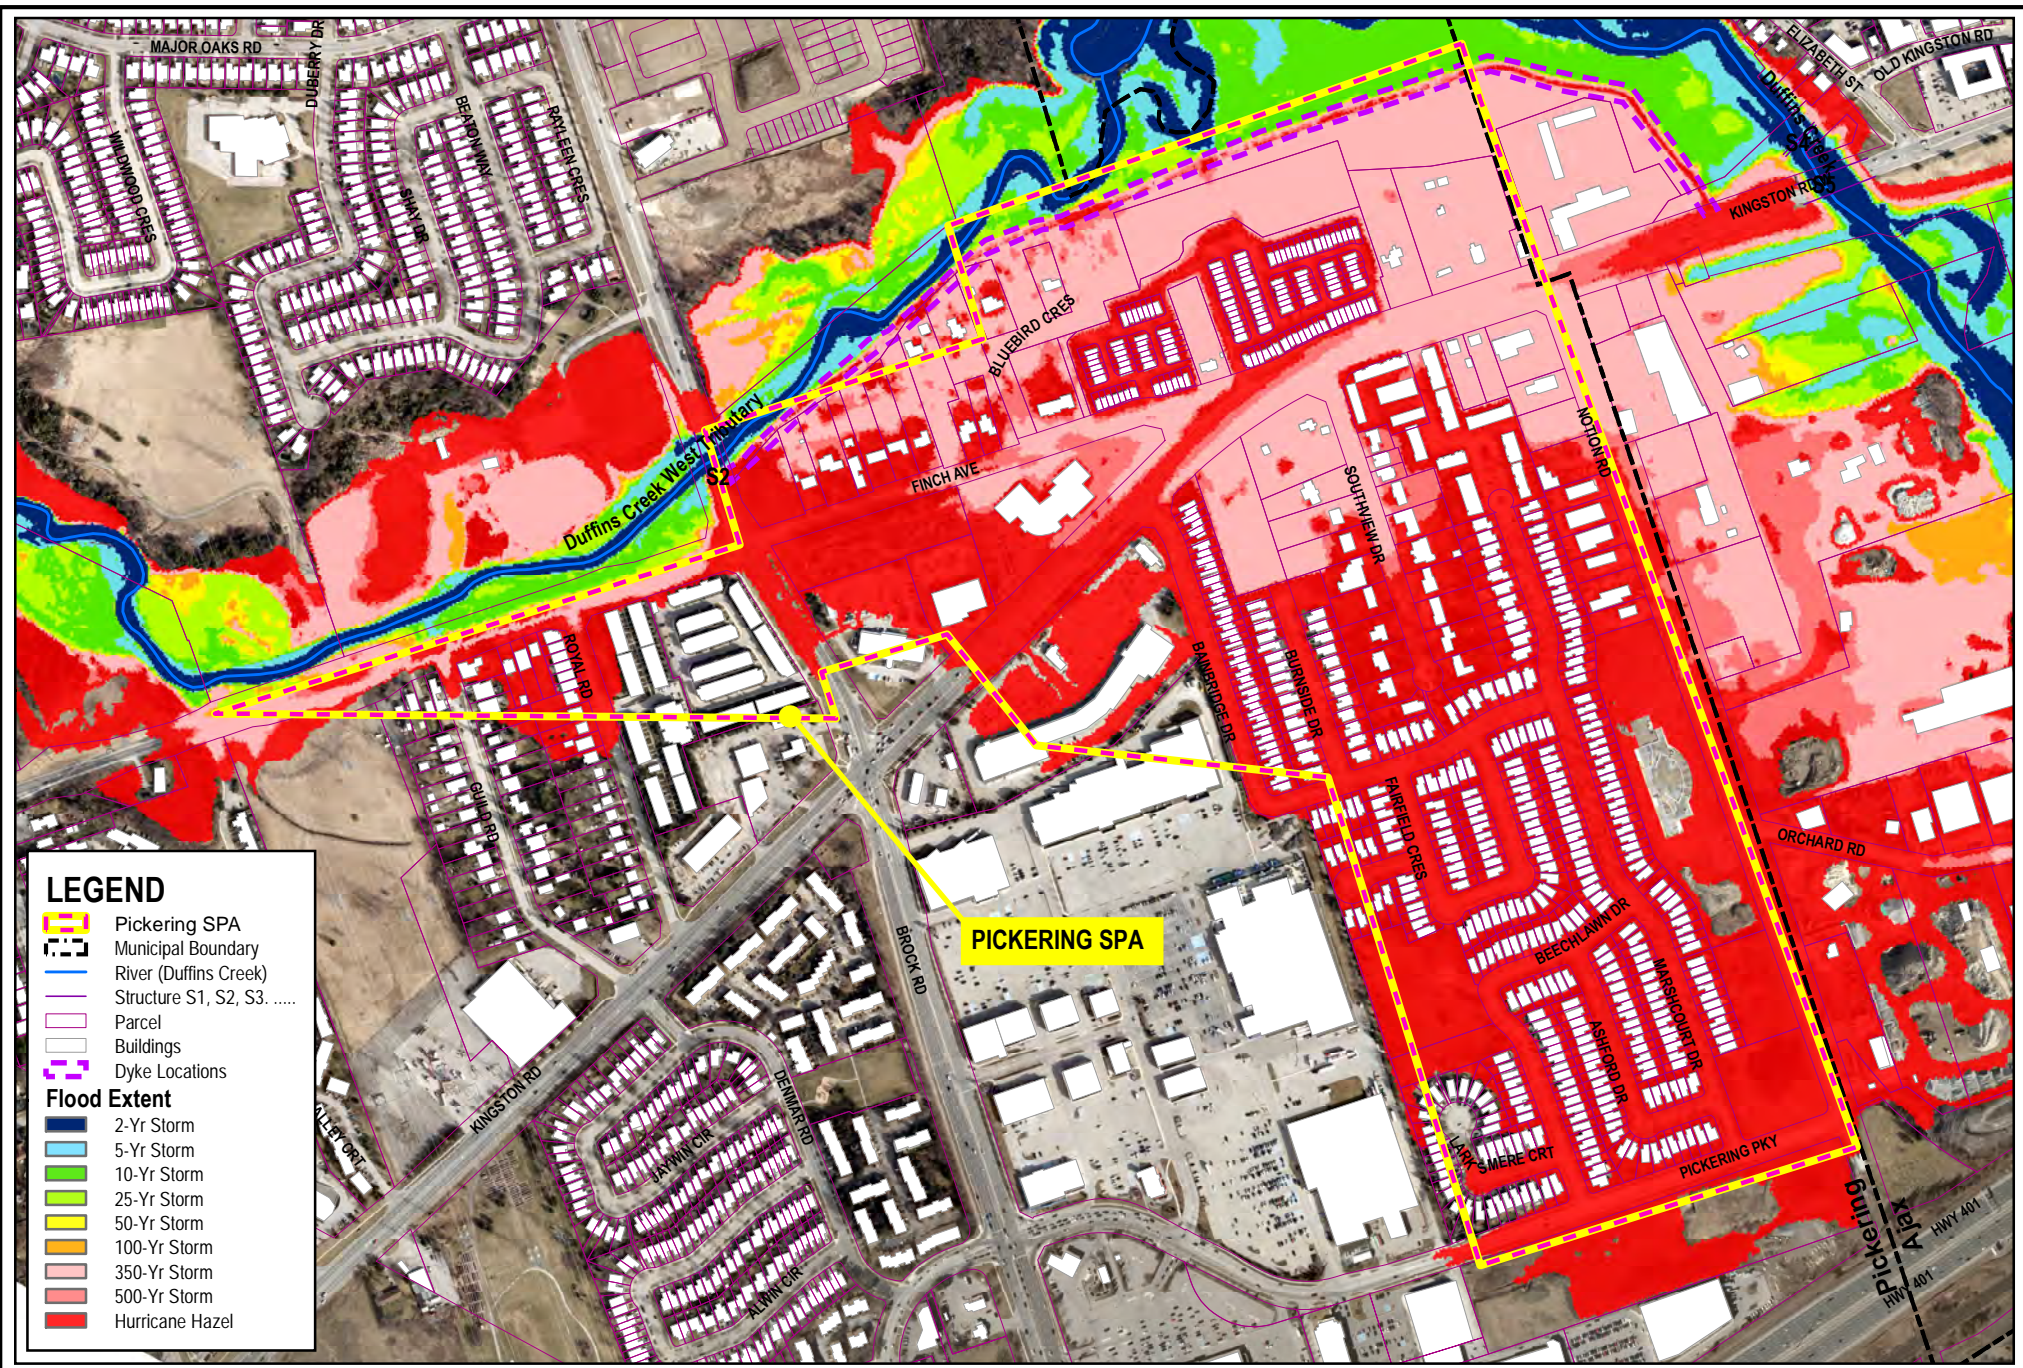
FIGURE A.11
FLOOD EXTENT CORRESPONDING TO VARIOUS STORMS
EXISTING CONDITION - PICKERING SPA
 (Hurricane Hazel, 500-yr, 350-yr, 100-yr, 50-yr, 25-yr,
 10-yr, 5-yr and 2-yr Storms)
